Location map of Dinero dumps and tunnel reclamation projects, west of Leadville, Colorado

Problem

Work to Date

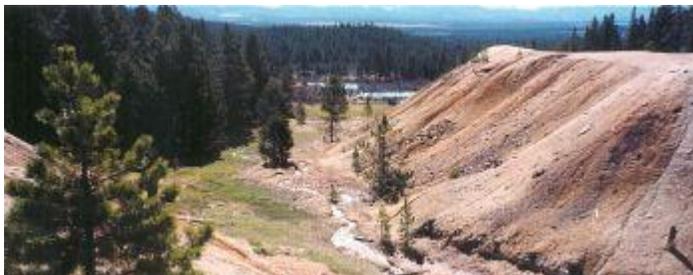
Photo showing South Dinero Dump in wetland

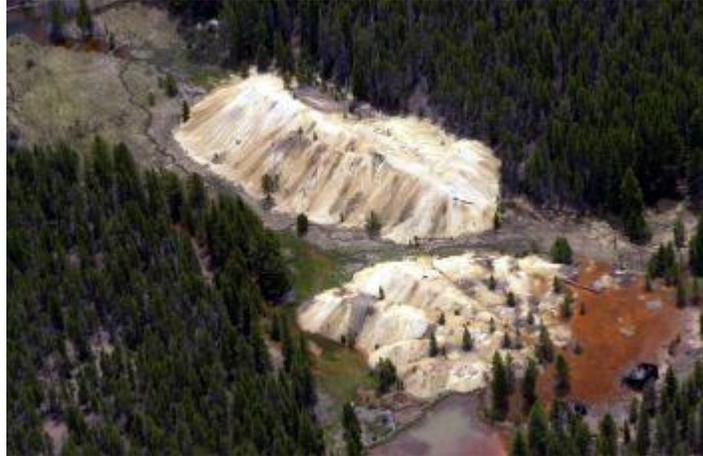
During construction, the lower part of the dumps were very loaded up with water that was "wicking" through the dumps and leaching out metals and contamination. There are many thousands of dumps located in Colorado but not all are a problem. In this situation, the location of the dumps in the wetlands was the primary issue and simply moving them to dry ground solves the problem. One of the extra accomplishments at this site was removing about a foot of original ground below the dumps that had become contaminated with heavy metals and including that along with the other dump materials in the repositories.

Aerial Photo of Dinero Dumps, upper dump is southern dump and closer dump is northern dump

Prior to construction, the two mine dumps were located within the wetlands area of the Sugarloaf Gulch area. The dump on the upper part of the above picture is termed the south dump and the dump on the lower part of the picture is termed the north dump. The decision was made to fold the north dump out of the wetlands to the area just below and south of the tunnel portal. Once this dump was moved, a repository was developed to house the south dump. This repository location also provided cover material for the north dump.

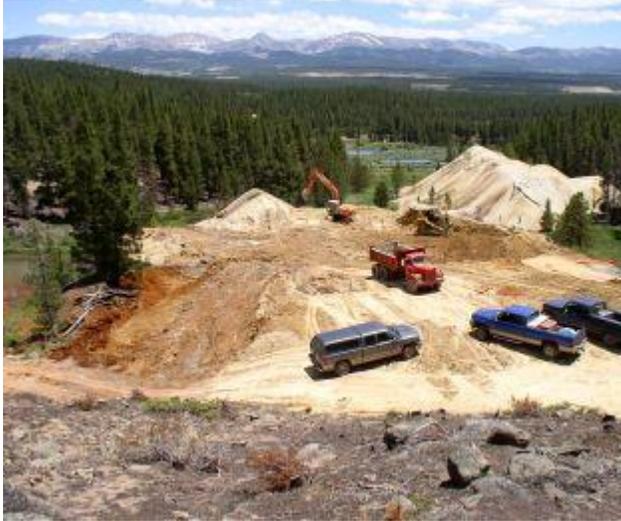
North Dump being folded back out of the wetlands

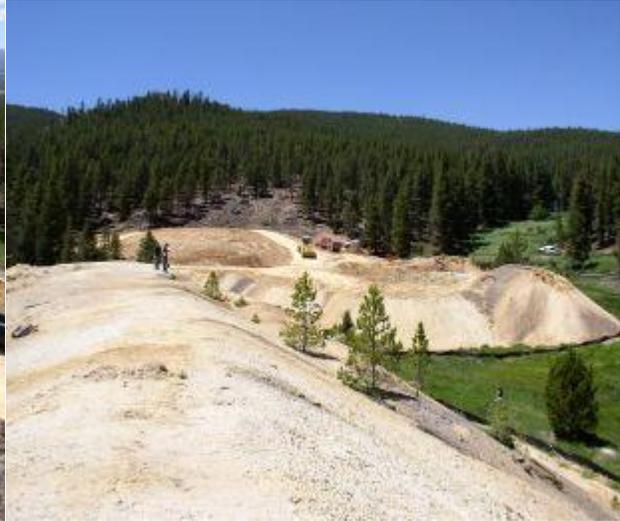
Looking west along the southern dump that is located in the wetlands Construction work on the northern dump is in progress

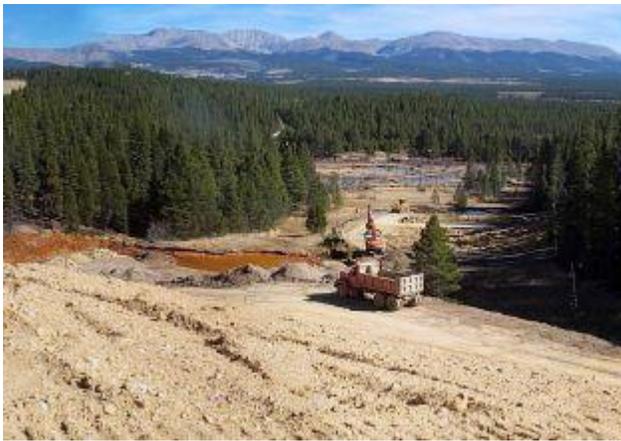
North repository under construction looking east

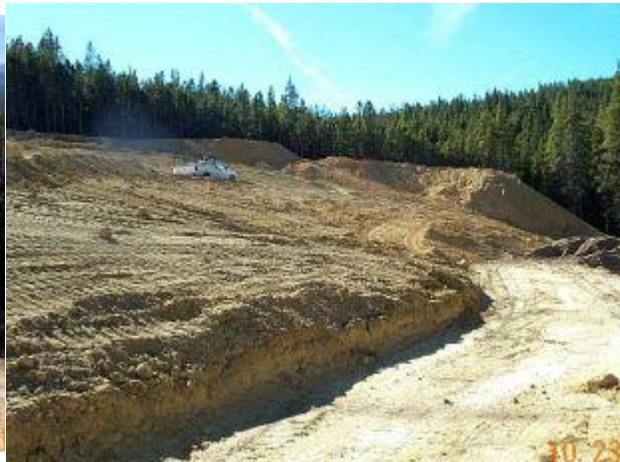
South repository after the majority of materials had been moved out of the wetlands. Cover material/topsoil is stored near the top of the repository.

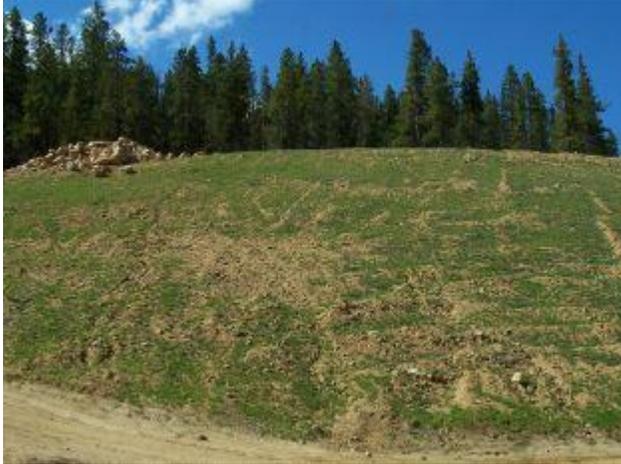
Looking northwest at the northern repository the first year after seeding took place.

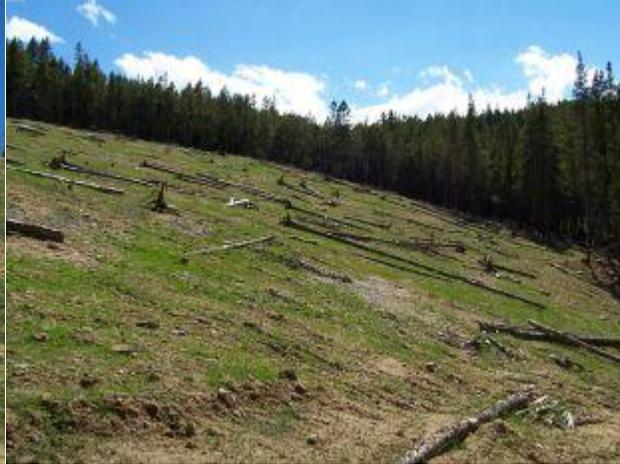
Southern repository one year after seeding took place

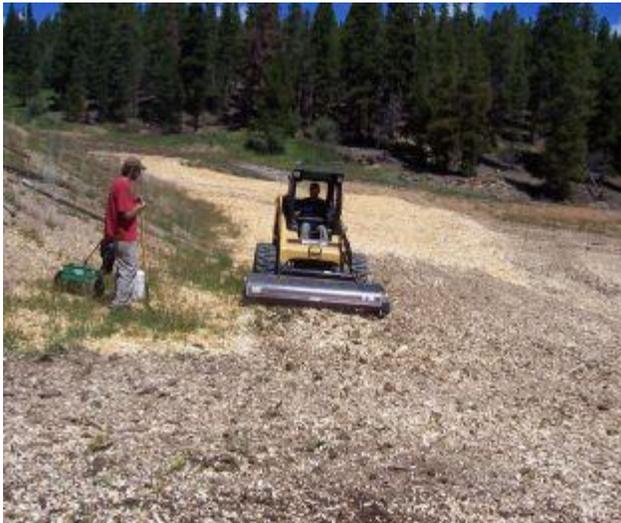
In the wetlands area where the dumps were formerly located, composted wood chips were incorporated into the soils to improve potential for wetlands vegetation to become established.
