Form 1: Document Wilderness Characteristics Inventory Findings on Record

Form 2: Current Conditions: Presence or Absence of Wilderness Characteristics

Area Unique Identifier: COF-020-088, Suzie's Ridge

Wilderness Characteristics Inventory Area Unique Identifier: COF-020-088, Suzie’s Ridge
Route or Route Segment Name and/or Identifier: CO-020-023-A, Fremont County Road 1, CO-020-023-C

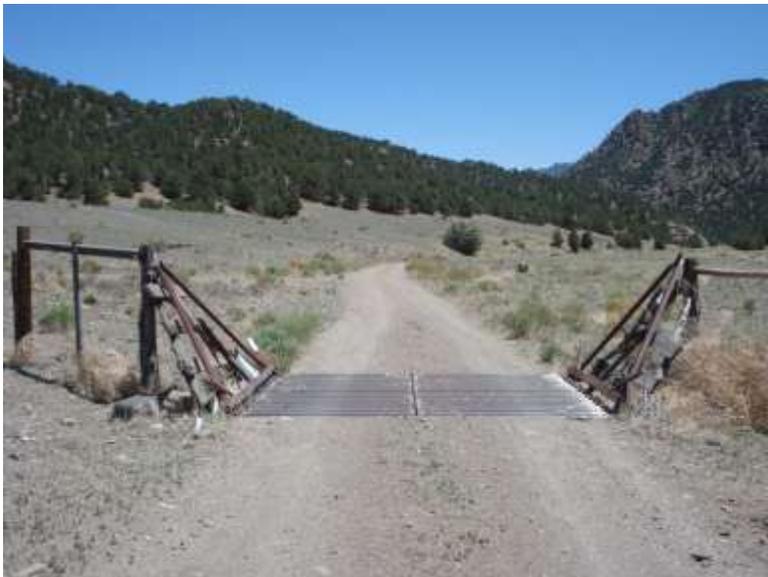
| Date | Frame # | Camera Direc. | Description | GPS/UTM Location | Township | Range | Sec. | Photo Point # |
|---|---|---|---|---|---|---|---|---|
| 6/6/2013 | DSC03633 | E | Cattle guard | See map | 20 S | 72 W | 2 | 1 |

#1, Route condition, Cattle guard

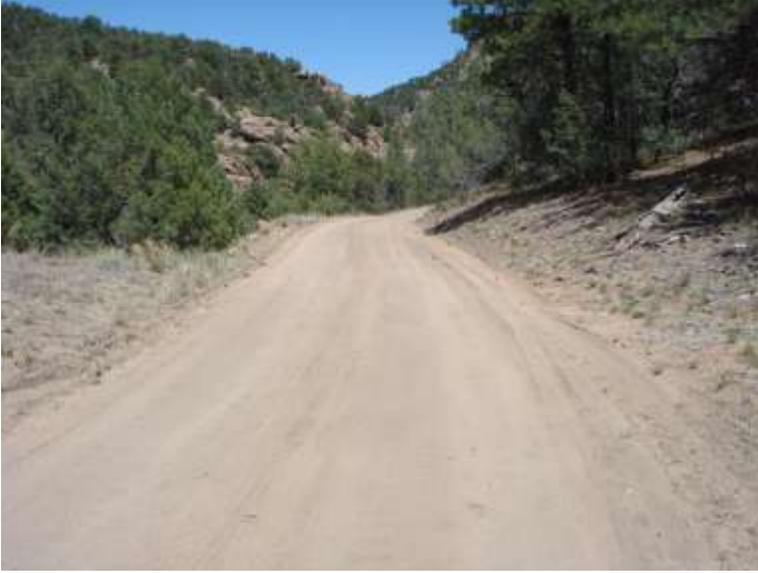
| Date | Frame # | Camera Direc. | Description | GPS/UTM Location | Township | Range | Sec. | Photo Point # |
|---|---|---|---|---|---|---|---|---|
| 6/6/2013 | DSC03641 | E | Route Condition | See map | 20 S | 72 W | 2 | 2 |

2, Route condition

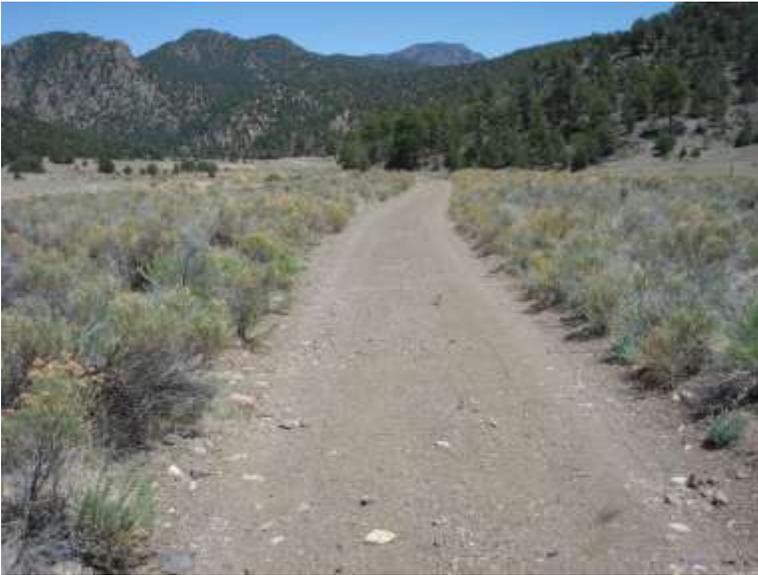
| Date | Frame # | Camera Direc. | Description | GPS/UTM Location | Township | Range | Sec. | Photo Point # |
|---|---|---|---|---|---|---|---|---|
| 6/6/2013 | DSC03642 | E | Route Condition | See map | 20 S | 72 W | 3 | 3 |

#3, Route COndition

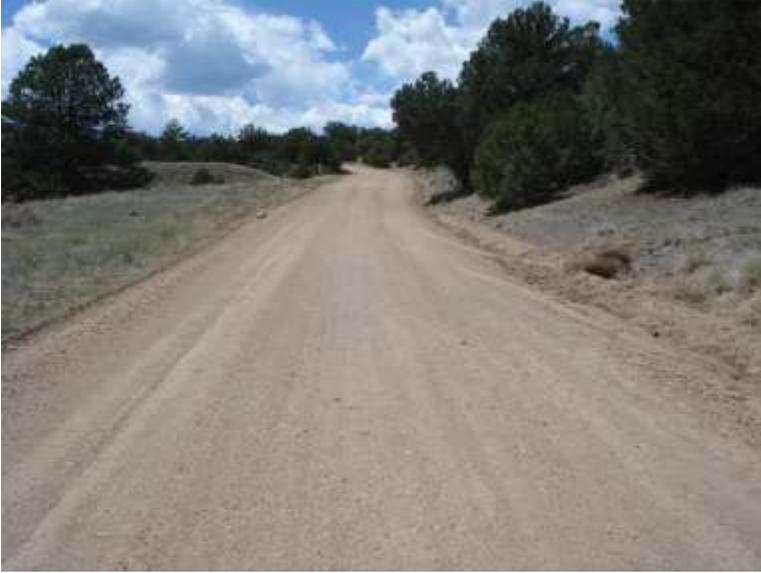
| Date | Frame # | Camera Direc. | Description | GPS/UTM Location | Township | Range | Sec. | Photo Point # |
|---|---|---|---|---|---|---|---|---|
| 6/6/2013 | DSC03644 | NW | Route Condition | See map | 19 S | 72 W. | 33 | 4 |

#4, Fremont County Road condition

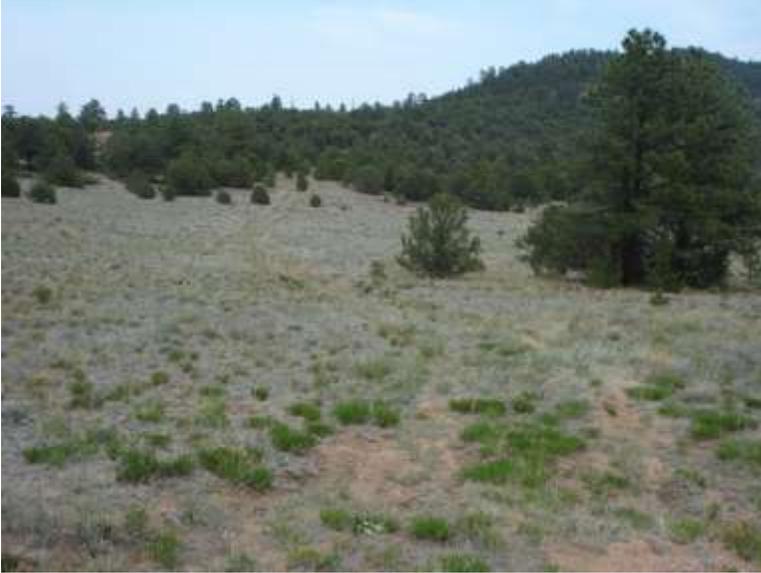
| Date | Frame # | Camera Direc. | Description | GPS/UTM Location | Township | Range | Sec. | Photo Point # |
|---|---|---|---|---|---|---|---|---|
| 6/20/2013 | DSC03675 | NE | Beginning of route | See map | 19 S | 72 W. | 26 | 6 |

#6, beginning of route

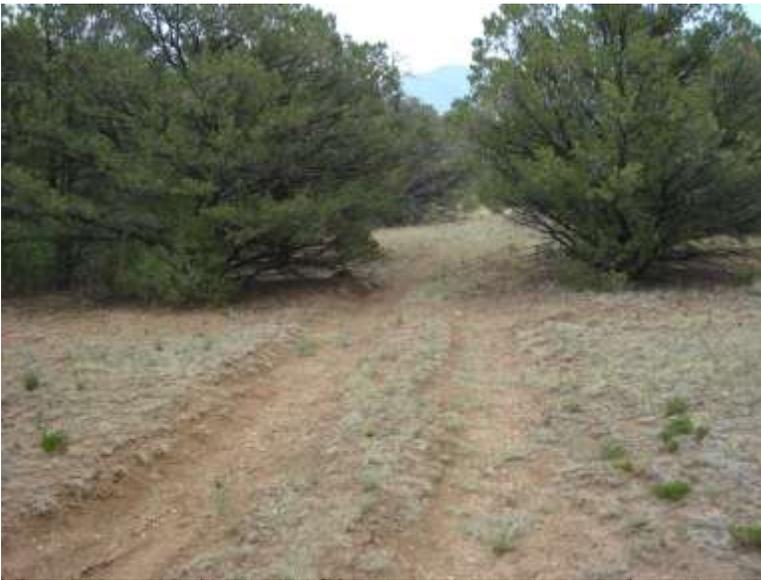
| Date | Frame # | Camera Direc. | Description | GPS/UTM Location | Township | Range | Sec. | Photo Point # |
|---|---|---|---|---|---|---|---|---|
| 6/20/2013 | DSC03676 | NE | Beginning of route | See map | 19 S | 72 W. | 26 | 7 |

#7, beginning of route

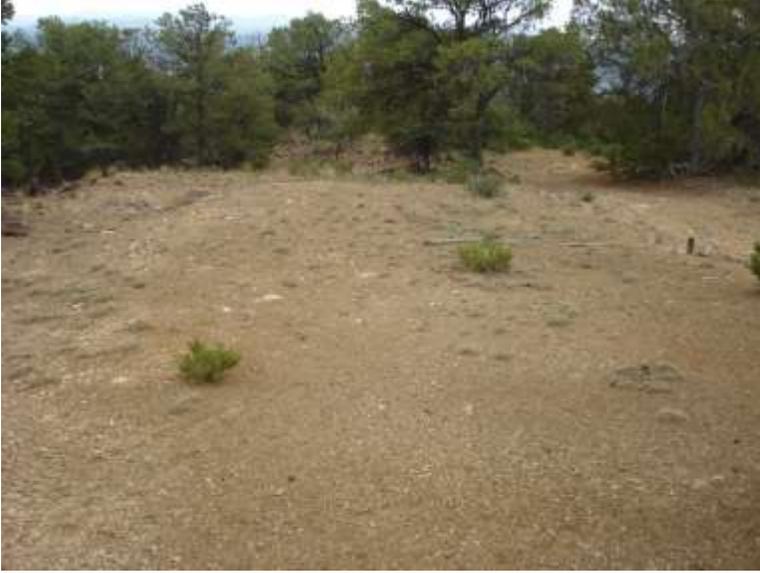
| Date | Frame # | Camera Direc. | Description | GPS/UTM Location | Township | Range | Sec. | Photo Point # |
|---|---|---|---|---|---|---|---|---|
| 6/20/2013 | DSC03677 | S | Drill Site | See map | 19 S | 72 W. | 26 | 8 |

#8, Drilling site

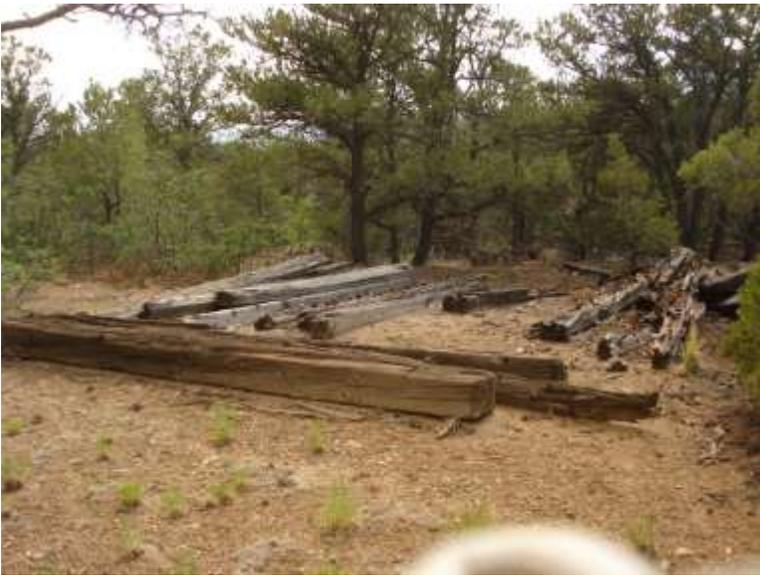
| Date | Frame # | Camera Direc. | Description | GPS/UTM Location | Township | Range | Sec. | Photo Point # |
|---|---|---|---|---|---|---|---|---|
| 6/20/2013 | DSC03685 | W | Milled Beams | See map | 19 S | 72 W. | 26 | 9 |

#9, Milled lumber

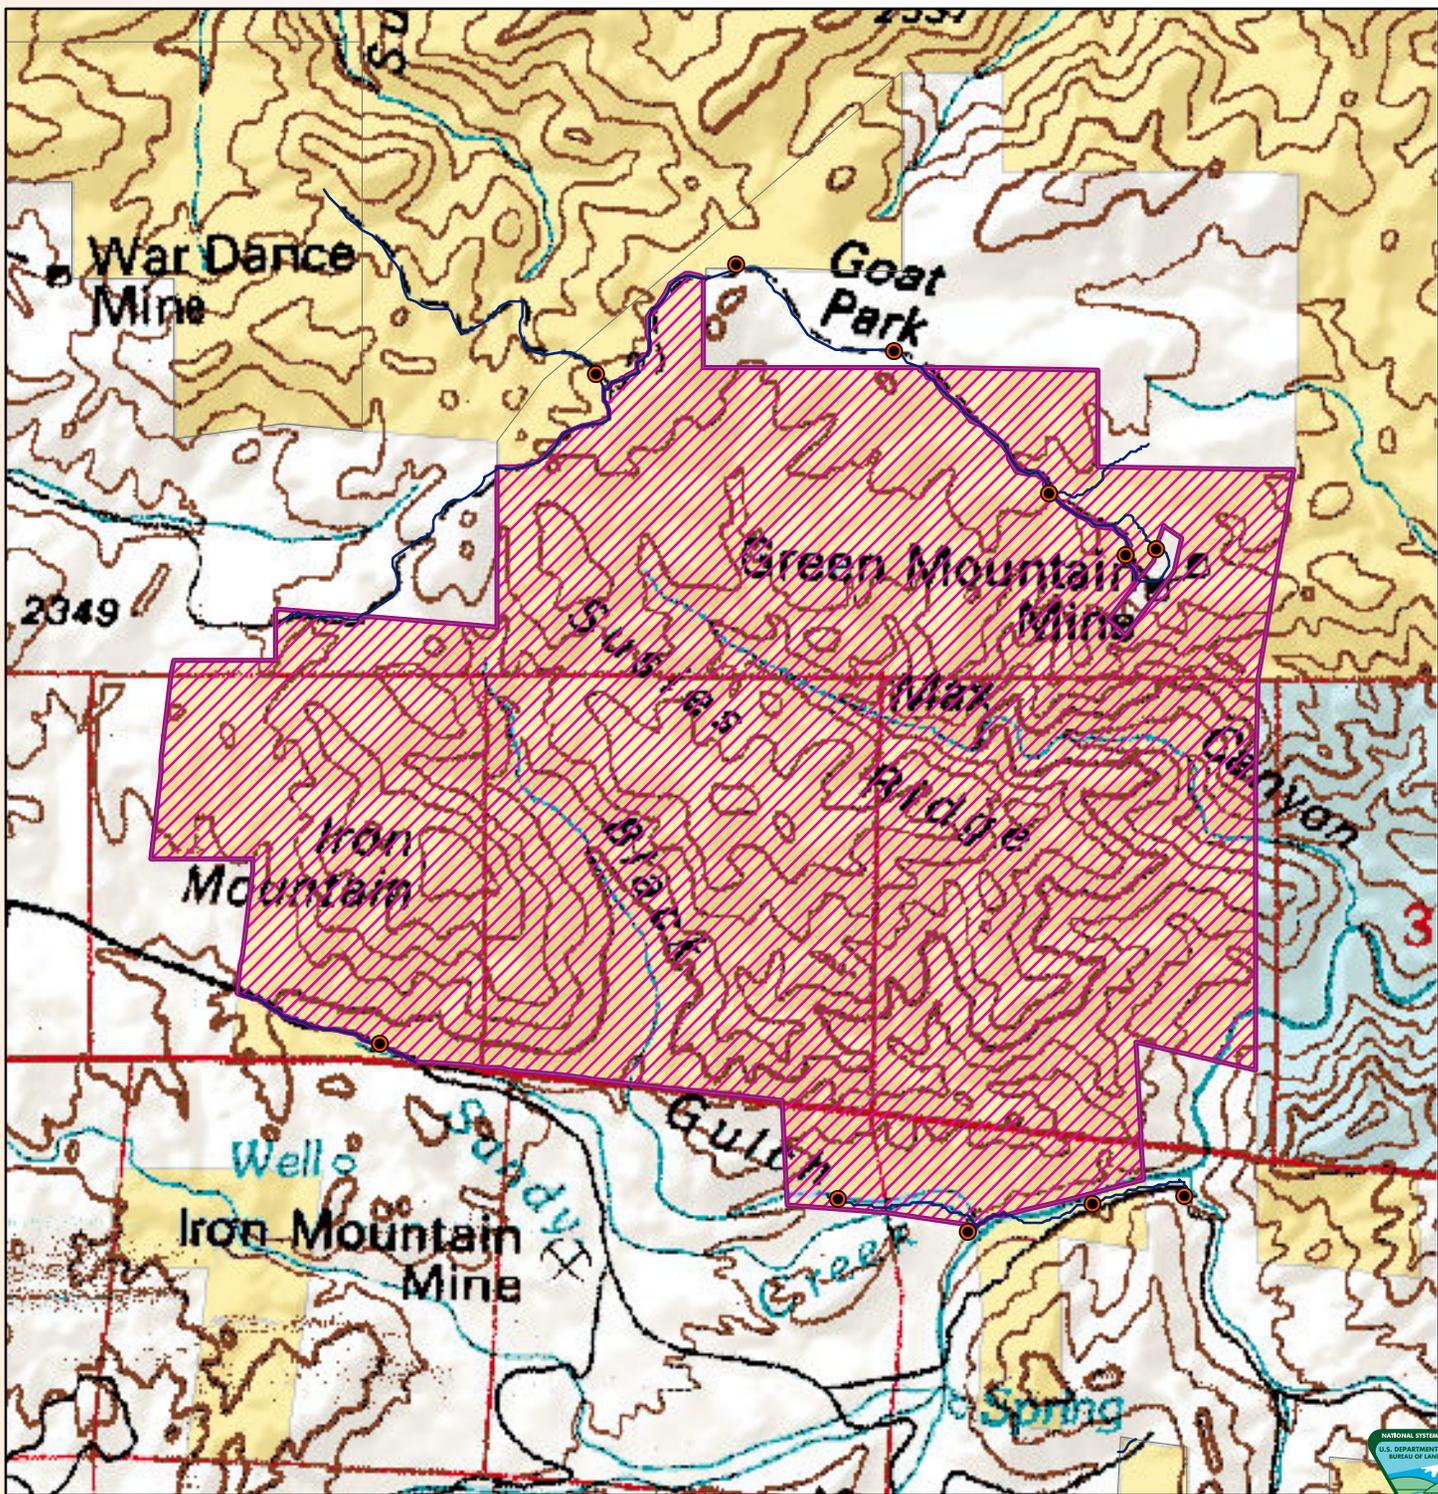
COF-020-088 Acreage: 2830.7

The map shows the parcel inventoried for wilderness characteristics and routes collected by GPS.
