# Form 1: Document Wilderness Characteristics Inventory Findings on Record

## Form 2: Current Conditions: Presence or Absence of Wilderness Characteristics

Area Unique Identifier: COF-020-042, Cucharas Canyon

## PHOTO LOG

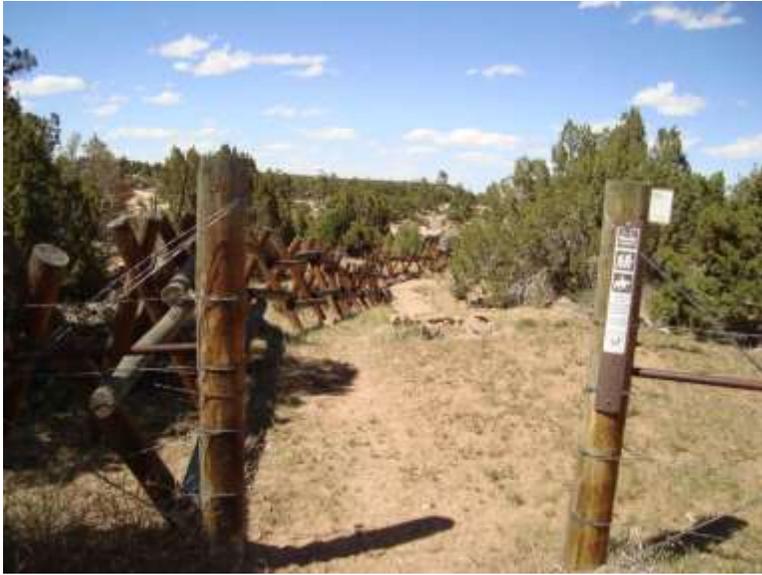
#1

<b>Date</b>	<b>Frame #</b>	<b>Camera Direc.</b>	<b>Description</b>	<b>UTM Zone 13</b>	<b>Town- ship</b>	<b>Range</b>	<b>Sec.</b>	<b>Photo Point #</b>
6/1/2013	DSC01381	N	Trail sign	N 4,188,753.24041 E 537,125.034776	25 S	64 W	29	1
6/1/2013	DSC01382	E	Property corner, fence	N 4,191,002.20324 E 537,614.514922	25 S	64 W	23	2
6/1/2013	DSC01383	E	Closed route	N 4,190,975.74486 E 537,627.744115	25 S	64 W	23	3
6/1/2013	DSC01384	E	Scenic	N 4,190,949.28647 E 537,773.265239	25 S	64 W	23	4
6/1/2013	DSC01385	W	Route condition	N 4,190,949.28647 E 537,773.265239	25 S	64 W	23	5
6/1/2013	DSC01391	E	Beginning of Sheep Crossing	N 4,184,374.37749 E 535,974.094974	26 S	64 W	8	6
6/1/2013	DSC01392	S	Route off sheep crossing	N 4,184,268.54394 E 536,331.283189	26 S	64 W	8	7
6/1/2013	DSC01393	W	End of route, sheep crossing	N 4,184,308.23152 E 536,767.846562	26 S	64 W	8	8
6/1/2013	DSC01394	NE	Metal gate, no motor vehicle sign	N 4,184,334.68991 E 536,794.304948	26 S	64 W	8	9

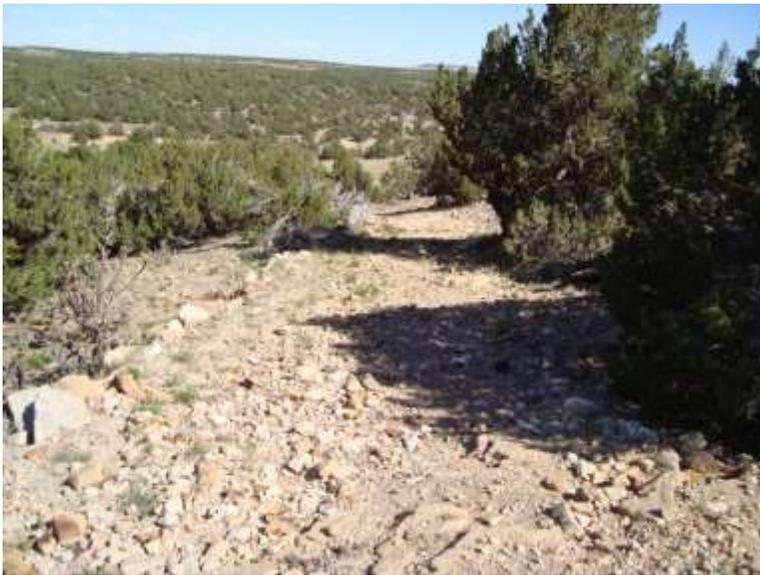
#10

6/1/2013	DSC01395	SE	Administrative route, Route Condition	N 4,184,295.00233 E 536,860.450914	26 S	64 W	8	10
6/1/2013	DSC01397	S	Route Condition	N 4,184,136.25201 E 536,992.742845	26 S	64 W	8	11
6/2/2013	DSC01400	W	Route past closed gate	N 4,185,869.27631 E 540,868.89643	26 S	64 W	3	12

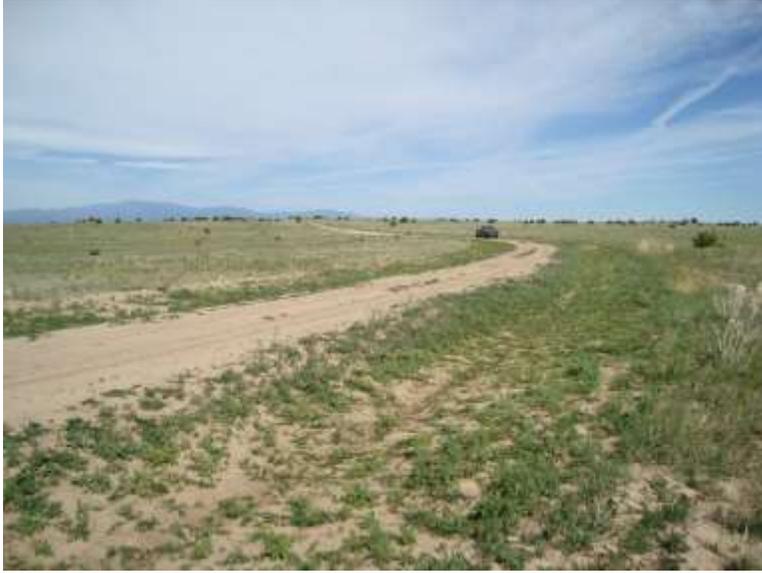
#13

6/2/2013	DSC01403	W	Route, Kenner Ranch Road Condition	N 4,188,396.0522 E 540,855.667237	25 S	64 W	27	13
6/2/2013	DSC01404	S	Kenner Ranch road facing south	N 4,188,396.0522 E 540,855.667237	25 S	64W	27	14
6/2/2013	DSC01406	N	Beginning of route	N 4,188,713.55283 E 539,598.89389	25 S	64 W	27	15
6/2/2013	DSC01407	N	Non maintained route	N 4,188,779.6988 E 539,559.206311	25 S	64 W	27	16
6/2/2013	DSC01409	W	Route Condition	N 4,188,713.55283 E 539,585.664697	25 S	64 W	27	17
6/2/2013	DSC01410	S	Facing ranch, CR ends at parking lot	N 4,188,713.55283 E 539,585.664697	25 S	64 W	27	18
6/2/2013	DSC01411	S	Stock ponds	N 4,188,607.71929 E 539,612.123084	25 S	24 W	27	19
6/2/2013	DSC01412	W	Route with tank in	N 4,188,396.0522 E 539,532.747925	25 S	64 W	27	20
6/2/2013	DSC01413	S	Route Condition	N, 187,602.30061 E 539,162.330517	26 S	64 W	33	21
6/2/2013	DSC01414	W	Route traveling to rim	N, 187,602.30061 E 539,162.330517	26 S	64 W	33	22

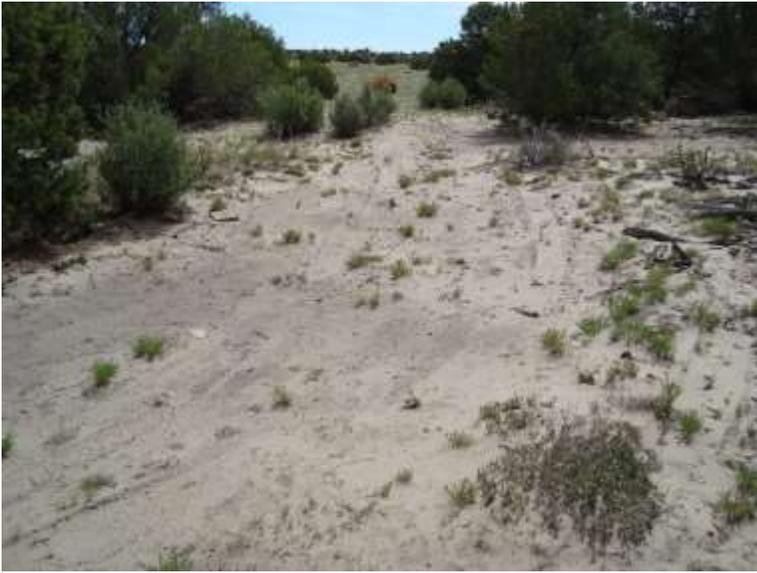
#24

6/2/2013	DSC01415	W	End of route	N 4,187,562.61303 E 538,871.288269	25 S	64 W	33	23
6/2/2013	DSC01416	S	End of route, CO-020-042-E, facing south	N 4,187,112.82046 E 539,598.89389	25 S	64 W	34	24
6/2/2013	DSC01417	N	End of route, CO-020-042-E, facing north	N 4,187,112.82046 E 539,598.89389	25 S	64 W	34	25
6/2/2013	DSC01423	E	At Kenner Ranch, facing E	N 4,188,660.63606 E 539,294.622449	25 S	64 W	27	26
6/2/2013	DSC01424	W	Facing west of Kenner Ranch	N 4,188,660.63606 E 539,294.622449	25 S	64 W	27	27
6/2/2013	DSC01425	W	Kenner Ranch view inside Gate	N 4,188,660.63606 E 539,294.622449	25 S	64 W	27	28

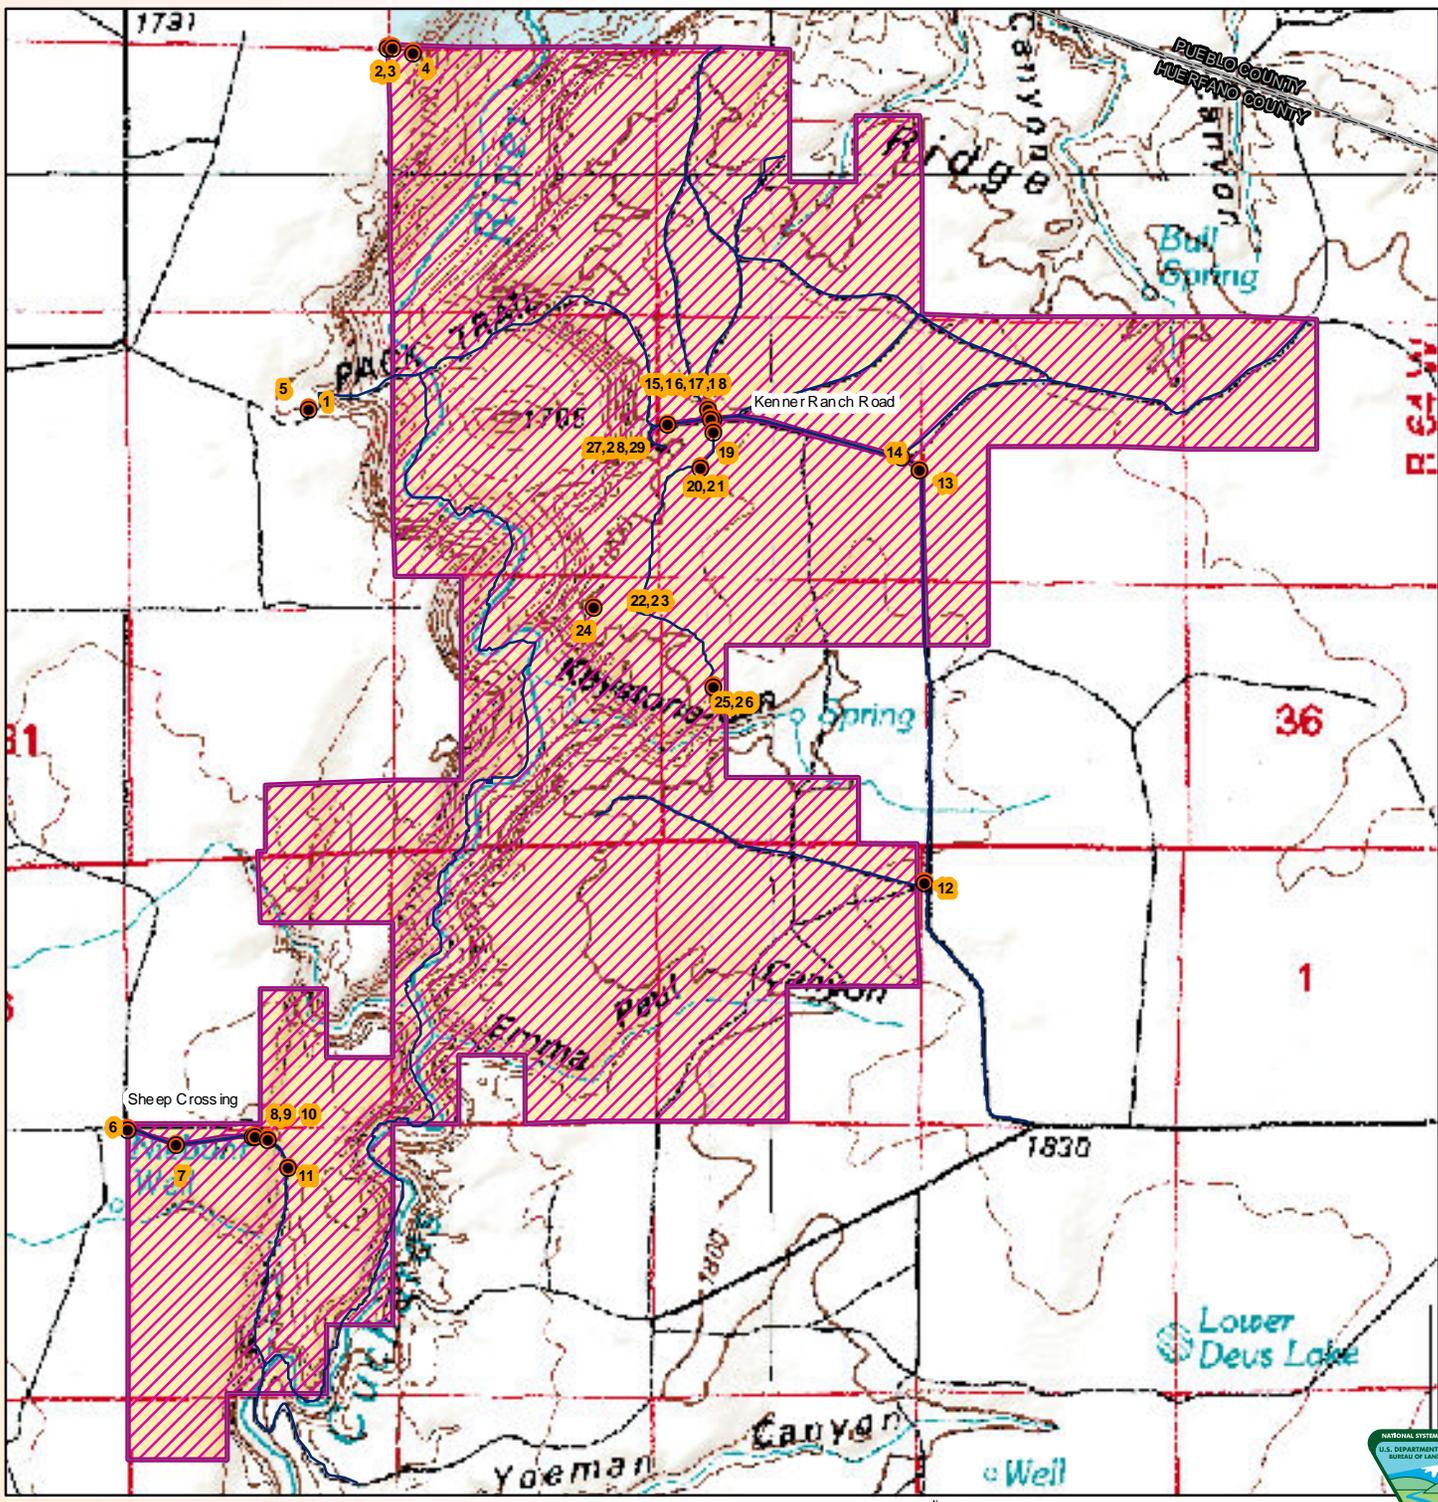
**COF-020-042**

The map shows the parcel inventoried for wilderness characteristics, and routes and photo points collected by GPS
