Form 1: Document Wilderness Characteristics Inventory Findings on Record

Form 2: Current Conditions: Presence or Absence of Wilderness Characteristics

Area Unique Identifier: CO-020-048, Poverty Mountain

PHOTO LOG

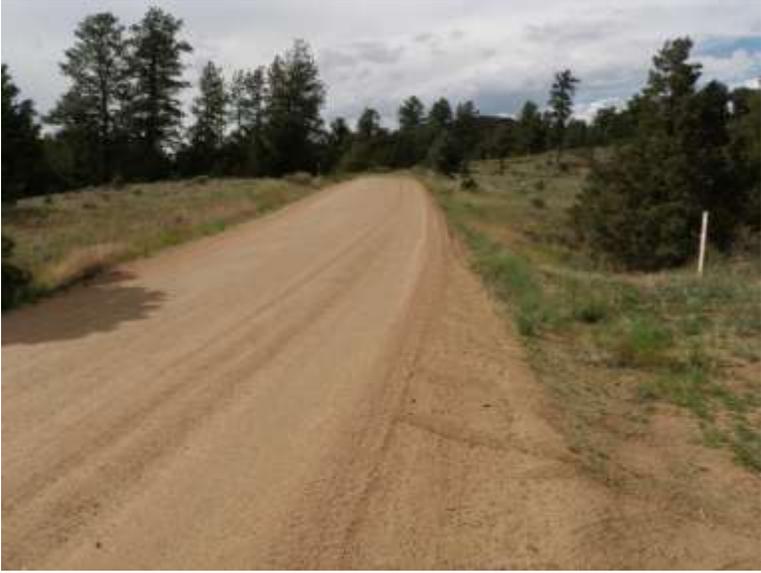
#1

| Date | Frame # | Camera Direc. | Description | GPS/UTM Location | Township | Range | Sec. | Photo Point # |
|---|---|---|---|---|---|---|---|---|
| 6/18/2013 | P6180478 | SE | Route condition | See map | 19 S. | 73 W. | 24 | 1 |

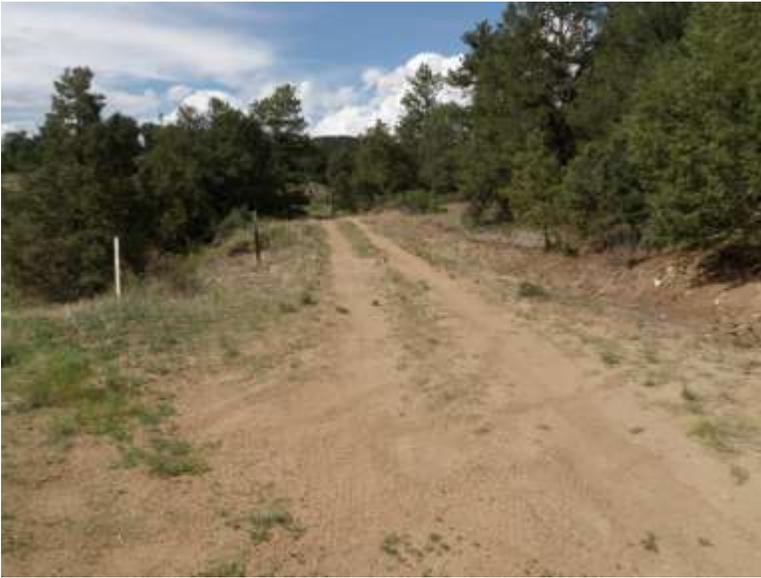
#2

| Date | Frame # | Camera Direc. | Description | GPS/UTM Location | Township | Range | Sec. | Photo Point # |
|---|---|---|---|---|---|---|---|---|
| 6/18/2013 | P6180479 | N | Trail signs | See map | 19 S. | 73 W. | 25 | 2 |

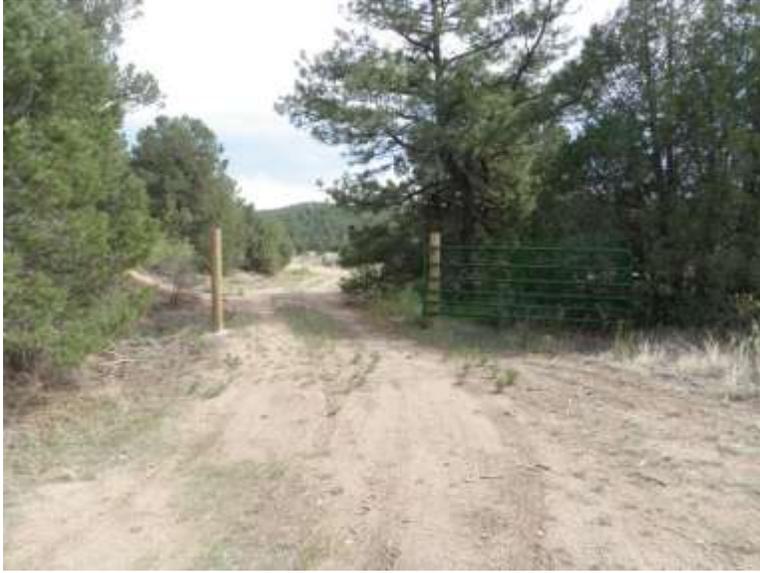
#3

| Date | Frame # | Camera Direc. | Description | GPS/UTM Location | Township | Range | Sec. | Photo Point # |
|---|---|---|---|---|---|---|---|---|
| 6/18/2013 | P6180480 | NE | Green pipe gate | See map | 19 S. | 73 W. | 25 | 3 |

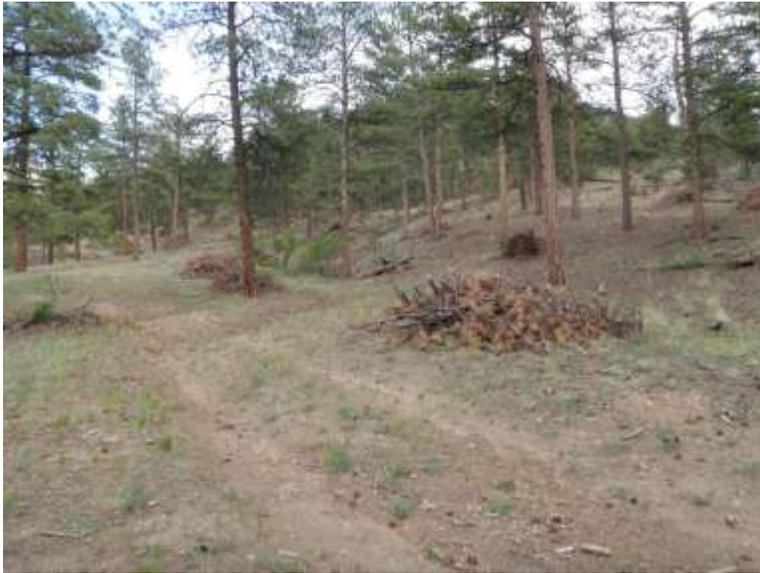
#4

mitigation. There are numerous stumps and slash piles that affect the natural character of the unit. Other disturbances in the area are created by public use. Trash piles, shooting ranges, and dispersed camping are all noticeable disturbances. The accumulative impacts of the man-made features within the unit affect the overall naturalness of the area; therefore the unit does not possess wilderness characteristics.

| Date | Frame # | Camera Direc. | Description | GPS/UTM Location | Township | Range | Sec. | Photo Point # |
|---|---|---|---|---|---|---|---|---|
| 6/18/2013 | P6180481 | E | Veg. Treatment project. | See map | 19 S. | 73 W. | 24 | 4 |

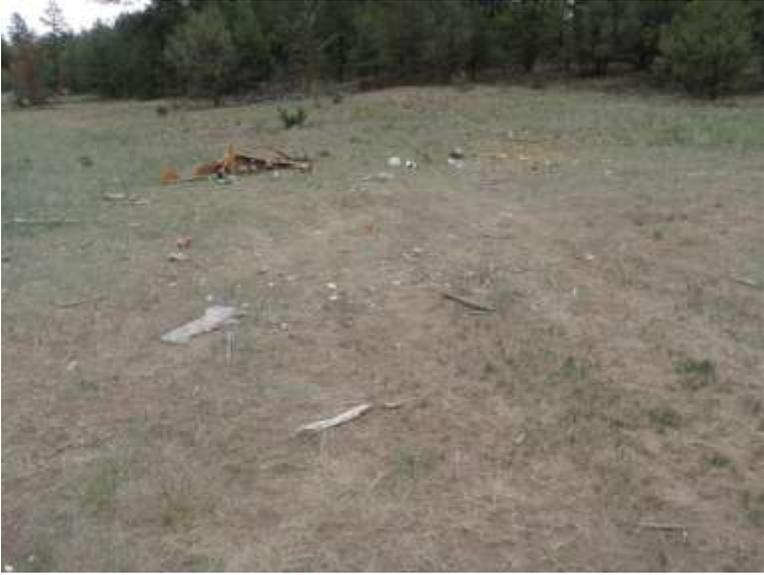
#5

| Date | Frame # | Camera Direc. | Description | GPS/UTM Location | Township | Range | Sec. | Photo Point # |
|---|---|---|---|---|---|---|---|---|
| 6/18/2013 | P6180485 | NE | Target shooting | See map | 19 S. | 73 W. | 25 | 5 |

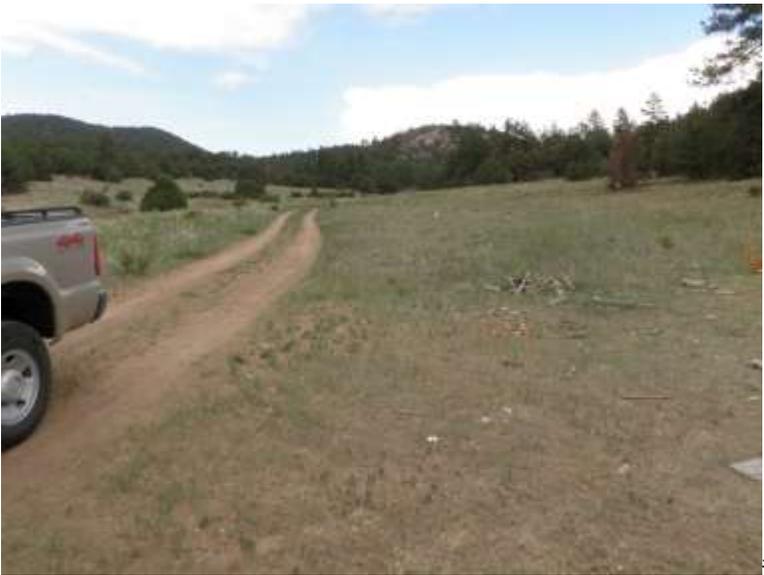
| Date | Frame # | Camera Direc. | Description | GPS/UTM Location | Township | Range | Sec. | Photo Point # |
|---|---|---|---|---|---|---|---|---|
| 6/18/2013 | P6180486 | N | Route Condition | See map | 19 S. | 72 W. | 20 | 6 |

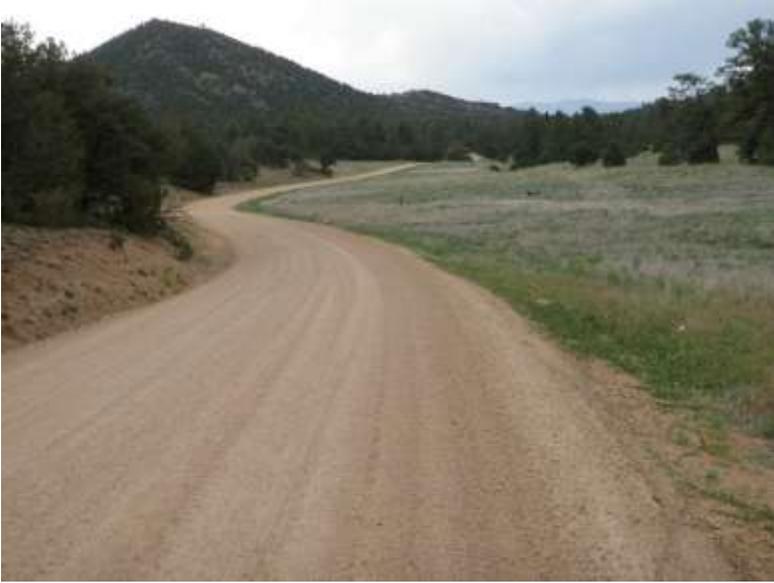
#7

| Date | Frame # | Camera Direc. | Description | GPS/UTM Location | Township | Range | Sec. | Photo Point # |
|---|---|---|---|---|---|---|---|---|
| 6/18/2013 | P6180487 | W | Route Condition | See map | 19 S. | 72 W. | 20 | 7 |

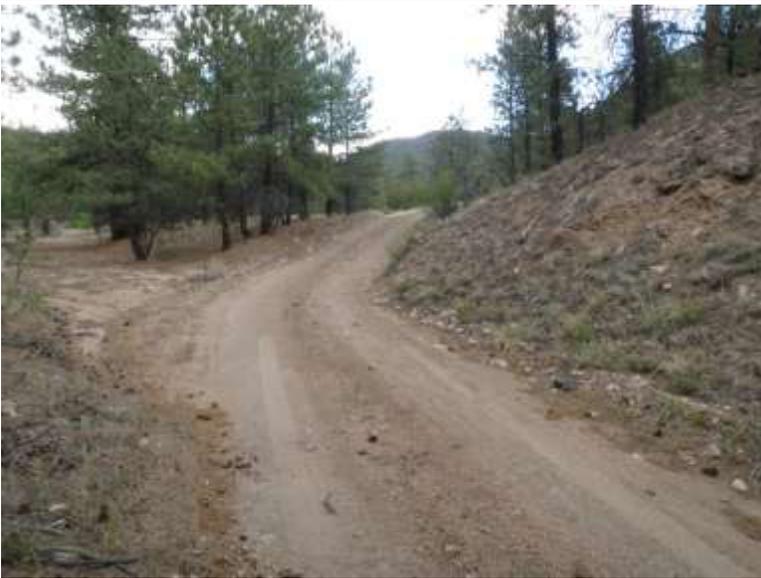
| Date | Frame # | Camera Direc. | Description | GPS/UTM Location | Township | Range | Sec. | Photo Point # |
|---|---|---|---|---|---|---|---|---|
| 6/18/2013 | P6180488 | NW | Route condition | See map | 19 S. | 72 W. | 17 | 8 |

#8, Route BLM 6170

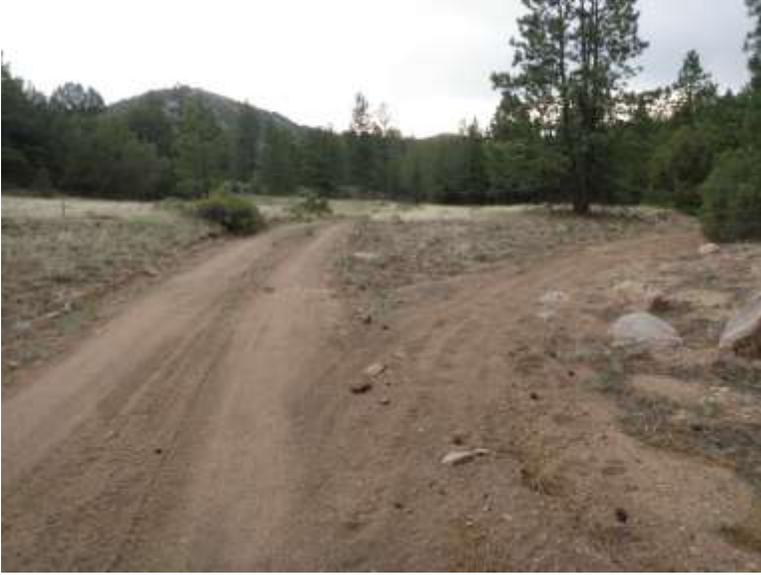
| Date | Frame # | Camera Direc. | Description | GPS/UTM Location | Township | Range | Sec. | Photo Point # |
|---|---|---|---|---|---|---|---|---|
| 6/18/2013 | P6180489 | NE | Route intersection | See map | 19 S. | 72 W. | 17 | 9 |

#9 intersection

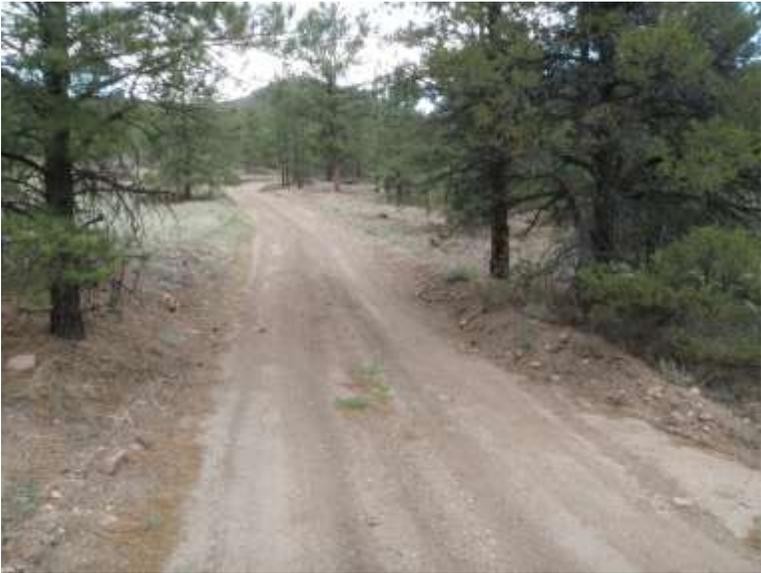
#10

| Date | Frame # | Camera Direc. | Description | GPS/UTM Location | Township | Range | Sec. | Photo Point # |
|---|---|---|---|---|---|---|---|---|
| 6/18/2013 | P6180490 | E | Route Condition | See map | 19 S. | 72 W. | 18 | 10 |

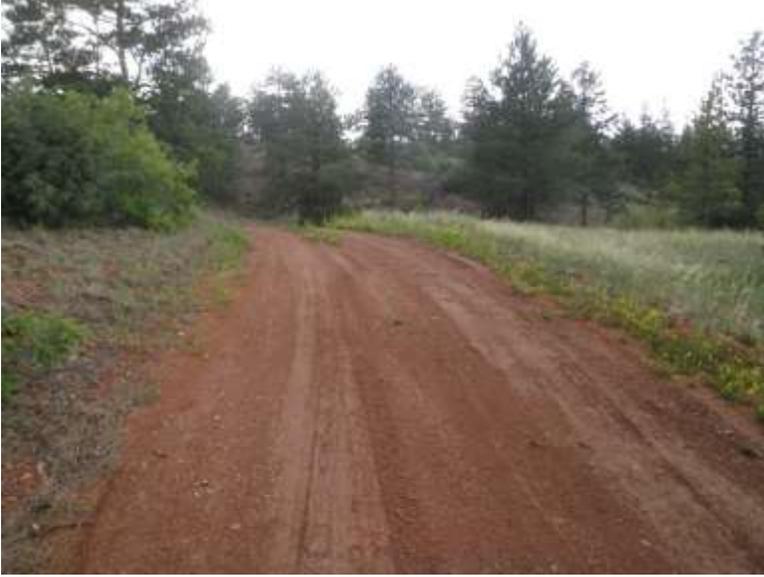
#11

| Date | Frame # | Camera Direc. | Description | GPS/UTM Location | Township | Range | Sec. | Photo Point # |
|---|---|---|---|---|---|---|---|---|
| 6/18/2013 | P6180491 | S | Route Condition | See map | 19 S. | 72 W. | 18 | 11 |

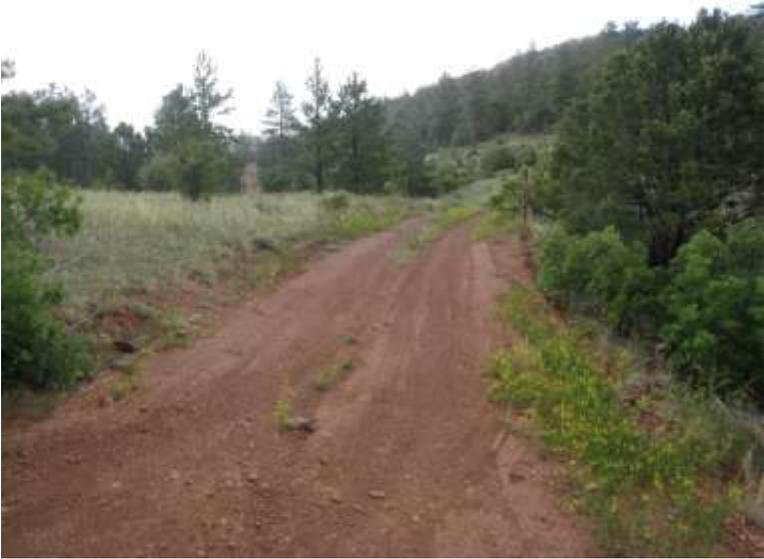
#12

| Date | Frame # | Camera Direc. | Description | GPS/UTM Location | Township | Range | Sec. | Photo Point # |
|---|---|---|---|---|---|---|---|---|
| 6/18/2013 | P6180492 | SW | Route Condition | See map | 19 S. | 72 W. | 18 | 12 |

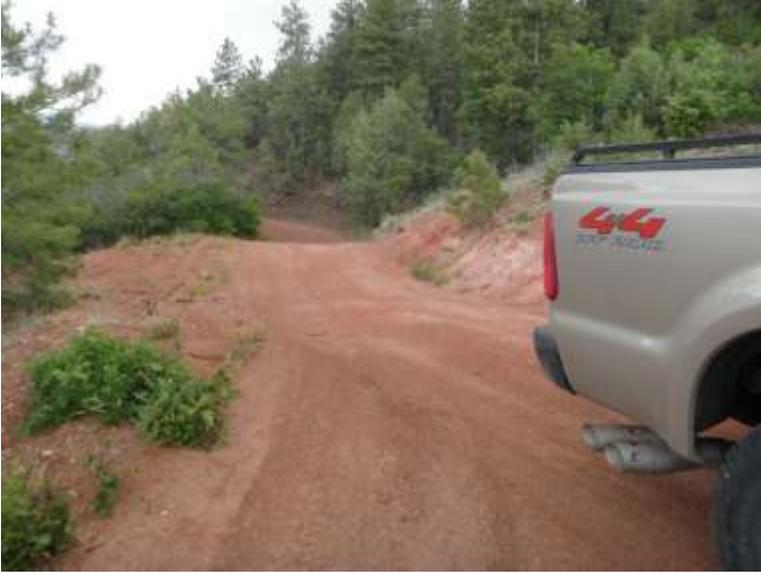
#13

| Date | Frame # | Camera Direc. | Description | GPS/UTM Location | Township | Range | Sec. | Photo Point # |
|---|---|---|---|---|---|---|---|---|
| 6/18/2013 | P6180493 | NW | Route Condition | See map | 19 S. | 72 W. | 18 | 13 |

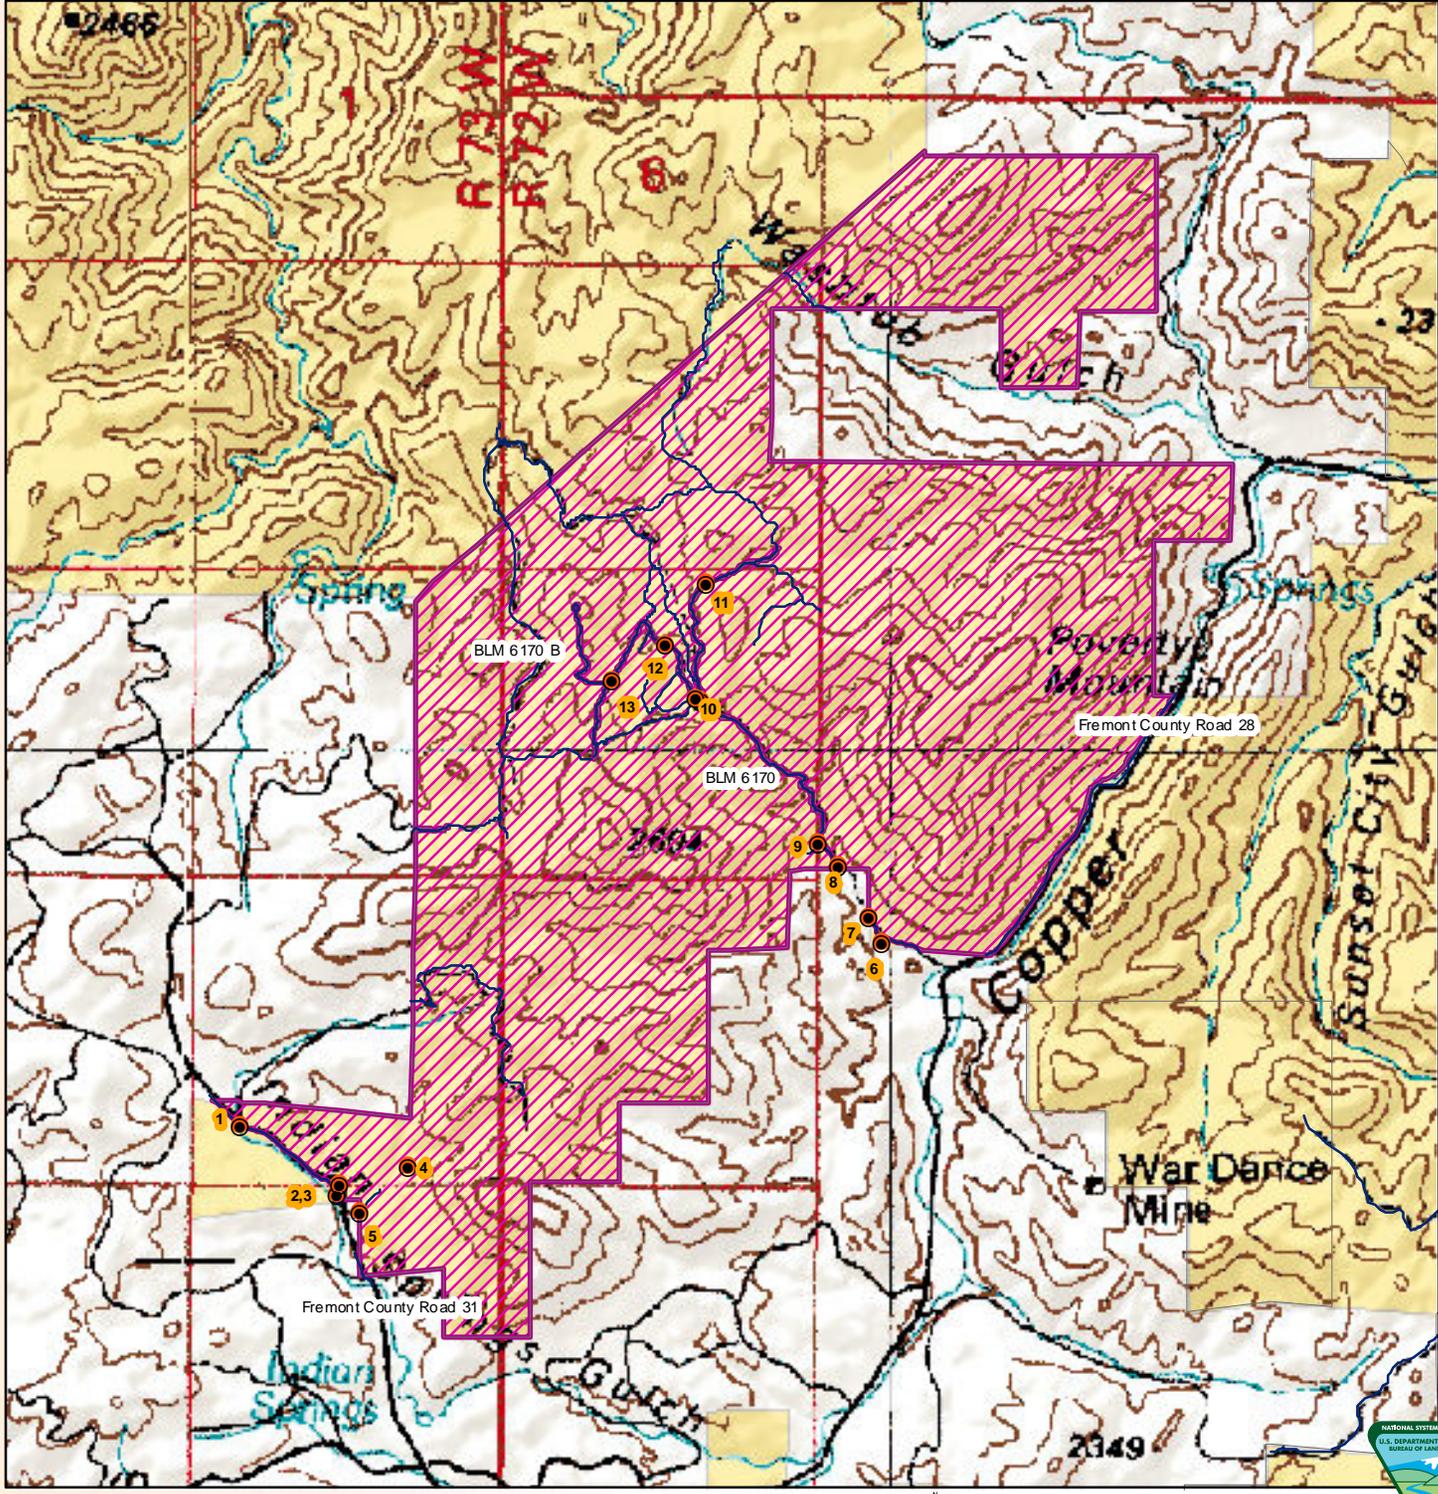
COF-020-048

The map shows the parcel inventoried for wilderness characteristics, photo points and routes collected by GPS
