CEDAR GULCH ALLOTMENT EVALUATION AND DETERMINATION

**Achieving the Idaho Standards for Rangeland Health
And
Conformance with the Guidelines for Livestock Grazing Management**

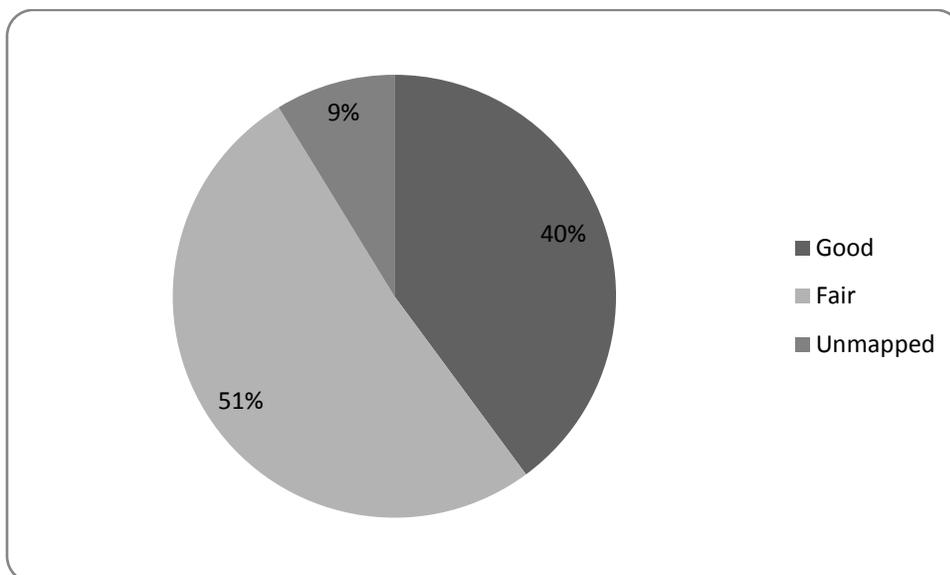
The Cedar Gulch Allotment is considered an *Improve* (I) allotment, as categorized by the SFO based on resource values and opportunities for improvement, and currently does not have an Allotment Management Plan (AMP). The stocking rate is 12.8 acres/AUM, which is influenced by soils, vegetation type, topography, water availability, and local weather. The kind and class of livestock authorized to graze on the allotment is cattle (cow/calf pairs). The ecological conditions (Figure 1) of the Cedar Gulch Allotment are 1,062 acres (40%) in Good condition, 1,365 acres (51%) in Fair condition, and 233 (9%) acres Unmapped (Figure 1) (RMP, 2001).

Figure 1: Ecological conditions of the Cedar Gulch Allotment (ESI, 1983).

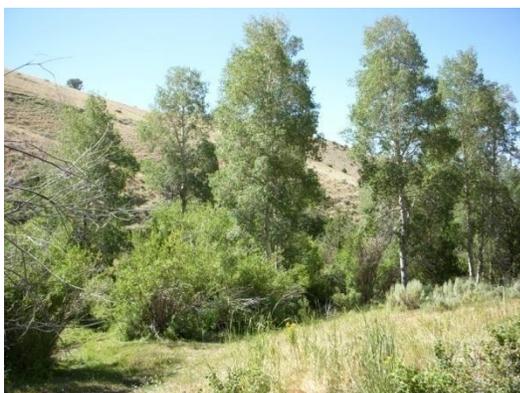
The majority of the undeveloped springs on the allotment are comprised of a fenced spring complex in the Lower Pasture. This area supports multiple age-classes of woody riparian species, predominantly willows, as well as herbaceous riparian vegetation. The other undeveloped spring is associated with Cedar Gulch, which is an ephemeral draw. Water flows down Cedar Gulch as far as the Middle Pasture in early spring, but the riparian vegetation is limited to the higher elevation Cedar Gulch Pasture due to water flowing sub-surface for most of the year. This lack of water does not support riparian obligate species downstream in the Middle Pasture. Multiple age-classes of woody riparian species is present along Cedar Gulch in the Cedar Gulch Pasture along the entire segment. Aspen regeneration was apparent near the undeveloped spring associated with Cedar Gulch.

2008-Upper Cedar Gulch

Riparian areas are in proper functioning condition within the allotment, except for the dewatered portion of lower Peterson Creek. Riparian vegetation is in good condition and multiple age-classes of woody riparian vegetation is present, as well as a variety of riparian species that will promote maintenance of riparian and wetland conditions.

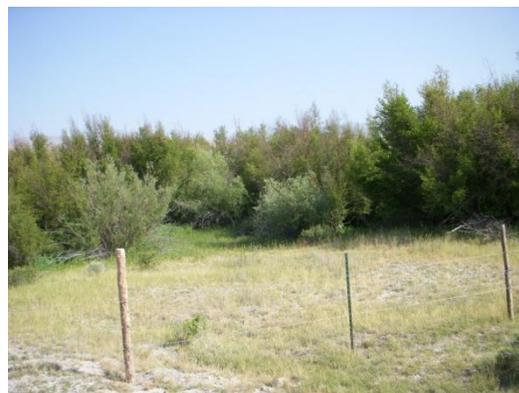
2008-Fenced Spring Complex in the Lower Pasture
