Reach #6 - Lotic Checklist

Name of Riparian-Wetland Area:		Missouri River	
Date:	Reach visited 7/6 & 7/7/10 – Form Completed 7/7/2010 Revisited 9/8/2010	Segment/Reach ID:	Reach #6 - River Mile 119 (Sturgeon Island) to 139 (CMR Boundary)
ID Team Observers:	<input checked="" type="checkbox"/> C. Krause, Hydrologist <input checked="" type="checkbox"/> V. Shea, Rangeland Management Specialist <input checked="" type="checkbox"/> A. Northerner, Range Technician (Riparian) <input checked="" type="checkbox"/> M. Forsyth, Rangeland Management Specialist <input checked="" type="checkbox"/> J. Peters, Wildlife Biologist <input checked="" type="checkbox"/> A. Ehlert, Range Technician <input checked="" type="checkbox"/> M. Philbin, Hydrologist <input checked="" type="checkbox"/> J. Sorlie, Soil Scientist <input checked="" type="checkbox"/> C. Meier, Soil Scientist <input checked="" type="checkbox"/> W. Elmore, Ecologist <input checked="" type="checkbox"/> S. Smith, Riparian/Rangeland Management Specialist & National Riparian Service Team Leader

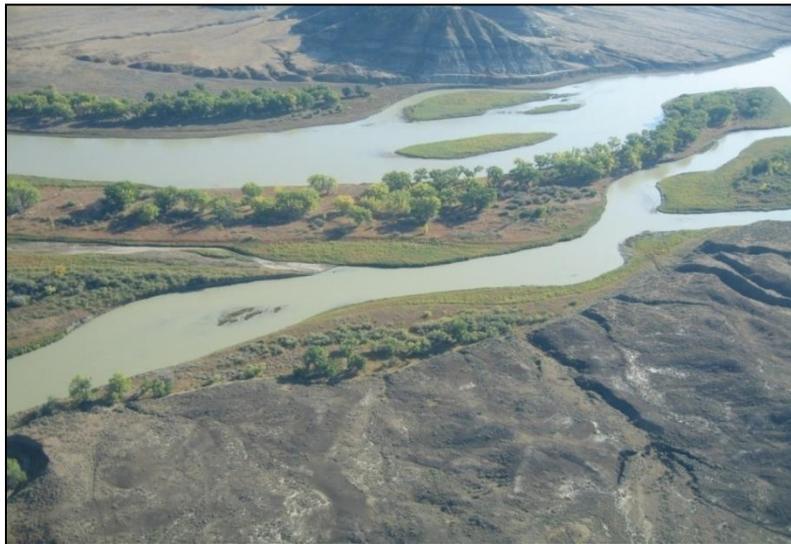
Figure 3 - Unconstrained Zone at Cow Island

Although ice drives strongly influence vegetative patterns through this constrained reach, unconstrained zones within the larger constrained zones do occur. They can be found near tributary junctions, channel islands, and overflow channels (Scott and Auble, 2002). In these unconstrained portions, recruitment of trees is less dependent on the large flood pulses because with the lateral movement and sediment aggradation, established trees are removed from the zone where they receive more frequent physical disturbance (Scott and Auble, 2002). See Figure 3 - Unconstrained Zone at Cow Island.

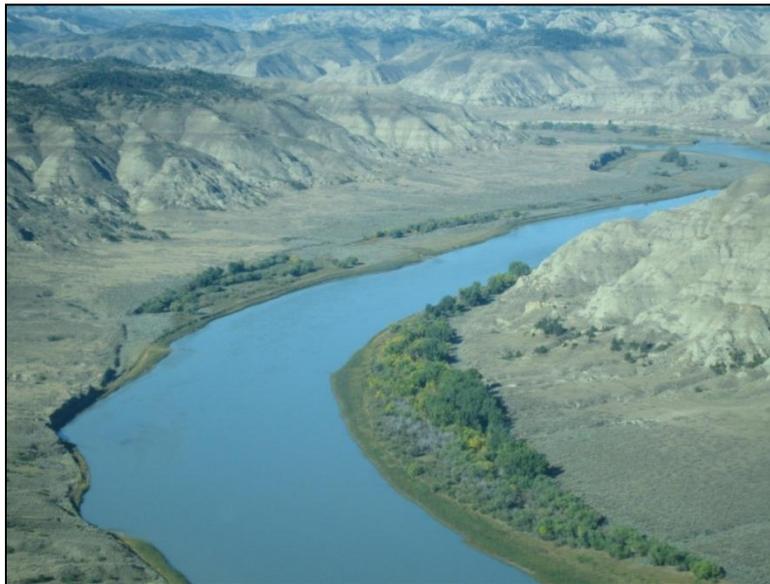
Figure 4 - Typical Existing Conditions Reach #6 - River Mile 119 (Sturgeon Island) to 139 (CMR Boundary)

LIMITING FACTORS: Two significant dams regulate flows on the Upper Missouri River through the Wild and Scenic reach, Canyon Ferry Dam on the Missouri and Tiber Dam on the Marias. Although the frequency of flood pulses and the timing of a snow-melt dominated hydrograph have not changed, the magnitude of large peak flows has been reduced from 40% to 50% as a result of regulation (Bovee and Scott, 2001). Examination of post dam recruitment patterns of cottonwood by Scott and Auble (2002) identified that all stands originating in the post dam period occurred within unconstrained channel reaches. Reduction in the magnitude of peak flows has resulted in establishment of stems at lower elevations that are subject to more frequent disturbance. If patterns continue, cottonwood recruitment would be limited to unconstrained reaches. In River Miles 119 to 139, this effect will be most noticeable in the constrained reaches, but more frequent unconstrained portions would be capable of maintaining cottonwood forests under lower flow regimes although in smaller amounts. The figure below shows typical existing landform, channel, and vegetative characteristics of Reach #6. See Figure 4 - Typical Existing Conditions Reach #6 - River Mile 119 (Sturgeon Island) to 139 (CMR Boundary).

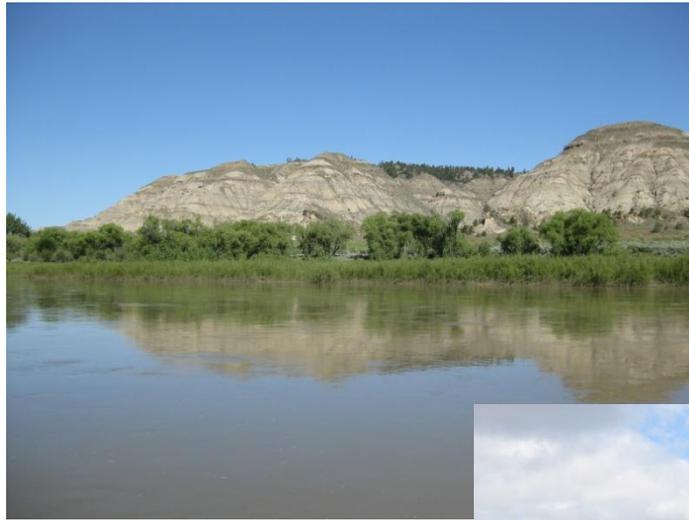
Dense sandbar willow community at the lower end of Reach #6.

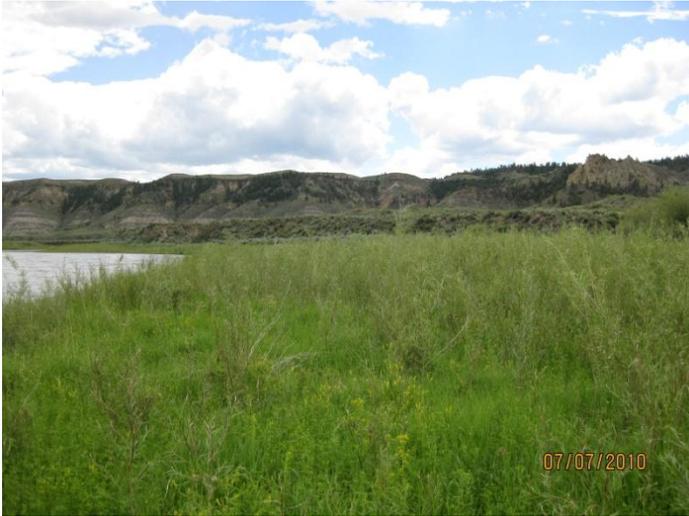
Sandbar willow community type found at South Stop #4 (Cow Island) with dense understory of smooth brome, Kentucky bluegrass, yellow sweetclover, red top and quackgrass, all non-native and invasive species.

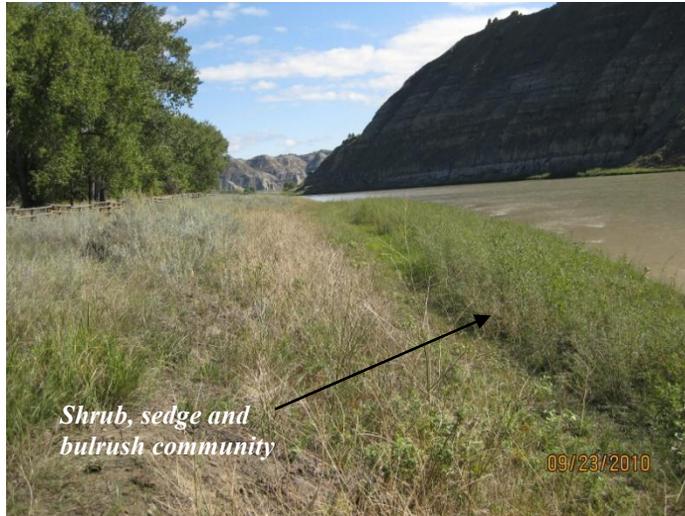
Sandbar and yellow willow community with understory of three-square bulrush and woolly sedge in front of the Gist Bottom Primitive Boat Camp (North Stop #4). These plants are strongly rhizomatous, spreading by underground roots, and growing together provides exceptional bank stability.

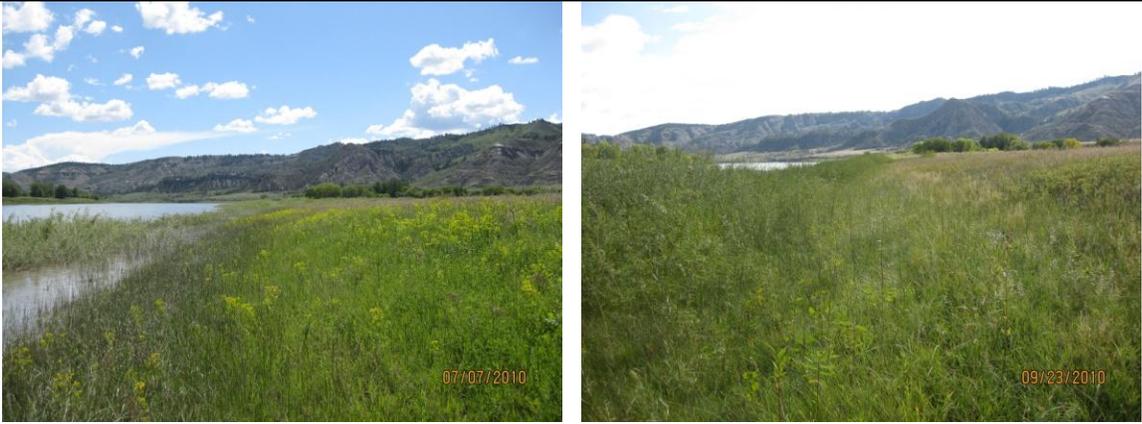
<p><i>The picture on the right illustrates the rapid growth of sandbar willow that occurred by late September after being submerged until July (picture on left) (South Stop #3).</i></p>
X			<p>11) Adequate riparian-wetland vegetative cover present to protect banks and dissipate energy during high flows (<i>enough</i>)</p> <p>Rationale for Answer</p> <p>The plants, plant groupings and community types observed in Zone 1 were well developed and the depositional surfaces well vegetated with riparian-wetland plants that have medium to high stability ratings. The amount of bare areas observed was normal and naturally occurring from recent sediment deposits and scouring from water and ice. The streambank riparian plants were spaced closely together and many areas were catching and depositing sediment. Sites are still capturing sediment and building with little evidence of bank instability (cutting/slumping).</p>

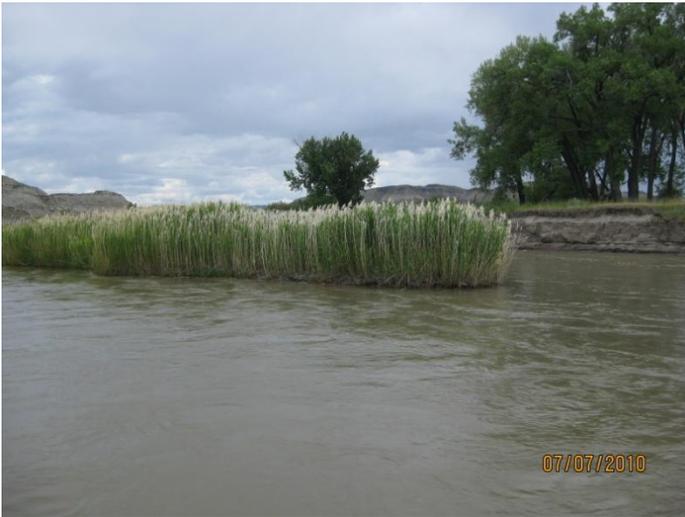
Numerous small communities of common reed were present, much more along this reach than others. A warm-season perennial grass which spreads aggressively by both rhizomes and stolons and is native to the United States, common reed plants can grow six to eight feet tall along the Missouri River. A non-native version was introduced to the United States in the 19th century and is now found throughout the United States and is believed to be present along the Upper Missouri River (USDA, National Invasive Species Information Center). However, the differences between the native and non-native plants are very subtle and difficult to determine in the field. Due to its aggressive nature, it has become weedy or invasive in some regions and is now considered a noxious weed in some states.

Common reed community in Cow Island area.

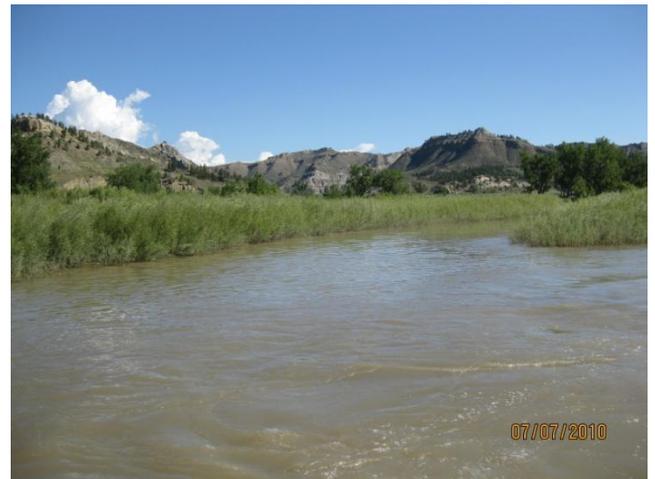
Several photos were taken looking up Bullwhacker Creek showing a dense stand of sandbar willow and sapling, pole and mature cottonwood trees farther up the drainage. The floodplain is wider, meandering and not constrained. The area is capturing and processing large amounts of sediment from upland areas. The area near the mouth of Bullwhacker is more protected and in a safe zone away from damage by ice drives.

The picture on the left shows the diverse age class of cottonwood trees along the channel at mouth of Bullwhacker Creek. The picture on the right is taken from the river looking at the mouth of Bullwhacker Creek.

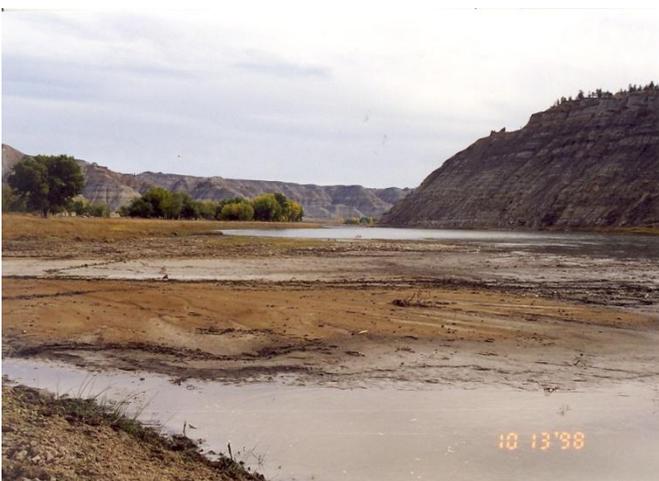
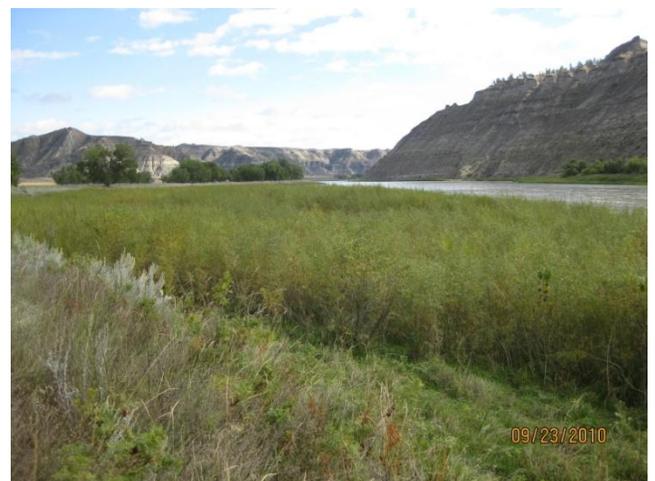
Sandbar willow community established at the mouth of Bullwhacker Creek covering a large depositional surface created after the winter of 1997/1998.

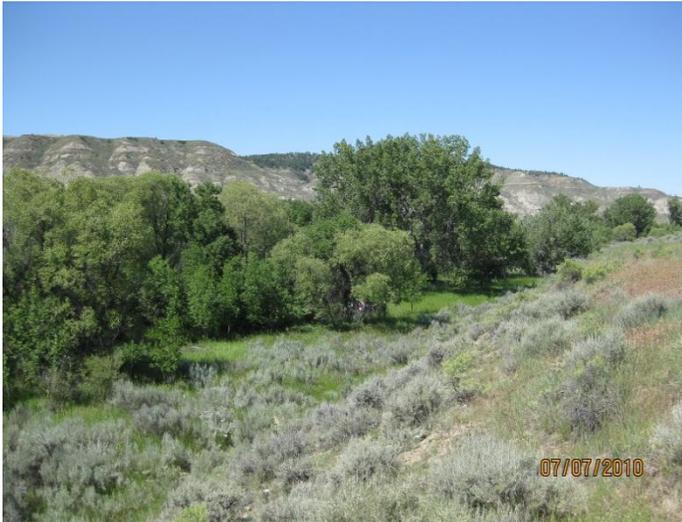
A Green ash community with all age classes represented. Site is located about one mile above Gist Bottom at North Stop #5. These site types, which are uncommon along the Missouri River, are referred to as “perched water tables”. They are located at higher elevations above the river and are strongly influenced by adjacent upland areas. Characteristic of this site, green ash has established on a poorly drained, heavy clay soil. Moisture is often stored longer into the growing season and through hot, dry periods supporting a more diverse vegetation community.
