Reach #1 - Lotic Checklist

Name of Riparian-Wetland Area:		Missouri River	
Date:	5/14/2010, 5/20/2010 & 7/16/2010	Segment/Reach ID:	Reach #1 - River Mile 0 (Fort Benton) to 22 (Marias River)
ID Team Observers:	<input checked="" type="checkbox"/> C. Krause, Hydrologist <input checked="" type="checkbox"/> V. Shea, Rangeland Management Specialist <input checked="" type="checkbox"/> A. Northerner, Range Technician (Riparian) <input checked="" type="checkbox"/> M. Forsyth, Rangeland Management Specialist <input checked="" type="checkbox"/> J. Peters, Wildlife Biologist <input checked="" type="checkbox"/> A. Ehlert, Range Technician <input type="checkbox"/> M. Philbin, Hydrologist <input checked="" type="checkbox"/> J. Sorlie, Soil Scientist <input type="checkbox"/> C. Meier, Soil Scientist <input checked="" type="checkbox"/> W. Elmore, Ecologist <input checked="" type="checkbox"/> S. Smith, Riparian/Rangeland Management Specialist & National Riparian Service Team Leader

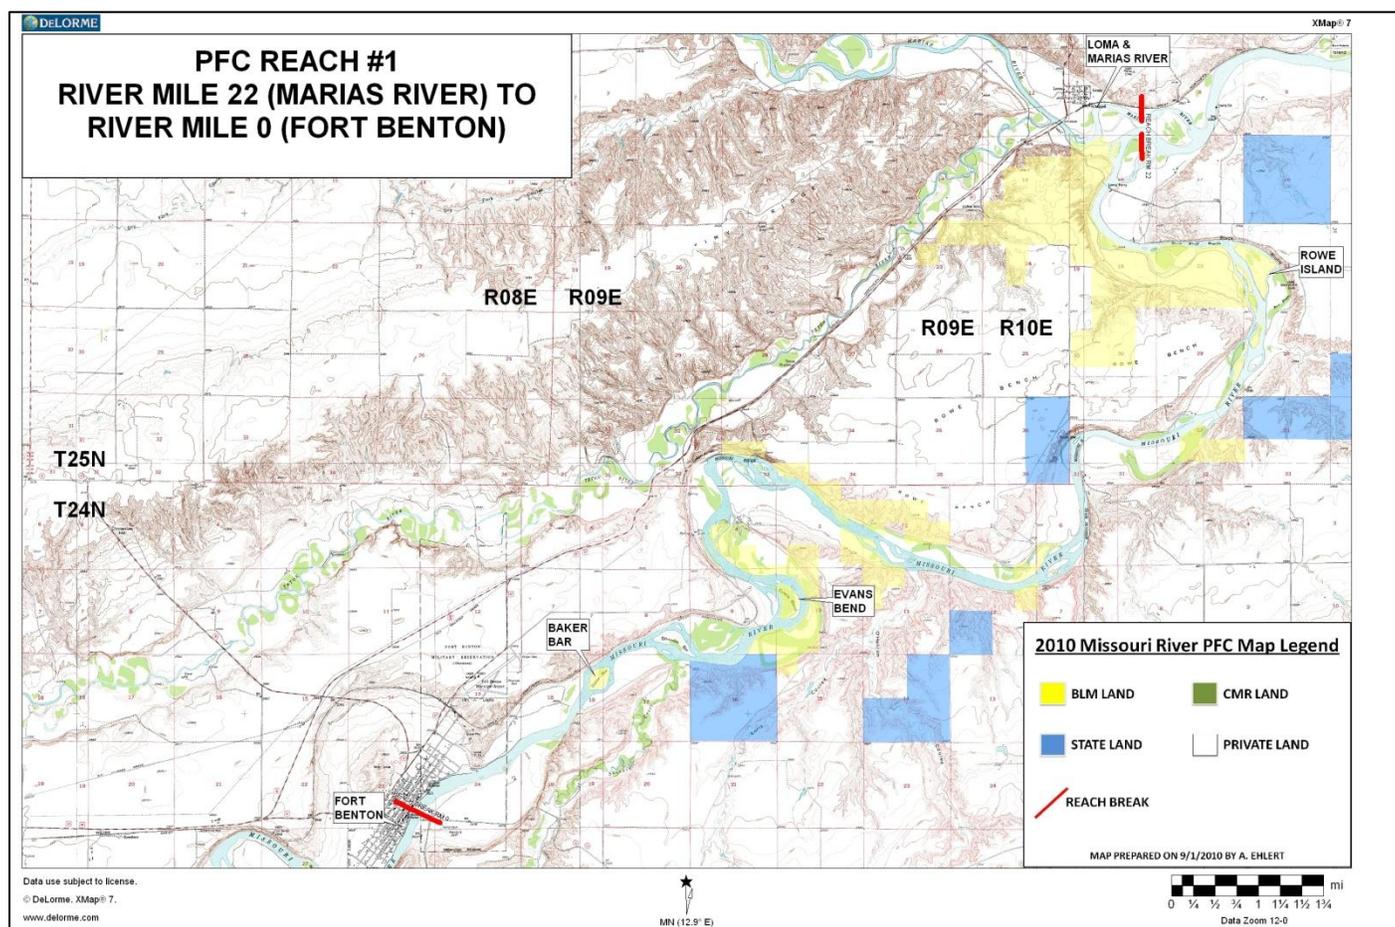
Figure 1 - Reach #1 - River Mile 0(Fort Benton) to 22(Marias River)

POTENTIAL: Reach #1 - River Mile 0(Fort Benton) to 22(Marias River), is located within the older, preglacial Missouri River valley. Relative to the constrained, postglacial river channel, the Upper Missouri River upstream of Coal Banks has relatively high sinuosities, wide valleys, and more rapid channel migrations (Scott et al., 1997). See Figure 1- Reach #1 - River Mile 0(Fort Benton) to 22(Marias River).

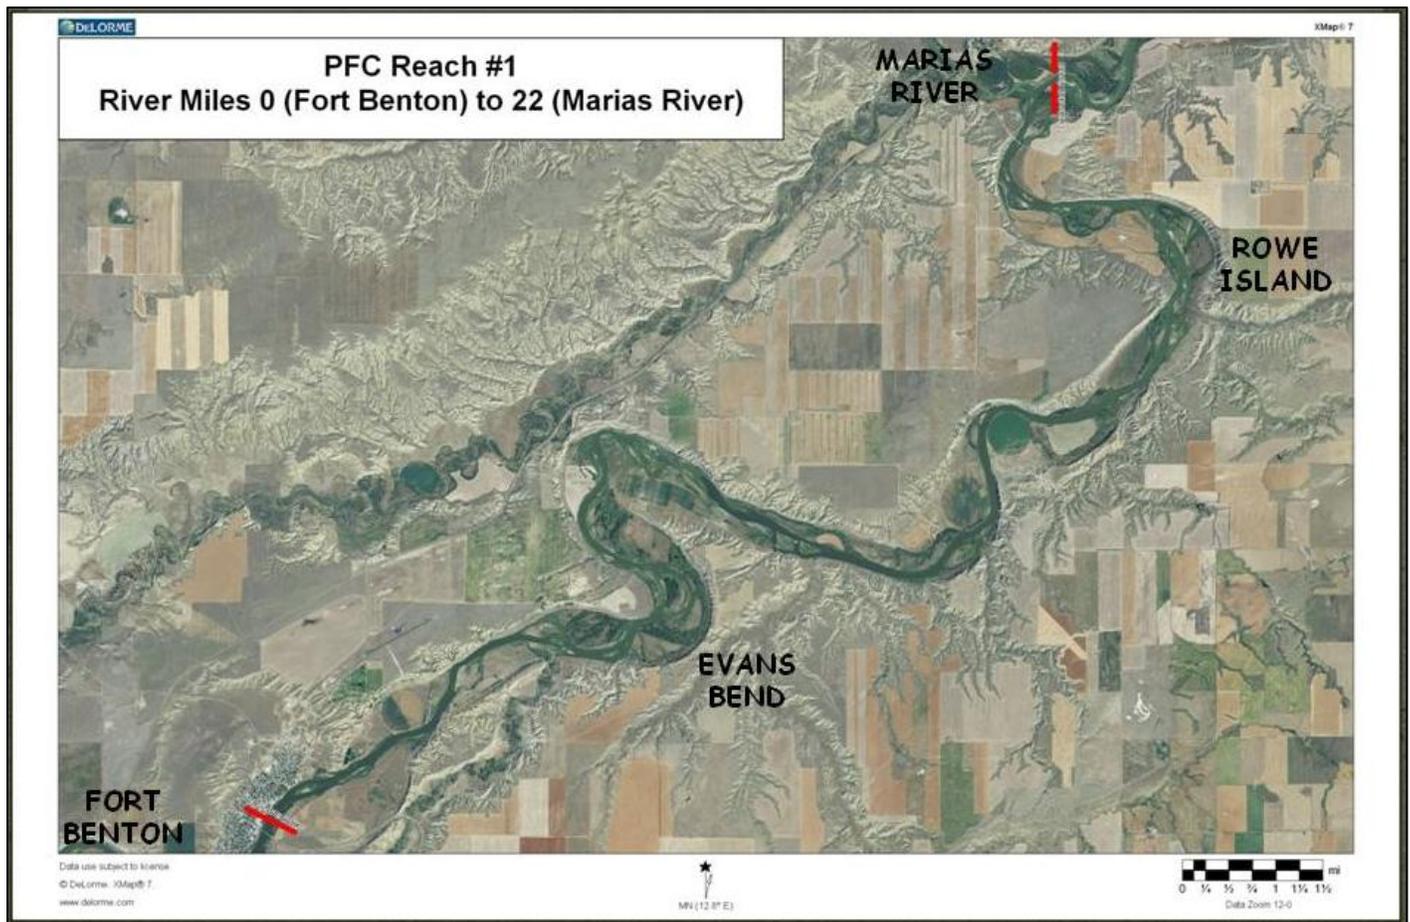
Figure 2 - Reach #1 - River Mile 0(Fort Benton) to 22(Marias River) – Aerial View

Evidence exists that the fore mentioned channel types would exist at potential. Comparisons of detailed maps from the 1890s do indicate a decrease in channel width as a result of channel narrowing. However, the decrease in channel width versus flood prone width would not have been large enough to change channel classifications. The channel has also been vertically stable during that time period. Scott et al. (1997) plotted stage at peak discharge for the Fort Benton gage prior to and after the construction of Canyon Ferry Dam. The period of record at the Fort Benton gage goes back to 1890, and Canyon Ferry Dam was completed in 1953. There was no downward shift in the stage-peak discharge relation. Although a stable stage-discharge relation associated with channel narrowing would generally indicate a deeper channel, it is not necessarily an indicator of vertical instability. See Figure 2 - Reach #1 - River Mile 0(Fort Benton) to 22(Marias River) – Aerial View.

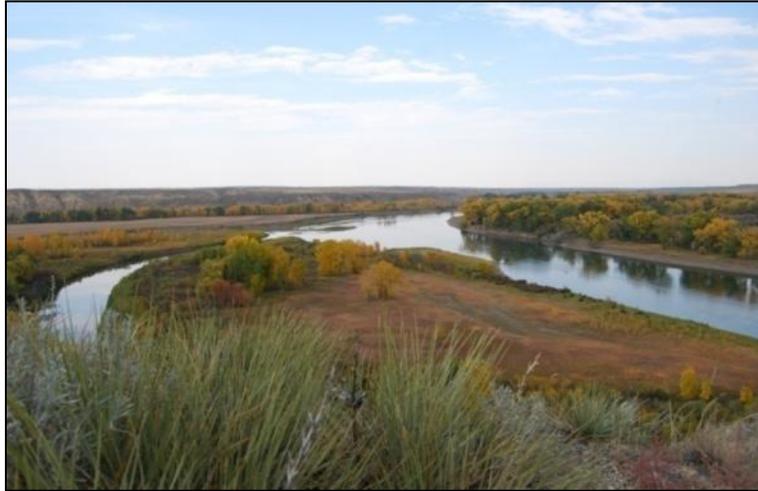
Figure 3 - Decision Point – Mouth of the Marias River

Because of the climate of northcentral Montana, which includes very cold temperatures, snow, and rapid warm up from “Chinook” winds, mechanical ice drives occur. The influence of this process on riparian vegetation is substantial. However, the effect is less noticeable in the unconstrained portion of the river relative to the constrained reaches. In these unconstrained portions, recruitment of trees is less dependent on the large flood pulses because with the lateral movement and sediment aggradation, established trees are removed from the zone where they receive more frequent physical disturbance (Scott and Auble, 2002). See Figure 3 - Decision Point – Mouth of the Marias River.

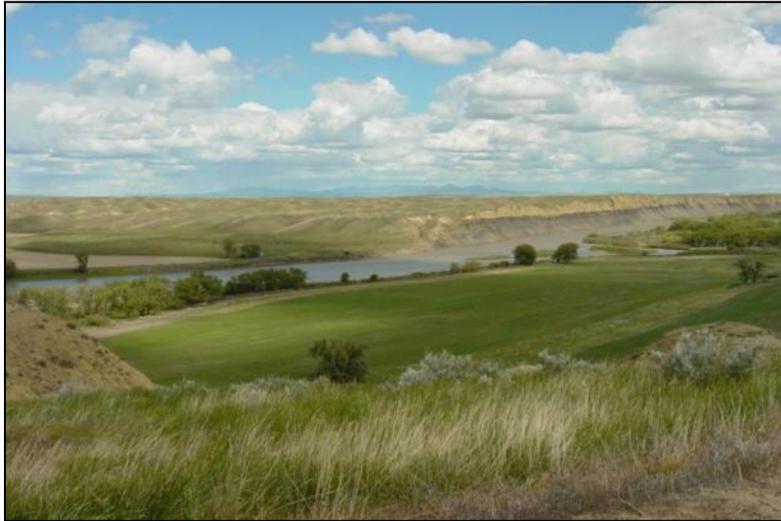
Figure 4 - Typical Existing Conditions on Reach #1 - River Mile 0 (Fort Benton) to 22 (Marias River)

LIMITING FACTORS INFLUENCING POTENTIAL: Reach #1 - River Mile 0 (Fort Benton) to 22 (Marias River) is above the confluence of the Marias River and the influence of Tiber Dam. However, flow is still regulated through this reach by Canyon Ferry Dam on the Missouri. Flow releases out of Canyon Ferry Dam are also limited by urban encroachment by the city of Great Falls and by housing developments on the Missouri River between Great Falls and Helena. A generalized channel narrowing has occurred on this reach, and riparian forest has actually increased from Fort Benton to Coal Banks (personal communication, G. Auble (USGS)). However, much of the non-cottonwood forest is Russian olive. See Figure 4 - Typical Existing Conditions on Reach #1 - River Mile 0 (Fort Benton) to 22 (Marias River).

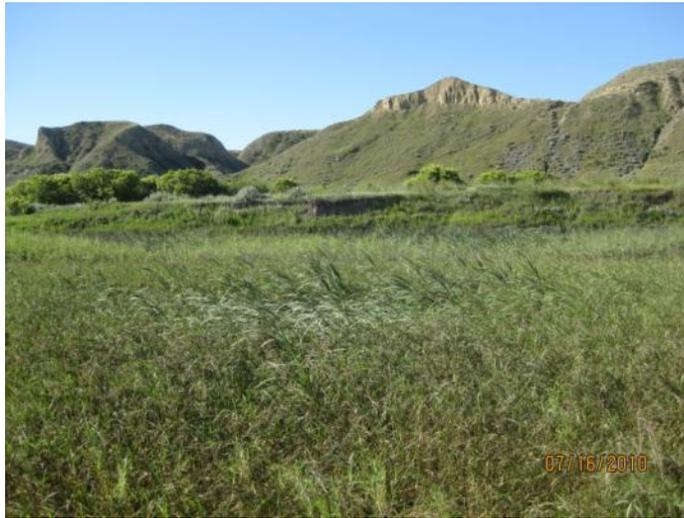
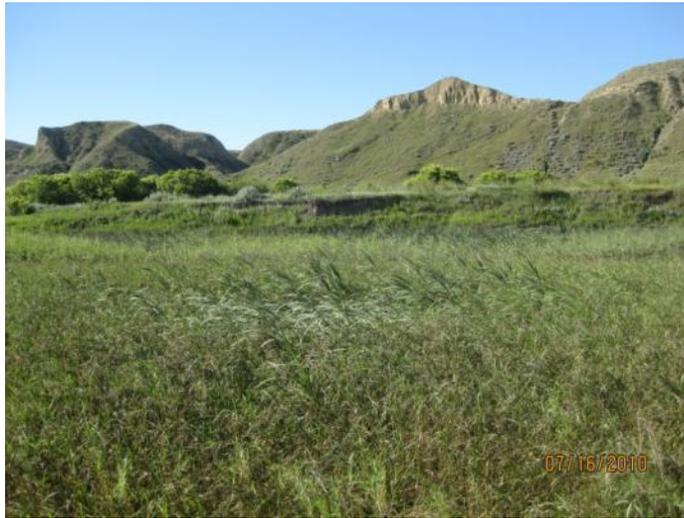
South Stop #2 - back channel of island with well established community of common cattail and small-fruit bulrush.

<p><i>South Stop #2 - back channel of island with well established community of common cattail and small-fruit bulrush.</i></p>

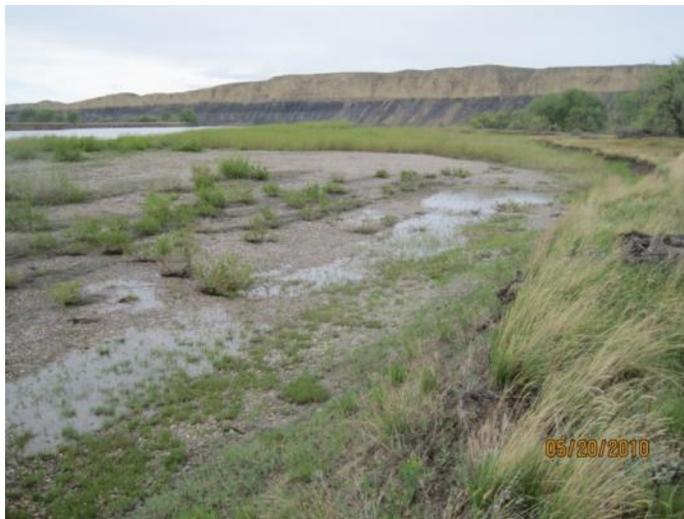
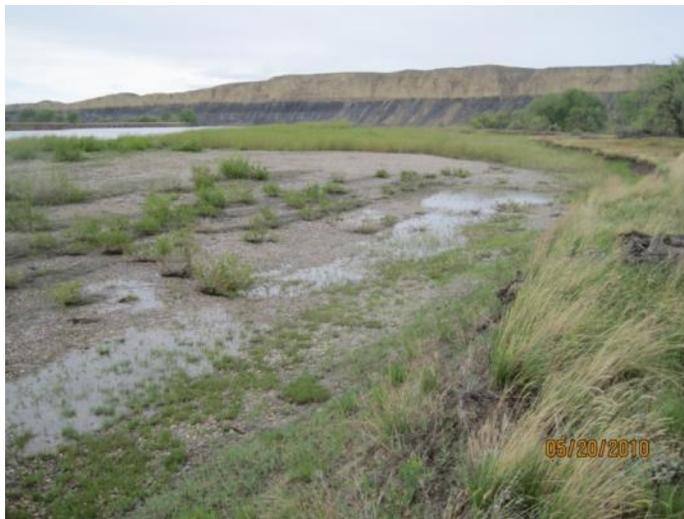
South Stop #4 (Rowe Island) provides an example of a larger depositional area that is building and moving laterally. Note the dense sandbar willow and hardstem bulrush community (towards top) and narrowleaf cottonwood (center). The narrowleaf cottonwood has taken on a clump growth form after being sheared off by beaver.

<p><i>South Stop #4 (Rowe Island) provides an example of a larger depositional area that is building and moving laterally. Note the dense sandbar willow and hardstem bulrush community (towards top) and narrowleaf cottonwood (center). The narrowleaf cottonwood has taken on a clump growth form after being sheared off by beaver.</i></p>
<p>X</p>		<p>7) Diverse composition of riparian-wetland vegetation (for maintenance/recovery) (<i>species present</i>)</p> <p>Rationale for Answer</p> <p>The ID Team identified a variety of riparian-wetland plant species encountered at the seven sites visited on public land. Species noted included alkali cordgrass, reed canarygrass, common spikeweed, common cattail, hardstem bulrush, three-square bulrush, rough horsetail, small-fruit bulrush, woolly sedge and other sedge species, sandbar willow, red-osier dogwood, narrowleaf cottonwood, plains cottonwood, green ash and peachleaf willow. Herbaceous sites also contained a large percentage of invasive plants and noxious weeds; smooth brome, creeping meadow foxtail, Kentucky bluegrass, leafy spurge, Russian knapweed, spotted knapweed, perennial pepperweed, common mullein and Canada thistle. The number of species and density varied between sites making it difficult to determine what extent non-native plants may be having on plant diversity and what competitive advantage they may be having over native plants.</p>

South Stop #4, Rowe Island, River Mile 18.5, contained a large, gravelly deposit at the lower end of the island with trace amounts of narrowleaf cottonwood. These trees, as with other sites containing narrowleaf cottonwood, exhibited a shrub-like growth form because of frequent beaver activity.

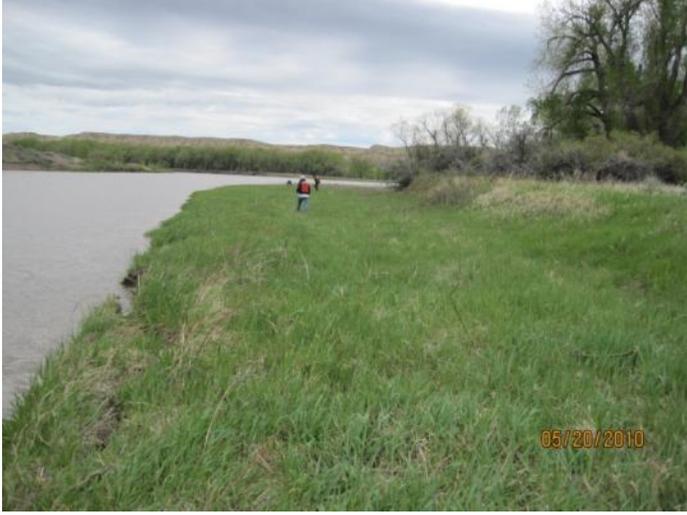
<p><i>The depositional surface at South Stop #1 (Evans Bend) is dominated by reed canarygrass.</i></p>
<p>X</p>			<p>8) Species present indicate maintenance of riparian-wetland soil moisture characteristics</p> <p>Rationale for Answer</p> <p>Redoximorphic (redox) features indicating that the soils undergo periodic saturation were prevalent in both Zones 1 and 2 except on the steep erosive bends of the river. Redox features were observed from the soil surface to within 20 inches of the soil surface. The depth to these features increases as the distance from the active channel increases. The redox features observed were reduced soil matrices in Zone 1 and redox concentrations and depletions in both Zones 1 and 2.</p> <p>Zone 1 is dominated by plants and plant communities consisting of obligate (OBL) and facultative wetland (FACW) plants. Plants noted included alkali cordgrass, reed canarygrass, common spikeseed, common cattail, hardstem bulrush, three-square bulrush, rough horsetail, small-fruit bulrush, woolly sedge and other sedge species, sandbar willow, red-osier dogwood, narrowleaf cottonwood, plains cottonwood, green ash and peachleaf willow. The back channel areas, which are prone to frequent flooding during the spring and early summer, also had riparian plant communities dominated by OBL and FACW plants. Moving away from the river into zones 2 and 3, (from the frequently wetted areas to sites less frequently flooded), there is a noticeable shift to facultative and facultative upland plants.</p>

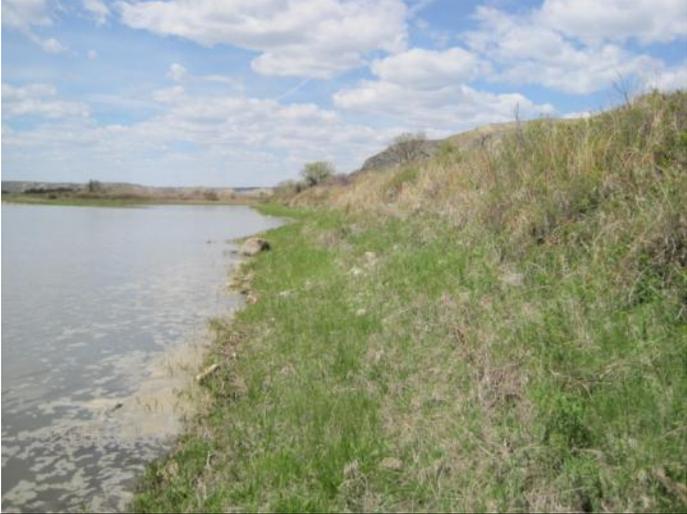
<p><i>Looking upriver at North Stop #3 at a steep walled bank with a narrow depositional surface. These sites have low potential for riparian development and are subjected to intense scouring by water and ice.</i></p>

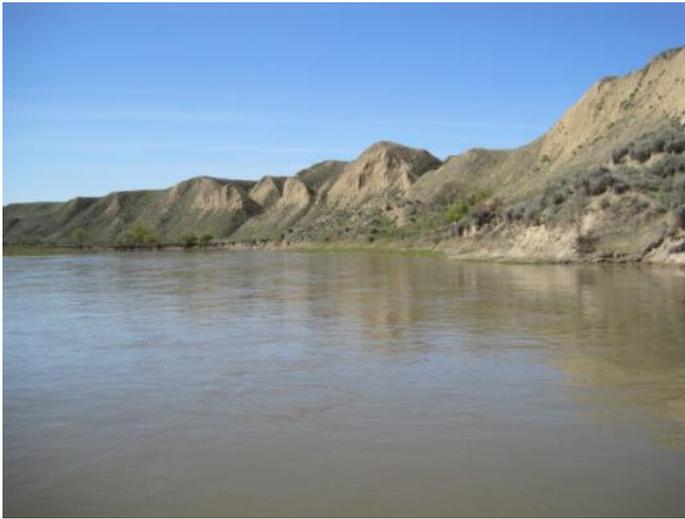
A large proportion of the banks on public land can be characterized as steep and nearly vertical, reaching five to ten feet in height in some places along the outside meander bend. Some parts of the bank within this reach are gravelly but where deposition is occurring, small stringers of herbaceous communities have established. The floodplain is very narrow and discontinuous.

View of steep walled banks with a narrow riparian zone characteristic of public land above Loma Bridge.

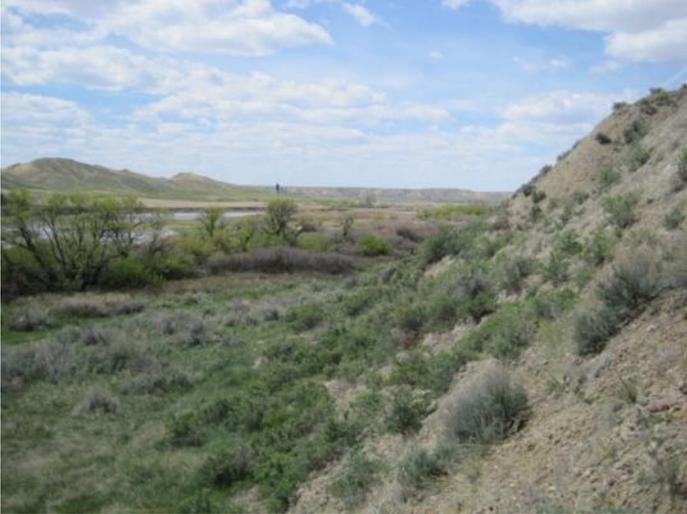
North Stop #3, River Mile 10.5, contains an old floodplain above the river with an overstory of plains cottonwood and boxelder trees, a dense shrub understory of chokecherry and golden currant and grass openings of crested wheatgrass and smooth brome. Narrowleaf cottonwood and green ash trees, primarily mature trees, are scattered throughout in small groups or pockets. These sites are often referred to as “perched water tables”. Overland flow of water from adjacent upland areas is normally trapped and stored supporting diverse woody riparian communities.

Site of perched water table at North Stop #3
