### Reach #3 - Lotic Checklist

Name of Riparian-Wetland Area:		<b>Missouri River</b>	
Date:	<b>Visited 4 days - Checklist on 7/14/2010 (Revisited 9/7/2010)</b>	Segment/Reach ID:	<b>Reach #3 - River Mile 49 ( Lonetree Coulee) to 86 (Above PN Bridge)</b>
ID Team Observers:	<input checked="" type="checkbox"/> C. Krause, Hydrologist <input checked="" type="checkbox"/> V. Shea, Rangeland Management Specialist <input checked="" type="checkbox"/> A. Northerner, Range Technician (Riparian) <input checked="" type="checkbox"/> M. Forsyth, Rangeland Management Specialist <input checked="" type="checkbox"/> J. Peters, Wildlife Biologist <input checked="" type="checkbox"/> A. Ehlert, Range Technician <input type="checkbox"/> M. Philbin, Hydrologist <input checked="" type="checkbox"/> J. Sorlie, Soil Scientist <input type="checkbox"/> C. Meier, Soil Scientist <input checked="" type="checkbox"/> W. Elmore, Ecologist <input checked="" type="checkbox"/> S. Smith, Riparian/Rangeland Management Specialist & National Riparian Service Team Leader

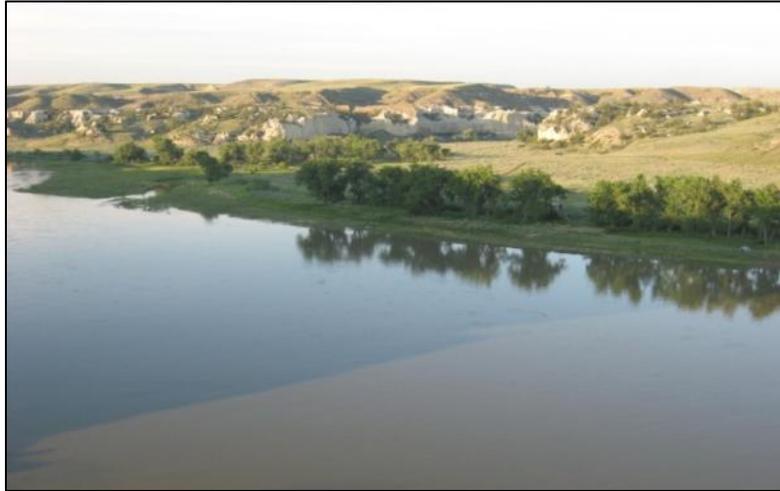
Figure 5 - Mouth of Eagle Creek

Although ice drives strongly influence vegetative patterns through this constrained reach, unconstrained zones within the larger constrained zones do occur. They can be found near tributary junctions, channel islands, and overflow channels (Scott and Auble, 2002). In these unconstrained portions recruitment of trees is less dependent on the large flood pulses because with the lateral movement and sediment aggradation, established trees are removed from the zone where they receive more frequent physical disturbance (Scott and Auble, 2002). See Figure 5 – Mouth of Eagle Creek.

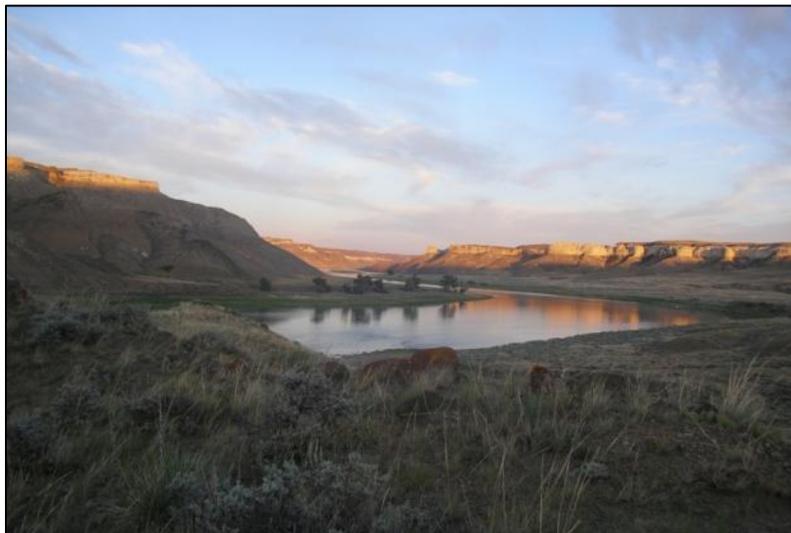
Figure 6 – Typical Existing Conditions on Reach #3 - River Mile 49 (Lonetree Coulee) to 86 (Above PN Bridge)

**LIMITING FACTORS:** Two significant dams regulate flows on the Upper Missouri River through the Wild and Scenic reach, Canyon Ferry Dam on the Missouri and Tiber Dam on the Marias. Although the frequency of flood pulses and the timing of a snow melt dominated hydrograph has not changed, the magnitude of large peak flows has been reduced from 40 to 50% as a result of regulation (Bovee and Scott, 2001). Examination of post dam recruitment patterns of cottonwood identified that all stands originating in the post dam period occurred within unconstrained channel reaches (Scott and Auble, 2002). Reduction in the magnitude of peak flows has resulted in establishment of stems at lower elevations that are subject to more frequent disturbance. If patterns continue, cottonwood recruitment would be limited to unconstrained reaches. In River Miles 49 to 86, this effect will be most noticeable because of the lack of unconstrained reaches. The figure below shows typical existing landform, channel, and vegetative characteristics of Reach #3. See Figure 6 – Typical Existing Conditions on Reach #3 - River Mile 49 (Lonetree Coulee) to 86 (Above PN Bridge).

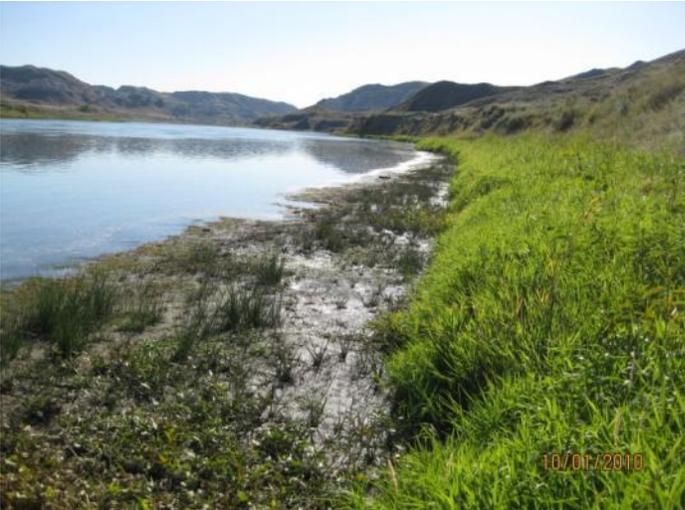
<div style="margin-left: 20px;"> <p><i>Continuous, linear and dense stand of reed canarygrass (bright green color) bordered by a hardstem bulrush community.</i></p> </div> </div>

The herbaceous riparian-wetland plants and plant communities at these sites were continuous, spreading from underground roots and colonizing depositional surfaces. Within Zone 1, dense communities of these rhizomatous herbaceous plants were common, indicating they are well established and expanding and thus exhibiting multiple “age-classes.”

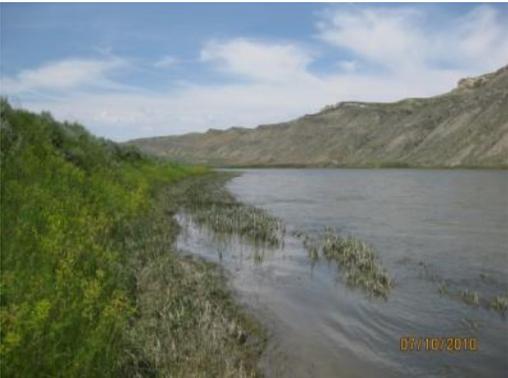
X		<p>10) Riparian-wetland plants exhibit high vigor</p> <p><b>Rationale for Answer</b></p> <p>Depending on the duration of annual high flows, streambanks can be submerged for a considerable portion of the growing season. In 2010, most of Zone 1 was inundated until late July. Hardstem and three-square bulrush and reed canarygrass were observed to be emerging through deposited sediment and standing water indicating that plants are well established and possess enough stored energy in roots to initiate and maintain growth during prolonged periods of flooding. Hardstem and three-square bulrush and reed canarygrass plants were observed to be tall, robust and have good coloration despite being under water. Several of these sites were checked and photographed again in September and October after water levels dropped and exposed more of the bank. In support of earlier findings, the riparian-wetland plants were robust, had good coloration, had flowered and produced seed and had rapidly grown when compared to earlier pictures.</p> <p>Trees and shrubs exhibited a multi-stemmed growth form (re-sprouting from the base of the plant) and showed signs of mortality from repeated removal of stems by beaver and damage by ice. Upriver from “The Wall” primitive boat camp, woody plants have been dying out over the last eight to ten years. The site is not flooded frequently enough to maintain the moisture requirements needed for willow and cottonwood survival. Also, the soils in this area are more porous reducing the water-holding capacity.</p>

<p><i>In July portions of Zone 1 and 2 were under water during high flows.</i></p>

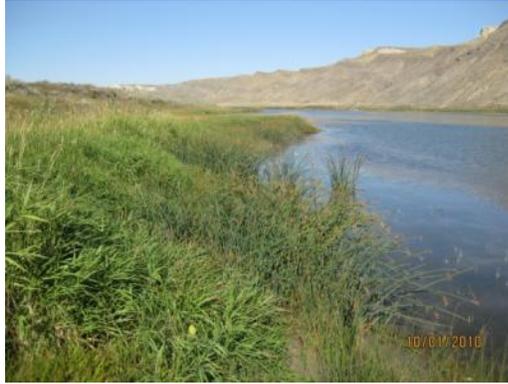
*October photograph showing response of riparian vegetation after water levels dropped.*

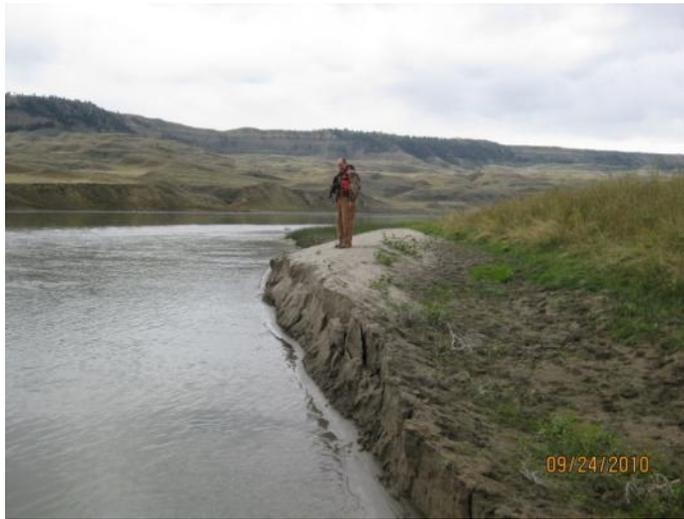
The plants, plant groupings and community types observed in Zone 1 were well developed and the depositional surfaces well vegetated with riparian-wetland plants that have medium to high stability ratings. The amount of bare areas observed was normal and naturally occurring from recent sediment deposits and scouring from water and ice. Sites are still capturing sediment and building with little evidence of bank instability (cutting/slumping).

*Bare areas from fresh sediment deposited after high flows were common throughout the reach.*

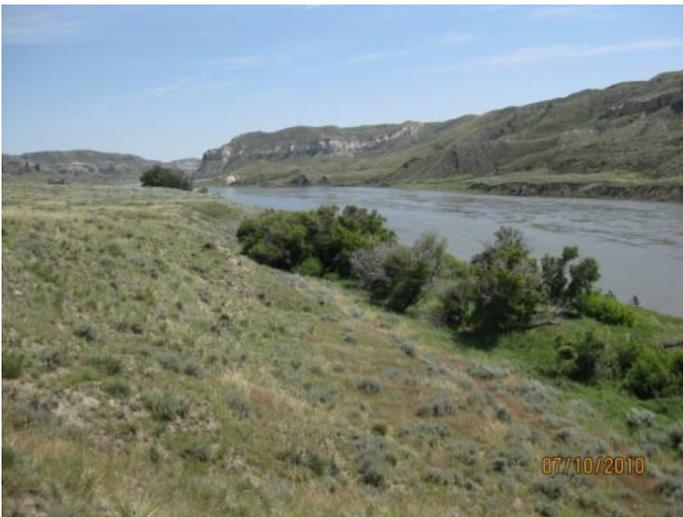
The green ash/boxelder community at North Stop #2 is unique and not a representative riparian plant community within Reach #3. These site types, which are uncommon along the river, are referred to as “perched water tables”. They are located at higher elevations above the river and are strongly influenced by adjacent upland areas. At this site, ice has bulldozed a berm in front of the trees trapping water flowing off upland areas. Moisture is stored longer into the growing season and through hot, dry periods supporting a more diverse vegetation community.

*Perched water table at North Stop #2.*

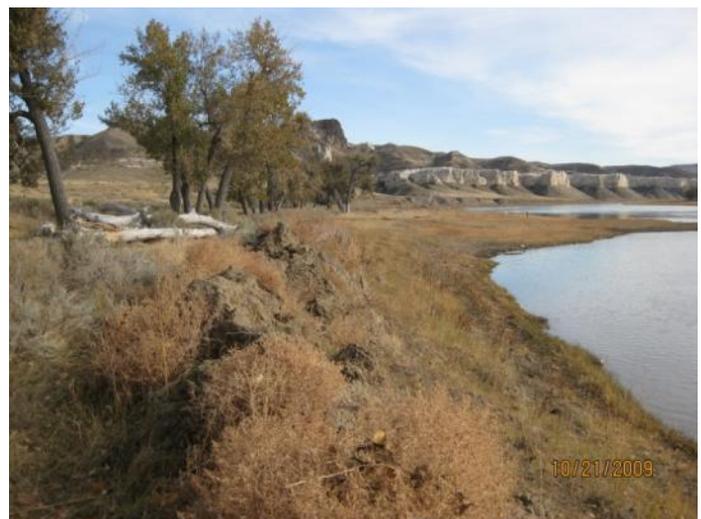
*Example of berm “bulldozed” by ice at Dark Butte primitive boat camp. Note the height above the river.*

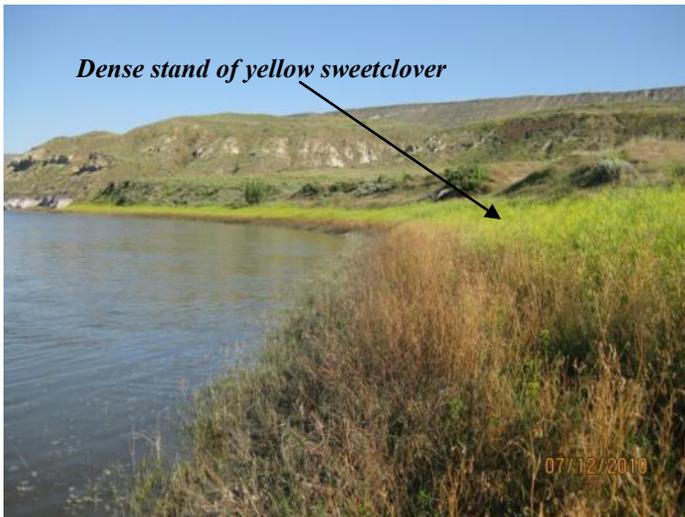
Yellow and white sweetclover, both non-native species, were very prominent in this reach and found at all twelve stops. It was more notable within Zone 2 on disturbed sites impacted by flooding and ice, and at some sites has formed dense monocultures.
