Reach #5 - Lotic Checklist

Name of Riparian-Wetland Area:		Missouri River	
Date:	7/9/2010 Revisited 9/8/2010	Segment/Reach ID:	Reach #5 - River Mile 102 (Stafford Ferry) to 119 (Sturgeon Island)
ID Team Observers:	<input checked="" type="checkbox"/> C. Krause, Hydrologist <input checked="" type="checkbox"/> V. Shea, Rangeland Management Specialist <input checked="" type="checkbox"/> A. Northerner, Range Technician (Riparian) <input checked="" type="checkbox"/> M. Forsyth, Rangeland Management Specialist <input checked="" type="checkbox"/> J. Peters, Wildlife Biologist <input checked="" type="checkbox"/> A. Ehlert, Range Technician <input checked="" type="checkbox"/> M. Philbin, Hydrologist <input checked="" type="checkbox"/> J. Sorlie, Soil Scientist <input type="checkbox"/> C. Meier, Soil Scientist <input checked="" type="checkbox"/> W. Elmore, Ecologist <input checked="" type="checkbox"/> S. Smith, Riparian/Rangeland Management Specialist & National Riparian Service Team Leader

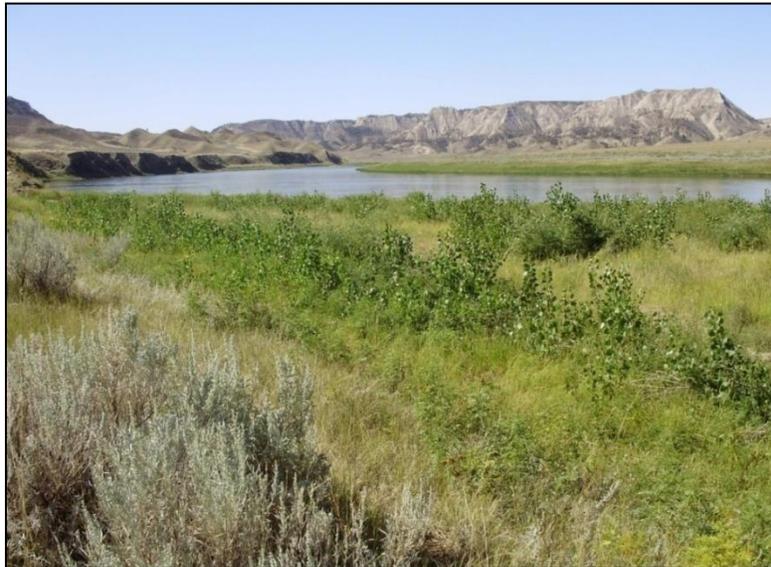
Figure 3 - Unconstrained Zone Near McGarry Bar

Although ice drives strongly influence vegetative patterns through this constrained reach, one unconstrained zone within the larger constrained zone does occur. Unconstrained zones can be found near tributary junctions, channel islands, and overflow channels (Scott and Auble, 2002). In these unconstrained parts, recruitment of trees is less dependent on the large flood pulses because with the lateral movement and sediment aggradation, established trees are removed from the zone where they receive more frequent physical disturbance (Scott and Auble, 2002). An unconstrained zone near McGarry Bar occurs within this reach. See Figure 3 - Unconstrained Zone Near McGarry Bar.

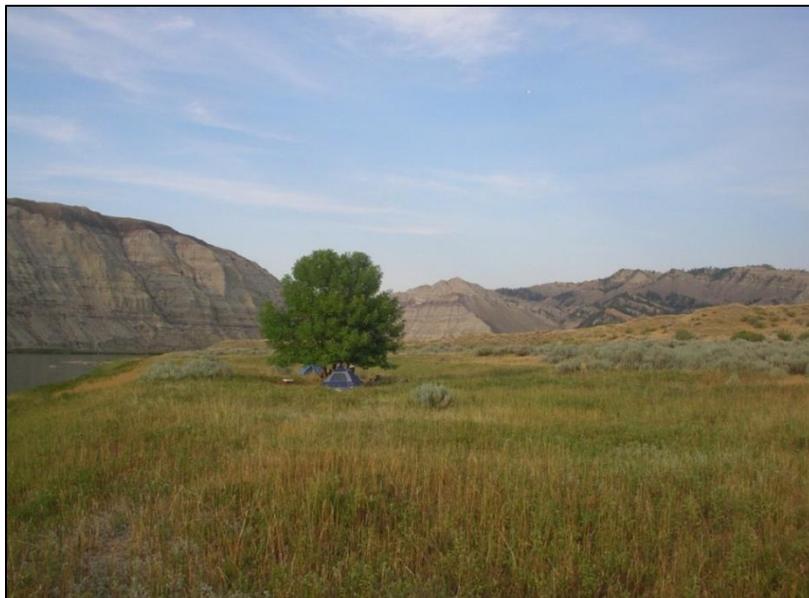
Figure 4 - Typical Existing Conditions on Reach #5 - River Mile 102 (Stafford Ferry) to 119 (Sturgeon Island)

LIMITING FACTORS: Two significant dams (Canyon Ferry Dam on the Missouri and Tiber Dam on the Marias) regulate flows on the Upper Missouri River through the Wild and Scenic reach. Although the frequency of flood pulses and the timing of a snow-melt dominated hydrograph has not changed, the magnitude of large peak flows has been reduced from 40% to 50% as a result of regulation (Bovee and Scott, 2001). Examination of post dam recruitment patterns of cottonwood by Scott and Auble (2002) identified that all stands originating in the post dam period occurred within unconstrained channel reaches. Reduction in the magnitude of peak flows has resulted in establishment of stems at lower elevations that are subject to more frequent disturbance. If patterns continue, cottonwood recruitment would be limited to unconstrained reaches. In Reach #5, this effect will be most noticeable due to the lack of unconstrained reaches. The figure below shows typical existing landform, channel, and vegetative characteristics of River Miles 102 to 119. See Figure 4 - Typical Existing Conditions on Reach #5 - River Mile 102 (Stafford Ferry) to 119 (Sturgeon Island).

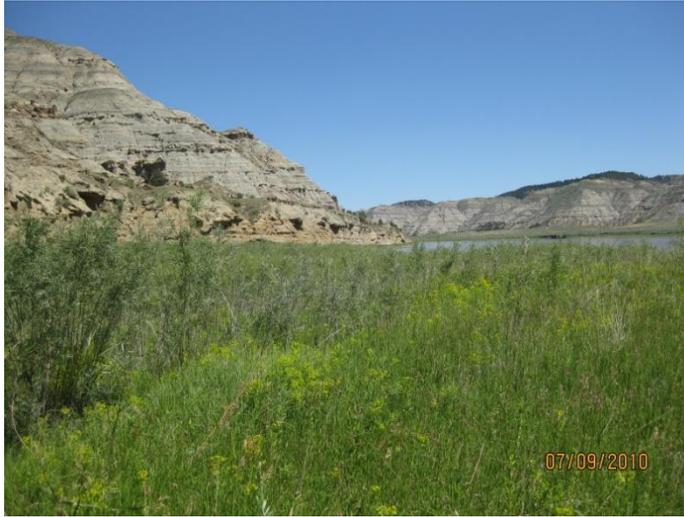
Dense sandbar willow community at North Stop #1.

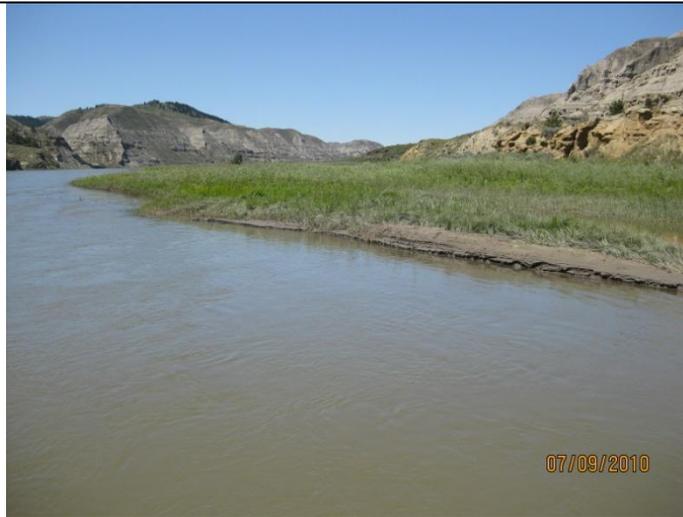
Lateral bar developing at North Stop #1 with dense stand of sandbar willow covering entire surface.

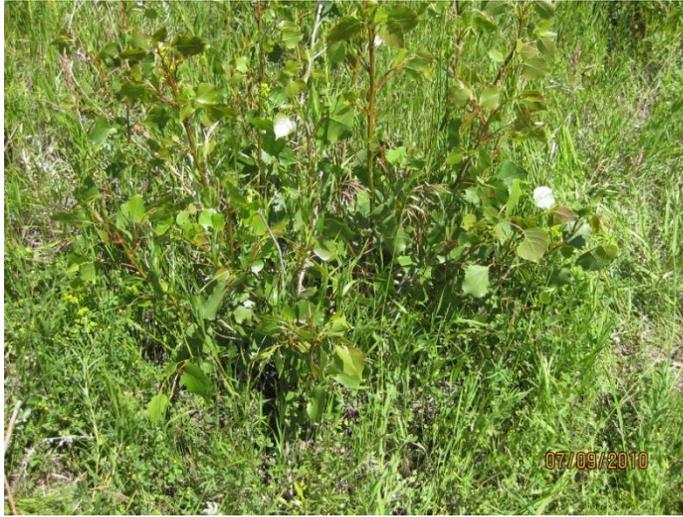
Cottonwood trees that have been sheared off by beaver were re-sprouting with 15 to 18 inches of new growth this year.

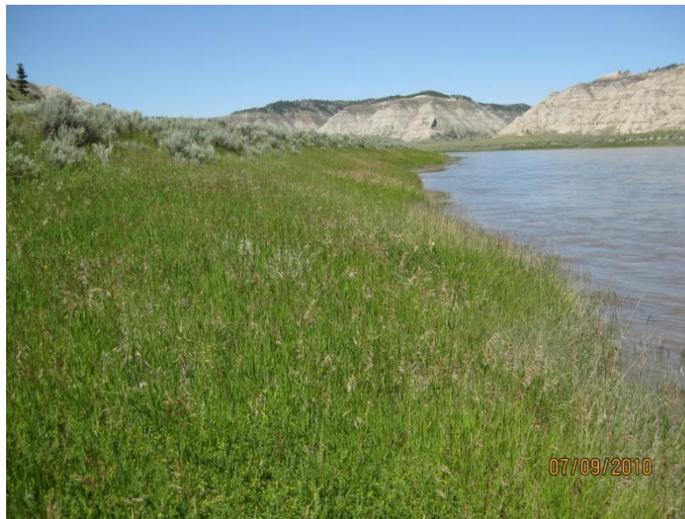
Streambanks are well vegetated to protect against scouring by water and to trap sediment.

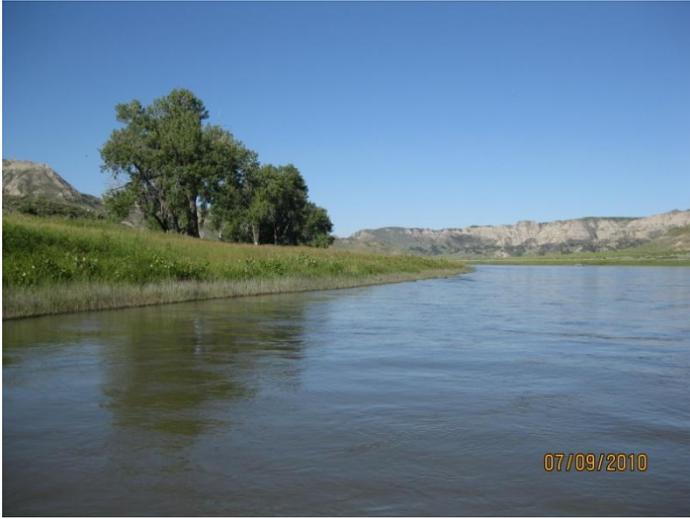
<p><i>Streambanks are well vegetated to protect against scouring by water and to trap sediment.</i></p>
		X	<p>12) Plant communities are an adequate source of coarse and/or large woody material (for maintenance/recovery)</p> <p>Rationale for Answer</p> <p>Large woody material is present within the reach; however, it is not required for function. During the steamboat era, a significant amount of woody material was pulled from the Missouri River to aid in navigation. Nevertheless, not only did the river fail to degrade (downcut) as a result of this activity, but it also narrowed during the past century. Although woody material is not a driver for function on the Upper Missouri, it can play an important role in small areas for floodplain development, energy dissipation, and aquatic habitat.</p>
