Rock Creek Watershed Report

April 23, 2004

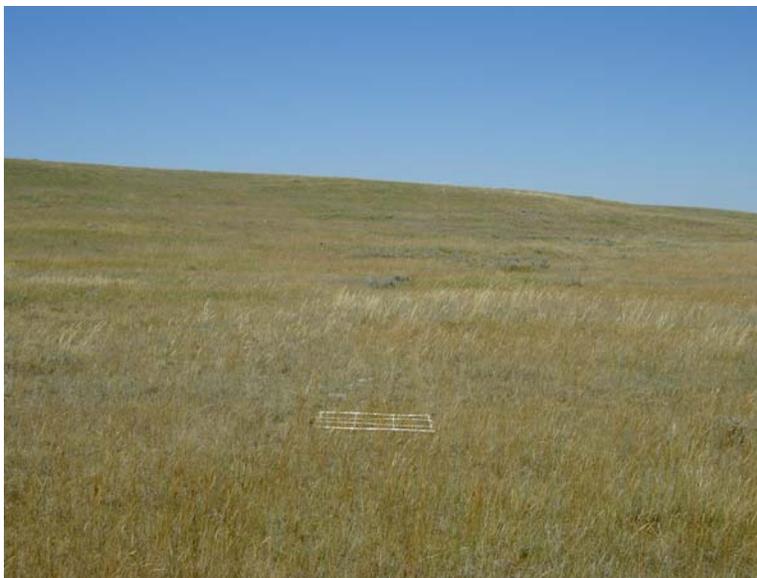
Proper Functioning Short\mid Grass Vegetation Type

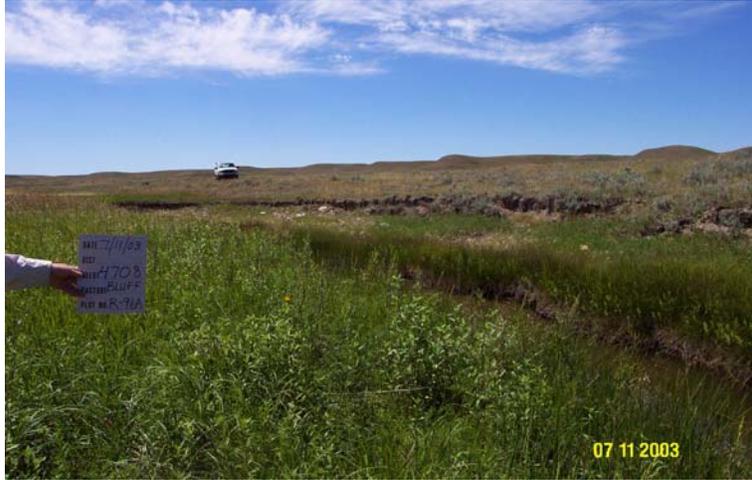
Bluff Creek, R-96 (PFC)

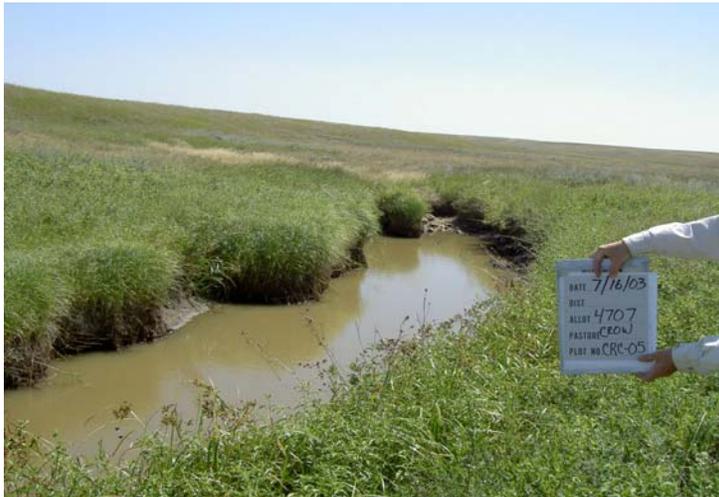
Crow Creek, RCRC-05 (PFC)

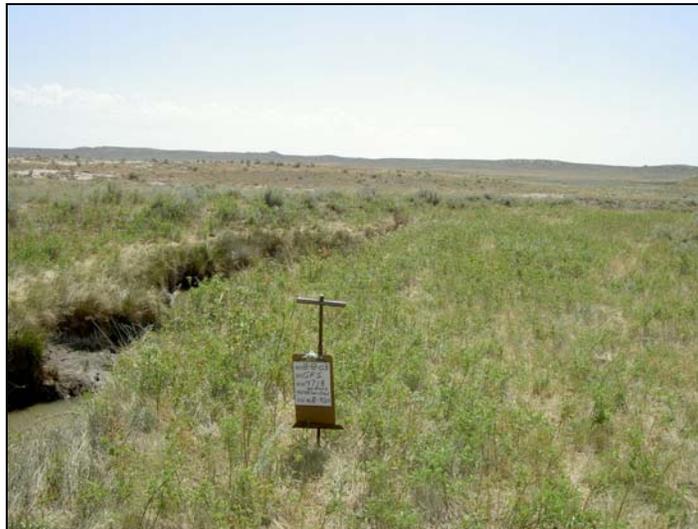
W.F. Willow Creek, R-420 (PFC)
