KOP 3 Crescent Valley

Figure 3.9-4

Falcon to Gonder Project EIS

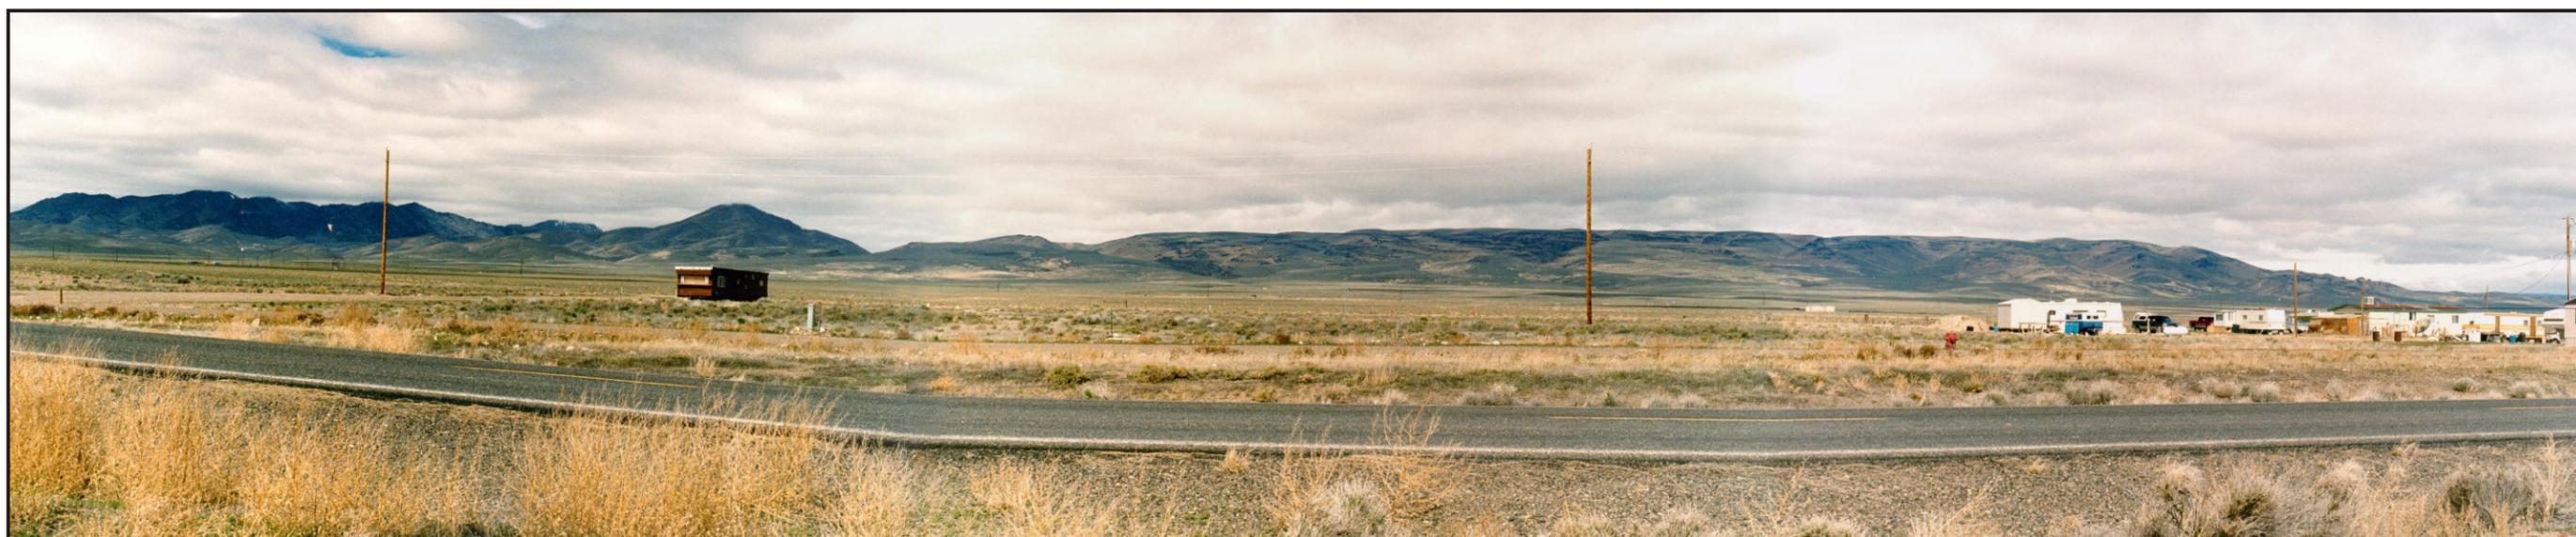
Context Photograph

Summary of Visual Changes

Type/Sensitivity of Users: Residential community; high sensitivity to visual quality

Volume of Users: Low - small community

T/L Distance from Viewer: Middleground - one-half to one mile

T/L Prominence in Landscape: Low - closely backdropped by hills

Existing Modifications: Existing wood pole transmission line and scattered residential and ranching structures.

Contrast rating: Moderate

VRM Class: IV

Visual Impact Rating: Medium
