**KOP 17  
 Buck Pass**

Figure 3.9-18

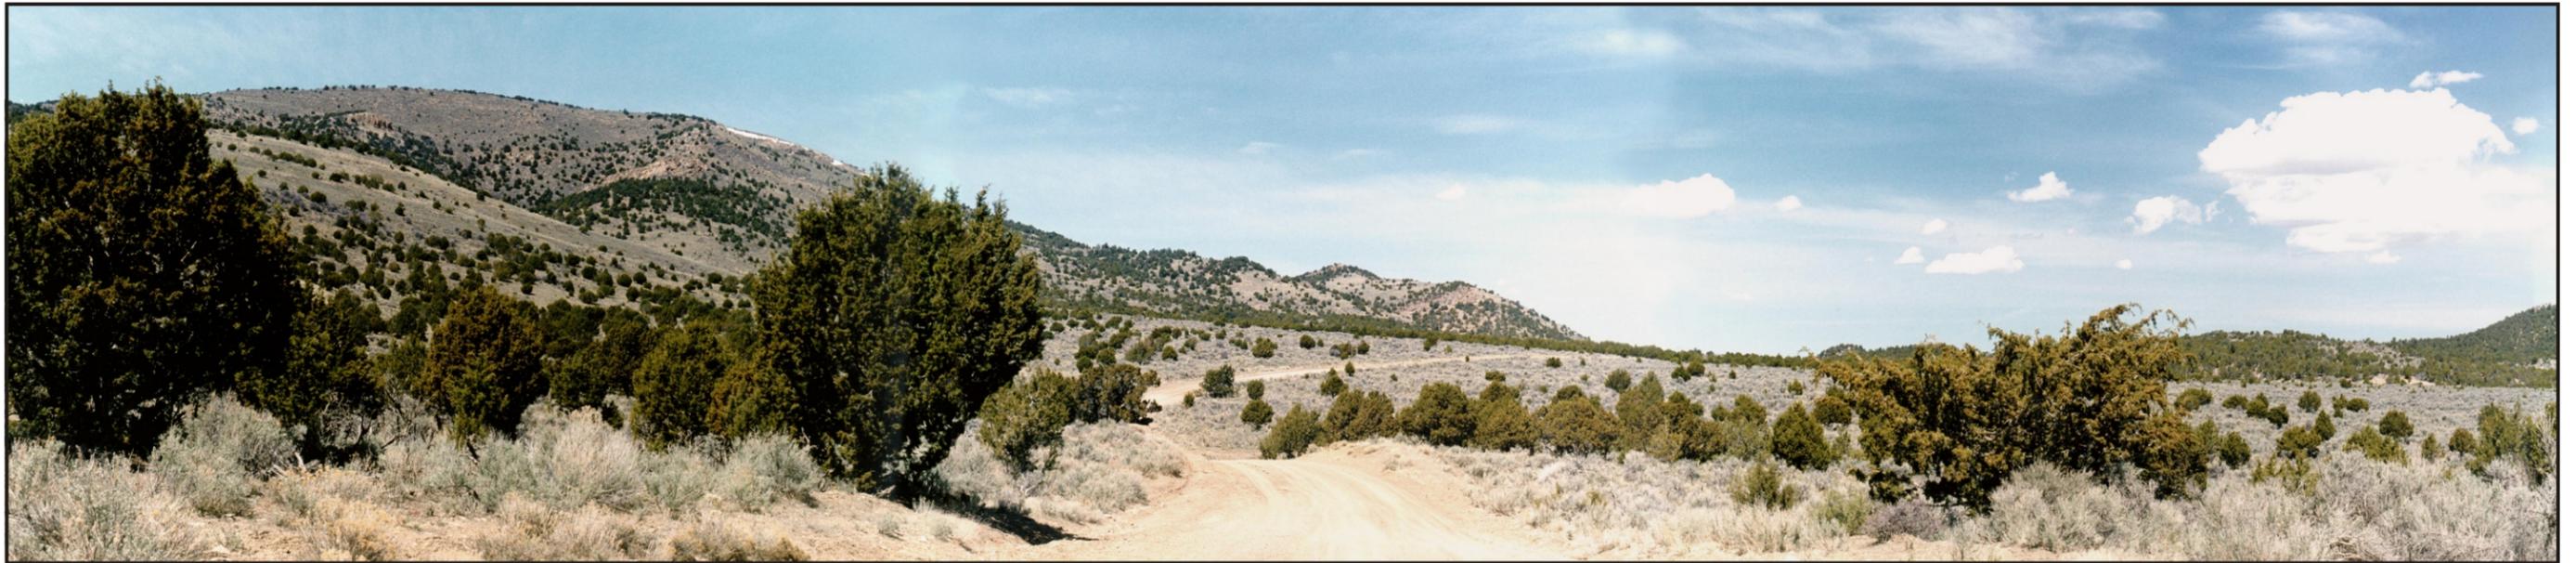
Existing Conditions

**Type/Sensitivity of Users:** Local travelers and recreationists with a moderate interest in the visual quality of the setting  
**Volume of Users:** Relatively few  
**T/L Distance from Viewer:** Middleground to foreground crossing views  
**T/L Prominence in Landscape:** High - the transmission line would closely parallel the road through this range and be seen under a variety of near-backdropped to skylined settings  
**Existing Modifications:** Essentially none

**Contrast Rating:** Strong  
**VRM Class:** III (Interim)  
**Visual Impact Rating:** High

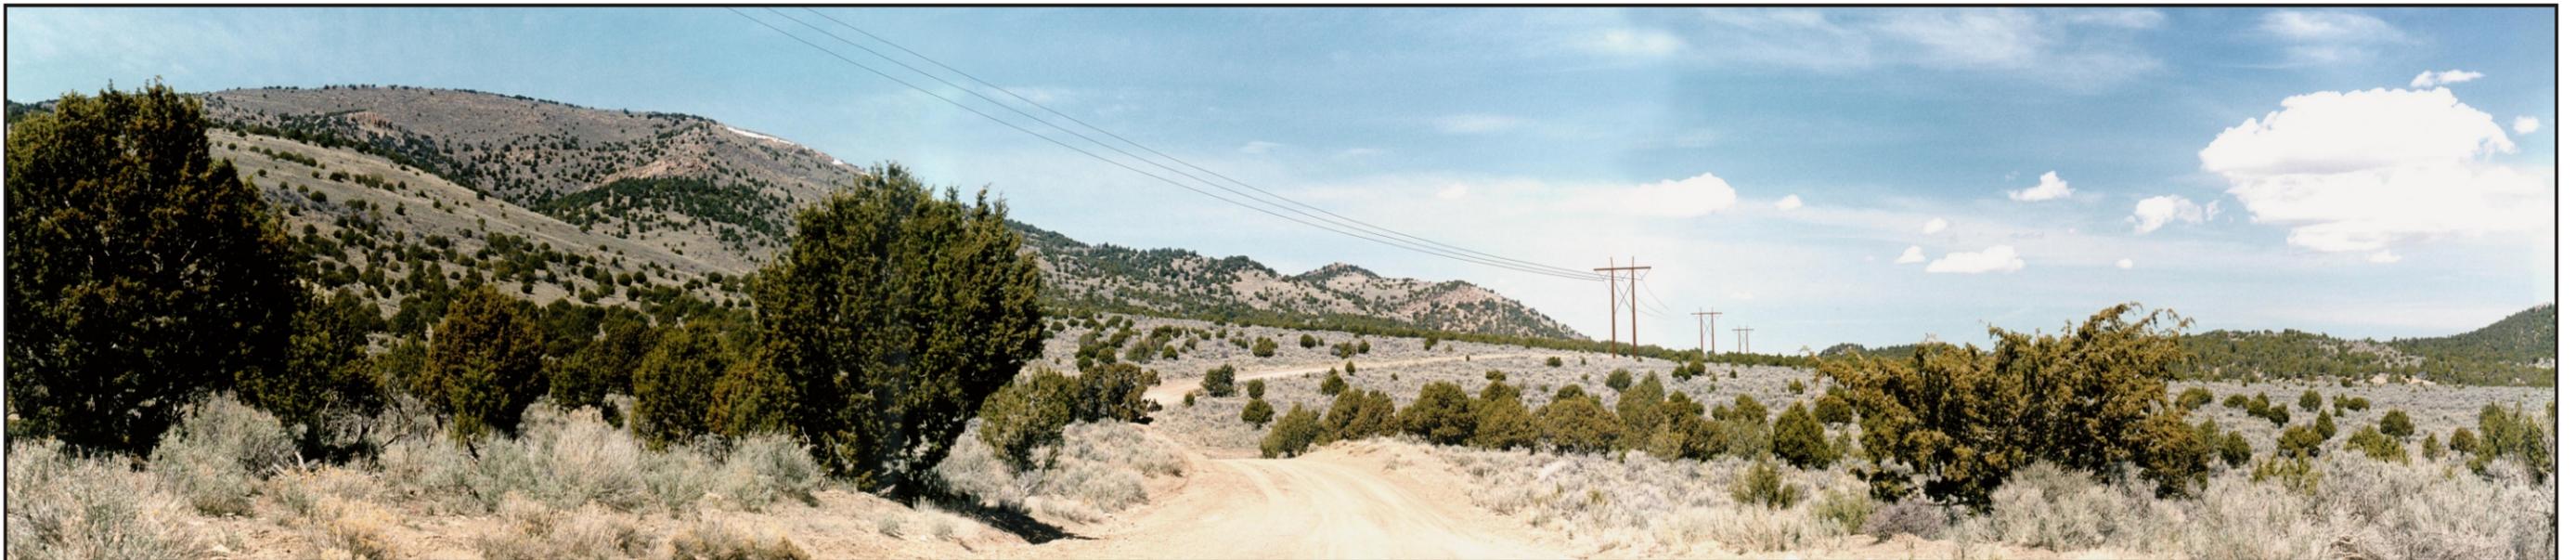
Future Conditions

**Summary of Visual Changes**
