**Appendix E – Visual Resources
Supporting Data**

APPENDIX E – VISUAL RESOURCES SUPPORTING DATA

Sigurd to Red Butte No.2
345kV Transmission Project
Figure E-1 Visual Study Flowchart

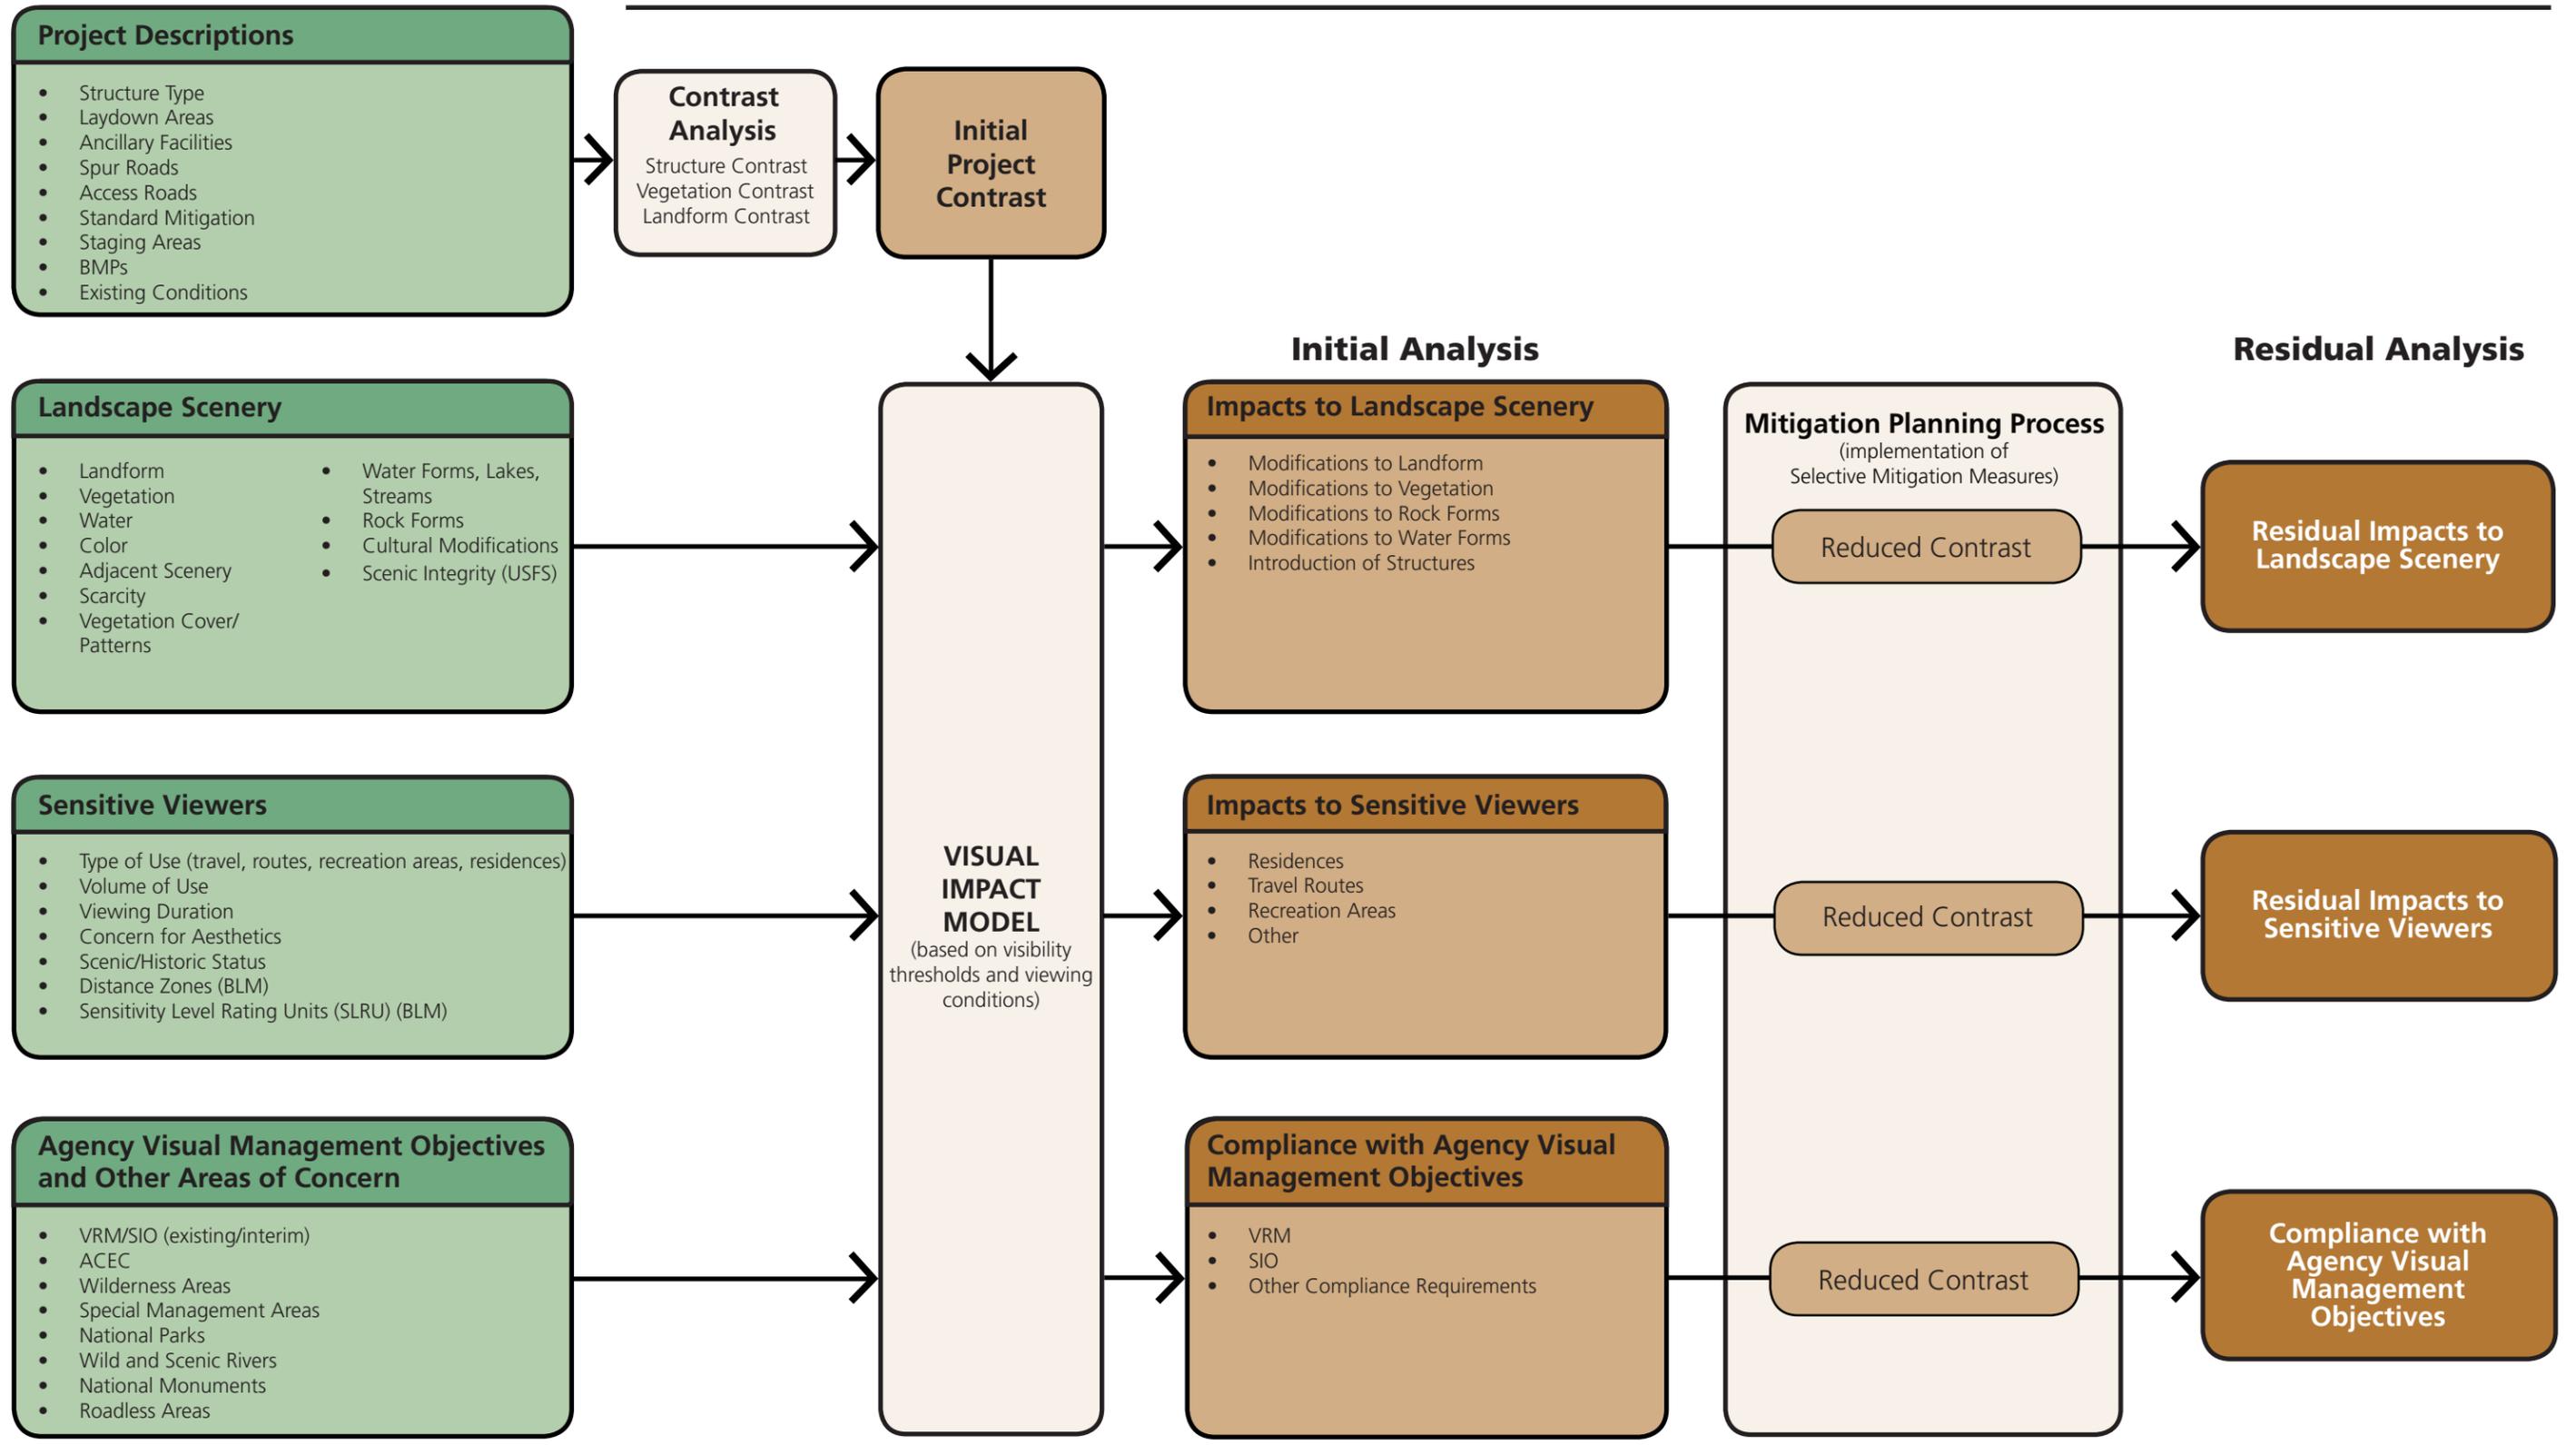
As discussed in Chapter 3, visual resources were inventoried and assessed for all land jurisdictions within a 6-mile-wide corridor (centered on the Project reference centerlines), including Bureau of Land Management (BLM), U.S. Forest Service (USFS), Bureau of Indian Affairs (BIA), state, and private. Landscape scenery, sensitive viewers, and agency visual management objectives were the primary inventory components as described in the following section. Where available, planning-level agency data were acquired and processed for inclusion in the affected environment and environmental effects discussions. Where such data were deficient, or were too general to be used for impact analysis, data were developed and reviewed by applicable agency visual resource personnel. Following is a summary of the methodology used to inventory visual resources (Figure E-1).

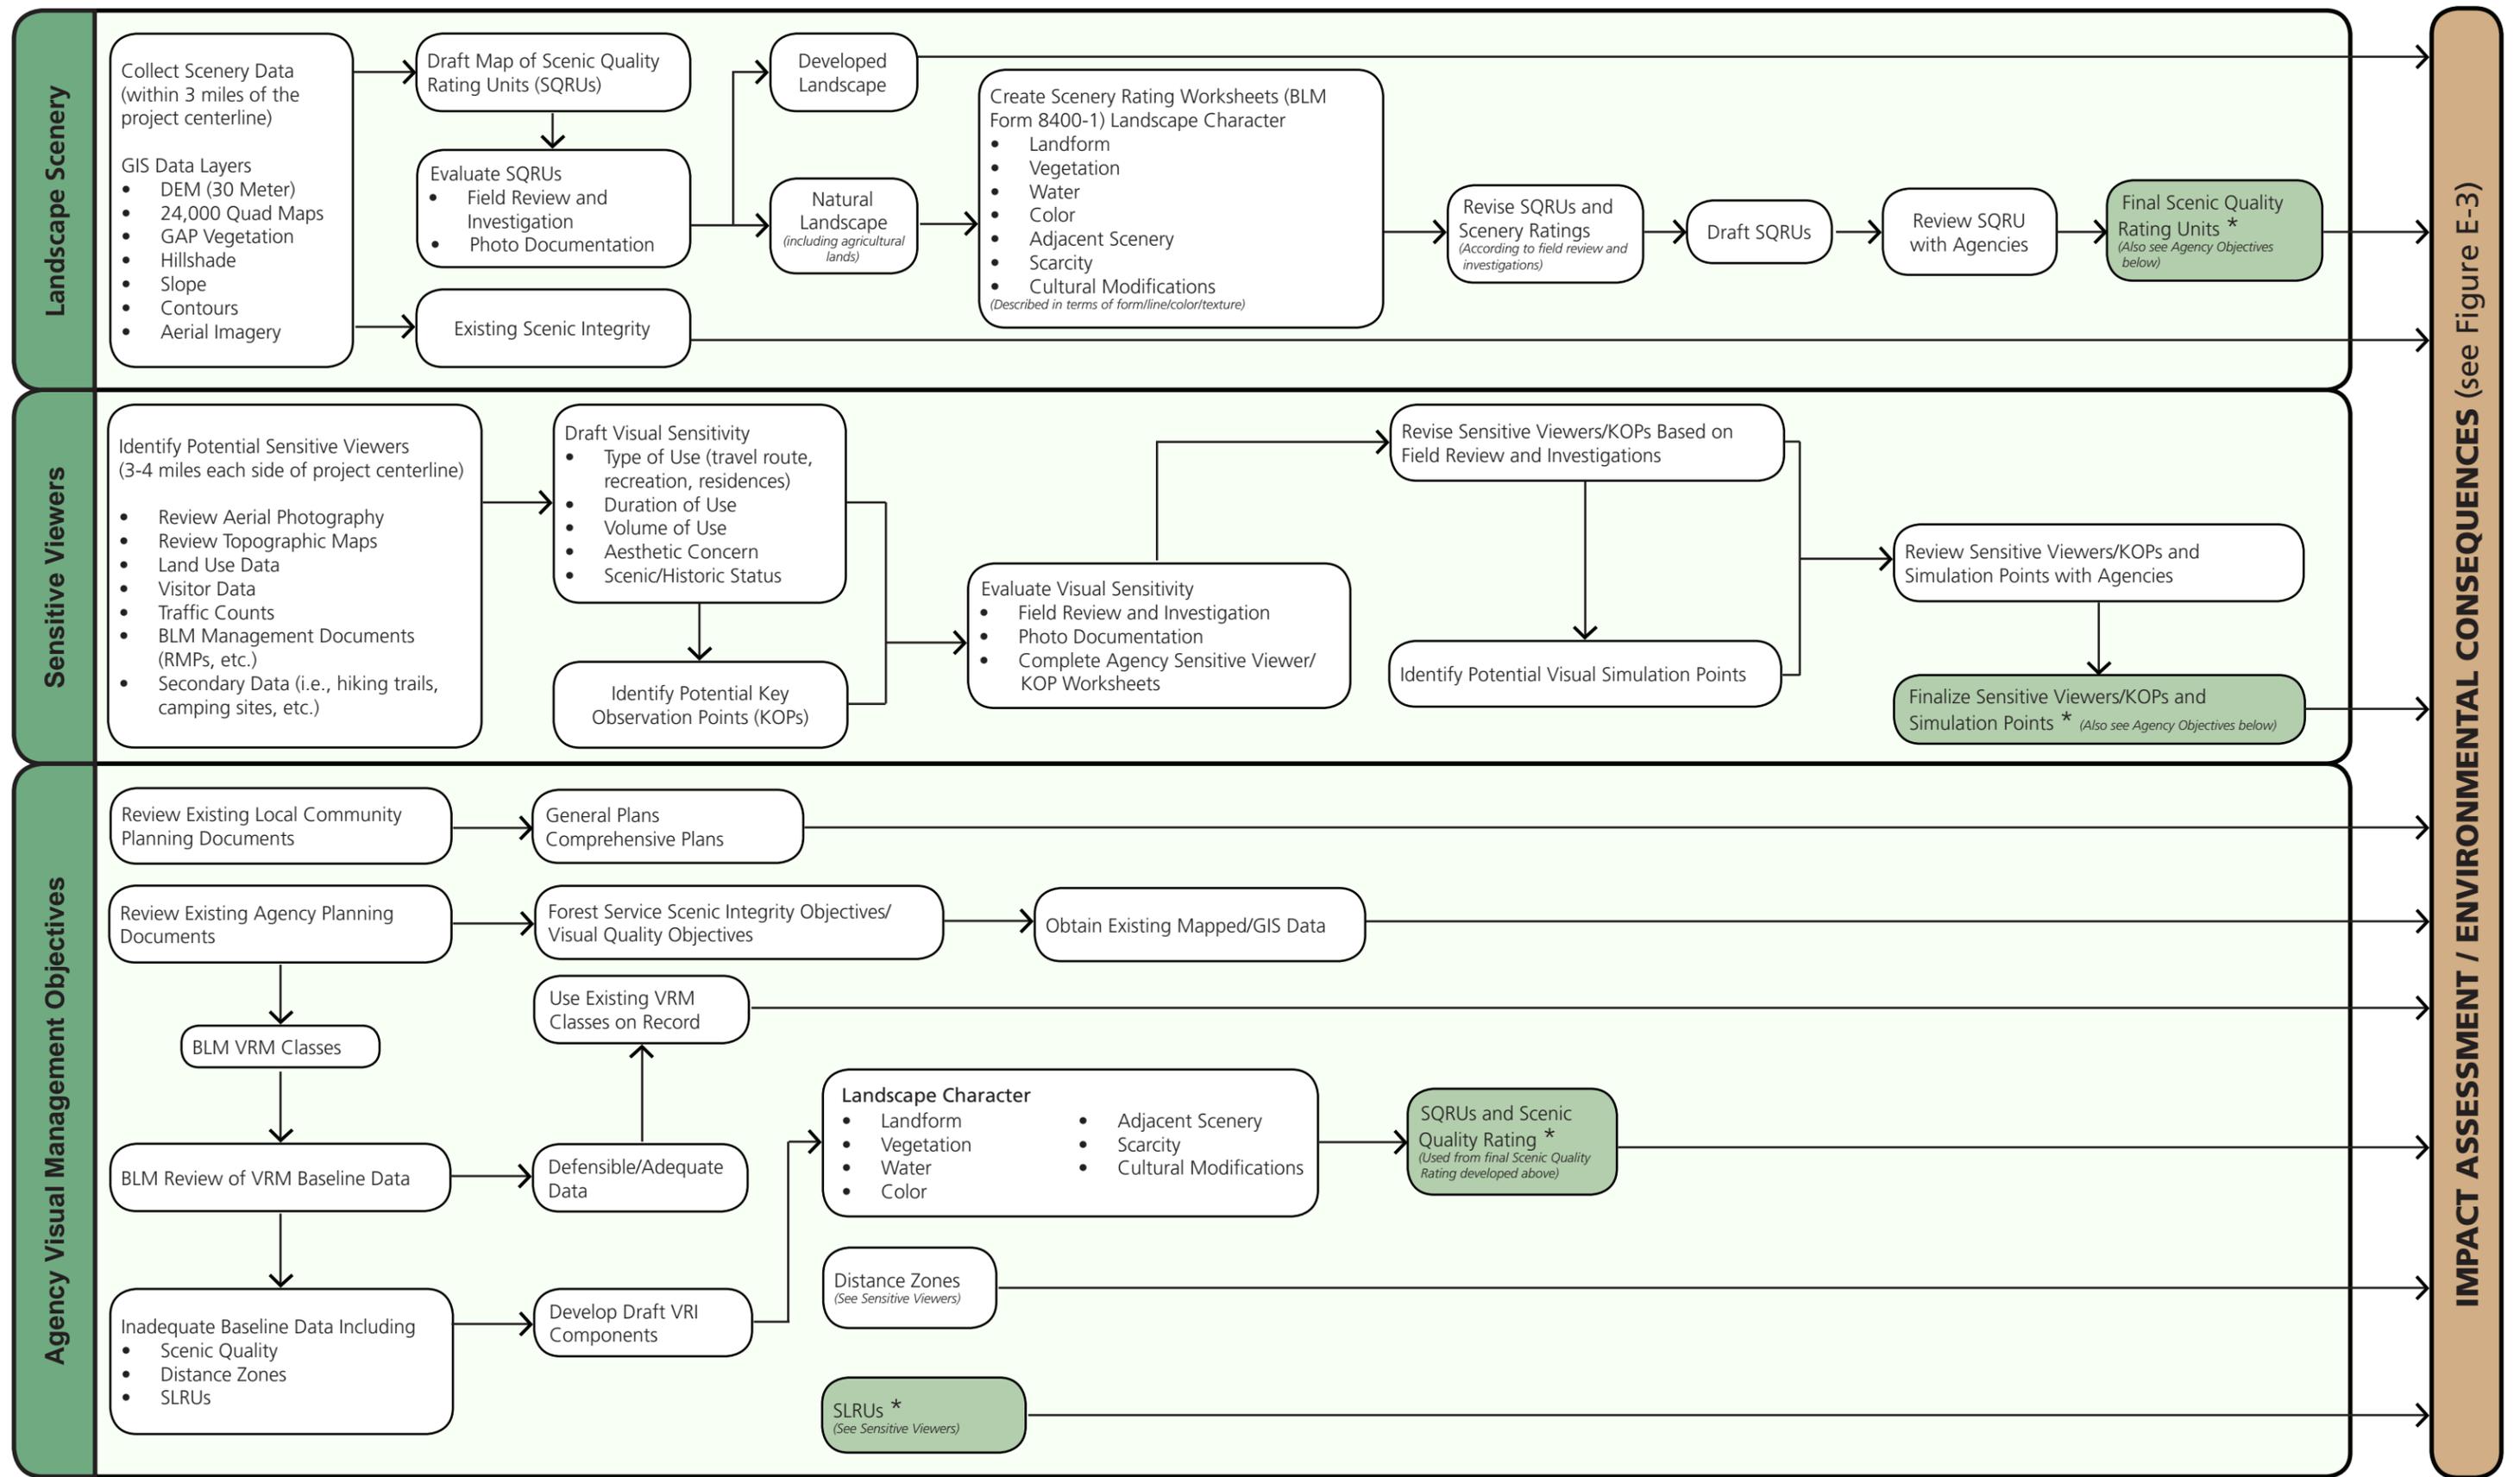
Sigurd to Red Butte No. 2
345kV Transmission Project
Figure E-2 Visual Inventory Process

**INVENTORY DATA /
AFFECTED ENVIRONMENT**
(see Figure E-2)

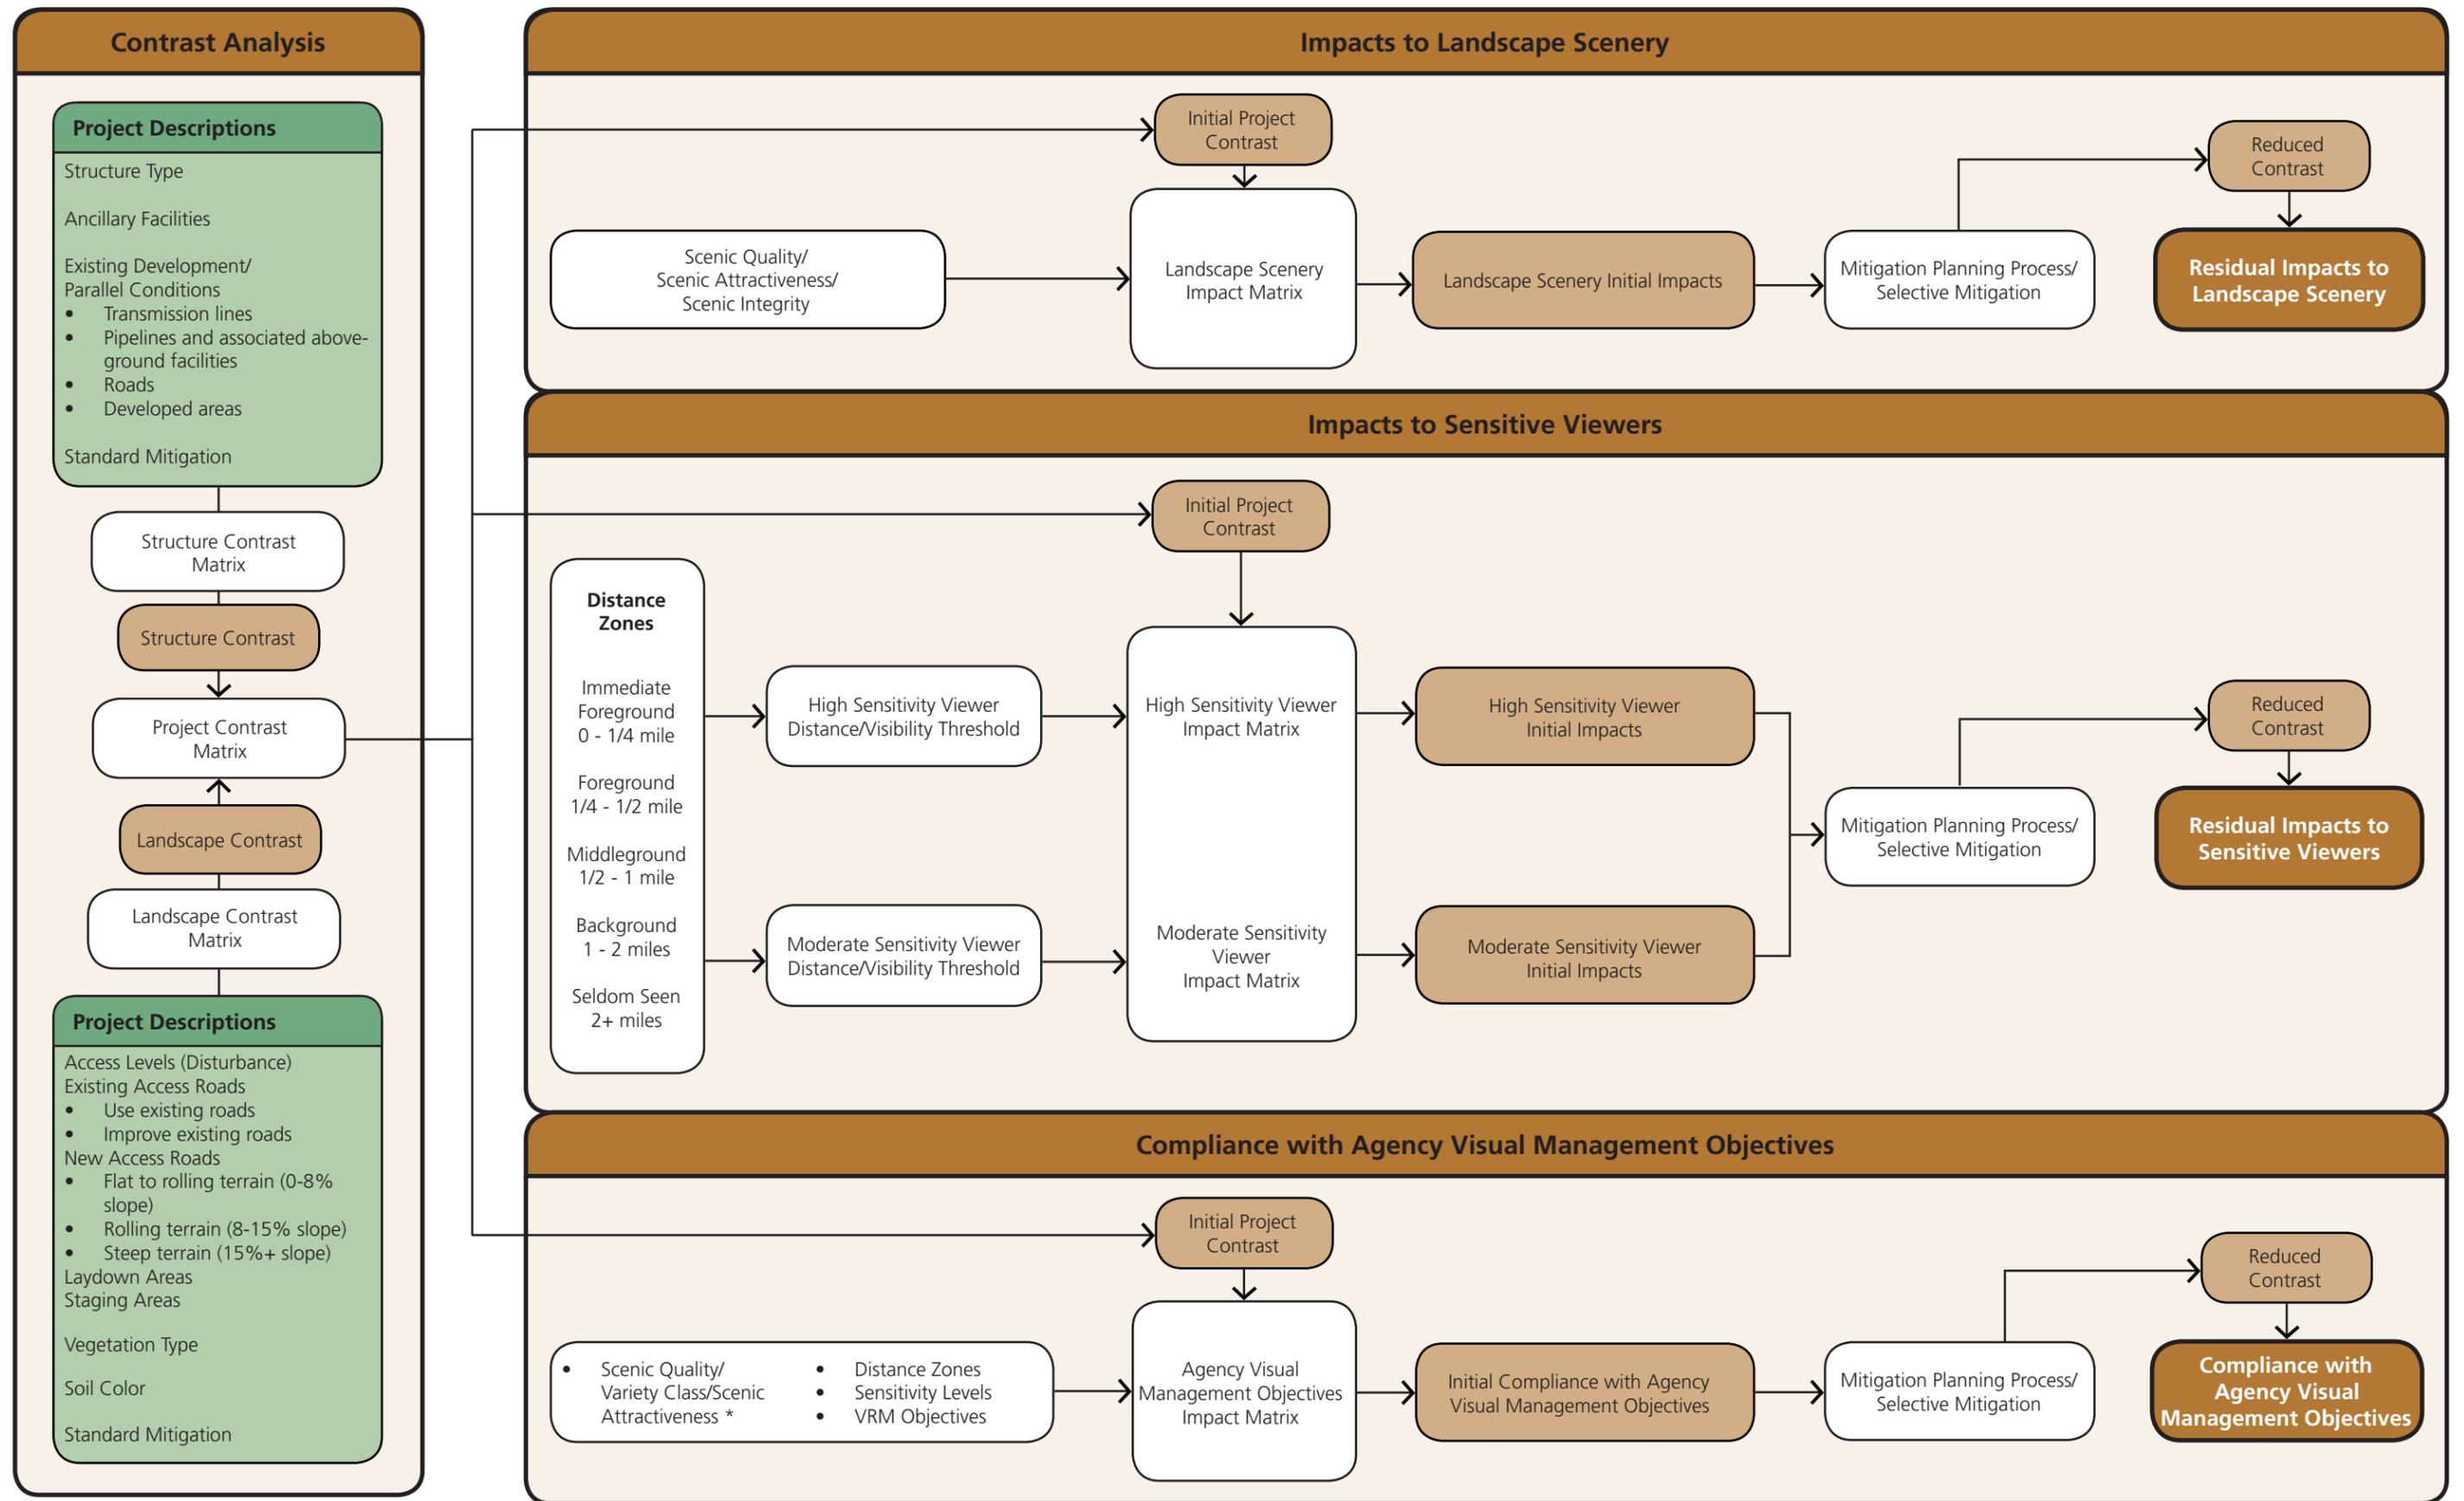
Sigurd to Red Butte No. 2
345kV Transmission Project
Figure E-3 Visual Impact Model

IMPACT ASSESSMENT / ENVIRONMENTAL CONSEQUENCES (see Figure E-3)

The contrast analysis for the Project considered the visual elements of form, line, color, and texture associated with existing vegetation communities, landform (i.e., slope and topographic variation), and existing utility infrastructure within the Project area. Using aerial imagery, vegetation data, soils data, and information gathered during initial field investigations, changes to landform and vegetation (landscape contrast) and the introduction of structures to the landscape (structure contrast) resulting from the Project were assessed and mapped (digitized accordingly). Using GIS, landscape and structure contrast were combined into a project contrast model that served as a baseline of landscape change (contrast) along each alternative in its entirety. Using GIS, project contrast was combined with scenic quality/scenic attractiveness rating to assess impacts on scenery. Similarly, project contrast was combined with the visibility analysis associated with sensitive viewers to determine impacts associated with sensitive viewers. Consistent with VRM Handbook 8431-1 – Visual Resource Contrast Rating, using worksheet 8400-1, contrast ratings were performed from each agency-approved KOP during field investigations to verify the impact model and document visual contrast resulting from the Project. These contrast ratings also were used to assess VRM class conformance for BLM-administered public lands. Applying this methodology resulted in a consistent characterization and documentation of visual resource impacts across all alternative routes being assessed for the Project.

Landscape and structure contrast were combined using GIS to identify and map project contrast for all alternatives (Table E-5). In that regard, project contrast provides the foundation for impact assessment of the Project based on concepts consistent with the VRM and SMS systems.

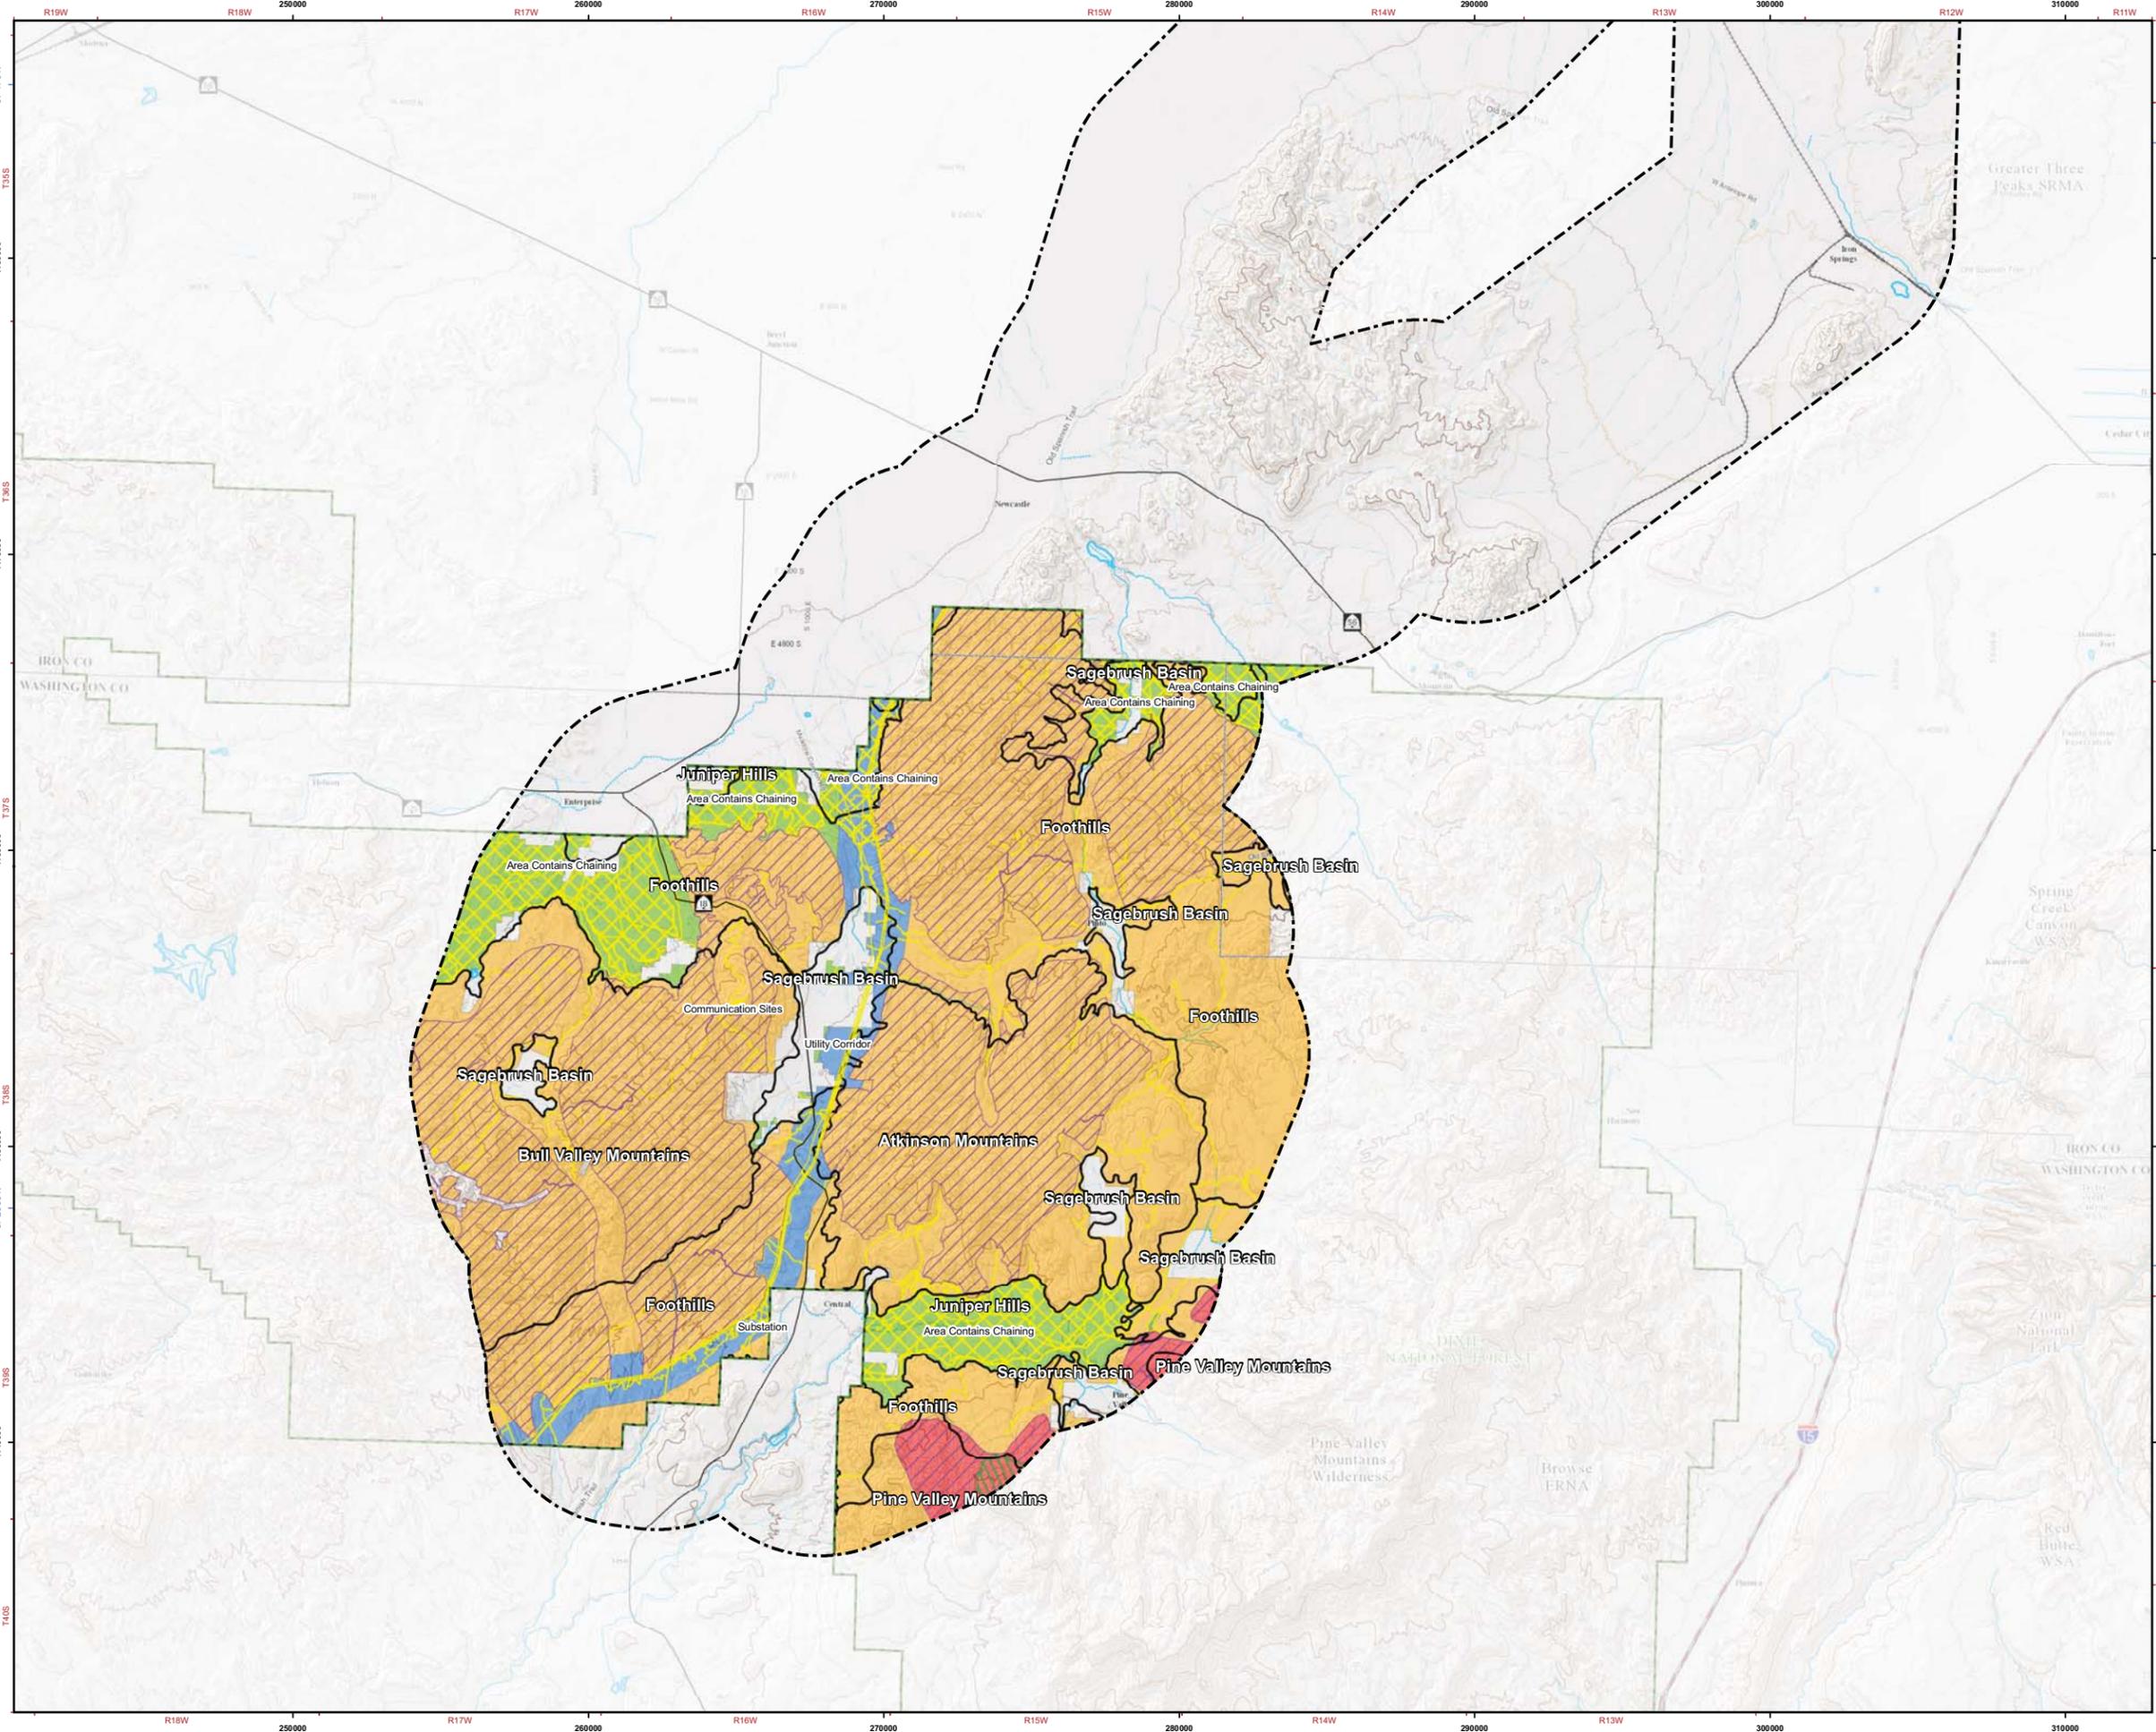
**FIGURE 2
EXISTING SCENIC INTEGRITY**

The majority of this landscape character unit lies within IRAs with few landscape character deviations. Due to the high level of intactness in the landscape, the existing scenic integrity is high. There are a few high-clearance and closed roads that deviate from the existing landscape character in terms of form, line, color, and texture but these do not dominate the landscape. The existing patterns of vegetation are well preserved and contribute to the overall integrity of this landscape. Along the west side of the landscape, a major transmission corridor impacts the existing scenic integrity by strongly modifying the form, line, color, texture, and pattern of the surrounding landscape. These areas have a low existing scenic integrity (see Figure 2 in Appendix B).
