RATTLE FIRE COMPLEX EMERGENCY STABILIZATION AND REHABILITATION FINAL MONITORING REPORT

February, 2006

U.S. Department of the Interior
BUREAU OF LAND MANAGEMENT
Moab Field Office
82 East Dogwood
Moab, Utah 84532
(435) 259-2100

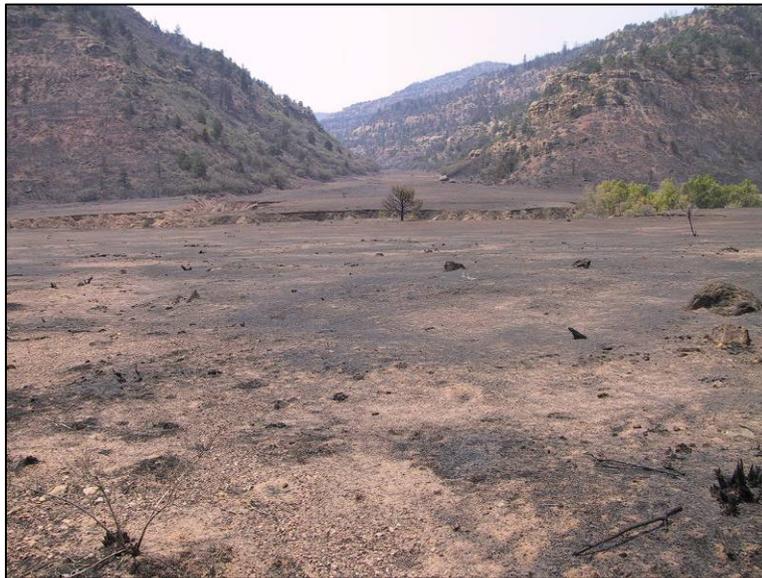
The Diamond Creek Fire burned portions of Willow Creek, Cottonwood Creek and Diamond Creek watersheds. Within the Diamond Creek and Cottonwood Creek watersheds over 36,881 acres burned, with 31,688 acres under BLM management. A majority (82%) of the burned acres in these watersheds had high to moderate burn severity (Map 5, Appendix A). The area with the highest burn severity was within the headwaters of Diamond Creek (Maps 6 & 7, Appendix A). Valley bottoms were also particularly hit hard (Photo 1.1).

Photo 1.1: “Most of the bottomlands ... had high vegetation mortality and high burn severity.” (BAER plan, p. vi)

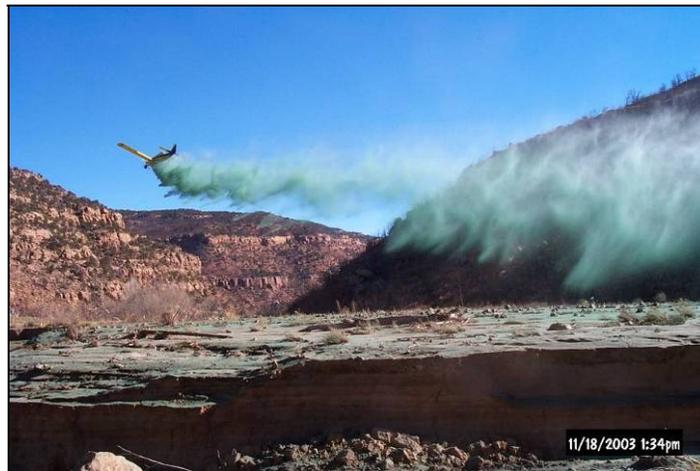
A hydro-mulch treatment was aerially applied on 650 acres immediately after the seeding (Photo 2.1). The mulch treatment was applied in an attempt to stabilize the soil and seed on site thus minimizing the loss of seed from erosion or predation. The mulch was also intended to increase the surface organic layer. The treatment consisted of 1,170,000 pounds of thermo-mechanically refined virgin wood fiber mulch with 117,000 pounds of guar tackifier.

Photo 2.1: Mulching in Diamond Canyon

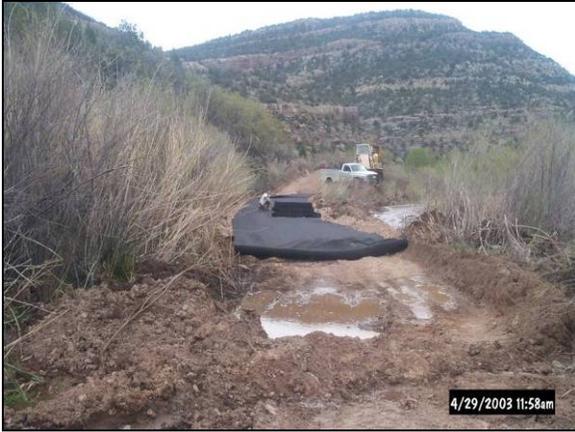
Photo 2.2: Mud bog adjacent to Cottonwood Creek

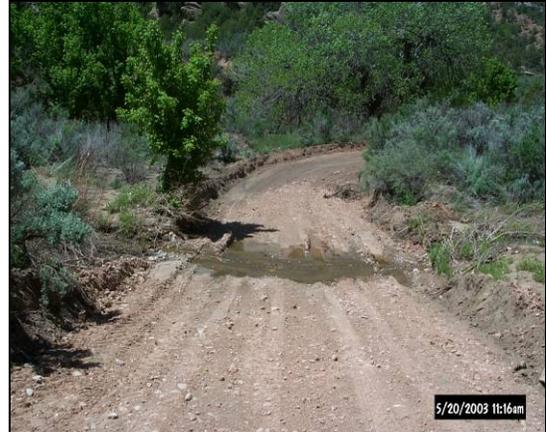
In April and May of 2003, the BLM Moab Field Office treated 10 low water crossings. Seven crossings in Diamond Canyon were armored and in Cottonwood Creek, two stream crossings were armored and one mud bog adjacent to the stream was treated (Photos 2.2 and 2.3). Each segment had a site-specific design which generally included applying erosion control material, gravel road base and restoring the pre-fire channel configuration.

Photo 2.3: Low Water Crossing Armoring

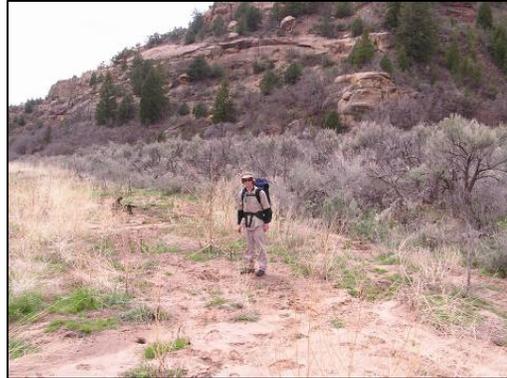
Photo 3.1: Remnant decadent sagebrush.

The Diamond and Cottonwood watersheds were historic grazing allotments retired in the mid 90's. Many years of preferential grazing of grasses and forbs by livestock and elk had resulted in bottomlands primarily filled with tall decadent basin big sagebrush, rubber rabbitbrush, and a cheatgrass understory (Photo 3.1). Riparian vegetation included various willows, box elder, cottonwood, and riparian grasses and grasslike species (Photo 3.2). Beaver ponds were present in the riparian zone. Uplands consisted of Pinyon-Juniper, Gambel Oak, Douglas Fir, Aspen, and some Ponderosa Pine communities. Quantitative pre-fire data is generally lacking and this information is compiled from anecdotal information, photographs and site reconnaissance.

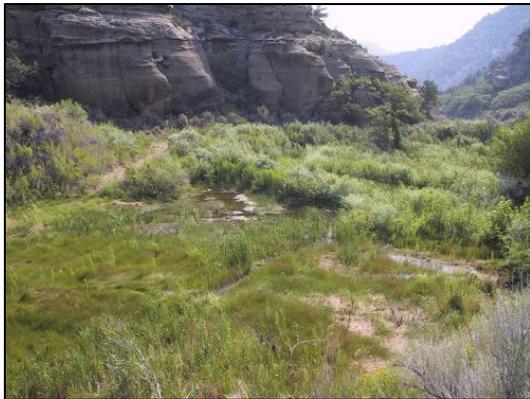
Photo 3.2: Pre-fire riparian area.

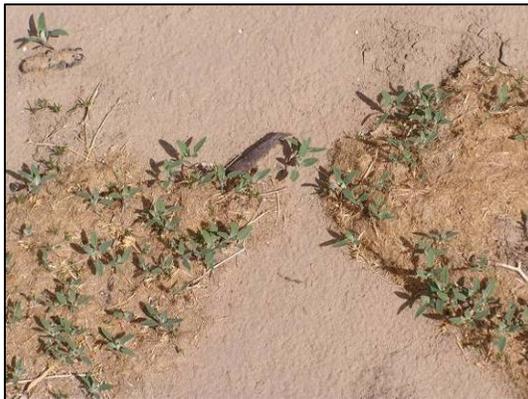
Photo 3.3: Annual *Chenopodium* species establishing in mulch in 2004.

The invasion and dominance of cheatgrass was attenuated in more mesic areas by the presence of native annual forb species like *Chenopodium pratericola*, *Chenopodium fremontii*, and *Chenopodium simplex*. These forb species were prolific in and around the floodplain areas often growing in mulch (Photo 3.3). Cheatgrass cover was very low in areas dominated by

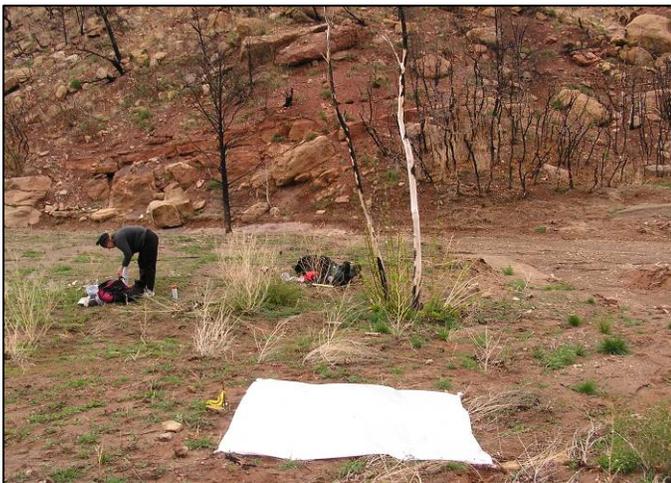
Photo 3.5: Box elder and Oak Skeleton forest on 04/18/04.

are very dense with little to no grass-forb understory beneath the overstory canopy. Grasses and forbs have established in the open spaces between oak canopies. The photos below show a Box Elder (*Acer negundo*) in the foreground and Gambel Oak in the background. Although photo 3.3 was taken in 2004 it shows what the post-fire skeleton forest looks like. Photo 3.4 shows the considerable resprouting that occurred by the early part of the 2004 growing season. Gambel Oak communities are extremely resilient to fire due to their extensive rhizomatous root system and their ability to resprout quickly and stabilize the soil. These communities should generally be considered a low priority for seeding treatments because of their fire resiliency and their competitive exclusion of other vegetation.

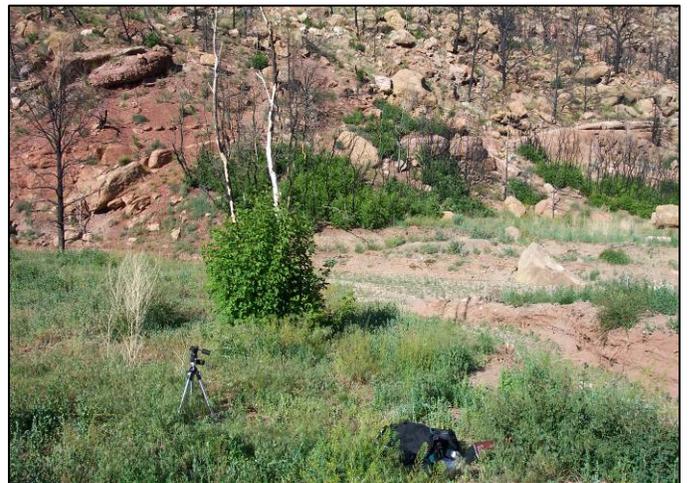
Photo 3.6: Box elder and Oak Skeleton Forest on 06/04/04

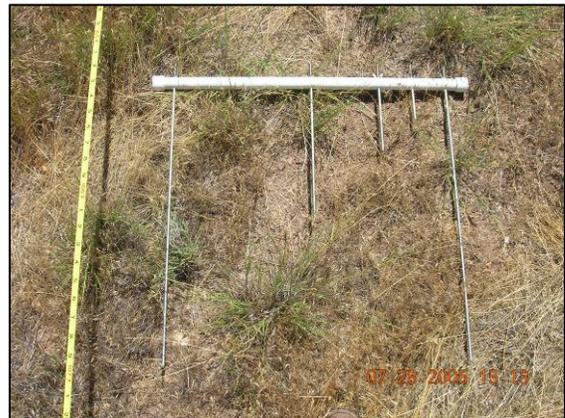
Photo 3.7: Sand Dropseed growing through Cheatgrass in the warm season.

It is the opinion of this author that the increased cover of cheatgrass in the mulch treatment is a significant factor contributing to the difference in preferred grass cover. In the mulch treatment, 59.2% of the preferred grass frequency consisted of the seeded warm season grass *Sporobolus cryptandrus* with no other warm season grasses present. In the “no mulch” treatment only 1.6% of the preferred grass frequency consisted of *Sporobolus cryptandrus* without any other warm season grasses present. Field observations show seedlings and juvenile *Sporobolus cryptandrus* growing through mats of senescent cheatgrass during the warm season (Photo 3.7). The prevalence of this seeded warm season grass over seeded cool season grasses in the mulch treatment indicates that it has a competitive advantage in areas of higher cheatgrass cover. The competitive advantage of *Sporobolus cryptandrus* is apparently gained through its phenological difference in growing season as it initiates growth under hotter and drier conditions when cheatgrass is senescent. *Sporobolus cryptandrus* has a growth form that even in the adult stage has significantly less cover than many of the cool season grasses occurring within the no mulch treatment area (Photo 3.8). In this case many *Sporobolus cryptandrus* individuals are seedlings or juveniles with lower cover than adults. The difference in preferred grass cover between treatments is accounted for by the growth form and life-stage of *Sporobolus cryptandrus*.

Seedlings of *Orhizopsis hymenoides* and *Sporobolus cryptandrus* were prolific during the 2005 growing season (Photos 5.2 and 3.7). High densities of *Orhizopsis hymenoides* seedlings were noticed on fresh alluvial deposits within the main channel and are not likely to persist. *Orhizopsis hymenoides* seedlings were also present in lower numbers in areas outside the channels. Persistence of these seedlings will depend on future climatic conditions

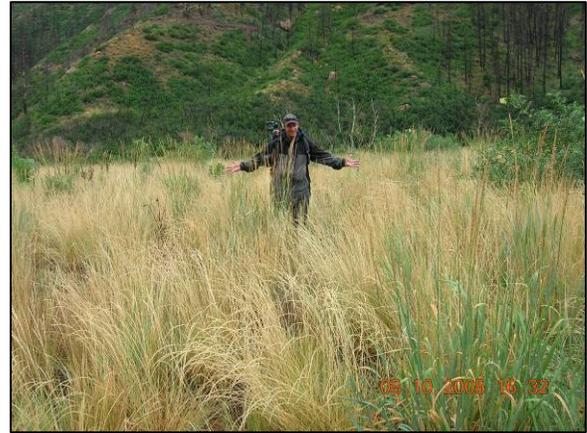
Photo 3.8: High cover of seeded cool season

The species that had the highest frequencies across variable burn severities and treatments were *Elymus trachycaulus*, *Elymus lanceolatus*, *Pascopyrum smithii* and *Pascopyrum spicatum inermis*. These cool season species were marginally successful in the first two post-fire years most likely in response to persistent drought conditions. These species responded dramatically with the above average precipitation in 2005. *Elymus lanceolatus* and *Pascopyrum smithii* were present in large high frequency sod-forming patches by the end of the 2005 growing season. *Leymus cinereus* did not account for a large portion of the absolute vegetative frequency but was well established when the pilot study was initiated in 2004. The early success of this species under drought conditions, monsoonal scouring and strong competition from annual forbs and grasses is worth noting. These perennial grass species should be considered in future seeding treatments in similar ecosystems.

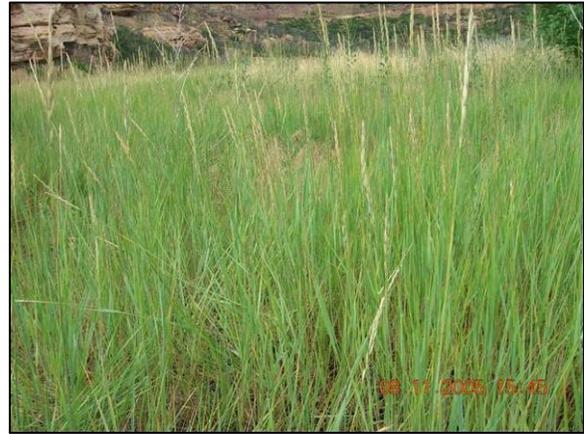
Photo 3.9: Vigorously growing *Pascopyrum smithii*.

It is impossible to quantify the effect of the mycorrhizal coating on germination and establishment without the proper control treatments or sites. There were no areas where the same seed mix was applied without the mycorrhizal component. However, some field observations support a possible effect on the establishment and vigor of *Pascopyrum smithii*. In the DCNM08 macroplot *Pascopyrum smithii* was observed growing in strong sod-forming monoculture with heights approximately 12 inches taller than typically observed in the region (Photo 3.9). It is possible that the mycorrhizal treatment has influenced this phenomenon. However, these monitoring studies cannot provide conclusive evidence indicating either success or failure of the mycorrhizal coating. Establishing control treatments and sites prior to treatment application is necessary to evaluate the success or failure of mycorrhizal coatings.

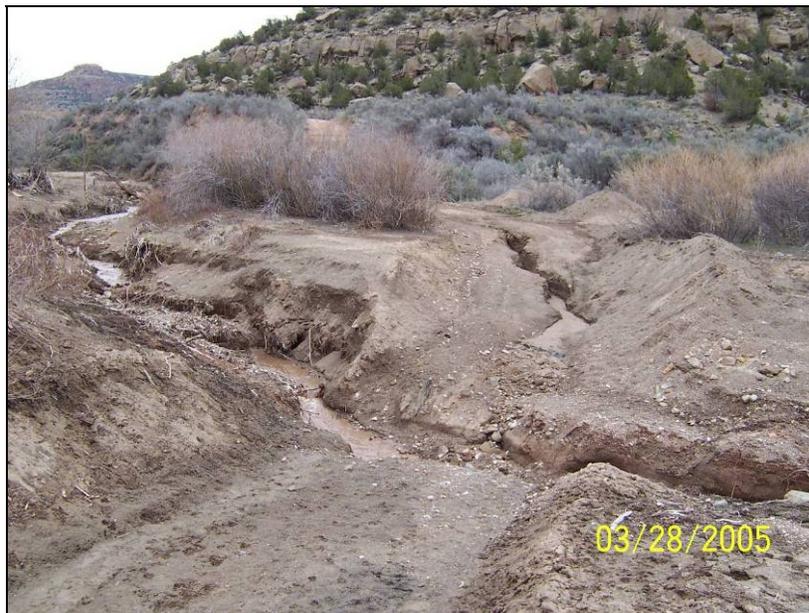
Photo 4.1: Diamond Creek, road crossing #1 (3 miles downstream of burn)

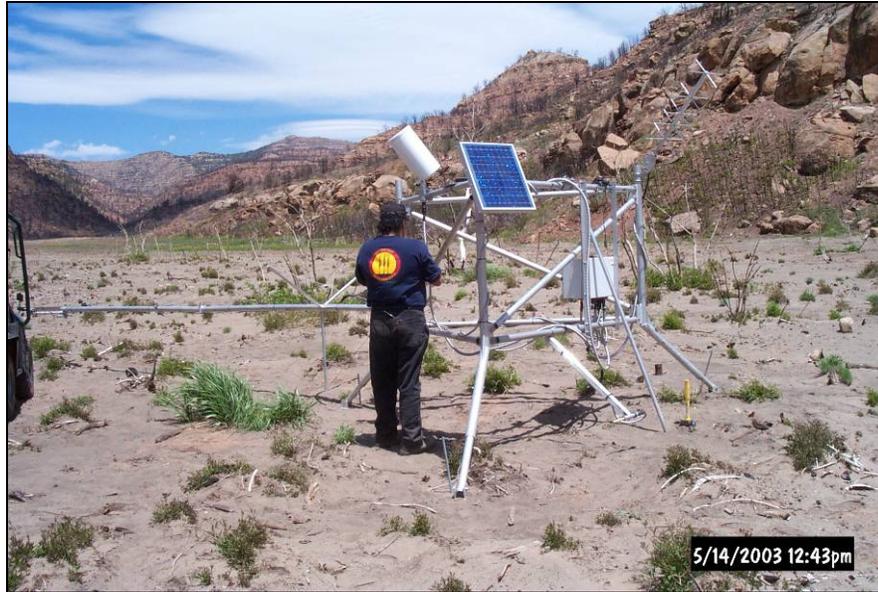
One Remote Automated Weather Station (RAWS) was installed in Diamond Canyon in May 2003 by National Interagency Fire Center (NIFC) staff (Photo 4.2). The station sits in a wide section of Diamond Canyon, at an approximate elevation of 6100'. The station recorded precipitation, soil moisture, relative humidity, air temperature, solar radiation, and wind speed and direction. Annual maintenance was conducted each spring by NIFC staff.

Photo 4.2: RAWS Station Installation

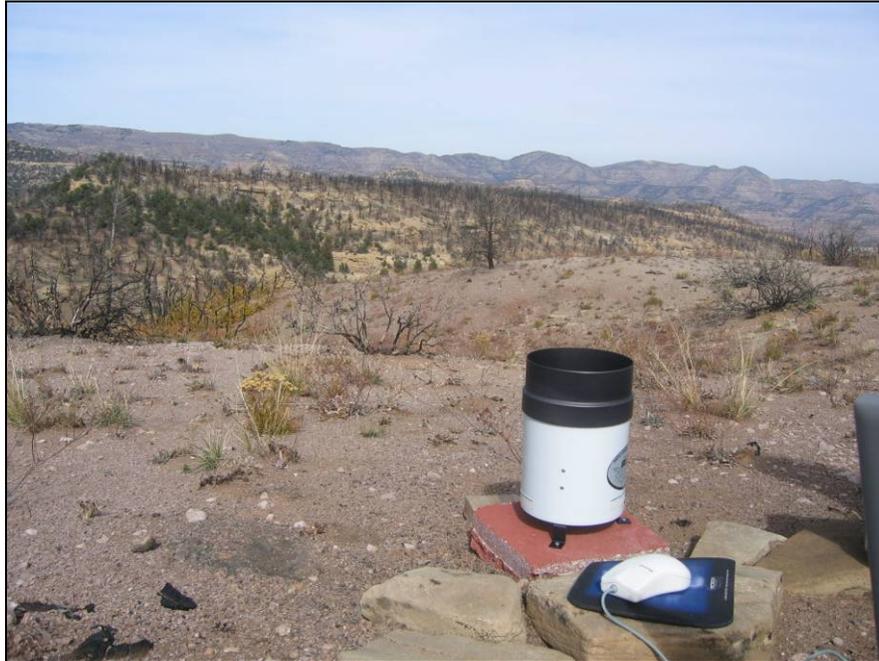
Five tipping bucket HOBO raincans (Photo 4.3) were set up in the burned area to understand precipitation patterns within the burned area. These raincans record with an accuracy of .01”, noting the time of each tip of the measuring bucket. This data was also used to generate storm duration and storm intensity statistics.

Photo 4.3: Hobo raincan on Cottonwood Ridge

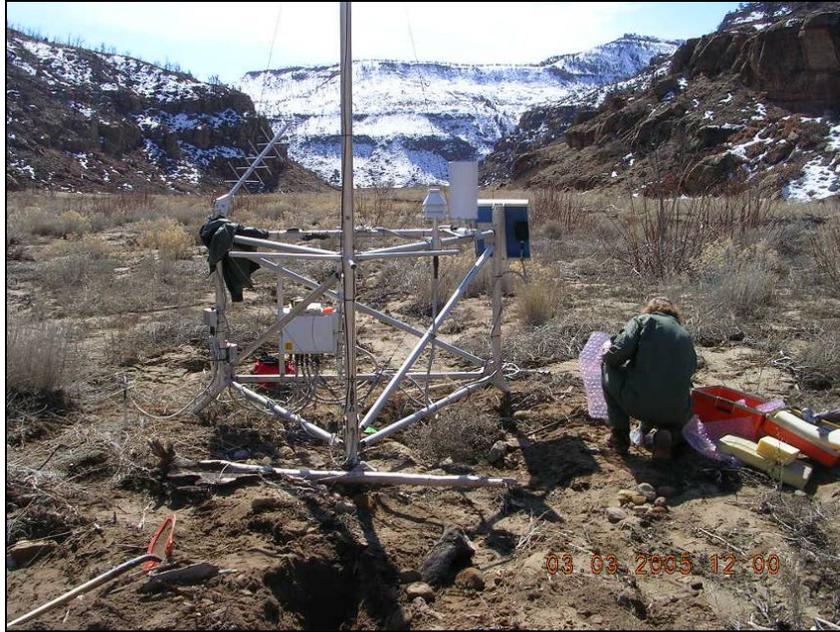
The Rattle RAWS soil moisture data is suspect due to repeated flooding and subsequent sedimentation. Repeated flooding events either deposited or scoured sediment around the probes, making the meter depths unknown. After one storm event in fall, 2004, the station was buried 3 feet deep (Photo 4.4). The wiring was compromised at least once from critter activity.

Photo 4.4: Note: 3' legs buried in sediment

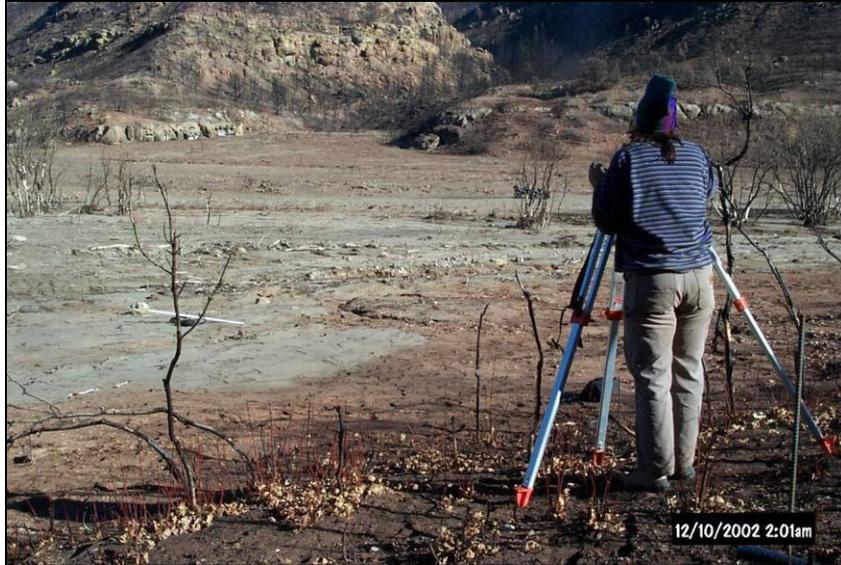
Photo 4.5: Diamond Canyon, downstream of Oak Springs

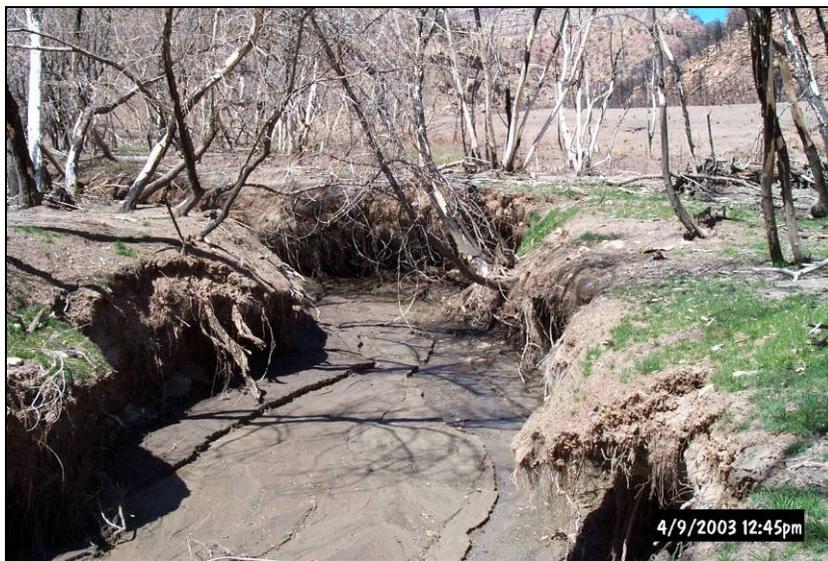
Surveys were also conducted on three large gullies forming upstream and downstream of Oak Springs in Diamond Canyon. These surveys included lineal (extent and direction), horizontal (width) and vertical (depth) measurements. These surveys were repeated in 2005 as access and time permitted.

Photo 4.6: Gully growing downstream of Halfway Canyon

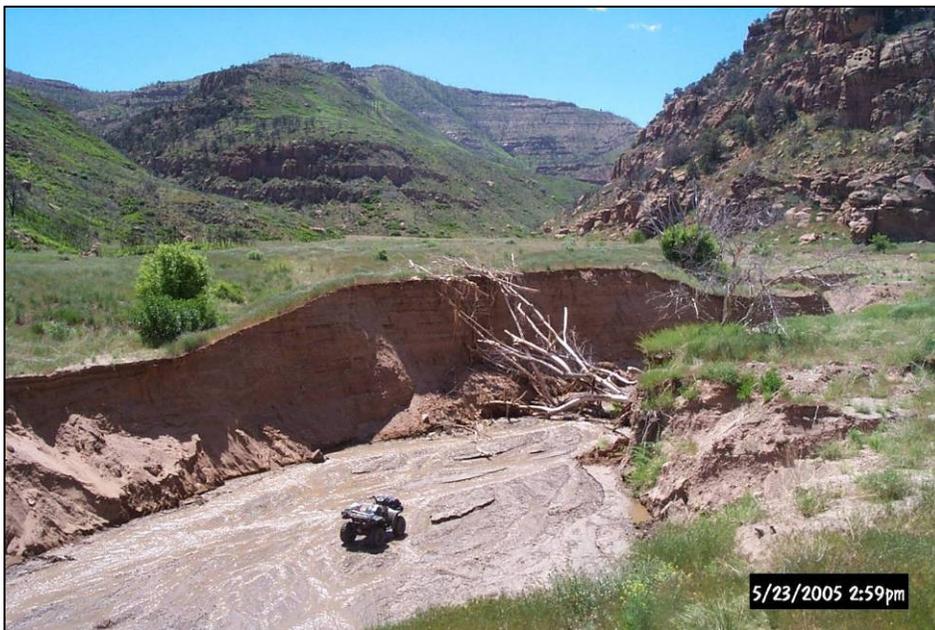
Photo 4.7

In 2002 there were three separate gullies growing in Diamond Creek. These gullies became one long gully by 2005, over one mile in length and an average of 30' deep (Photo 4.7).

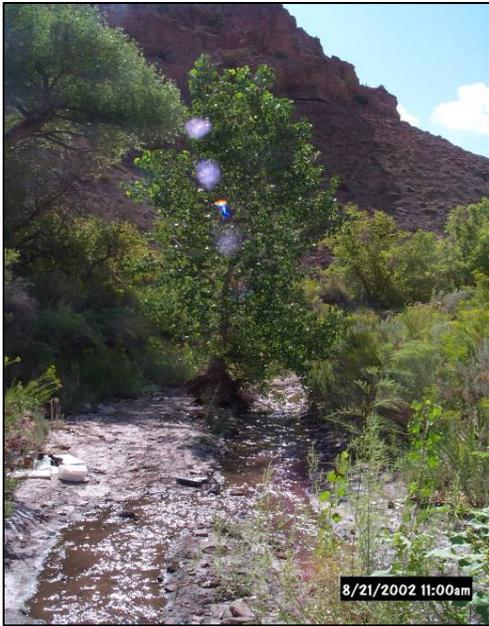
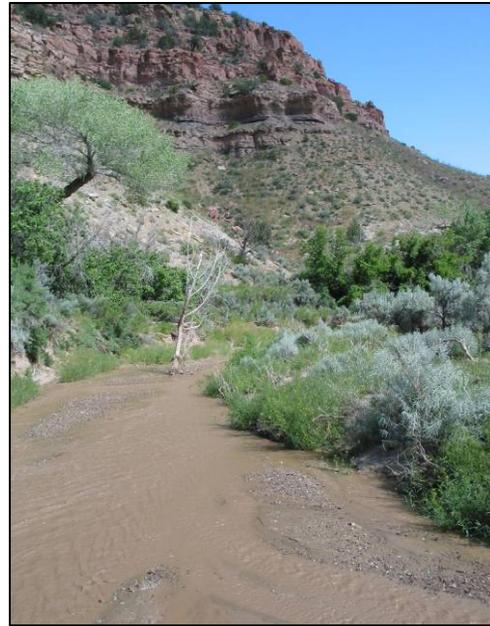
Downstream of the burn suffers the same erosion and sedimentation as in the burn area. Sediment slugs are moving through the system, burying stream channels in sections. The sediment is redistributed with each storm.

Photo 4.8: pre-burn
Diamond Creek, 1 mile above ranch

Photo 4.9: May 26, 2005

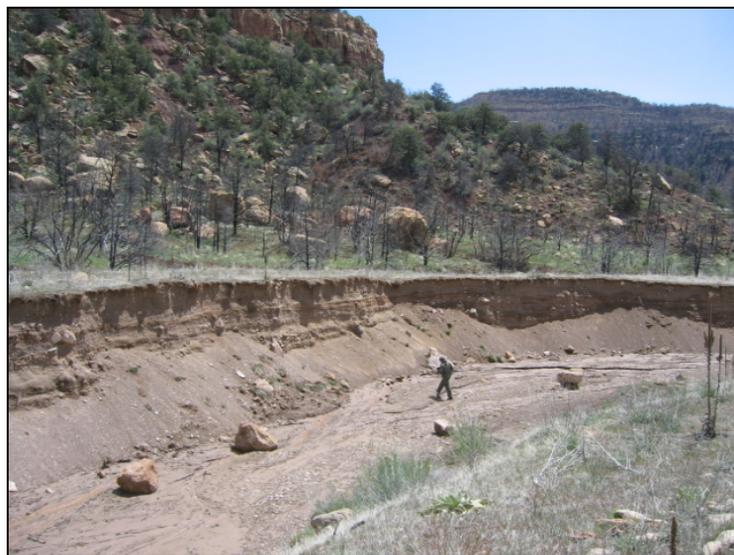
Cottonwood Canyon had less burned acres with high to moderate burn severity. There is both downcutting and channel widening in Cottonwood Canyon, but not to the extent in Diamond Canyon. Several tributaries of Cottonwood Canyon did erode to the same extent as Diamond Canyon and tributaries, including Spruce and Cherry Canyons (Photo 4.10).

Photo 4.10: Spruce Canyon, Tributary to Cottonwood Canyon, April 2005

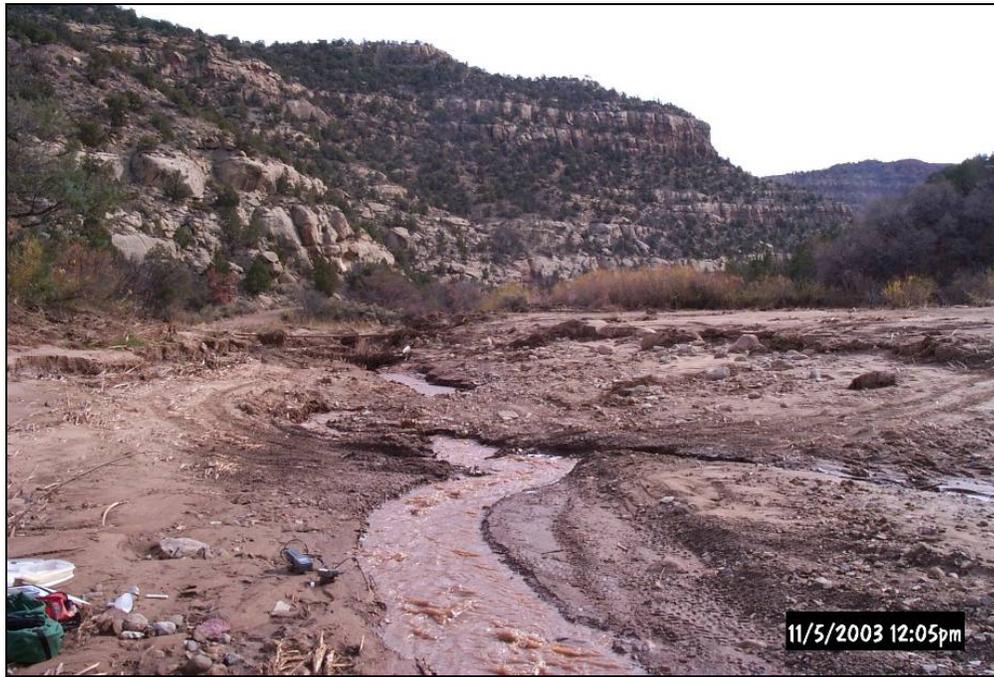
Photo 4.11: Cottonwood Canyon, 4 miles downstream of burn

Water quality monitoring involved testing an irrigation pond in 2002 and annual sampling in Cottonwood and Diamond Creeks. Each stream was sampled in the burn and several miles downstream of the burn (Map 9, Appendix A).

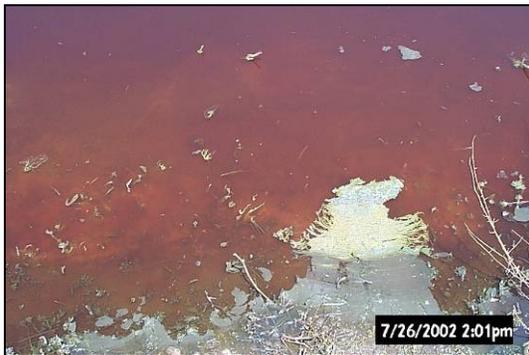
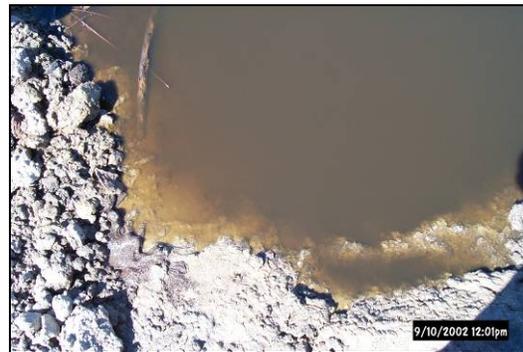
The upper irrigation pond filled with ash, debris and reddish water from post-fire storms by mid-August, 2002 (one month from fire containment). The irrigation ditch to the lower pond was blocked, and therefore this pond was not contaminated with post-fire debris, ash and sediment. A contractor was hired to dredge the sediments from the upper pond in early September 2002.

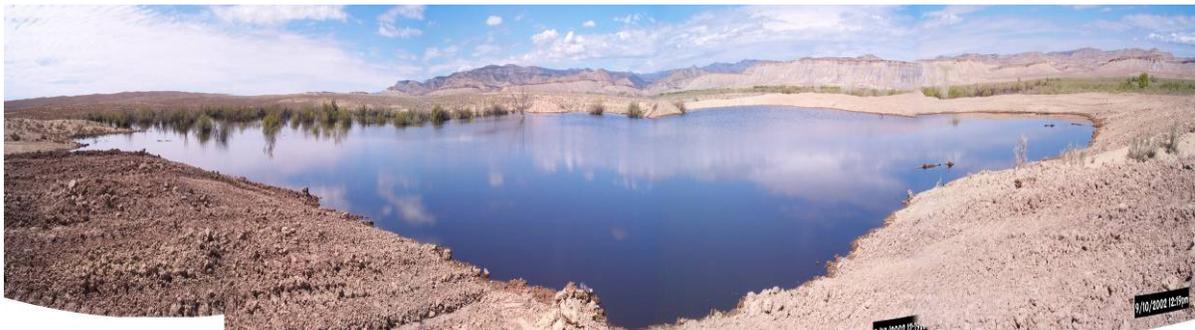
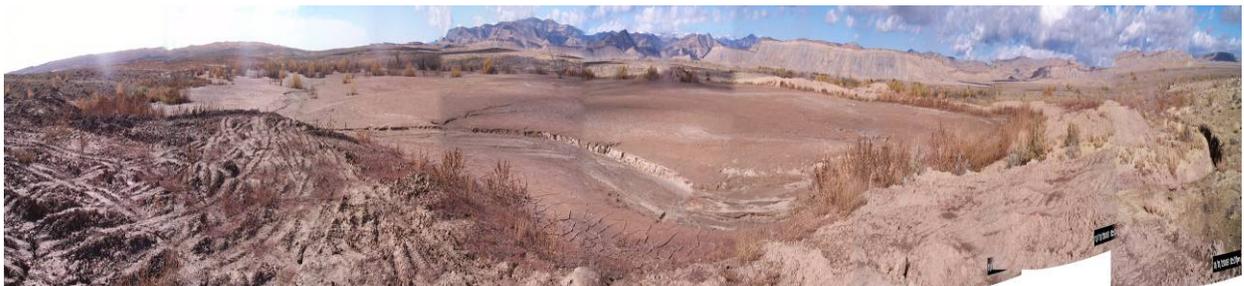
Water samples were collected at the upper pond in July and September, 2002. Analysis was conducted for cyanide, nitrate as N and total suspended sediments (TSS). Cyanide and nitrates were not detected. TSS levels dropped from 98 mg/l to 68 mg/l, pH levels dropped from 8.1 to 7.6. Turbidity levels dropped from 1600 to 147 NTUs. The pond completely filled again with sediment, ash and debris by summer 2003 (Photos 4.14 and 4.15).

Photo 4.14: Upper pond after initial dredging of sediments, 9/10/02

Photo 4.15: Upper pond after filling a second time with sediment, 11/11/03

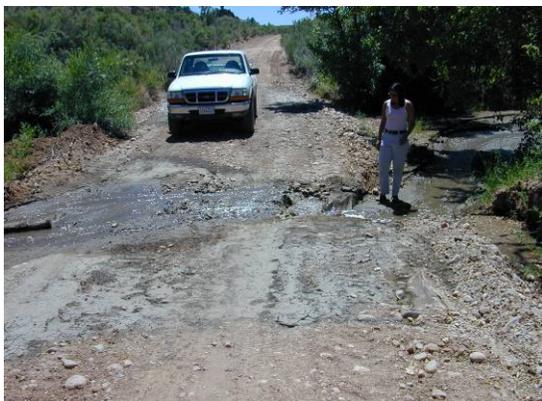
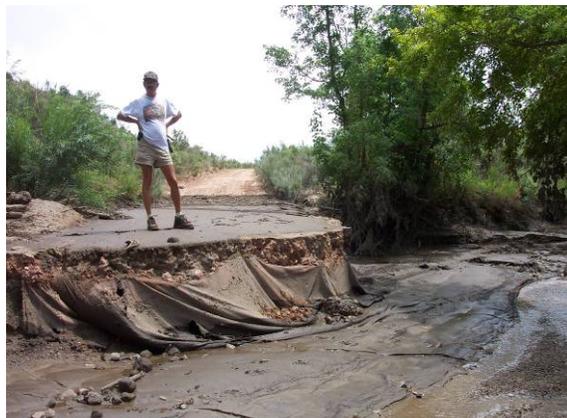
Treatments were constructed in April and May 2003. All the treatments had failed by July, 2003 after minor rainfall events. Either the stream channel was downcut 4-5' or more, or the crossing was clogged with 2-5' of additional sediment and debris.

Photos 4.16 & 4.17: These photos were taken at road crossing #6 in Diamond Canyon. The first photo was taken on July 23, 2003 to show road stabilization treatment. The second photo was taken on July 28, 2003 after an isolated storm dropped .23 inches of rain in 40 minutes (less than a one year event). You can see the erosion control material exposed in the second photo.

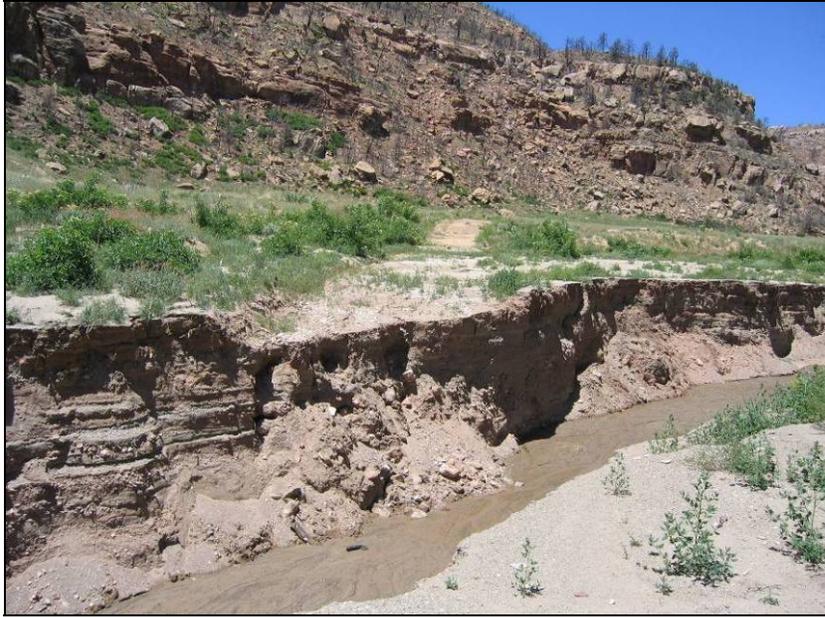
These same erosional and depositional events occurred repeatedly in and downstream of the burn. Since 2003 had few precipitation events, there were only a few floods to make changes. In 2004 and 2005, there were more frequent precipitation events with higher storm totals. Flooding was damaging to the roads throughout 2004 and 2005. Although the Grand County Road Dept. graded both roads several times a year, road conditions remained poor.

Photo 4.18: Diamond Creek, road crossing #8, May 2005 (30' cut)

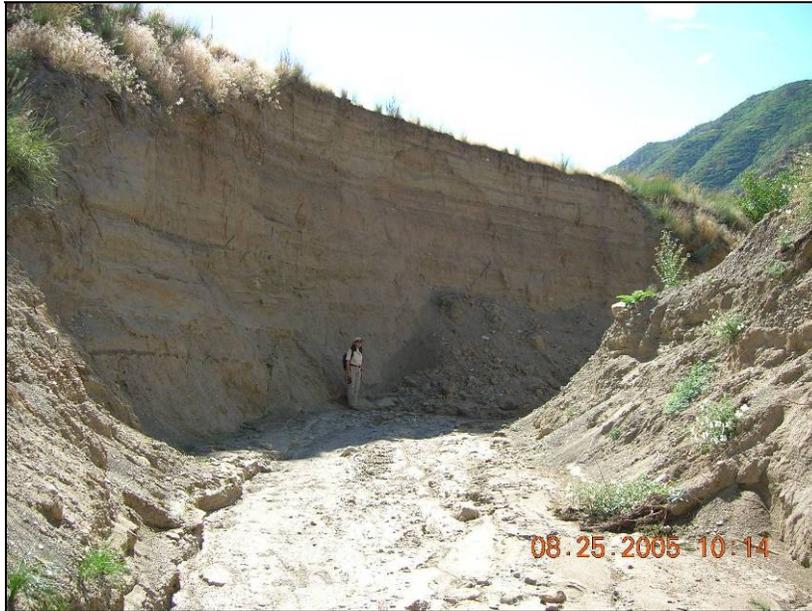
Photo 4.19

The canyon bottoms and floodplains remain in very unstable condition in 2005. There is accelerated erosion and sedimentation both in the burn area and for several miles downstream. Peak stream flows are still exaggerated. Bank storage capacity has been reduced due to major bank erosion and channel downcutting. The water table has dropped an average of 5-10' throughout the area. The stream channels continue to be unstable, moving laterally and vertically. Large slugs of sediment continue to move downstream. The ranch access and irrigation ditch system 5 miles downstream of the burn are still impacted by excessive sediment loads in the stream channel.

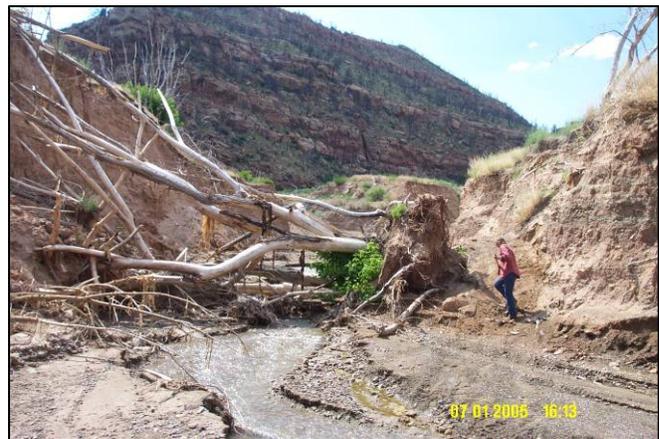
Photo 5.1: Naturally occurring check dam

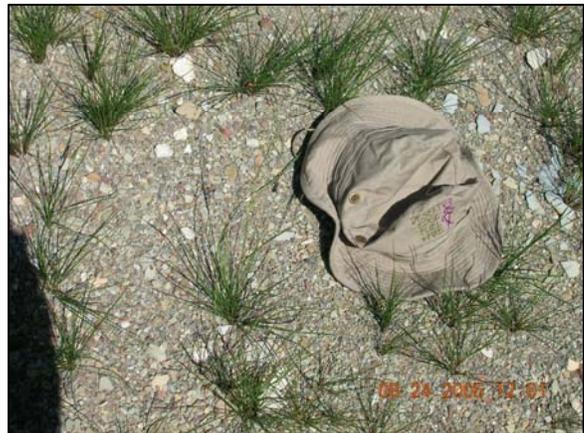
Photo 5.2: Indian Ricegrass seedlings in 2005

The primary ecological goal of the seeding treatments was to quickly establish a diverse groundcover of native grass, forb and shrub species that would competitively exclude cheatgrass to some degree. The effectiveness of the seeding treatments was limited in the 2003 and 2004 growing seasons by persistent drought conditions. Precipitation patterns were more favorable in the 2005 growing season which resulted in a dynamic response from seeded grasses. Seedlings that established in 2003 and 2004 grew vigorously and many new grass seedlings germinated during the 2005 growing season (Photo 3.7 & 5.2).
