United States Department of the Interior Bureau of Land Management

Environmental Assessment
DOI-BLM-UT-C030-2013-0010-EA

Preliminary Red Cliffs Recreation Area Deferred Maintenance and Capital Improvement Projects

Location: T41S, R14W, Sections 14, 15, and 22

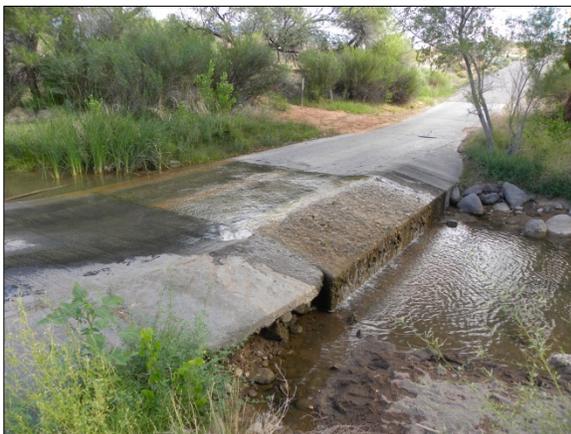
Figure 1: Crossing #1 showing low water flow over roadway surface, undermining, and cracking

As relates to this EA, two existing vehicle low water crossings on Quail Creek, hereinafter referred to as crossing #1 and #2, are affected by flooding several times a year and have also reached the end of their useful life. The consequence of this flooding has been damage to the concrete crossing structures. Cracking, uplifting, and undermining of the structures is apparent today. As a result of flood damage, the crossings have deteriorated to the point that they present a public safety hazard; new flooding events accelerate the rate of deterioration. See Figure 1 and Figure 2 for photos of crossing #1 condition taken in 2013.

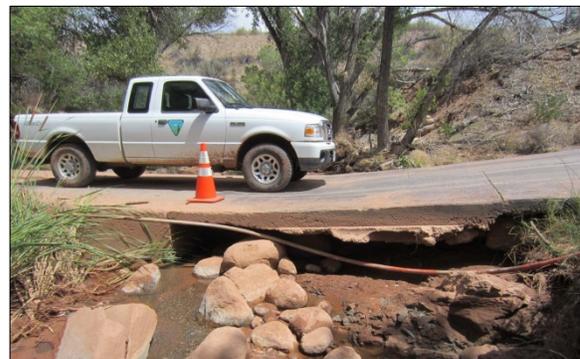
Figure 2: Crossing #1 showing undermining after a flood event

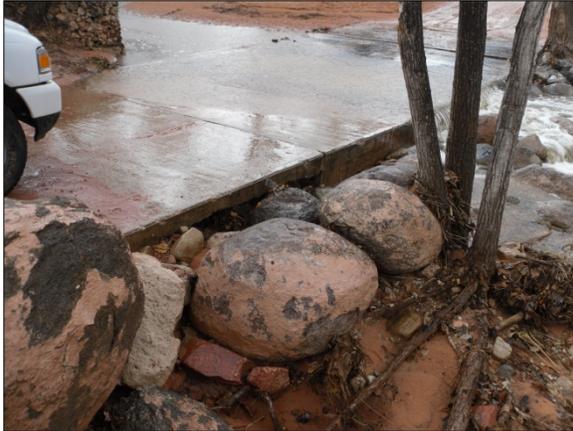
Figure 3: Crossing #2 showing low water flow over roadway surface during autumn months.

Vehicle access to the day use (picnic) and camping facilities requires all users to cross Quail Creek four times, twice at crossing #1, once at crossing #2, and once at crossing #3 (not a subject of this EA, as no changes will be made to this crossing). Crossing #1 has a year-round flow of water over its structure (see Figure 1). Crossing #2 only has water flowing over its structure in spring, fall, and winter (see Figure 3). Both structures are inadequate to provide a consistently safe crossing. During flash flood events, the crossings are undermined and damaged by high

velocity stream and debris flows, creating the problems described above. Additionally, these flash flood events cover the structures in deep mud and debris, making all crossings temporarily impassable until clean-up efforts can be undertaken (see Figure 4). The crossings are deteriorated and functionally inadequate, as they cannot withstand the volume and velocity of the seasonal flood flows.

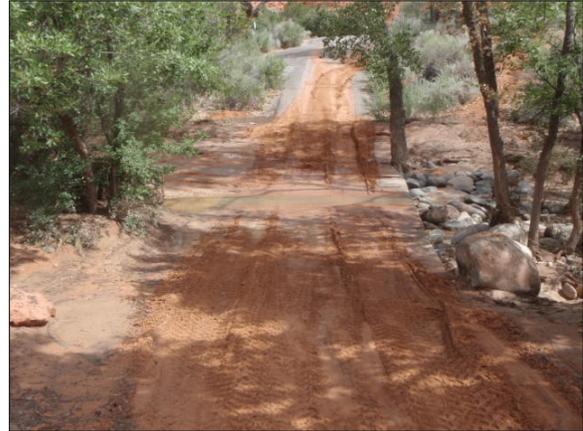
Figure 4: Crossing #2 and roadway covered in deep sand after flood event

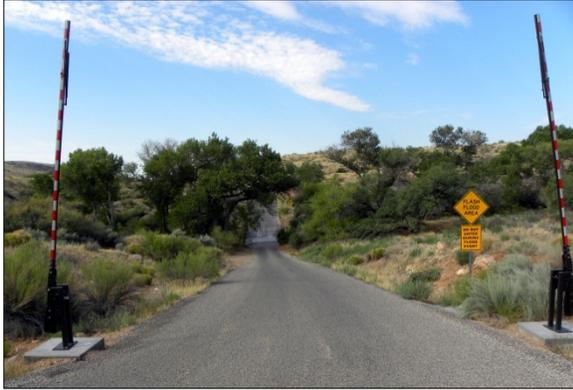
Figure 5 Traffic control gate and flood warning signs at crossing #1

After the fatality in 2005, BLM's Serious Accident Investigation Team (SAIT) made several recommendations to prevent future accidents at crossing #1. All were implemented by BLM, including signage warning of flash flood danger. The sign warns of flood danger, but again, visitors must use their own judgment about using the crossings. Additionally, BLM installed a gate to control traffic into the Recreation Area to prevent vehicles from using the low crossing during a flood event, but the effectiveness of the gate depends on staff being present to close the area at the appropriate time. The signs and gate are shown in Figure 5.

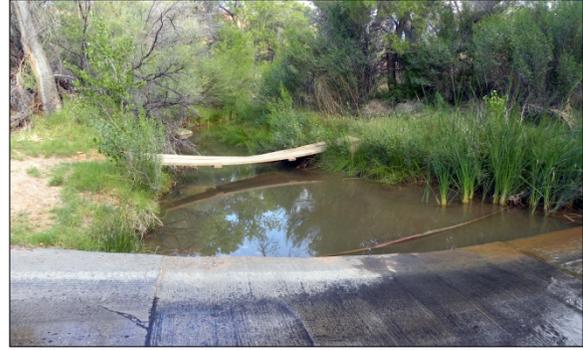
Figure 6: Non-motorized users wood plank bridge at crossing #1

The low water crossings also pose safety threats and inconveniences for bikers, hikers, and other non-motorized visitors to the Recreation Area. Since crossing #1 has year round flows of water over the structure and crossing #2 experiences water over the structure during three seasons, non-motorized traffic must enter the water. Currently, at crossing #1, non-motorized users have placed an unanchored wood plank upstream of the crossing (see Figure 6), to avoid getting wet. These users replace the structure after every flood event and/or after BLM staff has removed it, since it is, in itself, an unsafe method by which to cross Quail Creek.

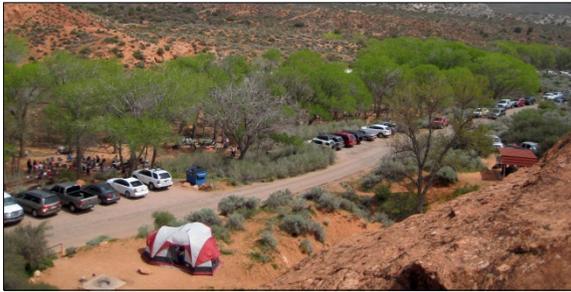
Figure 7: Parking issue showing vehicles lining narrow one-way access road within the campground loop

As there are no limiting mechanisms to control the number of visitors to the Recreation Area, parking is inadequate during the spring and fall; there are not enough parking spaces to accommodate all the day use visitors. As a temporary solution to increase parking, the White Reef Trailhead is being utilized as overflow parking for the recreation area. Parking here requires that visitors walk 1.5 miles, along the heavily used main access road (Red Cliffs Road), to the day use area and other popular day use trails and sites. There are no sidewalks, trails, or defined road shoulders along the Red Cliffs Road, putting pedestrians who attempt the walk at risk. Using the White Reef Trailhead for overflow parking creates additional problems by reducing the amount of parking for trailhead visitors. This severely impacts equestrian users, as trailer parking spaces are usurped by the overflow of passenger vehicles. See Figure 7 and Figure 8 for photos of parking conditions.

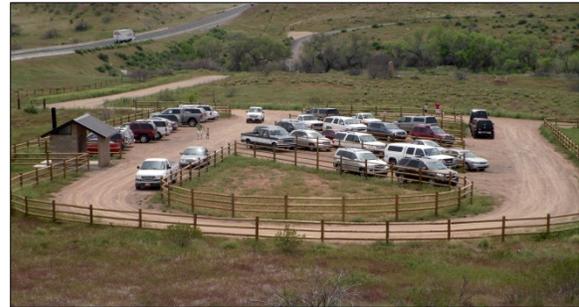
Figure 8: Parking issue showing overflow parking at White Reef Trailhead; note vehicles stacked in equestrian trailer parking spaces

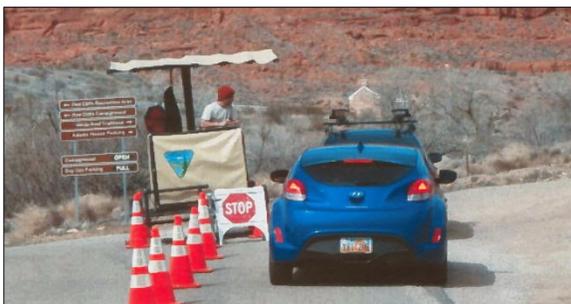
Figure 9: Temporary Visitor Contact Station to managed increased visitation

While the station itself is adequate, the location is less than ideal and is dictated by the width of operating space to accommodate the station and two-way traffic. However, this creates a vehicle stacking problem; vehicles waiting at the station for assistance backup into the two I-15 freeway underpasses. These underpasses are structures on the only road into the Recreation Area and are size restricted to a one lane width. Vehicle stacking here impedes two-way traffic and potentially emergency vehicle ingress and egress (see Figure 10). While the location of the temporary visitor contact station is currently in the most appropriate location without undertaking major renovations, its location also makes ingress and egress onto the White Reef Trailhead access road more complex, requiring additional temporary traffic control devices. To facilitate this temporary visitor contact station, a temporary traffic control plan was developed and must be implemented each time the station is utilized.

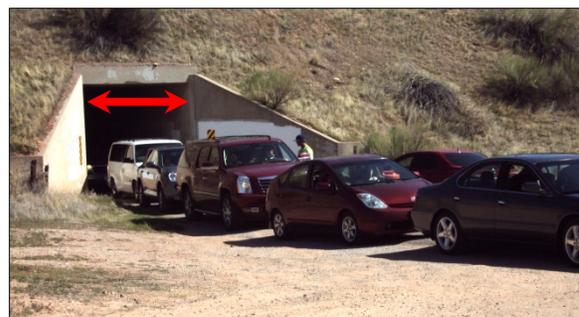
Figure 10: Vehicle stacking caused by location of Temporary Visitor Contact Station

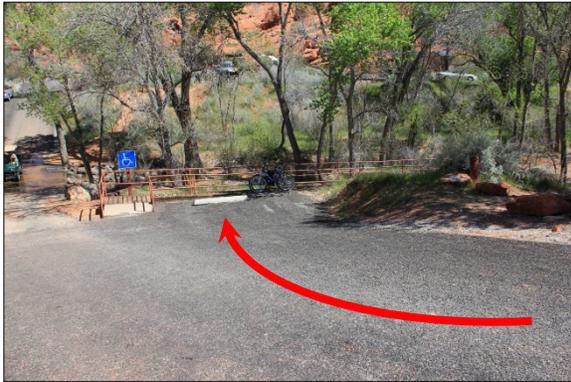
Figure 11: Accessible parking space showing steep incline that is not ABA compliant

parking spaces for the Recreation Area, the ABA AS requires at least one space be accessible, but the new requirement for accessible picnic areas is to have at least two accessible parking spaces. The picnic area has one designated accessible picnic site; however, the access route does not meet slope requirements and the access route around the table does not meet sizing requirements; the law also requires that the picnic area have a minimum of two accessible picnic sites. The current designated accessible campsites in the Recreation Area are not ABSAAS compliant as well, but are being addressed separately from this EA. See Figure 11 and 12 for photos of two non-complaint conditions.

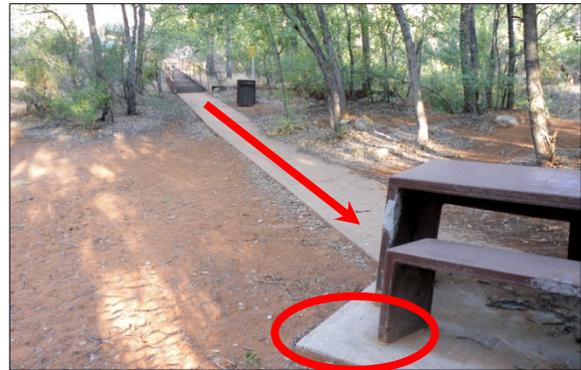
Figure 12: Accessible picnic site showing steep access route and inadequate clear space around table that is not ABA compliant

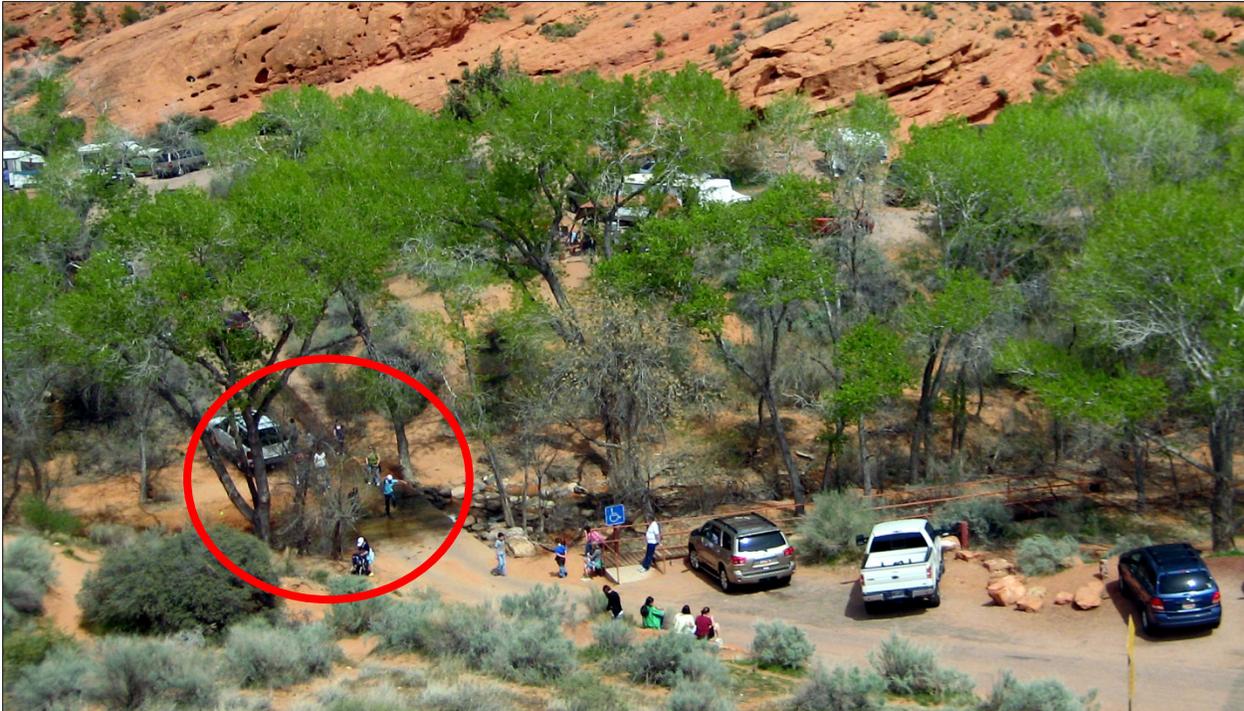
Figure 13: Crossing #2 with Quail Creek flowing over roadway creating an attractive nuisance

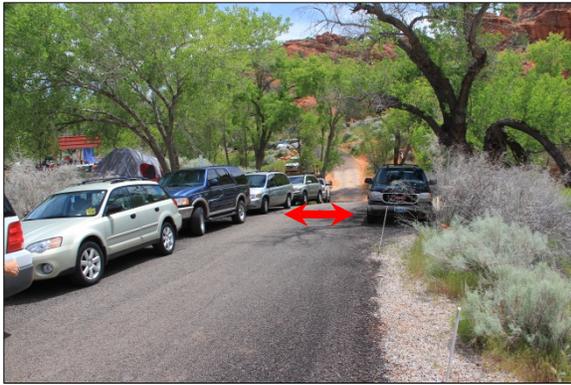
Figure 14: Parking issue showing vehicles parked on paved roadway within the campground loop

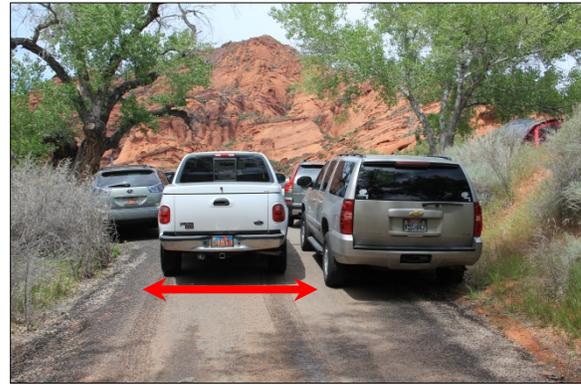
Figure 15: Parking issue showing narrow roadway conditions created by parked vehicles

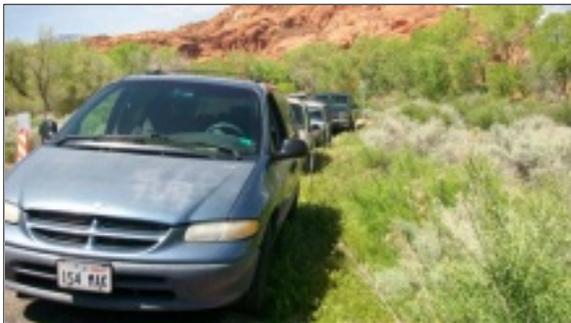
Figure 16: Illegally parked vehicles on vegetated roadway shoulder

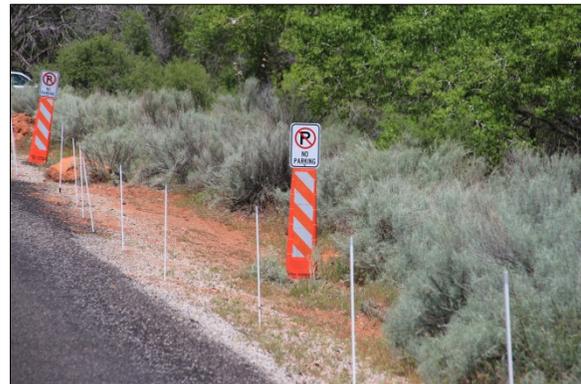
Figure 17: Roadway shoulder showing vegetation loss, parking barrier poles, and signage

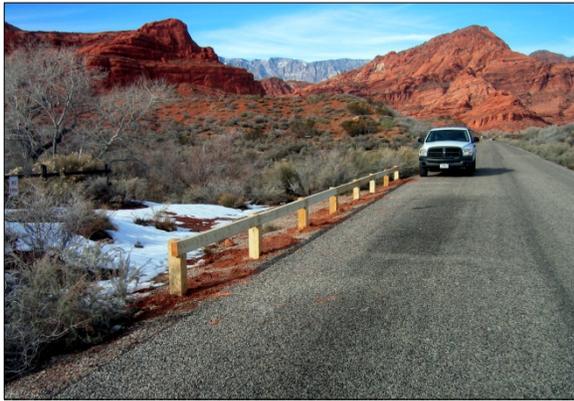
Figure 18: Wood barrier fence on roadway shoulder outside campground loop

In December 2013, the BLM installed a low wood fence to act as a barrier to prevent vehicles from illegally parking on the vegetated roadway shoulders. See Figure 18 and Figure 19 for photos of the new barrier fence along roadway shoulders, both inside and outside the campground loop. As this barrier fence will effectively eliminate unauthorized parking along the roadway, the need to develop additional visitor parking is more pressing now than it has been in the past.

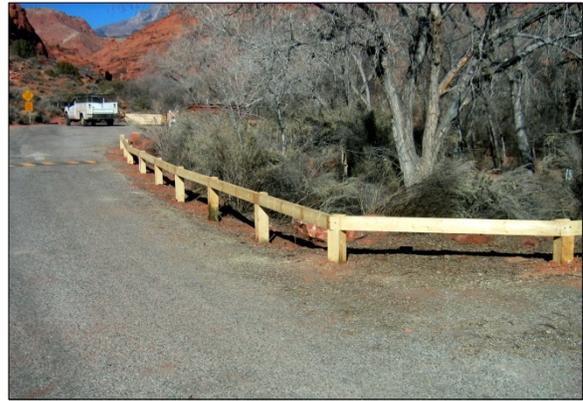
Figure 19: Wood barrier fence on roadway shoulder inside the campground loop

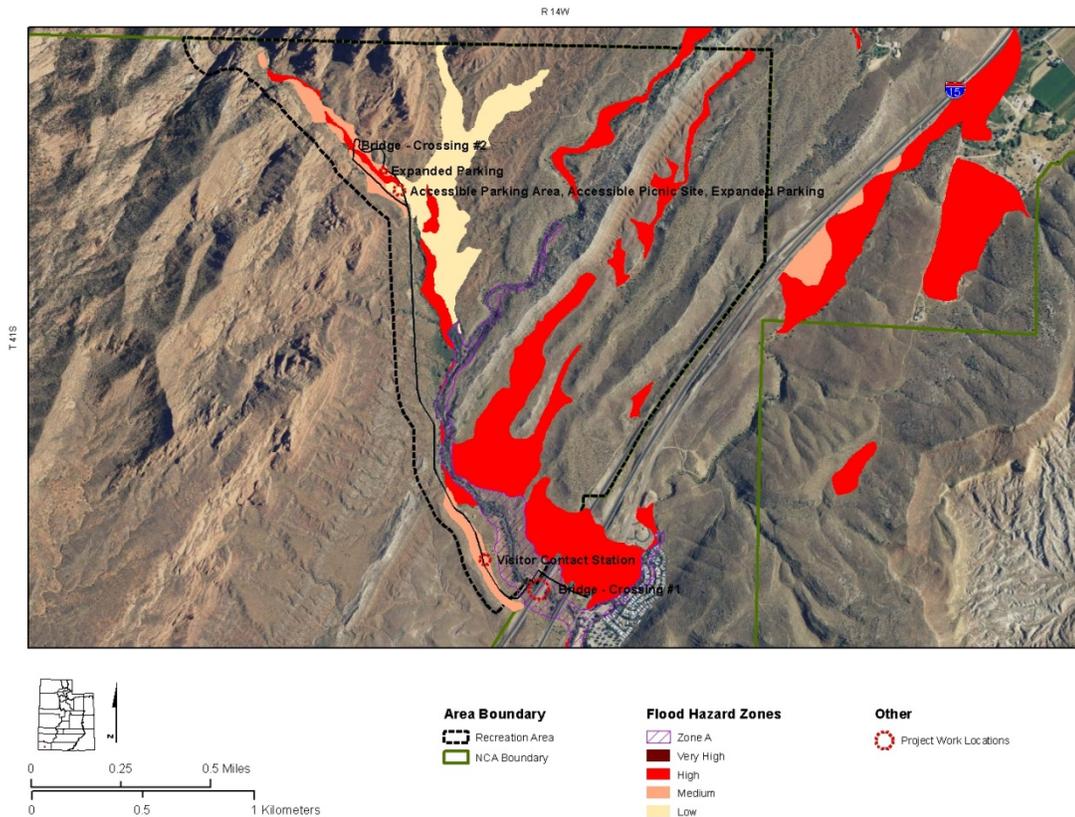
Map 4: Flood Hazard Zones

A large area surrounding crossing #1 lies within the 100 year floodplain as determined by FEMA Flood Insurance Rate Map Zones 2011. The campground and day use area, including crossing #2, and the proposed Visitor Contact Station do not lie within the 100 year floodplain. However these areas are affected by erosion hazards caused by flooding. Map 4 illustrates the extent of Zone A⁴, otherwise known as the 100 year floodplain. It also illustrates the erosion hazard zones at varying risks for erosion during flooding. Low, medium, and high zones are present, but the highest risk zone, very high, is not present in the recreation area. These flood erosion hazard categories are based on the geologic deposits mapped by the Utah Geological Survey.

#1 for a 50 year flood event at 6,400 cfs. The NOC hydrologist also found that the box culvert under I-15—less than 100 feet south of crossing #1—is not large enough to carry the estimated 50 year flood. In the event of a 50 year flood, water would back up over crossing #1, forming an unintentional retention basin.

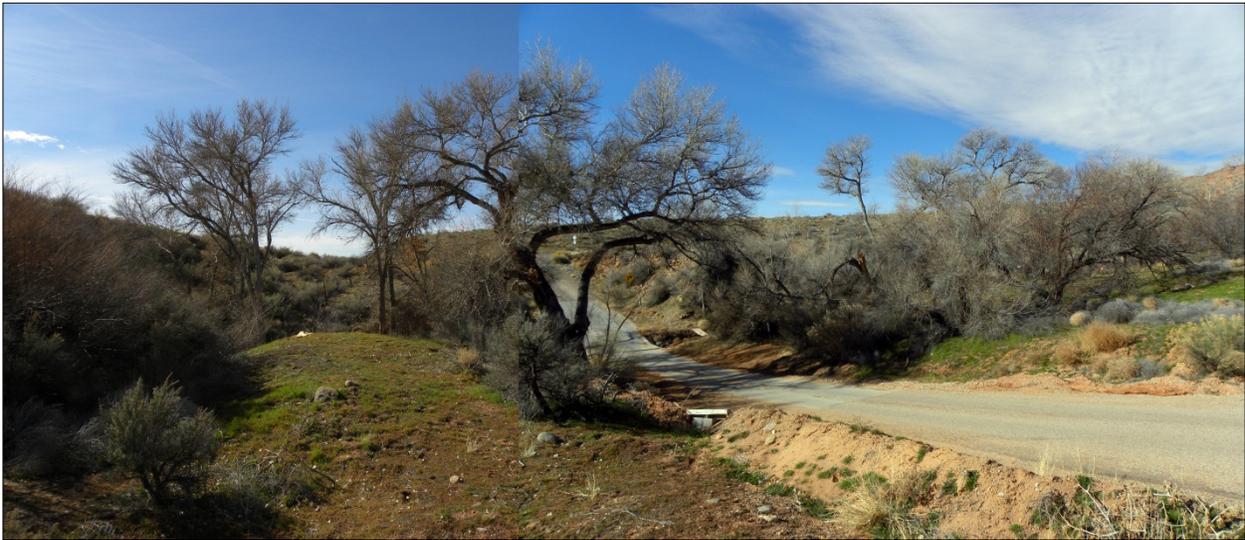
Figure 21: Riparian vegetation at crossing #1 viewed from north side of Quail Creek

Crossing #1 and crossing #2 are in the riparian zone of Quail Creek. The dominant plant species in the channel and floodplain zone are native willows (e.g., *Salix exigua*) and cottonwood trees (*Populus fermentii*) (see Figures 21 and 22, and 23). Crossing #1 supports a dense mix of native and non-native grasses and herbaceous plants in the understory such as cattail, datura, and sweet clover. In contrast the channel bed of crossing #2 is highly scoured and compacted from visitor use, showing only scattered stands of native grasses under the tree canopy. The upper terrace zone at crossing #1 consists of the invasive species cheat grass (*Bromus tectorum*) and Russian thistle (*Salsola tragus*), and native plant species of creosote bush, broom snake weed (*Gutierrezia sarothrae*), green rabbitbrush (*Chrysothamnus viscidiflorus*), rubber rabbitbrush, and sand sage. Crossing #2 lacks this diversity in understory on its upper terrace, consisting largely of arrowweed, and sand sage, with scattered fourwing saltbush (*Atriplex canescens*).

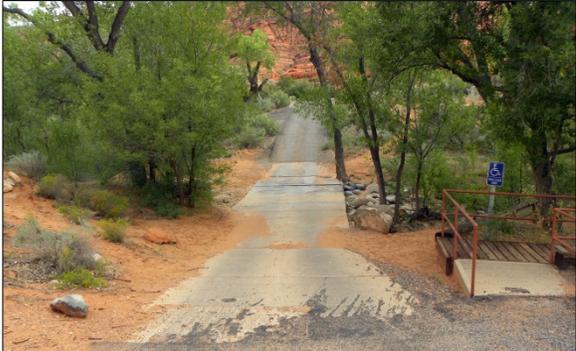
Figure 23: Riparian vegetation at crossing #2 viewed from the south side of Quail Creek

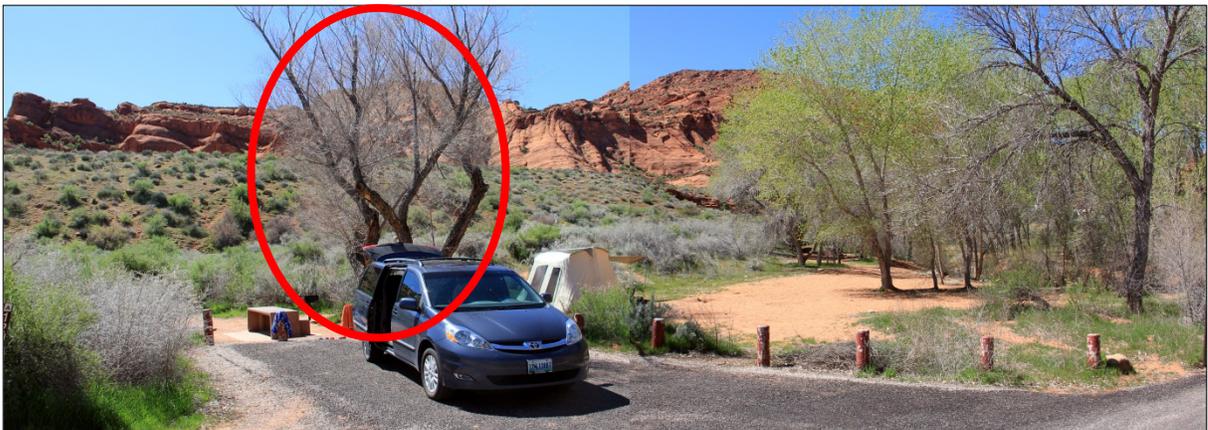
Figure 25: Vegetation at current campsite 12 that will be converted to an accessible parking area; only tree in red circle will be removed

Current human activities within the campground and day use area have primarily impacted the vegetation understory. At campsite 12, which will accommodate a portion of the accessible parking area, has few native shrubs remaining in the area heavily used by campers (see Figure 25). One Fremont's cottonwood tree, shown in the red circle on Figure 25, will be removed to accommodate the proposed new parking area. This tree has been heavily pruned in the past due to its hazardous limbs and is scheduled for a complete removal because of the hazards it poses to campers (note the position of the picnic table and tent in relationship to the hazardous tree). The remaining portion of the proposed accessible parking area will be located directing south of campsite 12. The vegetation consists of a dense stand of sand sage and desert almond (*Prunus fasciculata*) (see right side Figure 26).

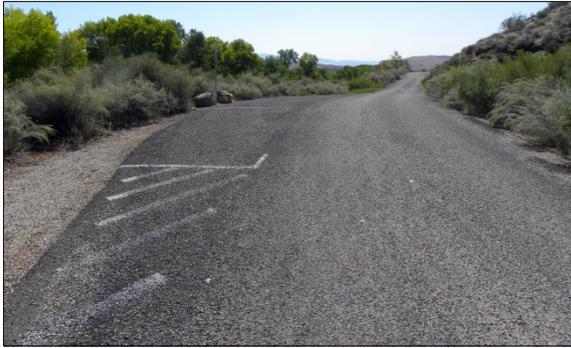
Figure 26: Vegetation at expanded parking area on left and accessible parking area on right

One of the expanded parking areas would be located at an existing paved pullout (see left side of Figure 26). The expansion to accommodate 8 vehicle parking spaces would require the removal of sand sage and desert almond shrubs. Another expanded parking area for three additional parking spaces would be located at the current maintenance shed area. Figure 27 shows this area and its gravel surface.

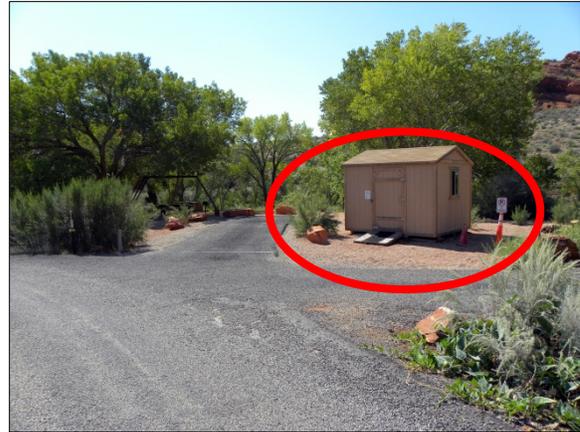
Figure 27: Vegetation at expanded parking area at current location of shed

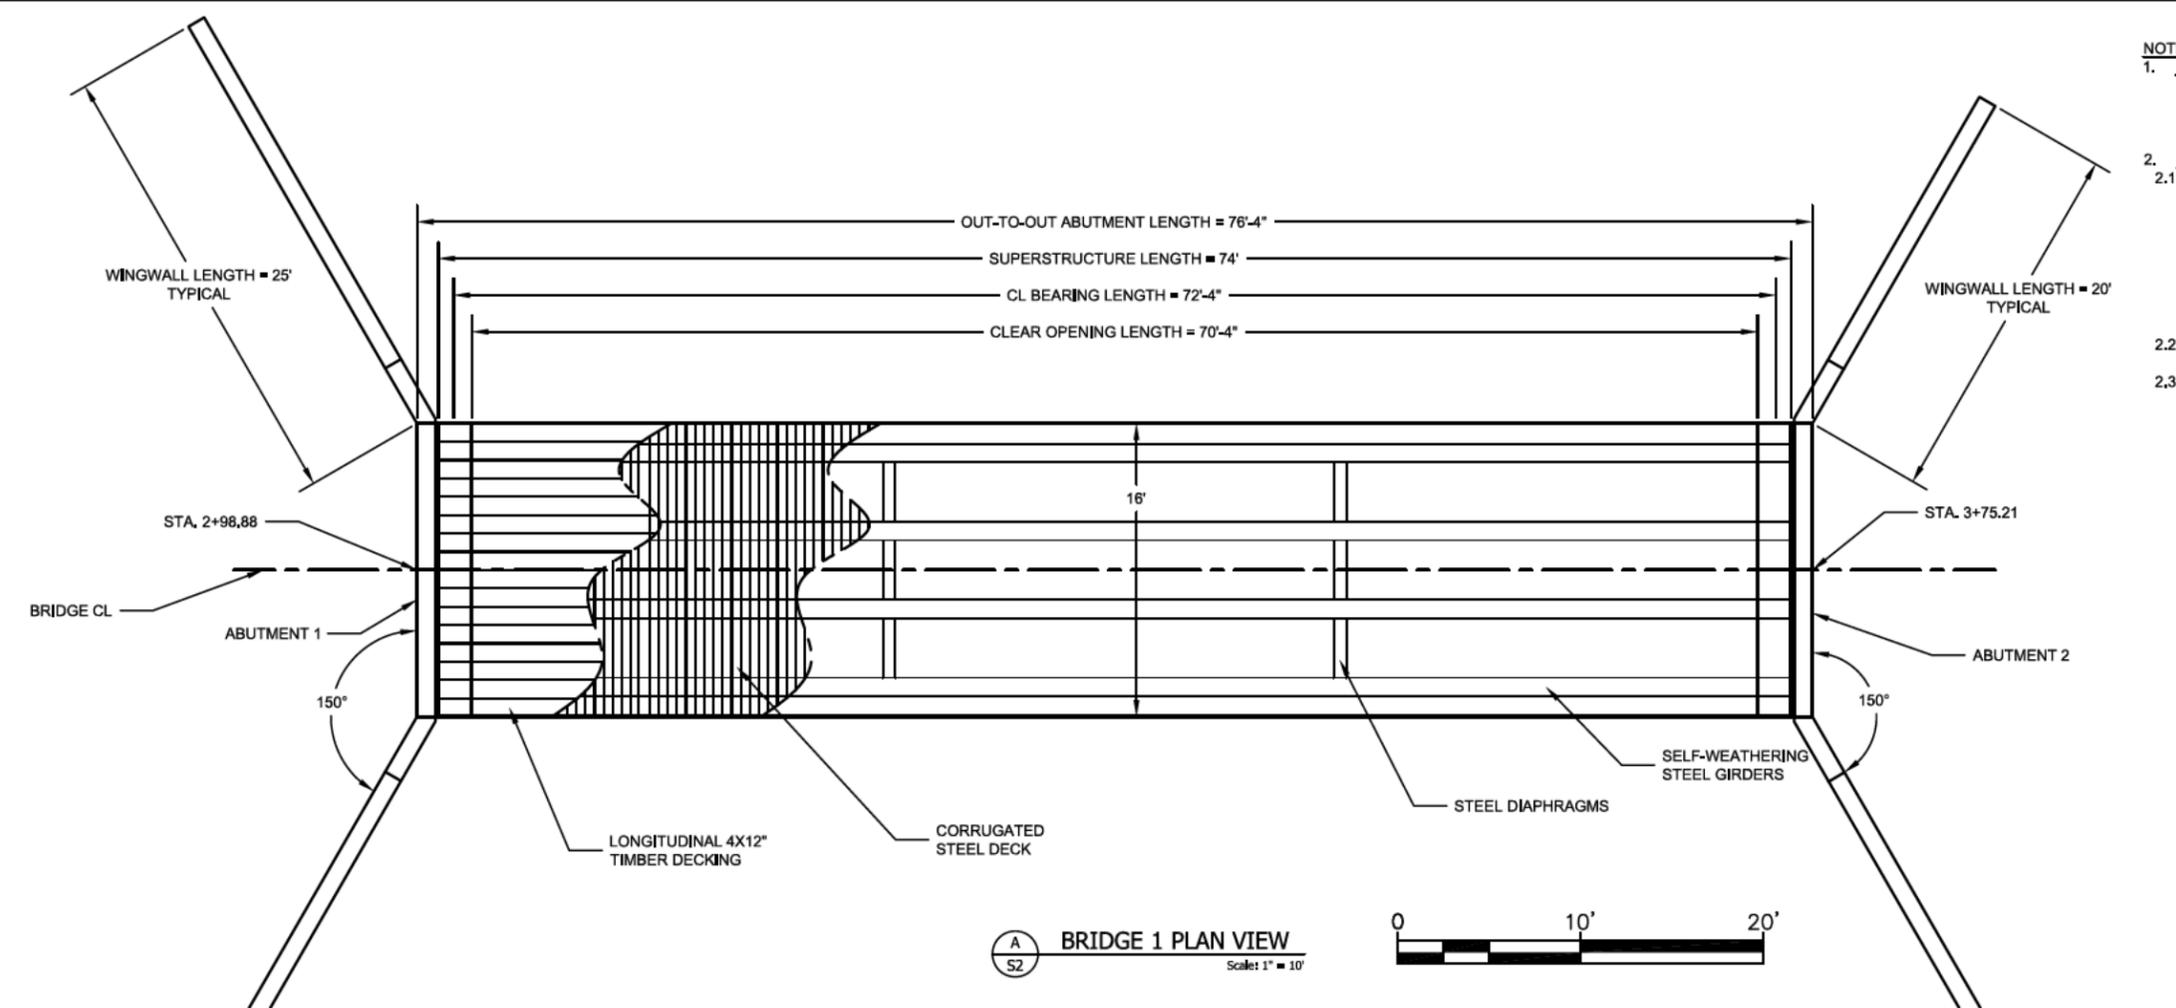
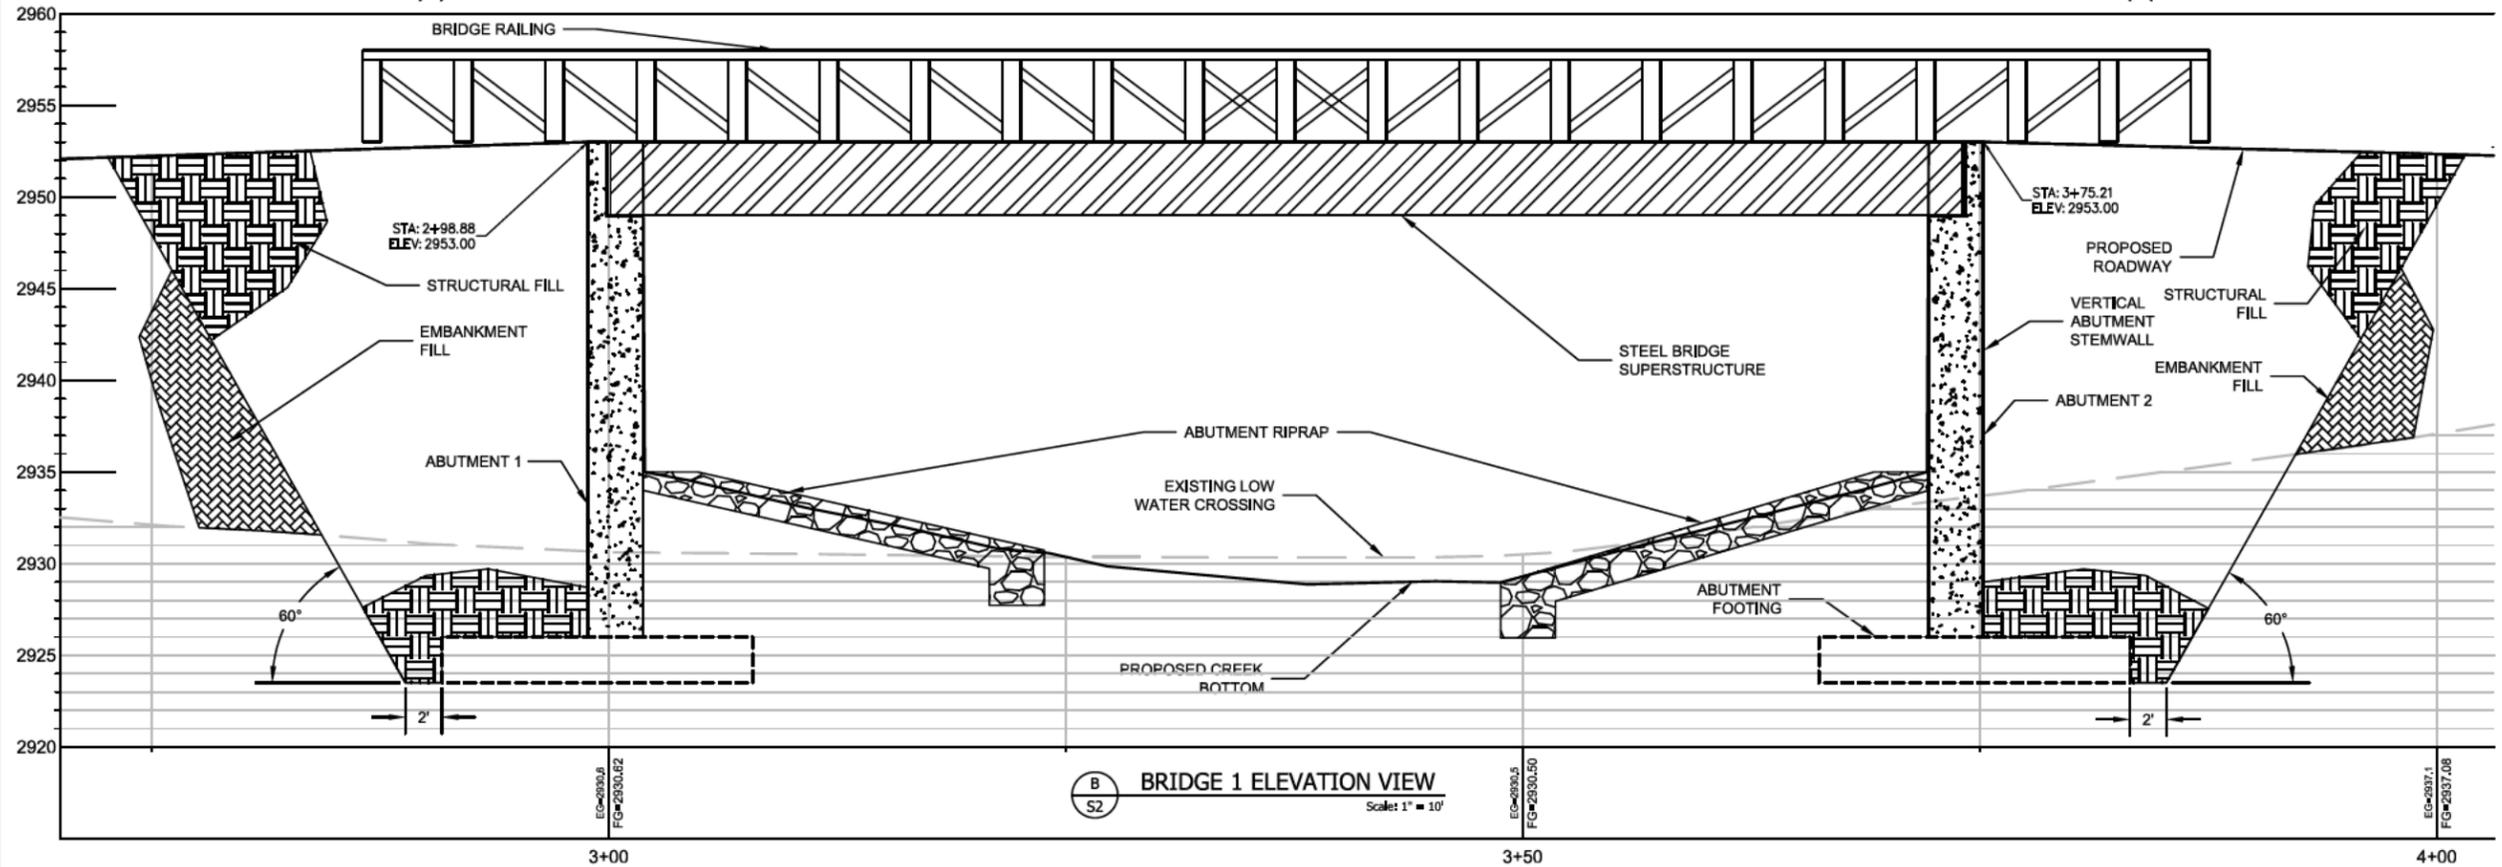
- NOTES:**
- BRIDGE SUPERSTRUCTURE:** THE CONTRACTOR SHALL FURNISH AND INSTALL TWO PREFABRICATED STRUCTURAL STEEL SUPERSTRUCTURES. SEE BLM SUPPLEMENTAL SPECIFICATIONS.
 - BRIDGE SUBSTRUCTURE:**
 - BRIDGE 1 ABUTMENT FOUNDATIONS** SHALL BEAR ENTIRELY ON COMPETENT BEDROCK. BOTTOM ELEVATION OF FOUNDATIONS SHALL BE ELEVATION 2924 FT. IF COMPETENT BEDROCK IS NOT FOUND AT ELEVATION 2924 FT., THEN EXCAVATION SHALL CONTINUE UNTIL COMPETENT BEDROCK IS FOUND BELOW ELEVATION 2924 FT.
 - CLEAR BEDROCK SUBGRADE OF ALL LOOSE FRAGMENTS.
 - BEDROCK SURFACE SHALL BE HORIZONTAL AND SHOULD CONSIST OF CLEAN, DURABLE ROCK.

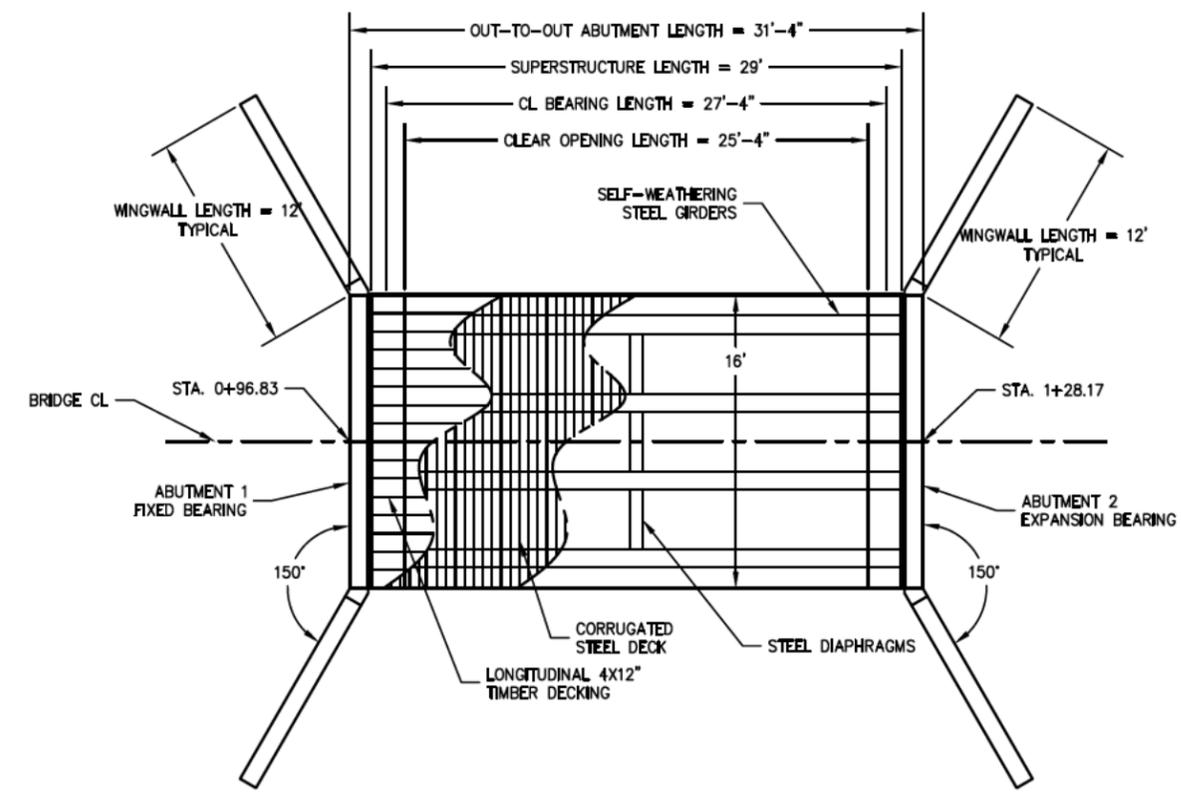
A BRIDGE 2 PLAN VIEW
Scale: 1" = 10'

5. COBBLES AND BOULDERS EXPOSED AT FOOTING ELEVATION SHALL BE REMOVED AND REPLACED WITH STRUCTURAL FILL TO AVOID POINT LOADING ON FOUNDATIONS.
