**Atlantic Rim Coal Bed Methane and Natural
Gas Project
Carbon County, Wyoming**

November 14, 2011

*Muddy Creek Monitoring
Report - 2011*

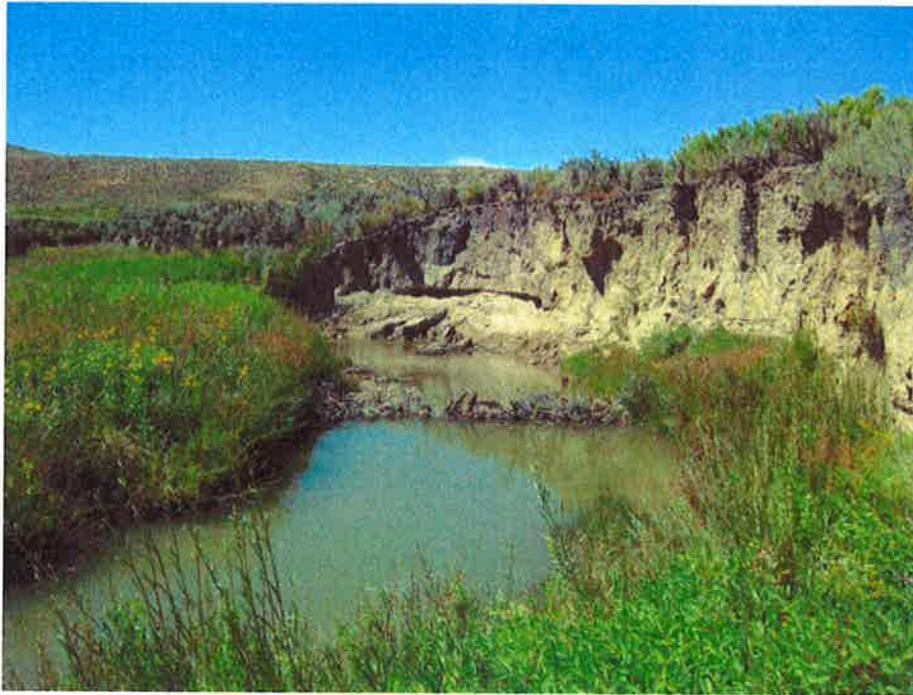
Figure 2-2. Beaver Dam at Site UMC6, August 2011.

Most of Site UMC 6 is now composed of a pool formed behind a beaver dam that was first observed in 2010 (Figure 2-2). There is one riffle section (approximately 25 feet) below the beaver dam. The long pool formed by the beaver dam accounts for the channel material at Site 6 being composed largely of silt and clay.

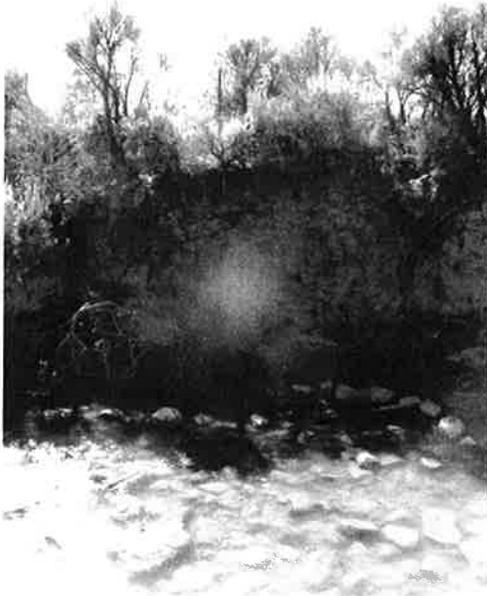
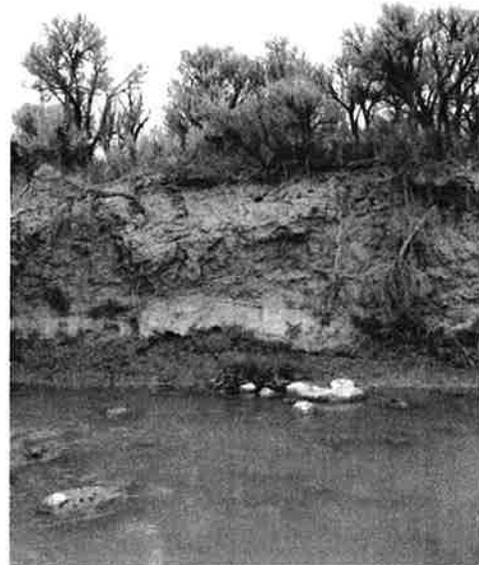
UMC-1 XS-4, Right Bank

The reference sections at stations UMC3 and UMC6 have remained generally unchanged since 2009. At stations UMC1 XS-4 and UMC4 XS-3, large amounts of material were deposited on the right bank since 2010. Stations UMC2 XS-5 and UMC5 XS-3 show that large amounts of channel scour occurred since 2010 lowering

* the thalweg by about three feet and eroding considerable material from the right bank. This amount of scour had not occurred in previous years and is undoubtedly due to the high runoff that resulted from the greatest precipitation amount in a 30-year period of record. This large variation in the amount of deposition and scour that occurs between consistently wetter than normal years demonstrates the highly dynamic response of this stream to variations in hydrology.
