**Atlantic Rim Coal Bed Methane and Natural
Gas Project
Carbon County, Wyoming**

April 6, 2010

*Muddy Creek Monitoring
Report - 2009*

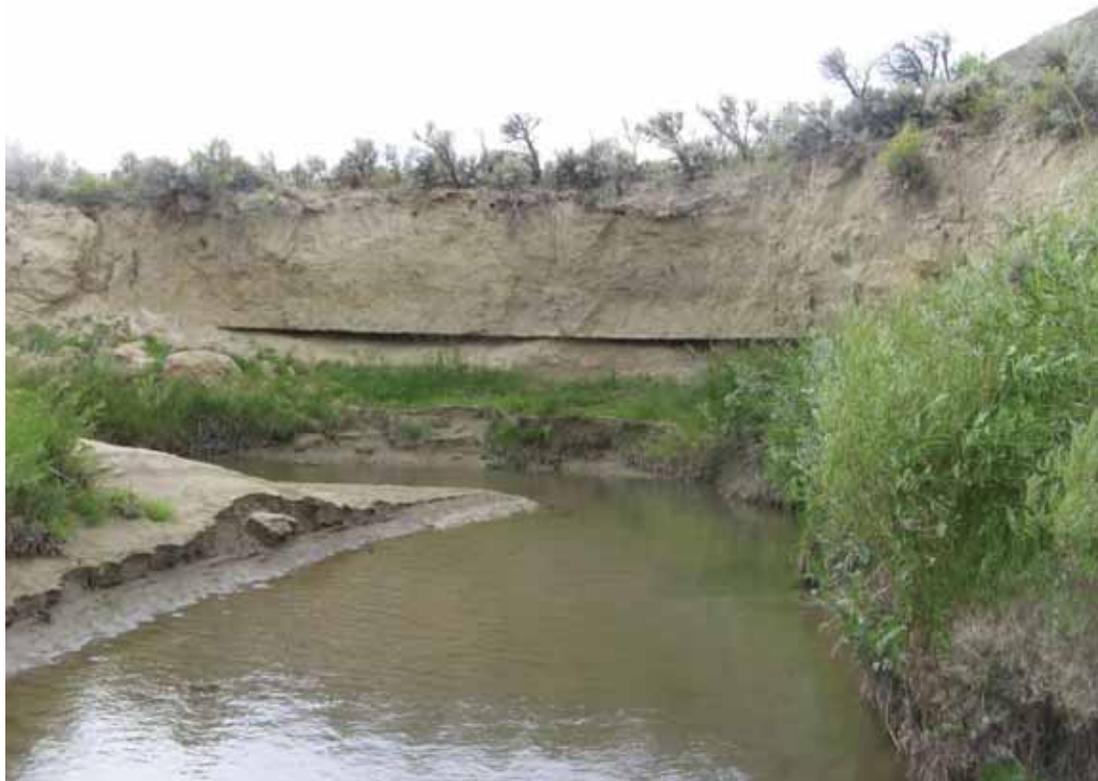
Figure 2-2. Erosion and deposition features upstream of Cross-section 1 at Site UMC4.

The patterns of fresh erosion and deposition documented at the reference cross-sections were observed at numerous locations along the stream. It is apparent that a large amount of sediment moved during runoff in Muddy Creek this year with sediment eroding, moving downstream, and depositing in other areas. Figure 2-2 is an example of an area that shows fresh deposition on the left bank, erosion on the right bank as well as a presumed high water indicator on the far bank.

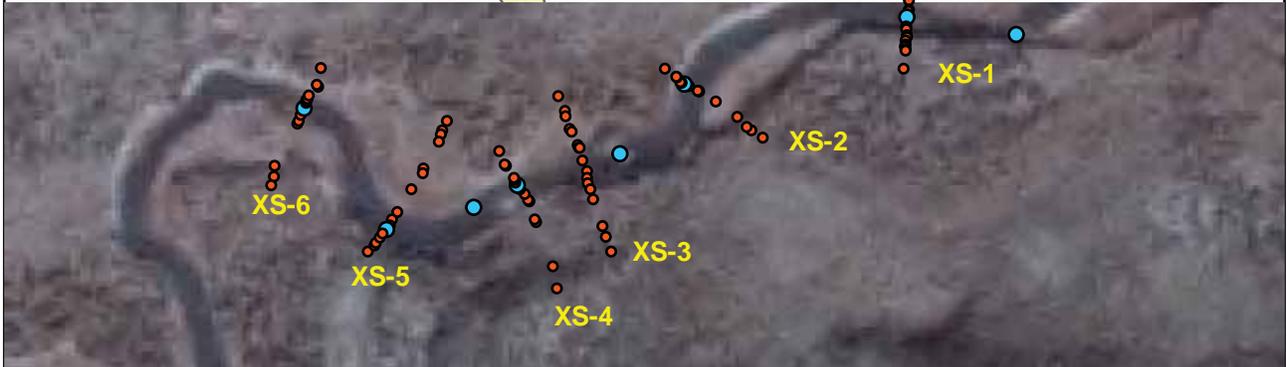
**Monitoring Site UMC-3
Plan View
Upper Muddy Creek
Atlantic Rim Project
Carbon County, Wyoming**

Reference Cross-section

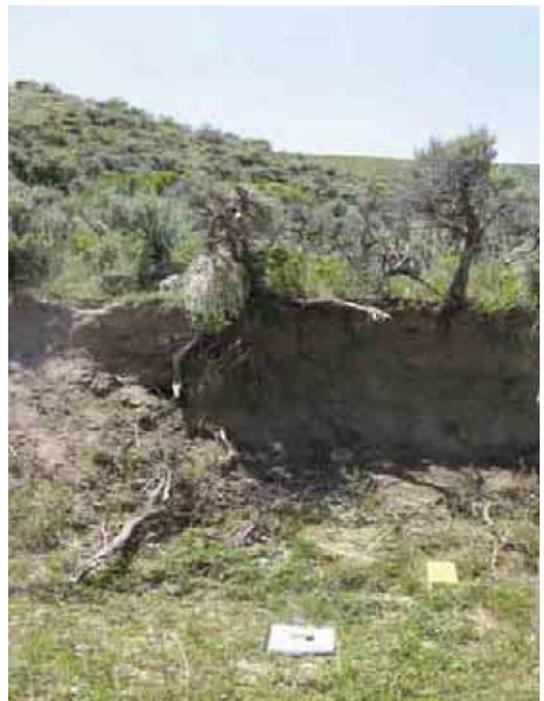
Photo 1. UMC1, XS-1, Left Bank

UMC1, Cross-section 1, Left bank

Category	Value	Index
Bank ht/Bankfull Depth	2.5	8.6
Root Depth/Bank ht	0.2	7
Root Density	<5%	10
Bank Angle	58	3.8
Surface Protection	0%	10
Bank Material	Silt	0
Stratification	None	0
Index sum	--	39.4
BEHI Rating	--	High
Radius of Curvature	Straight	--
Bankfull Width	--	--
NBS Rating	--	N/A

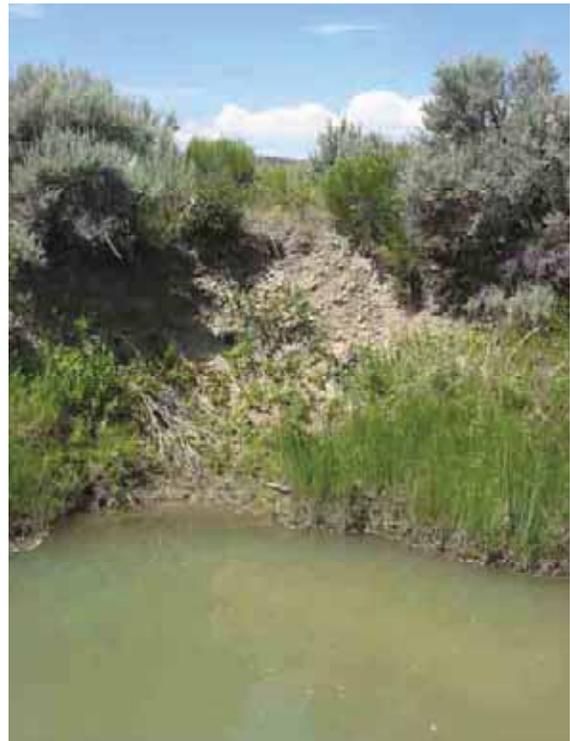
Photo 2. UMC1, XS-2, Right Bank

Category	Value	Index
Bank ht/Bankfull Depth	1.7	6.2
Root Depth/Bank ht	0.2	6.5
Root Density	<5%	10
Bank Angle	64	4.3
Surface Protection	26%	10
Bank Material	Silt	0
Stratification	None	0
Index sum	--	37.0
BEHI Rating	--	High
Radius of Curvature	23	--
Bankfull Width	90.3	--
Rc/W	0.255	--
NBS Rating	--	Extreme

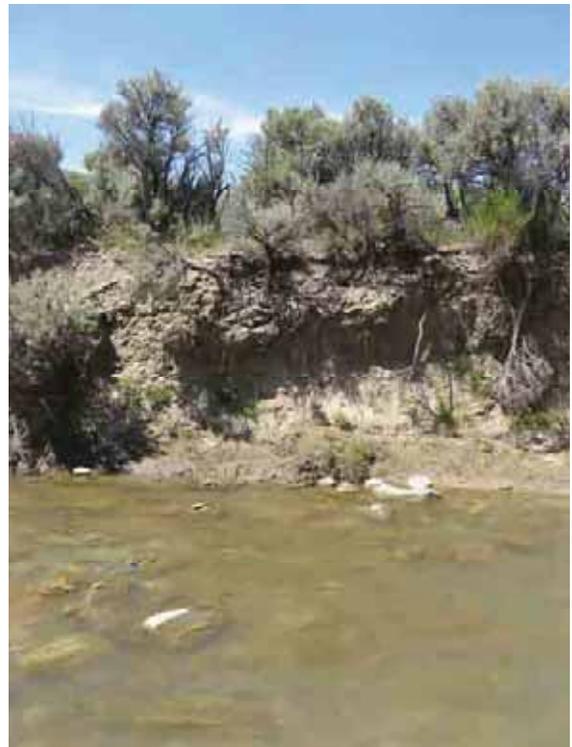
Photo 3. UMC1, XS-4, Right Bank

UMC1, Cross-section 4, Right bank

Category	Value	Index
Bank ht/Bankfull Depth	2.8	9
Root Depth/Bank ht	0.2	7
Root Density	<5%	10
Bank Angle	72	5.1
Surface Protection	3.6%	10
Bank Material	Silt	0
Stratification	None	0
Index sum	--	41.1
BEHI Rating	--	Very High
Radius of Curvature	Straight	--
Bankfull Width	--	--
NBS Rating	--	N/A

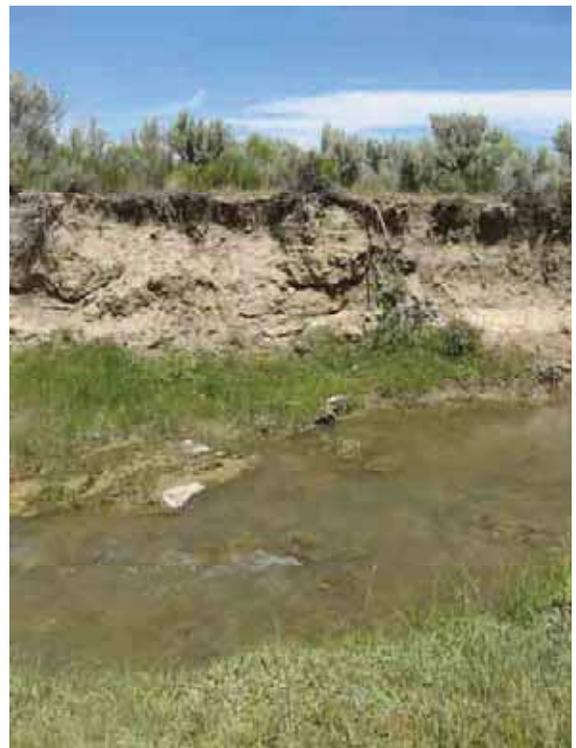
Photo 4: UMC1, XS-6, Right Bank

Category	Value	Index
Bank ht/Bankfull Depth	4	1.6
Root Depth/Bank ht	0.4	5
Root Density	<5%	10
Bank Angle	80	5.9
Surface Protection	0%	10
Bank Material	Silt	0
Stratification	None	0
Index sum	--	32.5
BEHI Rating	--	High
Radius of Curvature	Inside of bank	--
Bankfull Width	--	--
NBS Rating	--	N/A

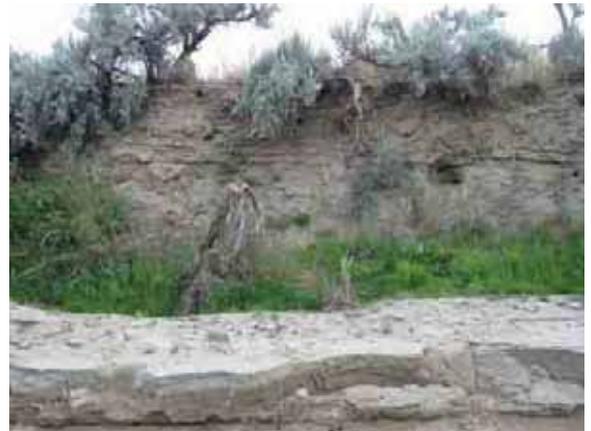
Photo 5: UMC2, XS-1, Left Bank

UMC2, Cross-section 1, Left bank

Category	Value	Index
Bank ht/Bankfull Depth	2	7.9
Root Depth/Bank ht	0.1	8.5
Root Density	<5%	10
Bank Angle	73	5.2
Surface Protection	18.75%	6.5
Bank Material	Silt	0
Stratification	None	0
Index sum	--	32.9
BEHI Rating	--	High
Radius of Curvature	47	--
Bankfull Width	32	--
Rc/W	1.5	--
NBS Rating	--	Extreme

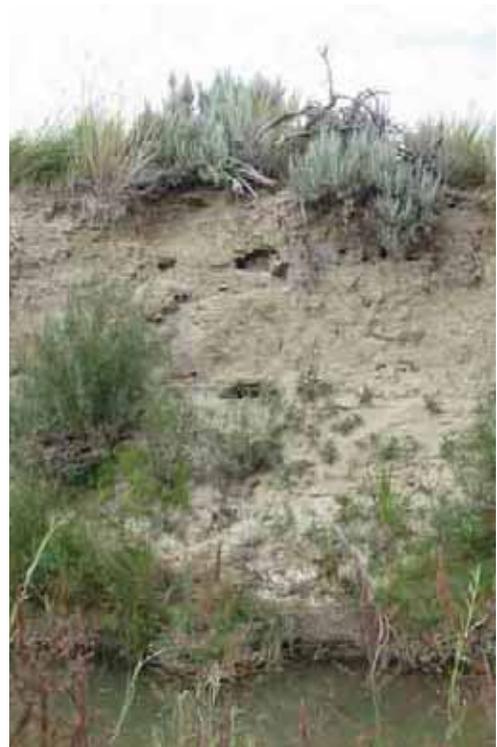
Photo 6. UMC2, XS-2, Right Bank.

Category	Value	Index
Bank ht/Bankfull Depth	2.14	8
Root Depth/Bank ht	0.3	5.9
Root Density	<5%	10
Bank Angle	70	4.9
Surface Protection	10%	9
Bank Material	Silt	0
Stratification	None	0
Index sum	--	37.8
BEHI Rating	--	High
Radius of Curvature	37	--
Bankfull Width	24	--
Rc/W	1.5	--
NBS Rating	--	Very High

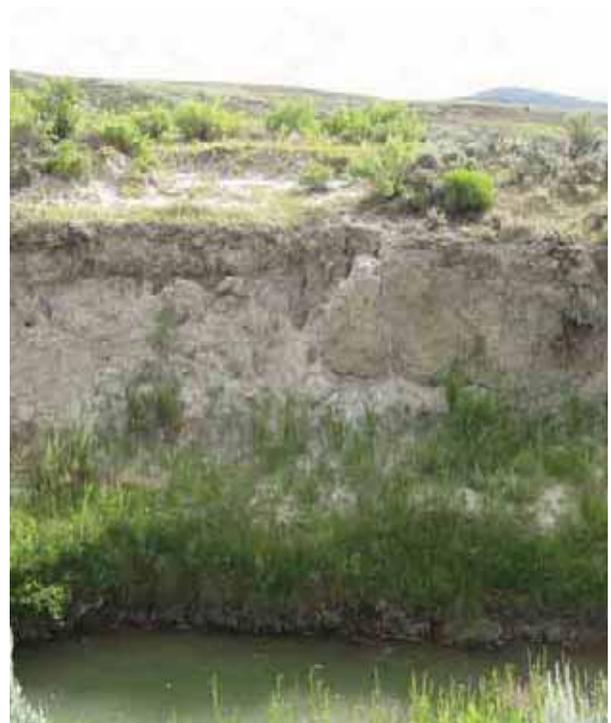
Photo 7. UMC, XS-4, Left Bank.

Category	Value	Index
Bank ht/Bankfull Depth	2.1	8
Root Depth/Bank ht	0.2	7
Root Density	<5%	10
Bank Angle	53	3.7
Surface Protection	5%	10
Bank Material	Silt	0
Stratification	None	0
Index sum	--	38.7
BEHI Rating	--	High
Radius of Curvature	32	--
Bankfull Width	23	--
Rc/W	1.4	--
NBS Rating	--	Extreme

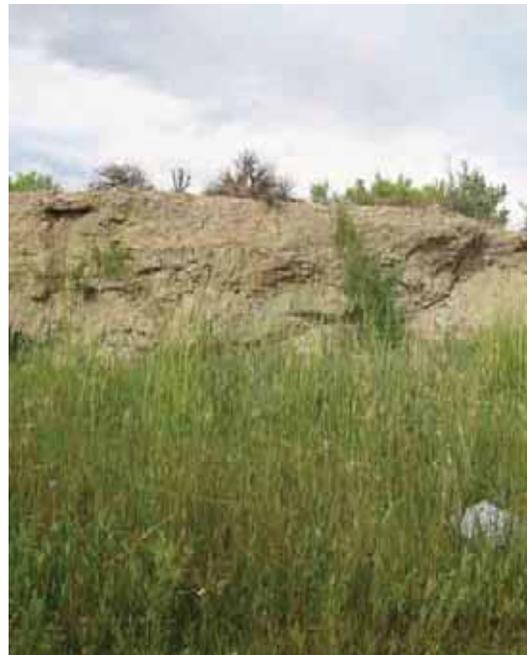
Photo 8: UMC2, XS-5, Right Bank

UMC2, Cross-section 5, Right bank

Category	Value	Index
Bank ht/Bankfull Depth	2.56	8.65
Root Depth/Bank ht	0.1	8.5
Root Density	<5%	10
Bank Angle	75	5.4
Surface Protection	<5%	10
Bank Material	Silt	0
Stratification	None	0
Index sum	--	42.6
BEHI Rating	--	Very High
Radius of Curvature	73	--
Bankfull Width	33	--
Rc/W	2.2	--
NBS Rating	--	Moderate

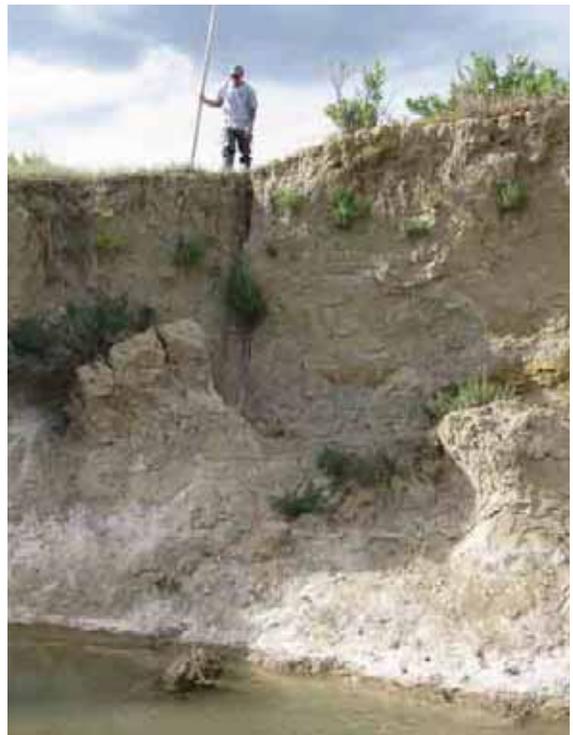
Photo 9: UMC2, XS-6, Right Bank

Category	Value	Index
Bank ht/Bankfull Depth	5.7	10
Root Depth/Bank ht	0.1	8.5
Root Density	<5%	10
Bank Angle	60	3.9
Surface Protection	0%	10
Bank Material	Silt	0
Stratification	None	0
Index sum	--	42.4
BEHI Rating	--	Very High
Radius of Curvature	45	--
Bankfull Width	37	--
Rc/W	1.2	--
NBS Rating	--	Extreme

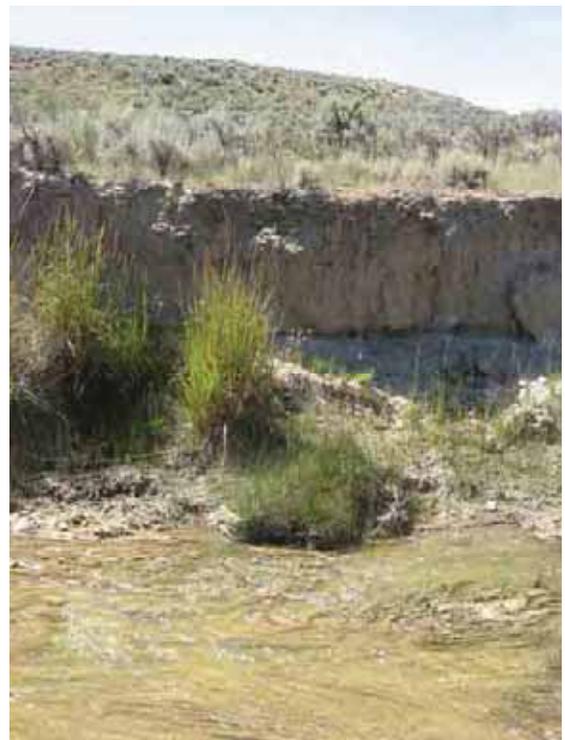
Photo 10: UMC3, XS-1, Left Bank

Category	Value	Index
Bank ht/Bankfull Depth	2.8	9
Root Depth/Bank ht	0.3	9.5
Root Density	<5%	10
Bank Angle	76	5.5
Surface Protection	0%	10
Bank Material	Silt	0
Stratification	1 ft Weak Layer	0
Index sum	--	44
BEHI Rating	--	Very High
Radius of Curvature	86	--
Bankfull Width	42	--
Rc/W	2.1	--
NBS Rating	--	Moderate

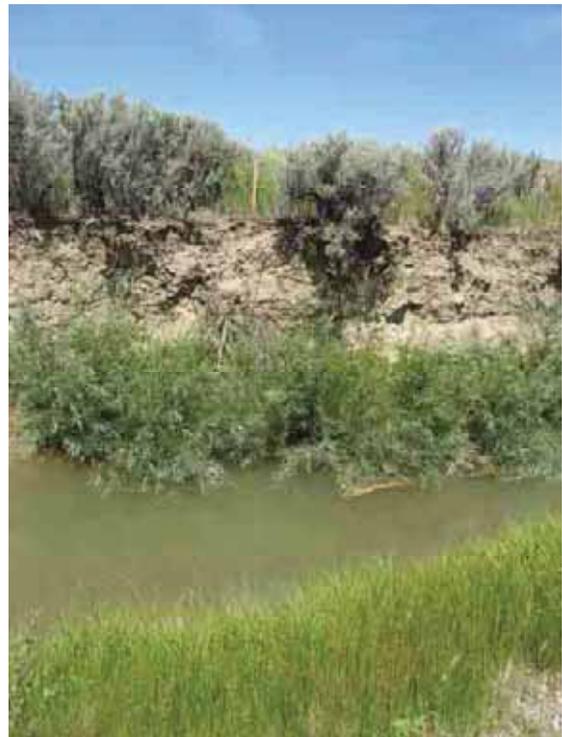
Photo 11: UMC3, XS-2, Right Bank

Category	Value	Index
Bank ht/Bankfull Depth	2.1	8.
Root Depth/Bank ht	0.7	3
Root Density	<5%	10
Bank Angle	70	4.9
Surface Protection	21.4%	7
Bank Material	Silt	0
Stratification	None	0
Index sum	--	32.9
BEHI Rating	--	High
Radius of Curvature	53	--
Bankfull Width	50	--
Rc/W	1.1	--
NBS Rating	--	Extreme

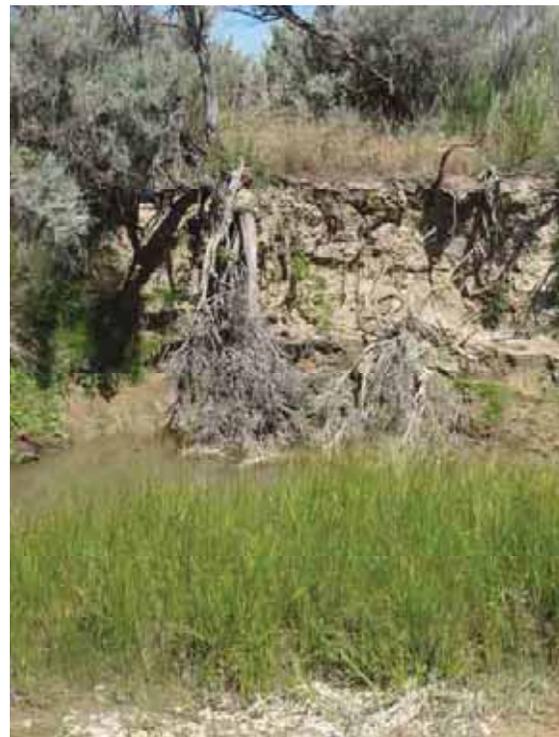
Photo 12: UMC3, XS-3, Right Bank

UMC3, Cross-section 3, Right bank

Category	Value	Index
Bank ht/Bankfull Depth	1.9	7.4
Root Depth/Bank ht	0.2	7
Root Density	<5%	10
Bank Angle	67.5	4.65
Surface Protection	0%	10
Bank Material	Silt	0
Stratification	None	0
Index sum	--	39.05
BEHI Rating	--	High
Radius of Curvature	Straight	--
Bankfull Width	--	--
NBS Rating	--	N/A

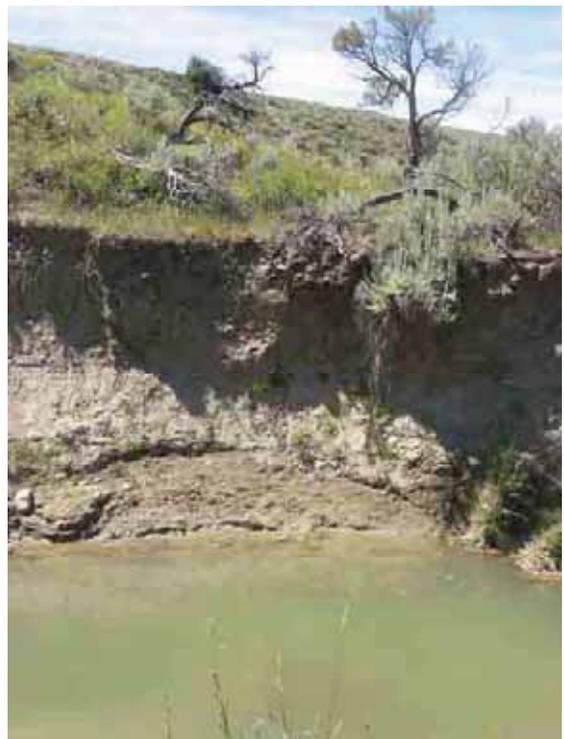
Photo 13: UMC3, XS-5, Left Bank

Category	Value	Index
Bank ht/Bankfull Depth	2.3	8.33
Root Depth/Bank ht	0.2	7
Root Density	<5%	10
Bank Angle	70	4.9
Surface Protection	0%	10
Bank Material	Silt	0
Stratification	None	0
Index sum	--	40.23
BEHI Rating	--	Very High
Radius of Curvature	48	--
Bankfull Width	41	--
Rc/W	1.2	--
NBS Rating	--	Extreme

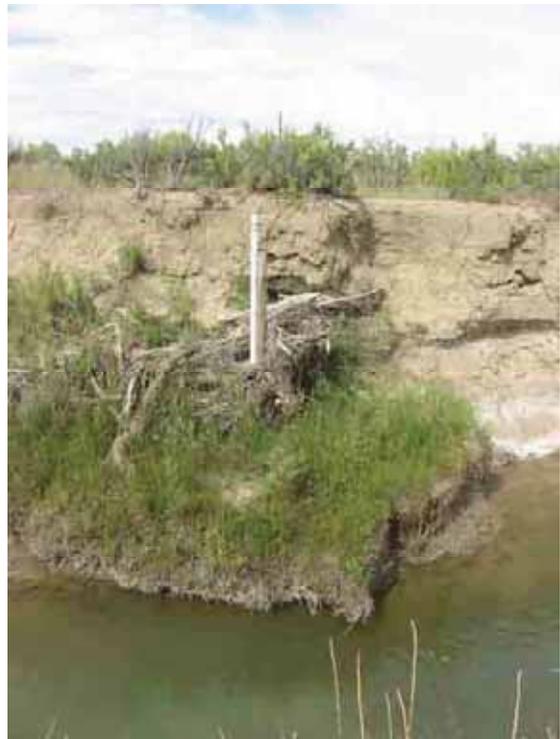
Photo 16: UMC4, XS-3, Right bank

UMC4, Cross-section 3, Right bank

Category	Value	Index
Bank ht/Bankfull Depth	2.4	8.43
Root Depth/Bank ht	0.3	5.9
Root Density	<5%	10
Bank Angle	74	5.3
Surface Protection	17.5%	7.56
Bank Material	Silt	0
Stratification	None	0
Index sum	--	37.2
BEHI Rating	--	High
Radius of Curvature	121	--
Bankfull Width	26	--
Rc/W	4.7	--
NBS Rating	--	Very Low

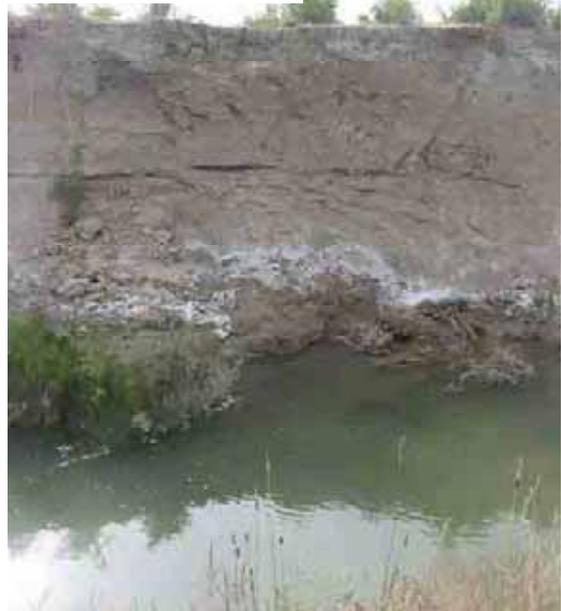
Photo 17: UMC4, XS-6, Right Bank

UMC4, Cross-section 6, Right bank

Category	Value	Index
Bank ht/Bankfull Depth	2.1	8.0
Root Depth/Bank ht	0.2	7
Root Density	<5%	10
Bank Angle	71.25	4.67
Surface Protection	0%	10
Bank Material	Silt	0
Stratification	None	0
Index sum	--	40.17
BEHI Rating	--	Very High
Radius of Curvature	43	--
Bankfull Width	21	--
Rc/W	2.1	--
NBS Rating	--	Moderate

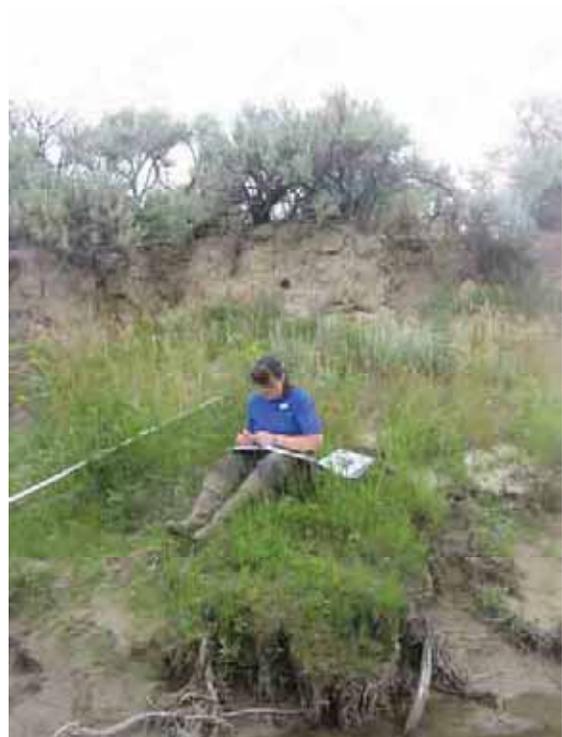
Photo 18: UMC5, XS-1, Right Bank

Category	Value	Index
Bank ht/Bankfull Depth	3.0	10
Root Depth/Bank ht	0.3	5.9
Root Density	<5%	10
Bank Angle	42	3.0
Surface Protection	30%	5.9
Bank Material	Silt	0
Stratification	None	0
Index sum	--	34.8
BEHI Rating	--	High
Radius of Curvature	Straight	--
Bankfull Width	--	--
NBS Rating	--	N/A

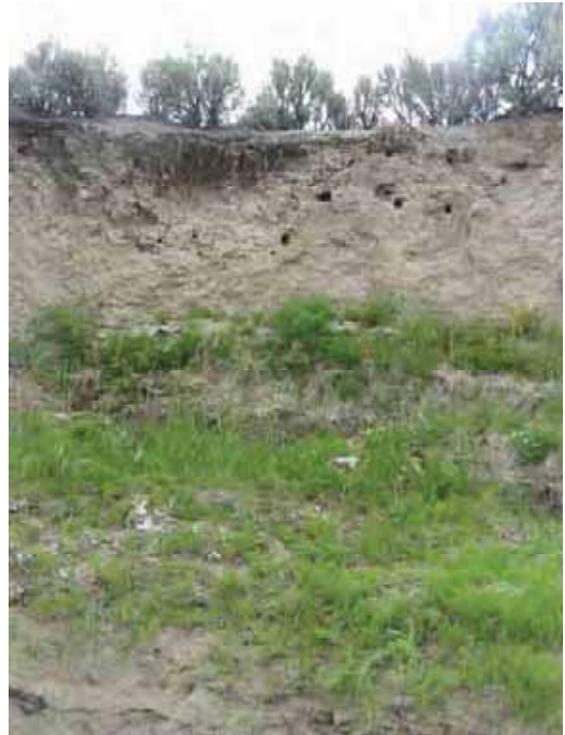
Photo 19: UMC5, XS-2, Right Bank

Category	Value	Index
Bank ht/Bankfull Depth	4.2	10
Root Depth/Bank ht	0.1	8.5
Root Density	<5%	10
Bank Angle	52	3.5
Surface Protection	20%	7.2
Bank Material	Silt	0
Stratification	None	0
Index sum	--	39.2
BEHI Rating	--	High
Radius of Curvature	Straight	--
Bankfull Width	--	--
NBS Rating	--	N/A

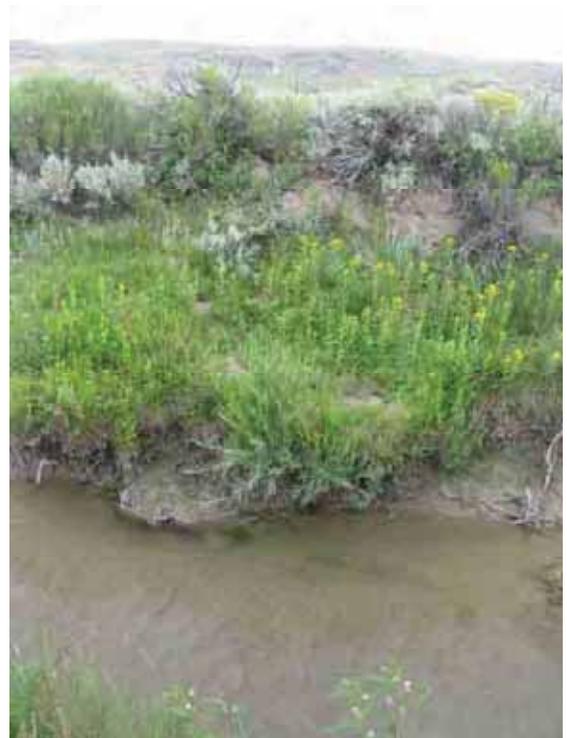
Photo 20: UMC5, XS-3, Right Bank

UMC5, Cross-section 3, Right bank

Category	Value	Index
Bank ht/Bankfull Depth	2.7	8.85
Root Depth/Bank ht	0.2	7.4
Root Density	<5%	10
Bank Angle	66	4.5
Surface Protection	20%	7.2
Bank Material	Silt	0
Stratification	None	0
Index sum	--	37.95
BEHI Rating	--	High
Radius of Curvature	43	--
Bankfull Width	16	--
Rc/W	2.8	--
NBS Rating	--	Low

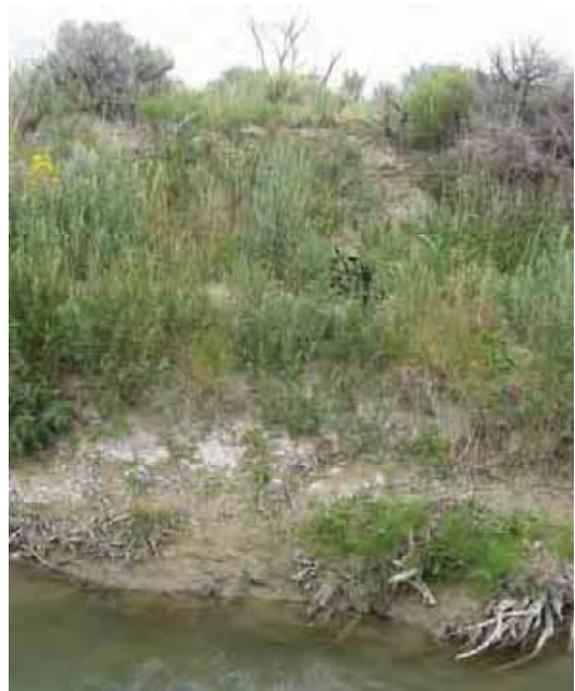
Photo 21: UMC5, XS-5, Right Bank

Category	Value	Index
Bank ht/Bankfull Depth	2.36	8.23
Root Depth/Bank ht	0.2	7.5
Root Density	<5%	10
Bank Angle	41	2.97
Surface Protection	45%	4.7
Bank Material	Silt	0
Stratification	None	0
Index sum	--	33.4
BEHI Rating	--	High
Radius of Curvature	Straight	--
Bankfull Width	--	--
NBS Rating	--	N/A

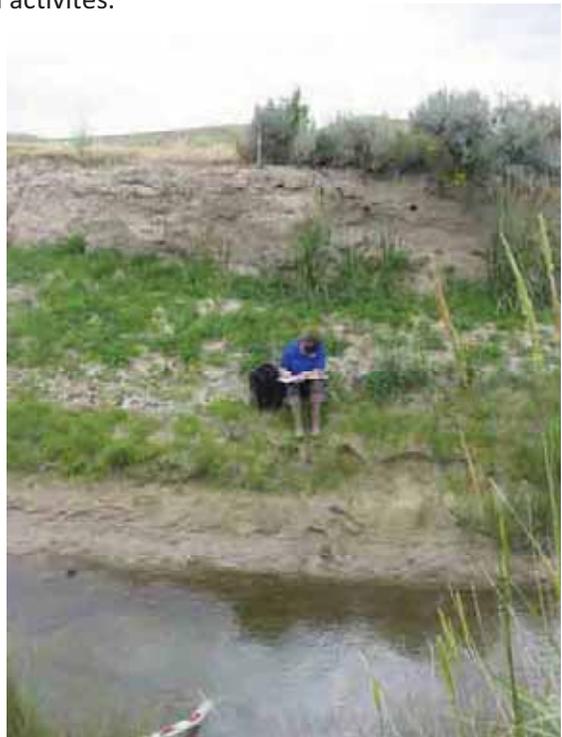
Photo 22: UMC5, XS-6, Right Bank

Category	Value	Index
Bank ht/Bankfull Depth	3.14	10
Root Depth/Bank ht	0.1	8.5
Root Density	<5%	10
Bank Angle	60	3.9
Surface Protection	16%	7.76
Bank Material	Silt	0
Stratification	None	0
Index sum	--	40.16
BEHI Rating	--	Very High
Radius of Curvature	91	--
Bankfull Width	21	--
Rc/W	4.4	--
NBS Rating	--	Very Low

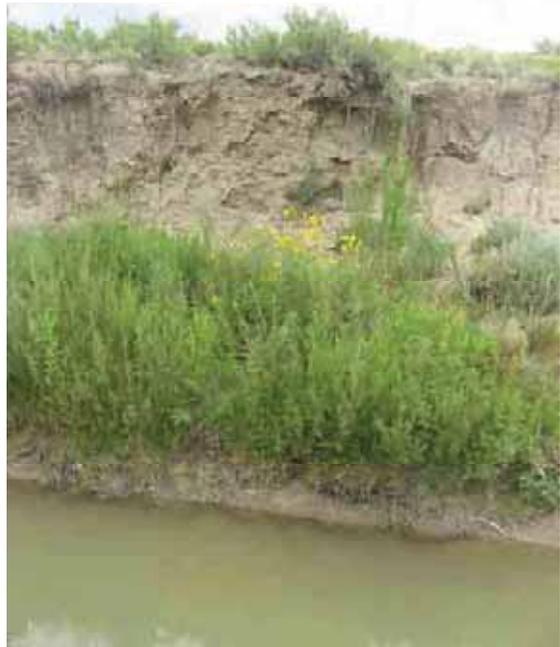
Photo 23 UMC6, XS-3, Right Bank

Category	Value	Index
Bank ht/Bankfull Depth	4.2	10
Root Depth/Bank ht	0.1	8.5
Root Density	<5%	10
Bank Angle	62	4.1
Surface Protection	19%	6.1
Bank Material	Silt	0
Stratification	None	0
Index sum	--	38.7
BEHI Rating	--	High

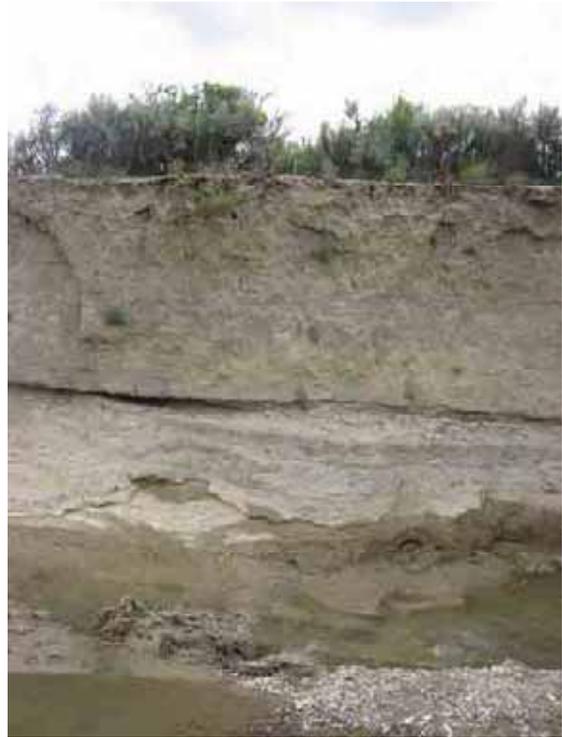
Photo 24: UMC6, XS-1, Left Bank

Category	Value	Index
Bank ht/Bankfull Depth	3.9	10
Root Depth/Bank ht	0.1	8.5
Root Density	<5%	10
Bank Angle	85	6.84
Surface Protection	0%	10
Bank Material	Silt	0
Stratification	None	0
Index sum	--	45.34
BEHI Rating	--	Very High

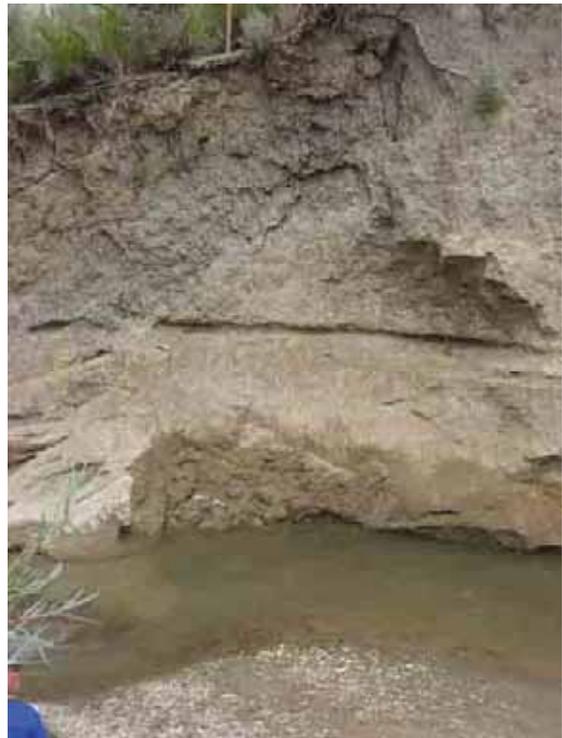
Photo 25: UMC6, XS-4, Right Bank

Category	Value	Index
Bank ht/Bankfull Depth	3.1	10
Root Depth/Bank ht	0.05	10
Root Density	<5%	10
Bank Angle	77	5.6
Surface Protection	0%	10
Bank Material	Silt	0
Stratification	None	0
Index sum	--	45.6
BEHI Rating	--	Extreme

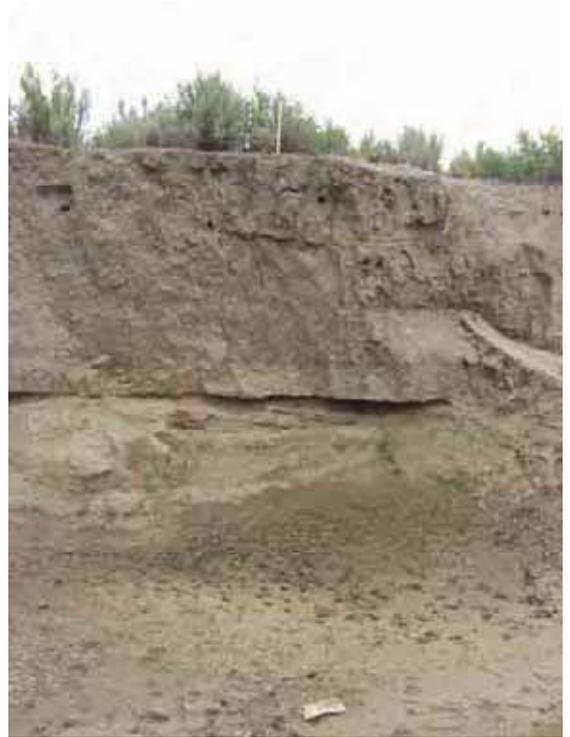
Photo 26: UMC6, XS-6, Left Bank

Category	Value	Index
Bank ht/Bankfull Depth	4.0	10
Root Depth/Bank ht	0.17	7.7
Root Density	<5%	10
Bank Angle	83.5	6.25
Surface Protection	0%	10
Bank Material	Silt	0
Stratification	None	0
Index sum	--	43.95
BEHI Rating	--	Very High
