**Atlantic Rim Coal Bed Methane and Natural  
Gas Project  
Carbon County, Wyoming**

October 19, 2010

*Muddy Creek Monitoring  
Report - 2010*

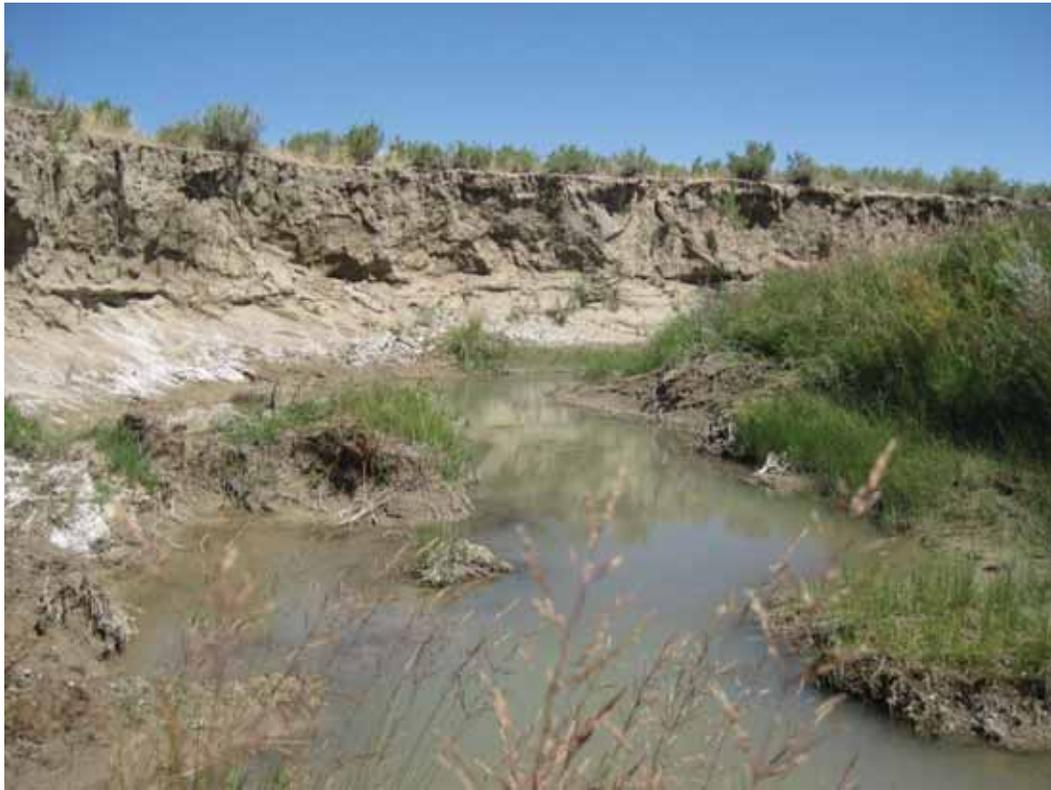
Figure 2-2. Lower section of UMC4, August 2010.

- Any stability in these apparent riffles is due to the presence of underlying clay beds; the gravel sizes found on these beds are small and easily mobilize even during low flows.
- In 2010 the previously measured sites were inundated and not acting as riffles.
- In 2010, turbid water conditions made it difficult to identify the locations of the previously sampled, inundated sites. Figure 2-2 shows the inundated condition of the lower portion of UMC4 in August 2010.

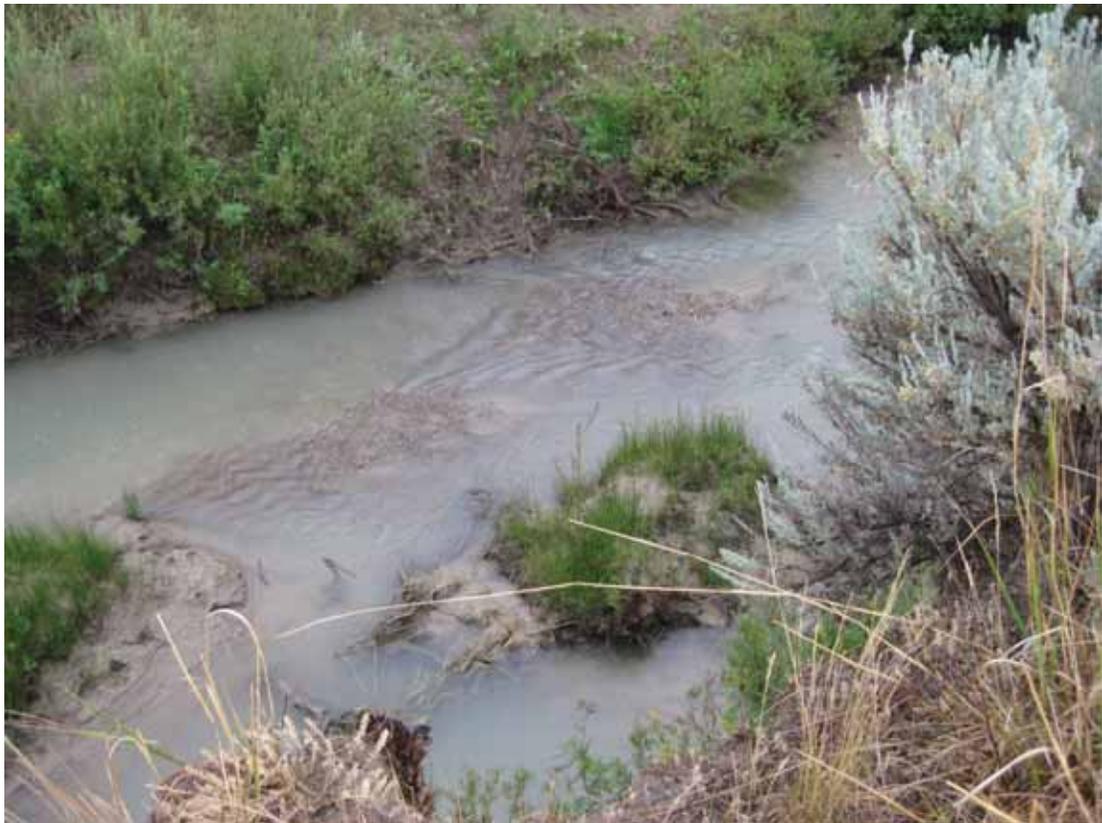
**Figure 2-3. Riffle at UMC2 XS-3, August 2010.**

The consistent decrease in pebble size at UMC2 XS-3 is indicative of a systematic change at this location and this riffle may not effectively control water elevations in the near future. Figure 2-3 shows the condition of this riffle in 2010.

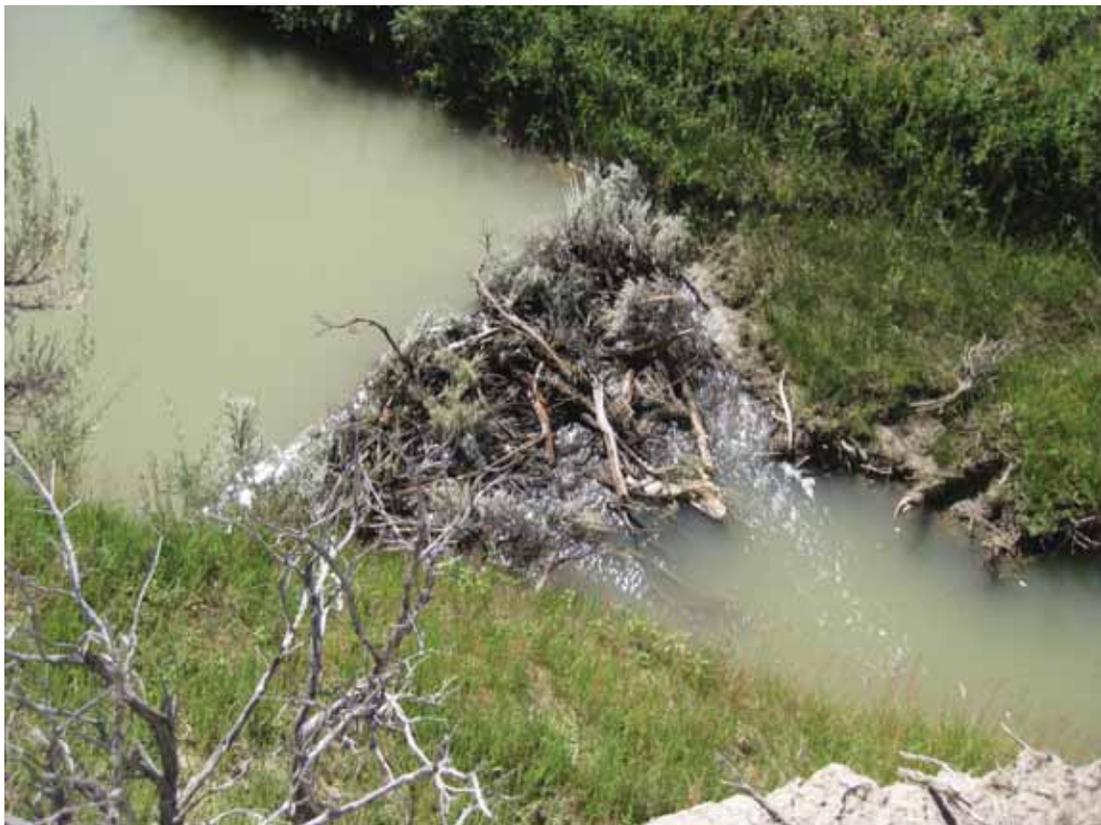
**Figure 2-4. Beaver dam at UMC6 XS-4, August 2010.**

Residual pool depth refers to the depth of the pools remaining when water stops flowing, leaving water only in the pools. The depth was obtained by subtracting the water depth at the riffle crest downstream of the pool from the water depth at the deepest portion of the pool. Measured depths may not always be maximum pool depths because turbid water prevented visual identification of the deepest pool location. As discussed in Section 2.3, riffles at sites UMC4, UMC5, and UMC6 were generally not identifiable this year because of the higher flows and higher turbidity and therefore residual depths could not be measured at some locations. At UMC6 cross-section 4 beavers have a constructed dam (Figure 2-4), which creates the residual pool measured at this section.

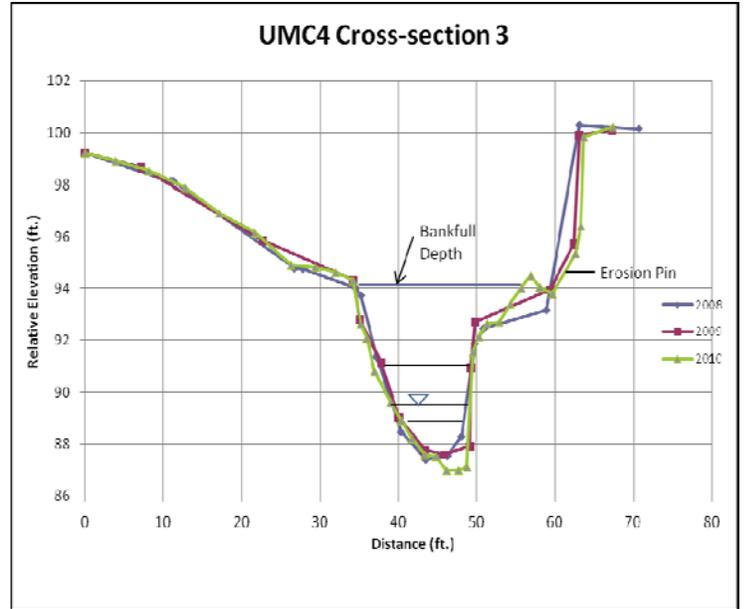
Photo 32: UMC4, XS-3, Right Bank (2010).

UMC-4, Cross-section 3, Right bank

Category	2010 Value	2010 Index	2008 Index
Bank ht/Bankfull Depth	1.7	6.5	4.5
Root Depth/Bank ht	0.3		5.9
Root Density	<5%		10
Bank Angle	54		8.5
Surface Protection	0%		10
Bank Material	Silt		0
Stratification	None		0
Index sum	--	36	38.9
<b>BEHI Rating</b>	--	<b>High</b>	<b>High</b>
Radius of Curvature			--
Bankfull Width			--
Rc/W			--
<b>NBS Rating</b>			<b>Very Low</b>

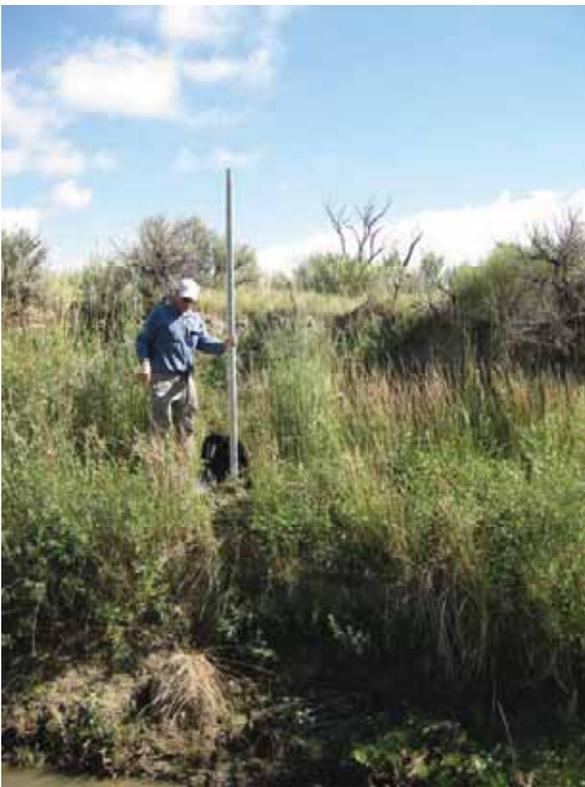
Photo 42: UMC5, XS-5, Right Bank (2010).

UMC-5, Cross-section 5, Right bank

Category	2010 Value	2010 Index	2008 Index
Bank ht/Bankfull Depth	1.9	7.5	7.5
Root Depth/Bank ht	0.2	7.5	7.5
Root Density	<5%	10	10
Bank Angle	60	3.9	4
Surface Protection	56%	3.85	5.5
Bank Material	Silt	0	0
Stratification	None	0	0
Index sum	--	32.75	34.5
<b>BEHI Rating</b>	--	<b>High</b>	<b>High</b>
Radius of Curvature		--	--
Bankfull Width		--	--
<b>NBS Rating</b>		<b>N/A</b>	<b>N/A</b>

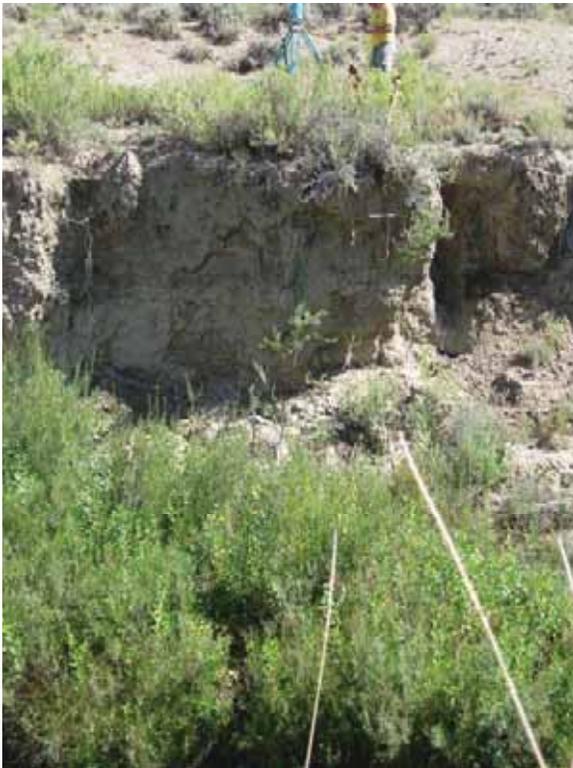
Photo 48: UMC6, XS-3, Right Bank (2010).

UMC-6, Cross-section 3, Right bank

Category	2010 Value	2010 Index	2008 Index
Bank ht/Bankfull Depth			10
Root Depth/Bank ht	2.7	8.9	8.5
Root Density	<5%	10	10
Bank Angle	48	5.3	4.1
Surface Protection	15%	7.9	6.2
Bank Material	Silt	0	0
Stratification	None	0	0
Index sum	--	40.6	38.8
<b>BEHI Rating</b>	--	<b>Very High</b>	<b>High</b>
