Bureau of Land Management

West Cottonwood Allotment #00535

Standards for Healthy Rangelands and Guidelines for Livestock Grazing Management

FY 2014/15

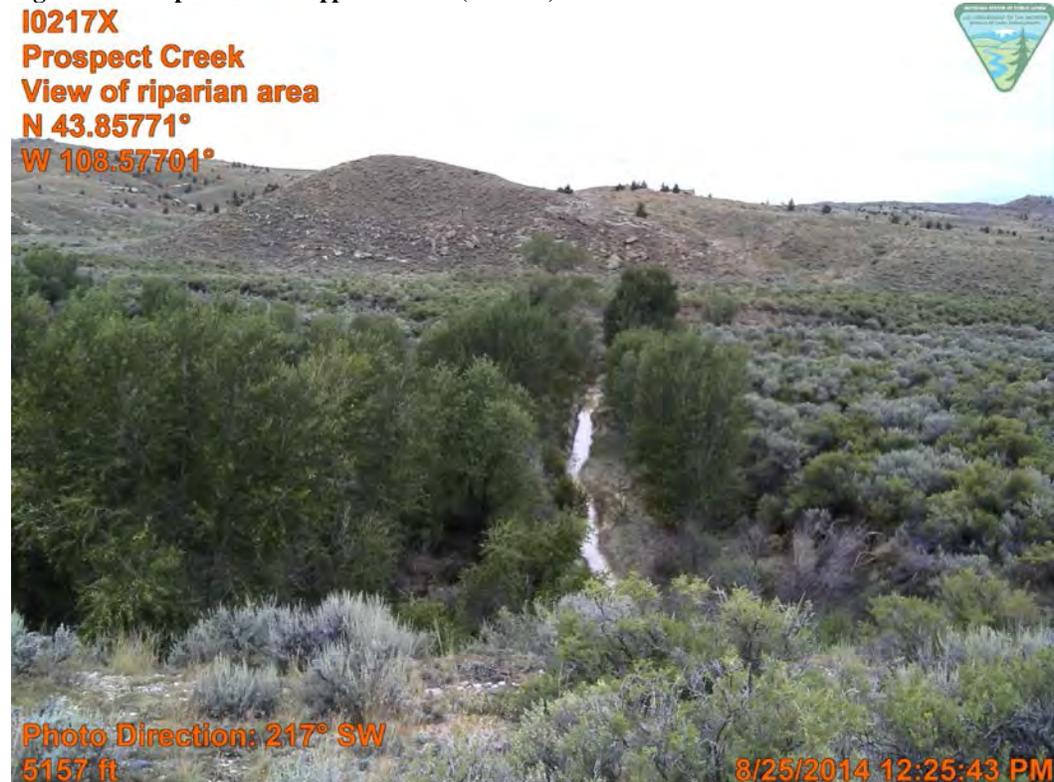
Figure 3- Prospect Creek Upper Reach (I0217X)

These segments were also assessed in the field season of 2014 following a local heavy rain event. There was evidence of minor erosion and scouring of channel banks. The upper reaches have greater riparian characteristics such as canopy cover provided mainly by Cottonwood trees and higher amounts of water in the soil profile (Figure 3-4) compared to lower segments (Figure 5) that are intermittent/ephemeral in nature. Periodic pooling of water is common in the channel following rain events as captured in the photos.

Segment I0217X currently was rated as functioning at risk with an upward trend in 2004 with the rating given due to some vertical and horizontal instability along with headcuts observed during the assessment. The rating was not livestock related with no signs of overuse in the riparian areas. This alteration was determined to be from historic alterations to vegetation cover in the watershed that has caused a slight to moderate and moderate increase in runoff as a result. In 2014 monitoring data suggest that the riparian area is improving and making progress toward achieving this standard. This segment was placed under category 2f with the causal factor being the channel condition as a result. Lower portions of the reach were rated as ephemeral and placed in category 3.

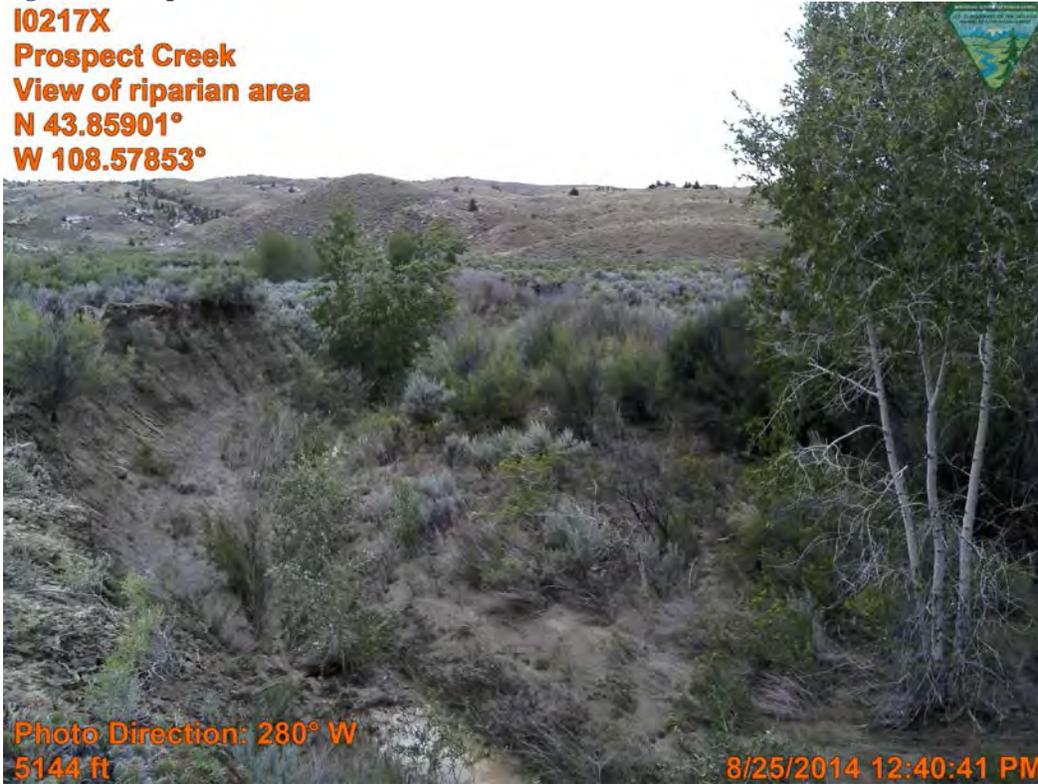
Figure 4- Prospect Creek (I0217X)

I0217X
Prospect Creek
View of riparian area
N 43.85901°
W 108.57853°

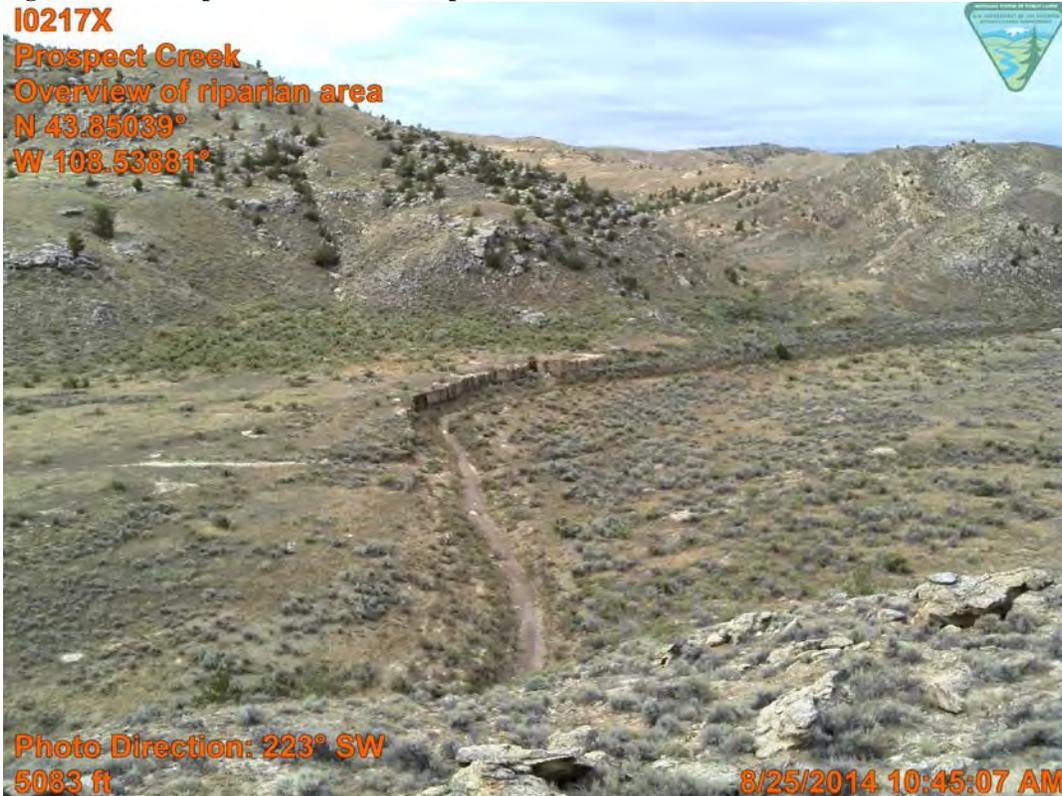
Figure 5-Lower Ephemeral Reach Prospect Creek (I0217X)

I0217X
Prospect Creek
Overview of riparian area
N 43.85039°
W 108.53881°

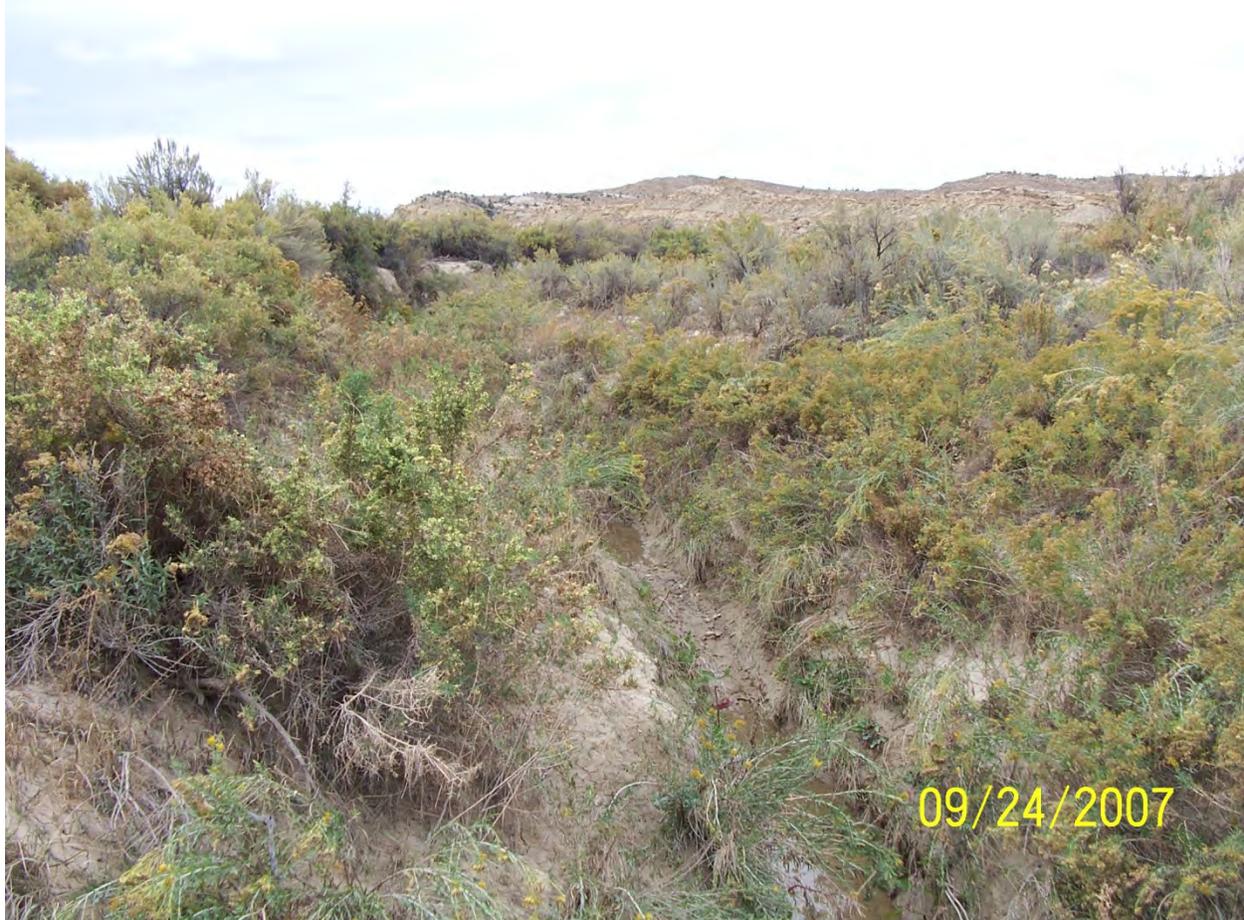
P0101X

This is a segment on public land at the confluence of Wagonhound and Cottonwood Creek. The vegetation consists of sedges, salt cedar, inland salt grass, alkali sacaton and Rubber Rabbit Brush. The flow regime is intermittent and this segment was rated to be in Proper Functioning Condition in 2002.

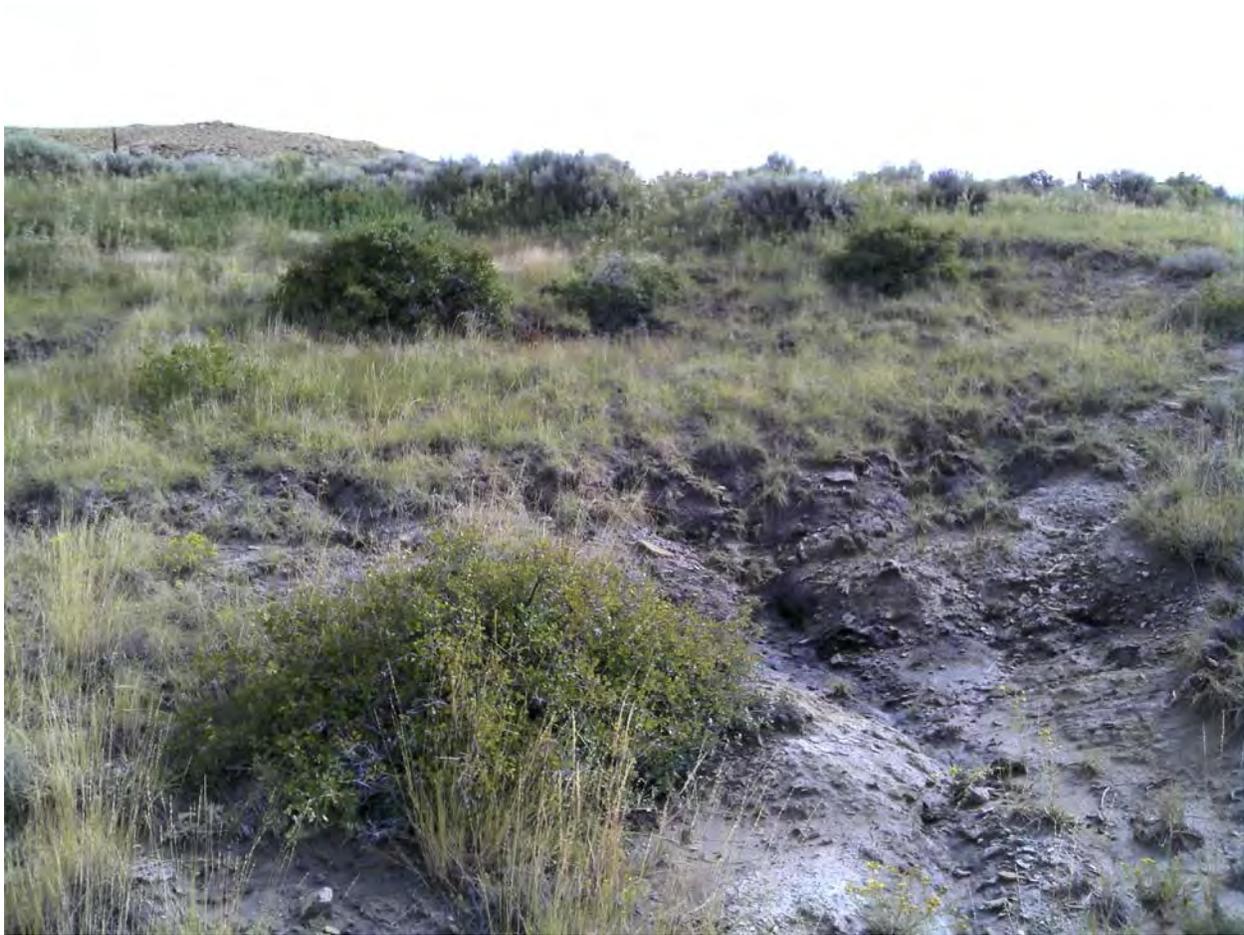
Norman Sanford Spring

This spring has been developed with the spring source fenced for protection. The majority of the water and riparian vegetation is present surrounding the tanks that are located below the enclosure. The natural spring area is dominated by facultative dry with some wet plant type species near the center of the area. There are cattails and sedges growing around the tank area. The area currently has a perimeter fence and the functionality of the area was rated to be in proper functioning condition (PFC).

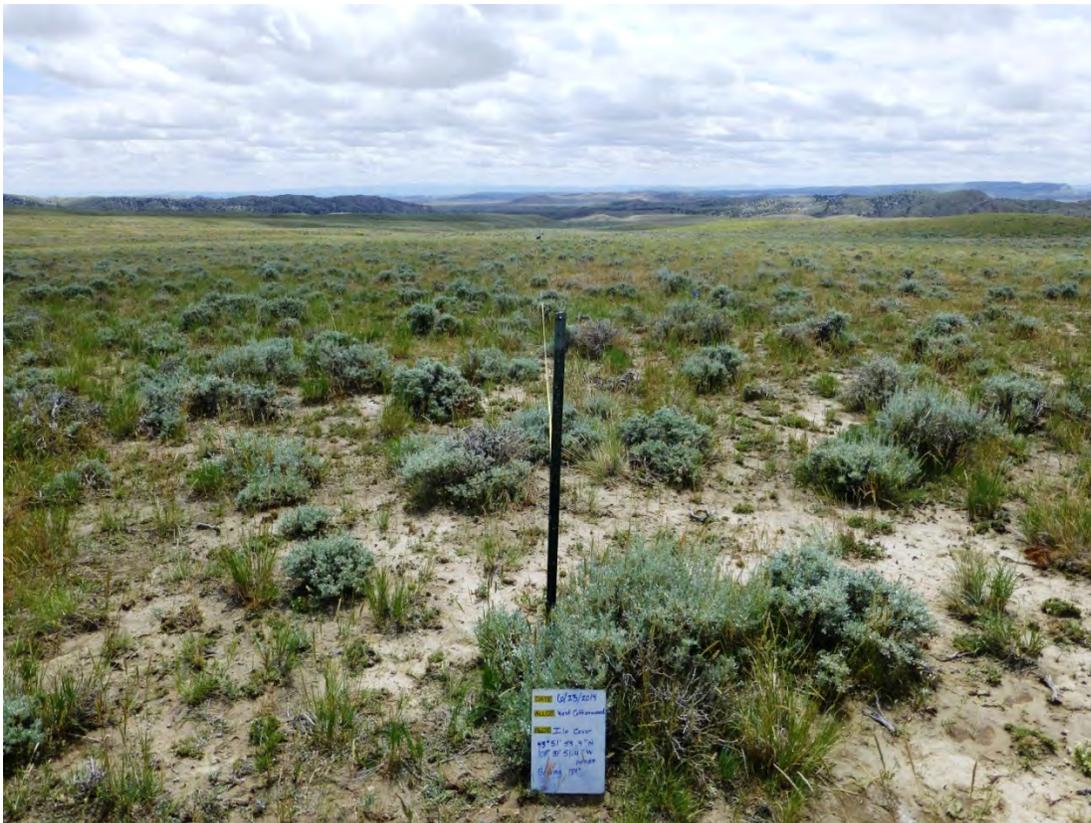
The data collected at this site indicates that this site has characteristics of a Perennial grass/sagebrush community. The attribute rating justification for the Biotic Integrity at this assessment was “Slight to Moderate.” The functional/structural groups are slightly altered from HCPC. The cool season bunch grasses on site include bluebunch wheatgrass, needle and thread grass, junegrass, poa’s, and there was also western wheatgrass (rhizomatous). Blue grama, a warm season native is also present which has likely reduced some of the perennial bunchgrasses. The forbs noted in the transect were a minor component. The main woody species on site is big sagebrush. The percent litter was within expected at the transect site but the bare ground was rated as slight to moderate even though the amount was within expected. The higher rating was because of the connectivity of the bare areas. The invasive plants indicator number 16 was rated as moderate because of the amount of cactus and blue grama on site. While no cheatgrass was documented within the transect it and cactus were noted as being in the area in small isolated locations.

Ho looking south

As was mentioned above in the rationale for Standard 3, one of the four monitoring sites, Ilo Cover, was best described as a Perennial grass/sagebrush community. This community still retains appropriate pathways available to respond to favorable environmental conditions, and environmental disturbances, and is stable, intact, resistant to change, and provides for soil and watershed stability. The Biotic Attribute of Rangeland Health for this site was rated at "Slight-Moderate", and this community maintains enough diversity and dominance by desirable perennial grasses to return to HCPC. It also provides for a diversity of plant species including an overstory of sagebrush and understory of bunchgrasses and forbs, and in turn provide for the diversity of wildlife habitat needs like cover, forage and nesting habitats. Most importantly these vegetation communities provide a diversity of native plant species that in turn provide for a diversity of animal species, of which all are appropriate to the habitat, and therefore do meet Standard 4.

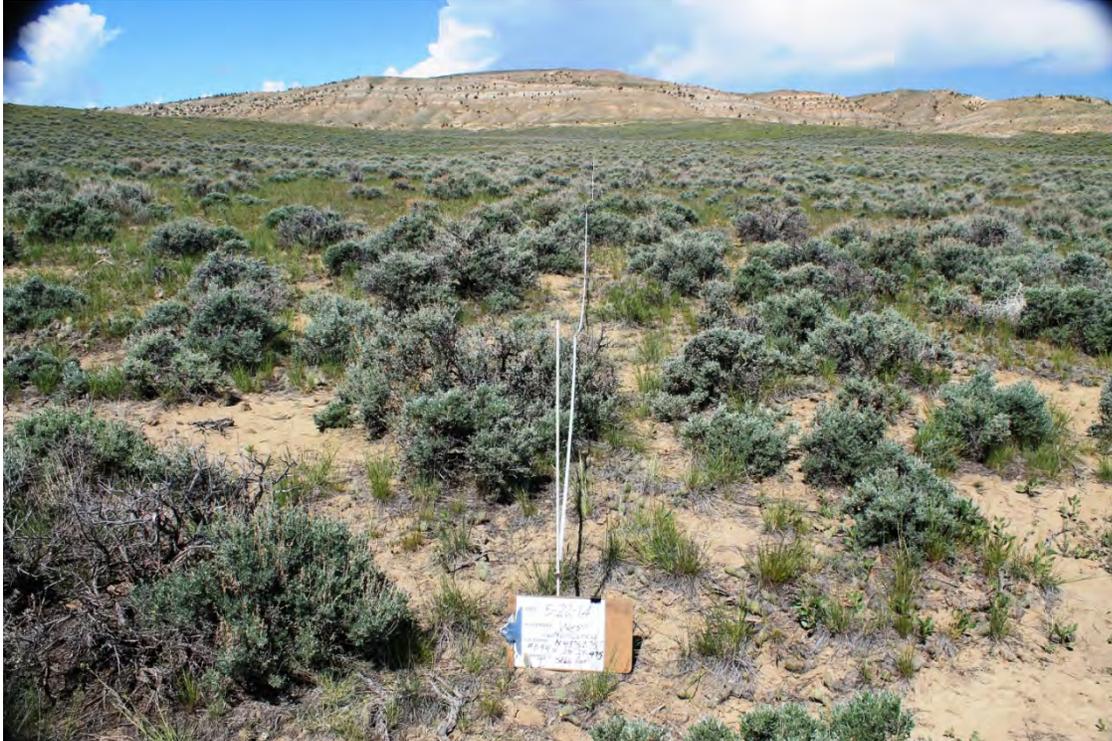
Looking north towards Ilo transect

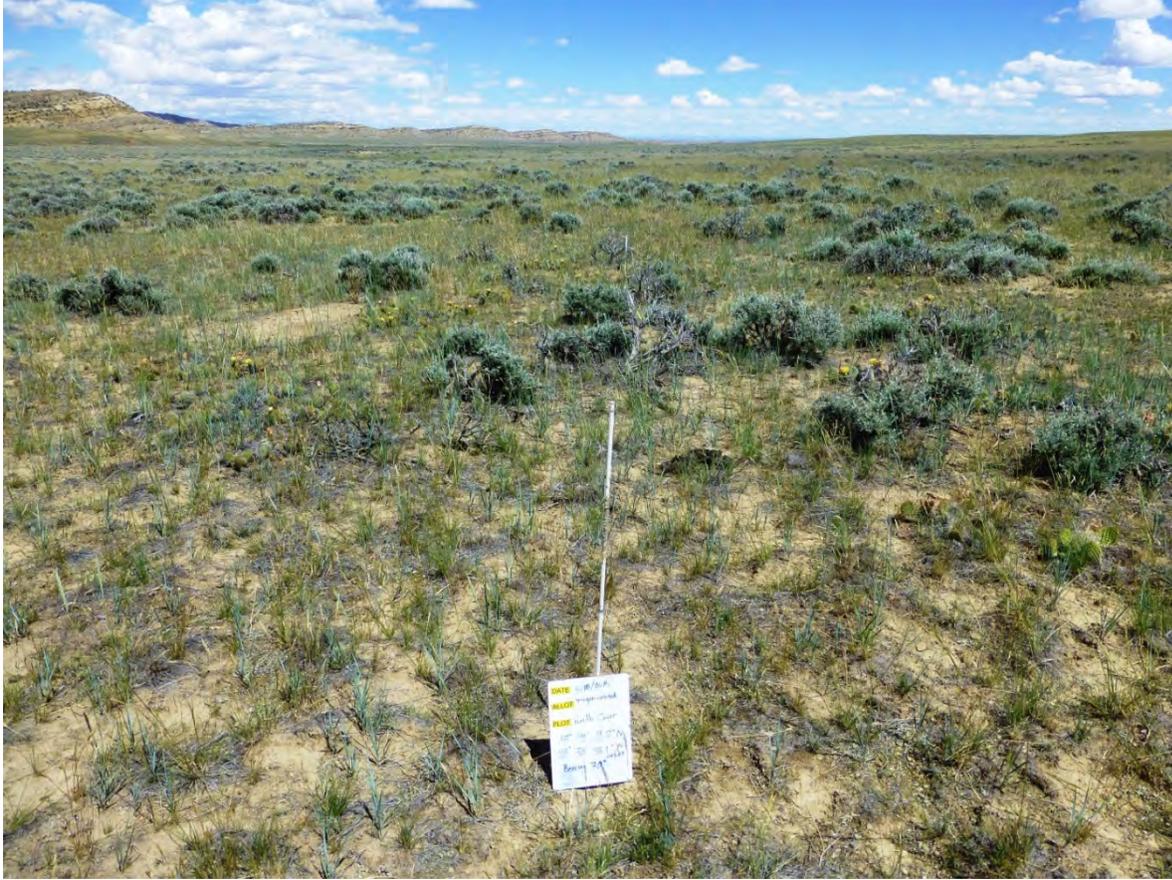
NORTH COVER

The data collected at this site indicates that this site has characteristics of a state in transition that is at a blue grama sod condition with indicators of recovering or moving towards a Perennial Grass/Big Sagebrush community. This transect, while in the neighboring allotment, represents that which was observed in the northeast of the West Cottonwood allotment. The attribute rating justification for the Biotic Integrity at this assessment was “Moderate.” The functional/structural groups are altered from HCPC (indicator 12 Moderate deviation from expected with 16 rated at moderate to extreme). The dominant grasses on site are bluegrama, sandberg blue grass, and needleandthread. It appears that blue grama and cactus once dominated these sites but needle and thread is still on site. The forbs were noted in the transect were in minor component and were primarily annuals in the area. The main woody species on site is sagebrush. Biological crusts were common in the area and readily observed on the transect. The percent litter was within expected at the transect site as was the amount of bare ground. The invasive plants indicator number 16 was rated as moderate to extreme because of the amount of cactus and blue grama on site. While no cheatgrass was documented within the transect it and cactus was noted as being in the area in small isolated locations.

The remaining three monitoring sites; South East Cover, North Cover and West Cover were found to best be described as Blue Grama sod Community for South East Cover and North Cover, and Big sagebrush/bare ground community for West Cover. These communities are characterized as being sites where invasive species, including Blue Grama and Prickly Pear, have either taken over the site, and/or sites where the desirable perennial grasses have been lost from the plant community. Also the Biotic Attribute of Rangeland Health was rated "Moderate" or "Moderate to Extreme" for these sites, meaning that they have at least moderately departed from what the potential Historic Climax Plant Community (HCPC) is for the site. These plant communities exhibit a low level of plant diversity and therefore do not provide for a diversity of wildlife habitat needs in the form of cover, forage, or nesting habitat. And most importantly these vegetation communities contain invasive species that are not appropriate for their habitats, and compete with native plant species for space and resources and in turn do not provide for a diversity of animal species, and for these reasons do not meet Standard 4.

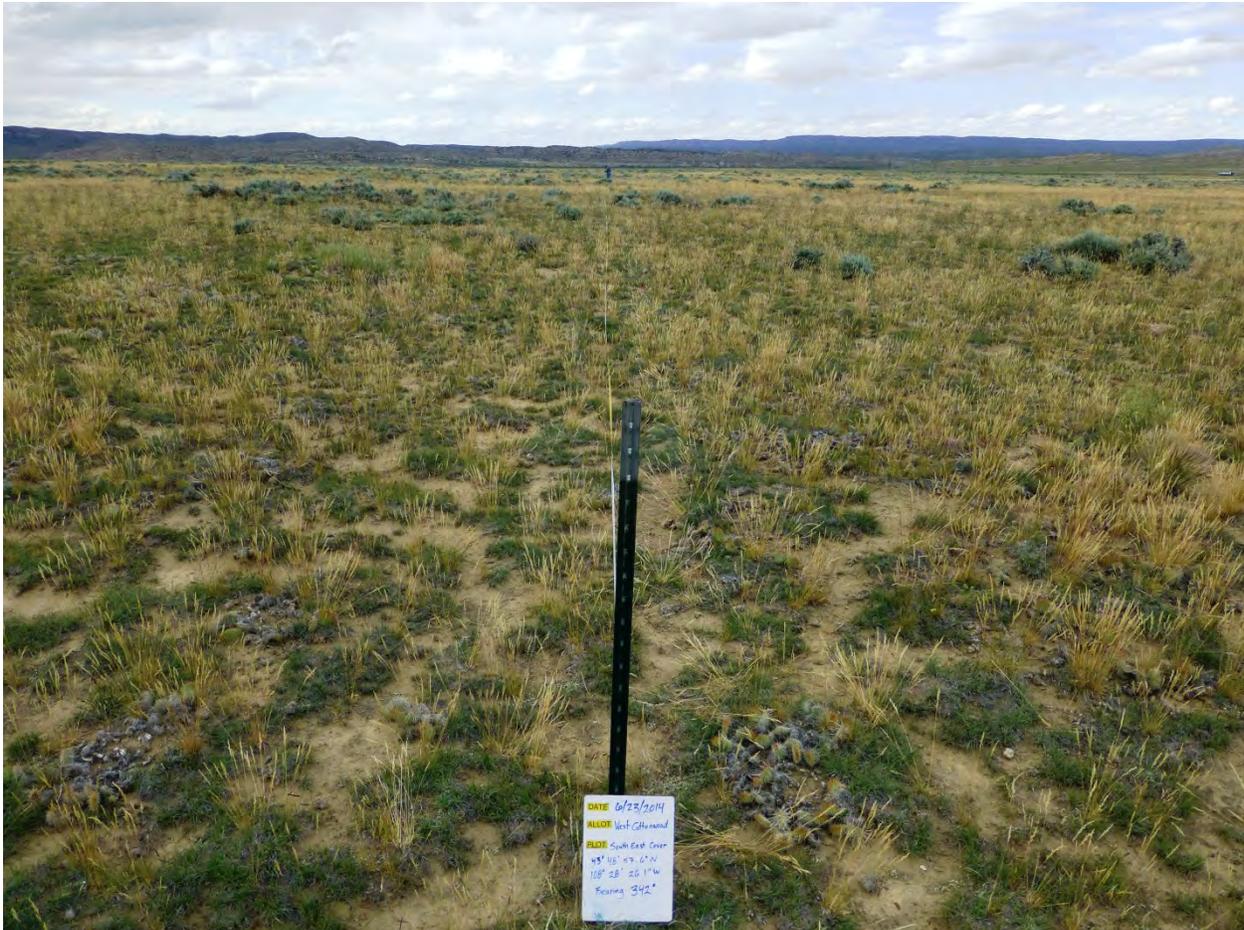
South East Cover

The data collected at this site indicates that this site has characteristics of a Blue Grama sod Community. The attribute rating justification for the Biotic Integrity at this assessment was “Moderate to Extreme.” The functional/structural groups are reduced/altered and the plant diversity is low with very few desirables on site. The grass on site is blue grama. Perennial forbs are few.. The main woody species on site is sagebrush. Biological crusts were common in the area and readily observed on the transect. The percent litter was less than expected and the bare ground was more than expected for the site. The invasive plants indicator number 16 was rated as moderate to extreme. While no cheatgrass was documented within the transect it was noted as being in the area in small isolated locations.

The areas represented from the SE cover transect have a moderate departure from reference conditions. The soil and hydrologic indicators evidence elevated runoff from these areas with minor instability and reduced infiltration as a result. These areas are located along the historic terraces of Prospect Creek where vegetation communities have been significantly altered.

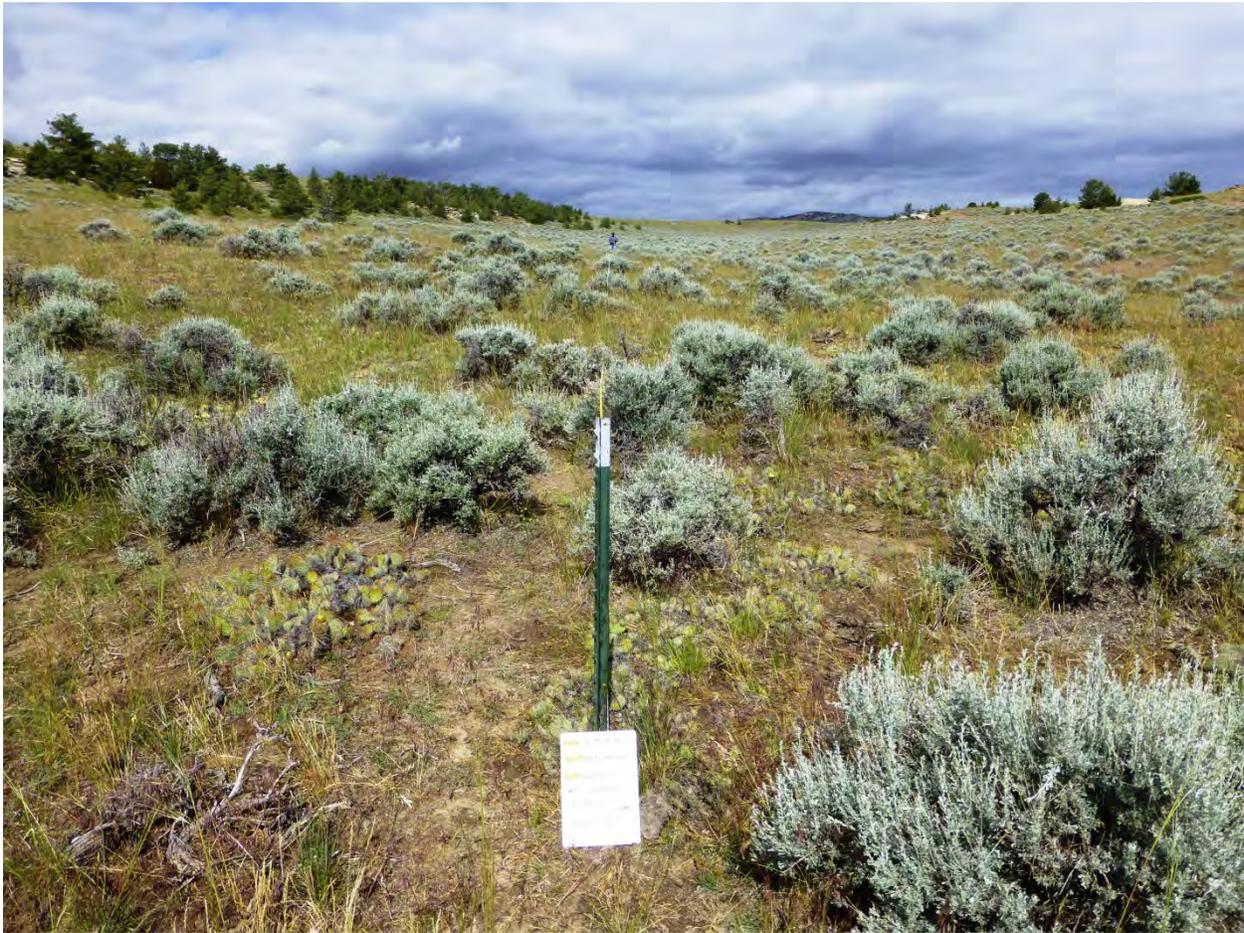
West Transect

The data collected at this site indicates that this site has characteristics of a Big sagebrush/bare ground community. The attribute rating justification for the Biotic Integrity at this assessment was “Moderate.” The functional/structural groups are lacking in the correct species. The dominant cool season grass is sandberg bluegrass with needleandthread grass present, the dominant species on site is cactus and big sagebrush. The forbs were a minor component of the area. The main woody species on site is big sagebrush and it makes up a larger than expected part of the community. The percent litter was within expected as was the amount of bare ground. The

invasive plants indicator number 16 was rated as moderate because of the amount of cactus present and found within the transect and the large areas of cheatgrass found throughout the range site. The cheatgrass is not being found within disturbed areas but actually dominates smaller polygons within the range site polygon.
