## H-6300-1-WILDERNESS INVENTORY MAINTENANCE

### APPENDIX B – INVENTORY AREA EVALUATION

a. Area Number/Name: Fortification Creek Citizen's Wilderness Proposal- Southeast Sub-Unit  
Acreage: 1,705 acres

a. Unit Number/Name Fortification Creek Citizen's Wilderness Proposal- Western Sub-Unit

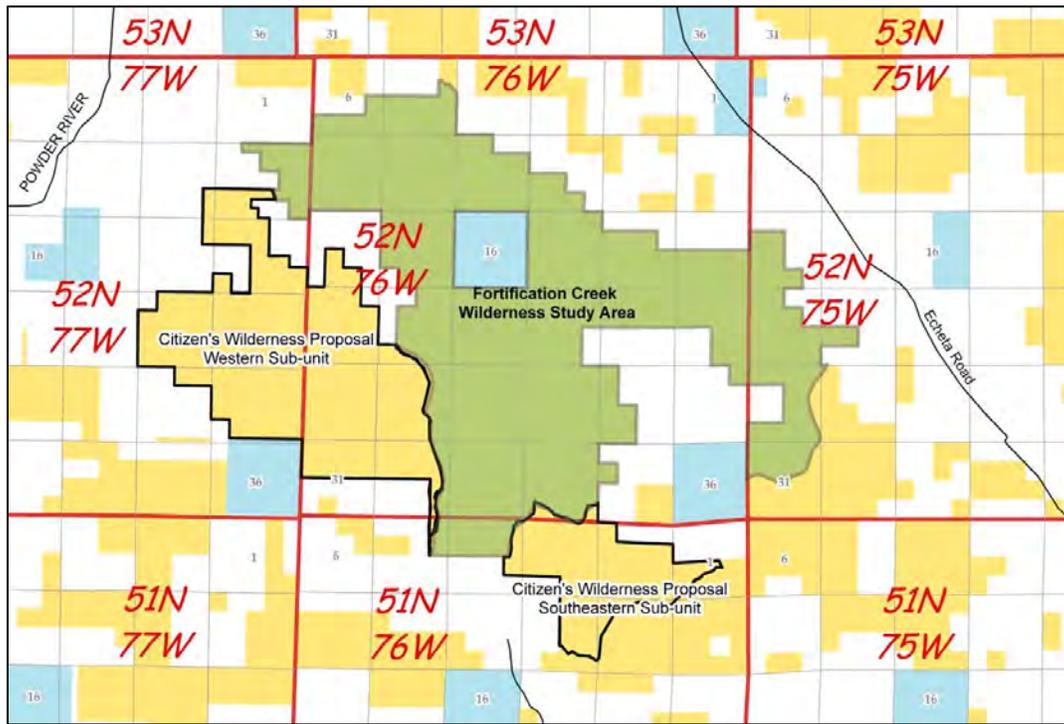
Figure 1. Fortification Creek Wilderness Study Area and Citizen's Wilderness Proposal Sub-Units.

The BLM Buffalo Field Office conducted an inventory of wilderness characteristics in the Fortification Creek area in 1978 and 1979 in accordance with the requirements of Section 603(c) of the Federal Lands Policy and Management Act (FLPMA). As a result of this study, the BLM determined that a portion of the Fortification Creek area met the requirements of the wilderness study process. In total, 12,419 acres were recommended to Congress as a Wilderness Study Area (WSA) for further examination and were subsequently designated as the Fortification Creek WSA. The BLM-administered lands outside of the WSA, including the acreage that constitutes the CWP, did not meet the wilderness inventory requirements (BLM, 1979). Table 1 summarizes the findings of the 1979 Fortification Creek Wilderness Inventory. Figure 1 illustrates the administrative boundaries of the Fortification Creek WSA and the CWP. For the purposes of this analysis, the CWP was divided into subunits based on road inventory data.

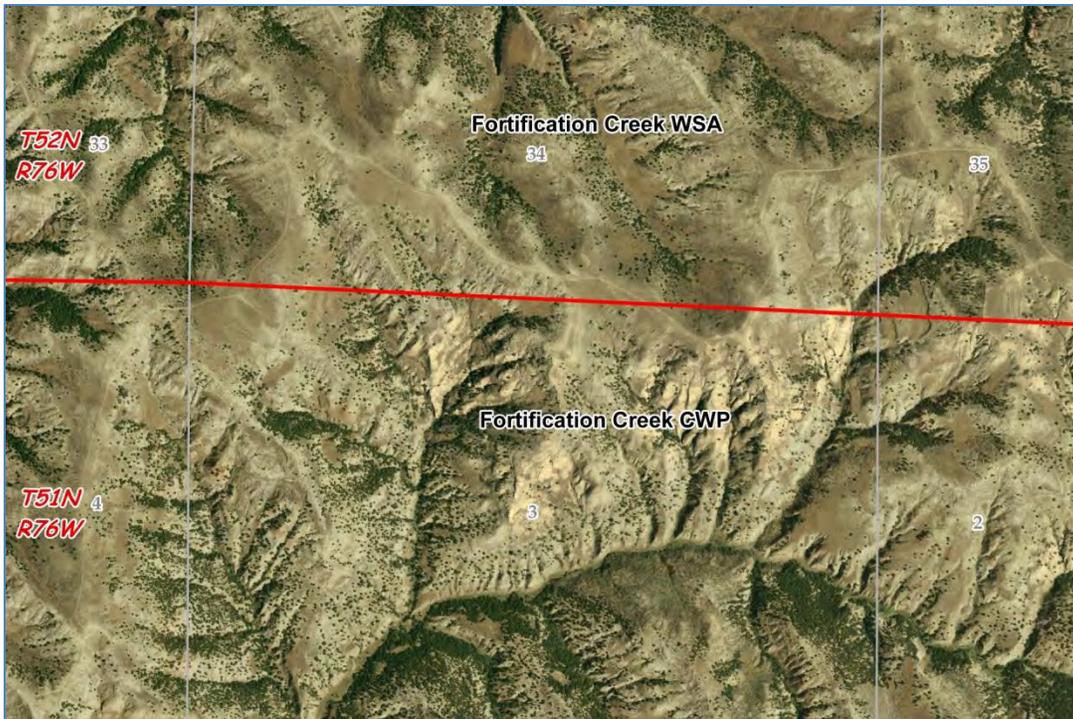
Figure 2. 2006 Aerial Imagery Depicting Northern Boundary Road of Fortification Creek Citizen's Wilderness Proposal Southeastern Sub-Unit.

The CWP Southeastern sub-unit is 1,705 acres and is separated from the Fortification Creek WSA by a mechanically constructed and maintained road, adjacent to a fenceline, currently used for livestock operations. The boundary road has been verified to be an existing constructed route passable to vehicles and used regularly. Tracks indicated that a vehicle had been on the road within a week prior to the BLM road verification visit December 21, 2010. The southeastern sub-unit consists of BLM administered lands outside of the Fortification Creek WSA in T 52 N R 76 W Section 34 and T 51 N R 76 W Sections 1, 2, 3, 4, 10 and 11. The entire southeastern sub-unit is located within Campbell County, Wyoming. The sub-unit boundary is formed by two roads in conjunction with land tenure. Figures 2 and 3 include aerial imagery (NAIP, 2006) depicting the existing roads in the Fortification Creek CWP southeastern sub-unit.

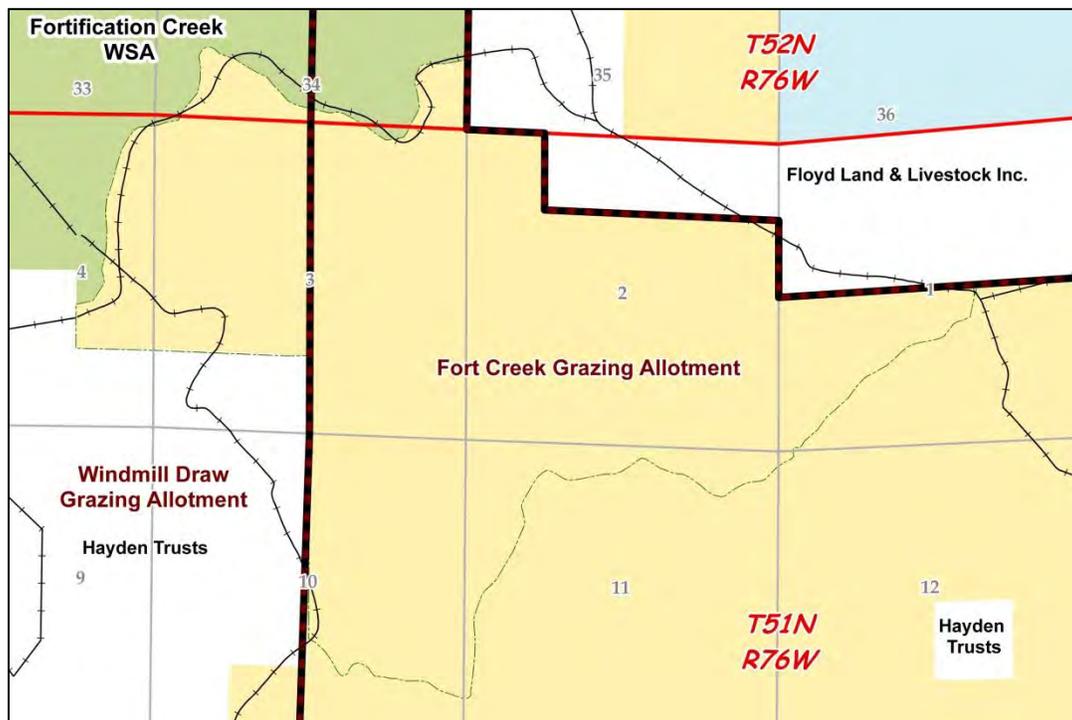
Figure 4. Land Tenure and Range Management Features within the Fortification Creek Citizen's Wilderness Proposal Southeastern Sub-Unit.

The portion of the allotment within the CWP southeastern sub-unit is largely one pasture, with portions of T 51 N R 76 W Sec 3, 4 and 10 being part of a second pasture. Land tenure, grazing allotment boundaries and approximate fence locations are depicted in Figure 4.

\*\* Fencelines displayed as hatched lines; boundary of sub-unit is displayed as a faint green line.

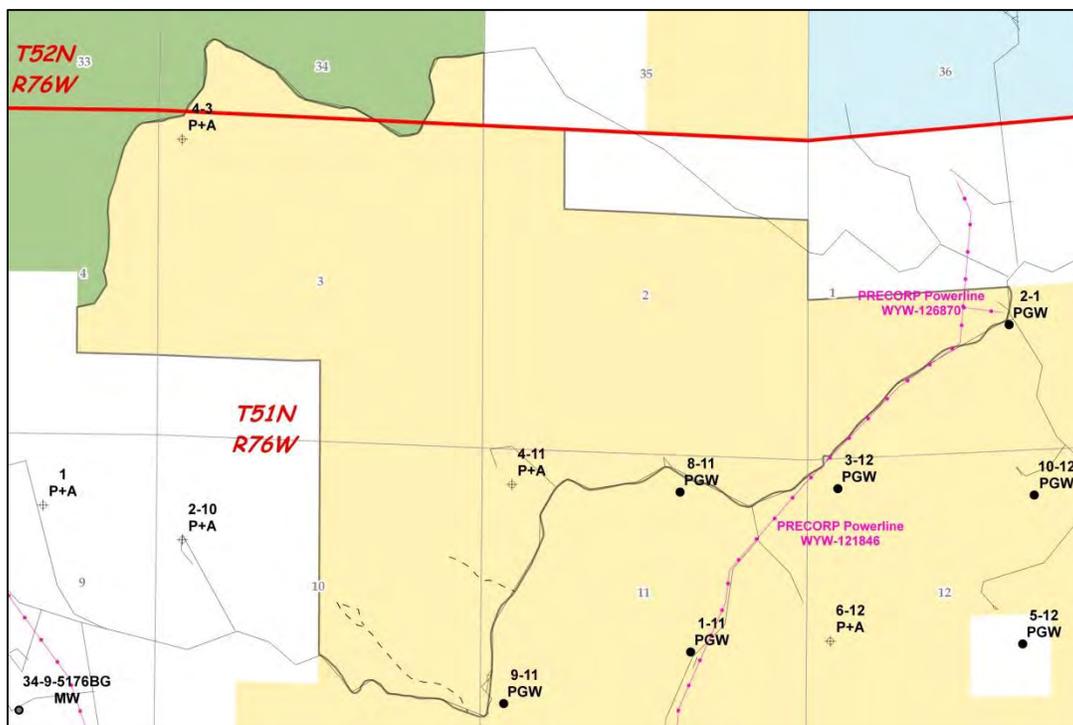
Figure 5. Existing Mineral Development and Energy Transmission in the vicinity of the Fortification Creek Citizen’s Wilderness Proposal Southeastern Sub-Unit.

Two plugged and abandoned (P&A) wells are located within the CWP southeastern unit. The P&A wells were not recontoured and were reclaimed with crested wheatgrass, an invasive species. Additional producing gas wells exist along the southern boundary road outside of the CWP. There are two rights-of-ways on record for roads including WYW-158710 by Lance Petroleum and W-86221 by Plaza Resources Co. The CWP boundary roads were improved for oil and gas development. There are new coalbed natural gas (CBNG) proposals within the sub-unit that BLM is evaluating for authorization. Additionally, two overhead powerlines maintained by the Powder River Energy Company (W-121846; W-126870) exist within the unit. There are no recorded easements within the unit. Figure 5 illustrates development associated with energy production and transmission.

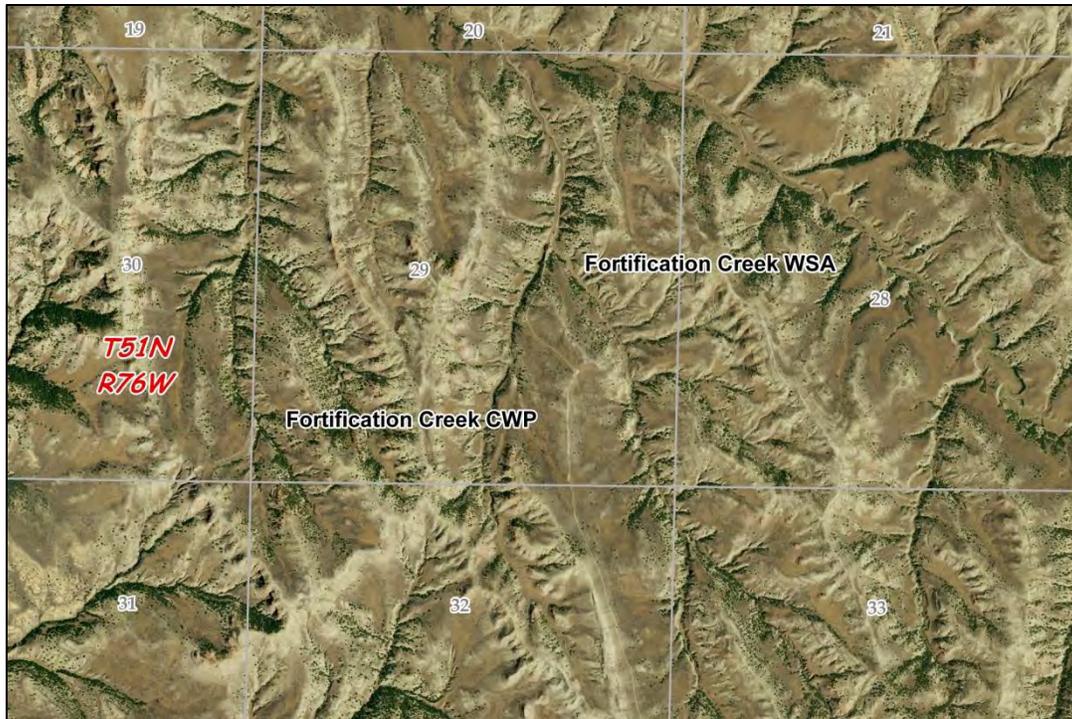
Figure 6. 2006 Aerial Imagery Depicting Eastern Boundary Road of Fortification Creek Citizen's Wilderness Proposal Western Sub-Unit.

The Citizen's Wilderness Proposal Western sub-unit is approximately 5,420 acres and is separated from the Fortification Creek Wilderness Study Area by a mechanically constructed and maintained road currently used regularly for livestock operations. The boundary road has been verified to be an existing route passable to vehicles. The western sub-unit consists of BLM administered lands outside of the Fortification Creek WSA in T 52 N R 77 W Sections 11, 12, 13, 14, 23, 24, 25 and 26 and T 52 N R 76 W Sections 18, 19, 20, 29, 30, 31 and 32. There is also a sliver of CWP located outside the WSA in T 51 N R 76 W Section 5. The western sub-unit is located within Johnson and Campbell counties. The sub-unit is separated from the WSA by a constructed road that runs from the Bull Creek monitoring wells to the Hayden Ranch House. Figure 6 includes aerial imagery (NAIP, 2006) depicting the eastern boundary road of the Fortification Creek CWP western sub-unit.

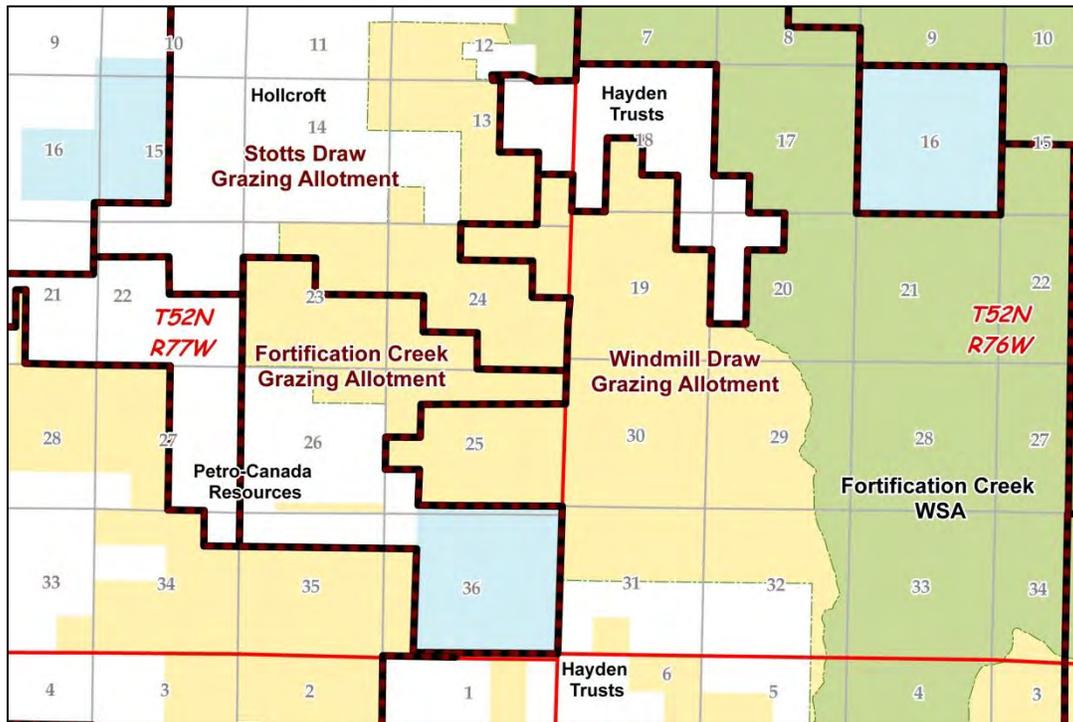
Figure 7. Land Tenure and Grazing Allotments within the Fortification Creek Citizen’s Wilderness Proposal Western Sub-Unit.

Data depicting fence locations for this area is inaccurate and has been omitted until on-the-ground verification can be completed. Land tenure and grazing allotment boundaries are depicted in Figure 7.

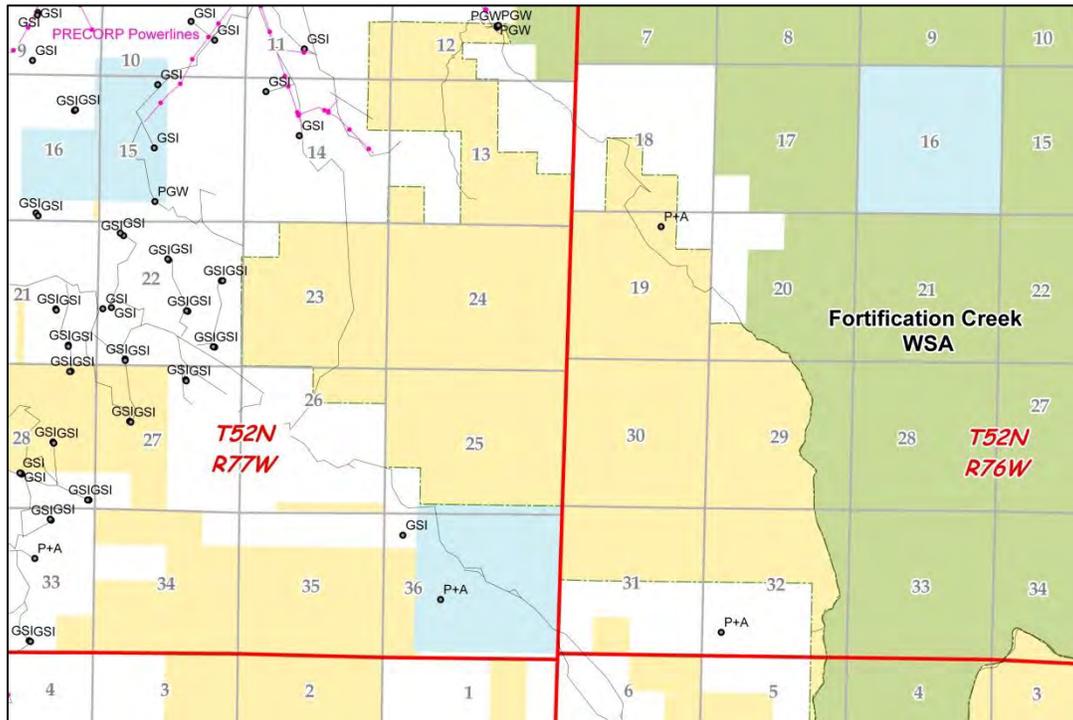
Figure 8. Existing Mineral Development and Energy Transmission in the vicinity of the Fortification Creek Citizen’s Wilderness Proposal Western Sub-Unit.

One plugged and abandoned well is located within the CWP western unit in T 52 N R 76 W Section 19 NWNE. Multiple producing and shut-in gas wells and other plugged and abandoned wells exist to the west of the unit. Valid leases exist within the area and there is evidence of CBNG development planning (well & utility stakes) along the WSA boundary road and the road with the abandoned reservoir. There are no right-of-ways on record for roads. Additionally, no overhead powerlines exist within the unit. There are no recorded easements within the unit. Figure 8 illustrates development associated with energy production and transmission in the vicinity of the sub-unit.

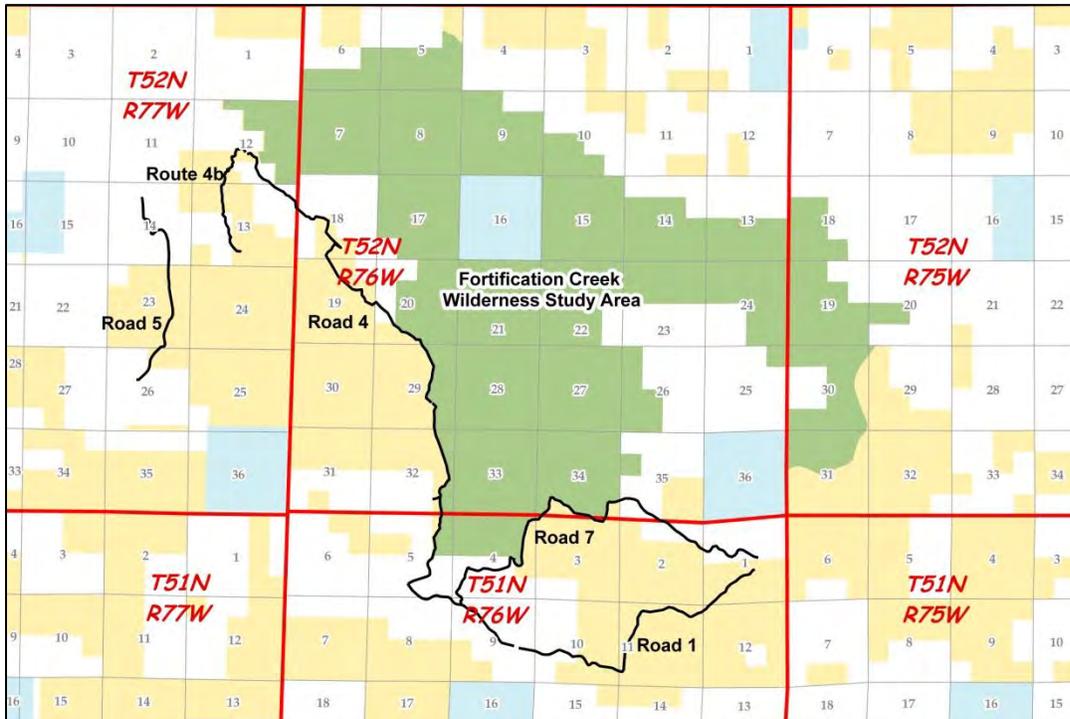
Figure 9. Roads\* Addressed during Route Analysis

\*Identified and numbered to remain consistent with the 1979 Inventory

**I. LOCATION:** T 51 N R 76 W Sec 1, 9, 10 and 11 (refer to Figure 9).
