## H-6300-1-WILDERNESS INVENTORY MAINTENANCE

Year 2011 Inventory Unit Number/Name Face of the Bighorns (WY-060-203)

**DOCUMENTATION OF BLM WILDERNESS INVENTORY FINDINGS ON RECORD**

Unit Name and Number: Face of the Bighorns (WY-060-203)

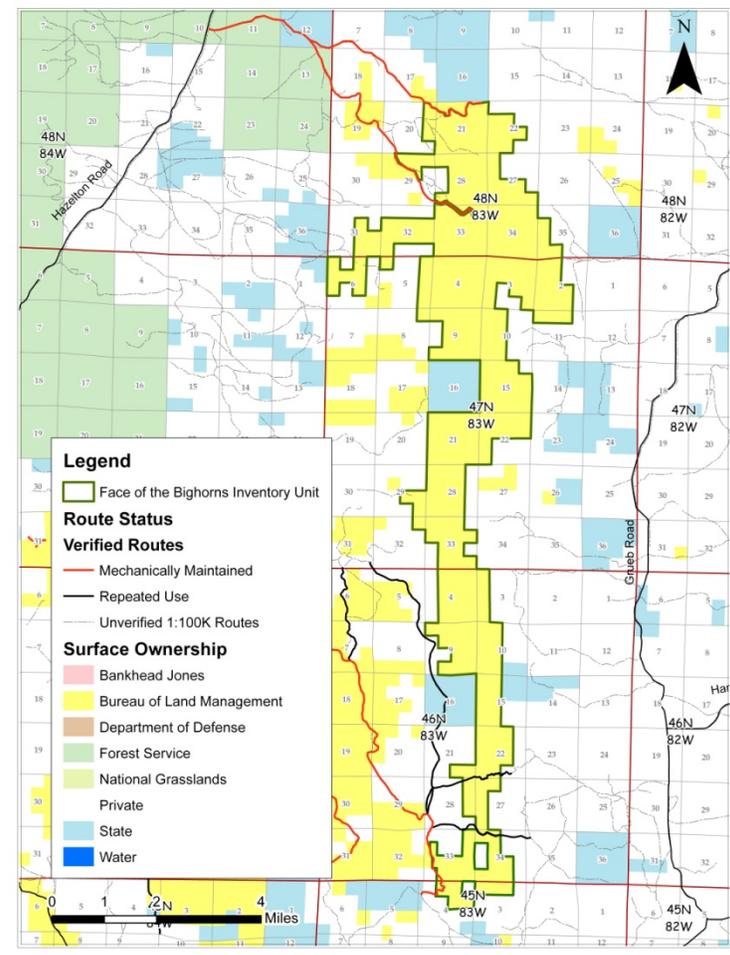
Figure 1. Face of the Bighorns Unit.

The BLM is reconsidering the Face of the Bighorns as part of an RMP revision. The unit boundaries are based on land tenure coupled with mechanically maintained roads. Table 1 summarizes the findings of the 1979 Face of the Bighorns Wilderness Inventory. Figure 1 illustrates the boundaries of the Face of the Bighorns unit.

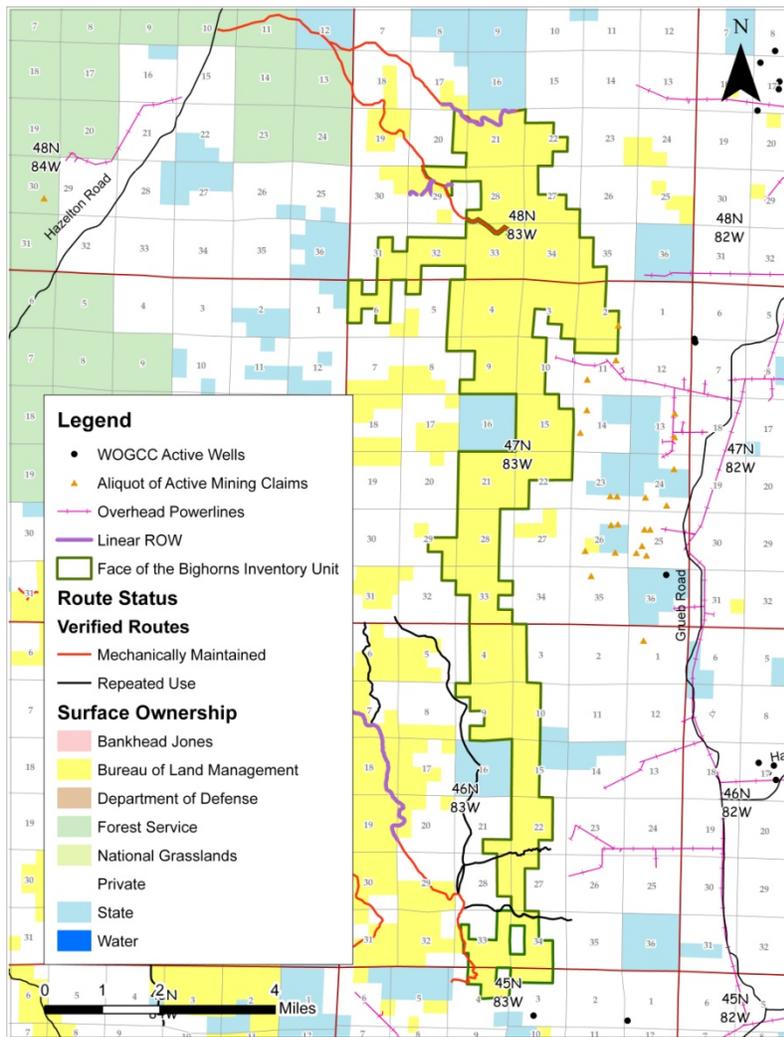
Figure 2. Development in the Immediate Vicinity of the Face of the Bighorns Unit.

The State Engineer’s Office (SEO) of Wyoming database indicates that several stock water ponds exist within the vicinity of the unit, but analysis of aerial photos indicated that these ponds are on private lands outside of the unit. There are no powerlines within the unit. There is one recorded right-of-way (ROW) within the unit to John Kolnik (WYW-161642) in T 48 N R 83 W Sec 29. There is one mining claim near the eastern boundary of the unit (WMC-259923) for a placer mine in T 47 N R 83 W Sec 2 SE. There are limestone, dolomite, and gypsum-containing formations occurring within the unit. These minerals are not likely targets for exploration or development, however, due to the area’s rough terrain and the long distance to markets.

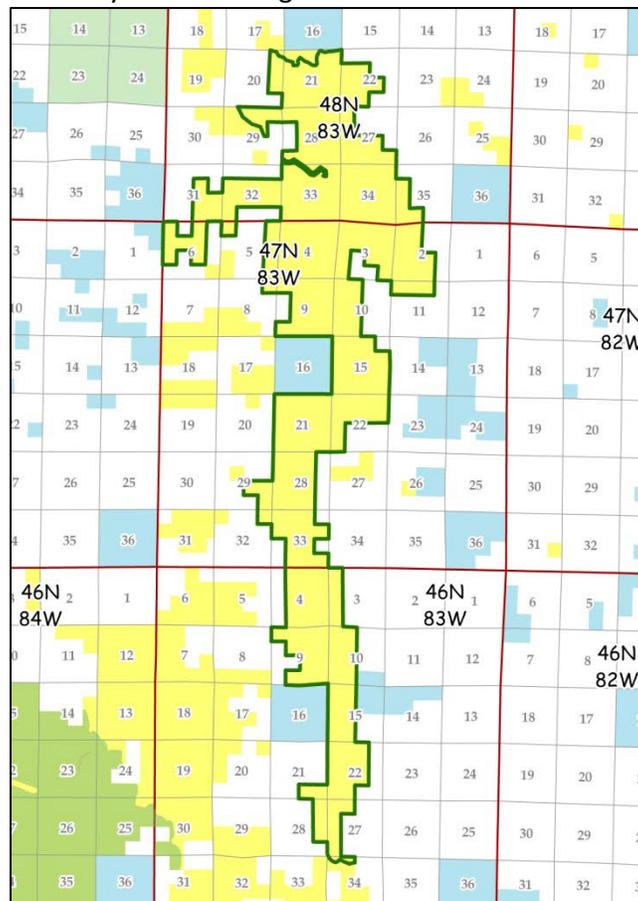
Figure 3. Portion of the Inventory Unit Meeting Lands With Wilderness Characteristics Criteria.

Given the presence of a route that would be maintained to provide access to the private inholdings and a nearby reservoir and the decreasing quality of unconfined recreation in the southern portion of the unit, the BLM recommends removing the portion of the inventory unit that is south of the route in T 46 N R 83 W Section 33 from further consideration. The total acreage of the Face of the Bighorns meeting the lands with wilderness characteristics criteria is ~12,237 acres and contains no private inholdings.

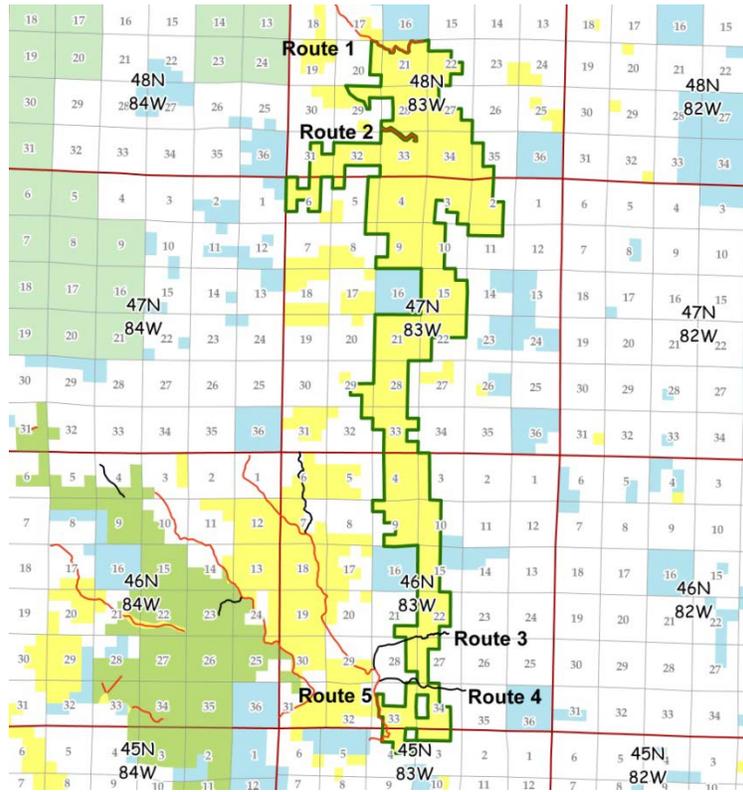
Figure 4. Routes Addressed During Route Analysis

**Route Name and/or Identifier:** Northern Boundary Road of Unit (Route 1) (refer to Figure 4).

**I. LOCATION:** T 48 N R 83 W Sec 26, 29 and 33 (refer to Figure 4).

**I. LOCATION:** T 46 N R 83 W Sec 21, 22, 26 and 27 (refer to Figure 4).

**I. LOCATION:** T 46 N R 83 W Sec 27 and 34 (refer to Figure 4).

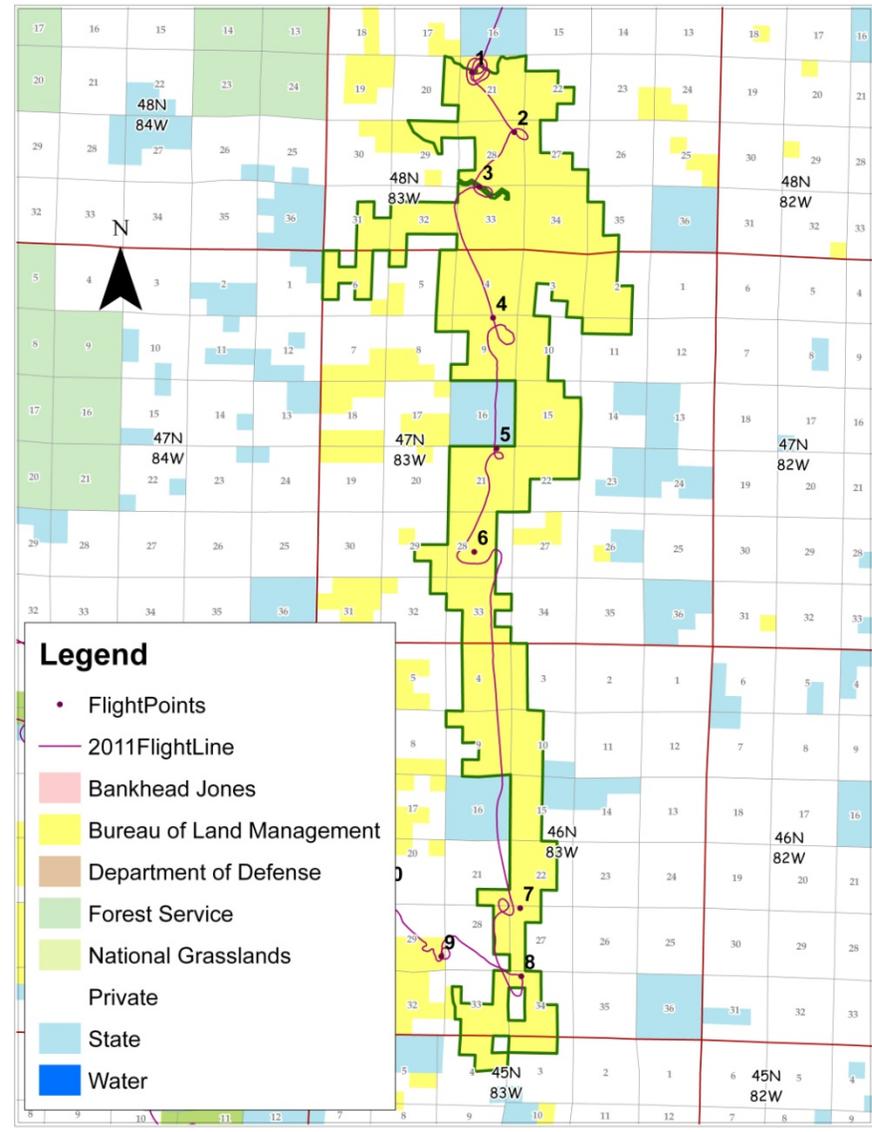
Figure 5. Helicopter Flight Line and Targets in Face of the Bighorns Area.

PHOTO	DATE	TARGET POINT	ME	MN	T	R	S	ROUTE	NOTES
FB1-2	9/9/11	1	352436.62	4886691.53	48	83	21	1	MECHANICALLY MAINTAINED
FB3	9/9/11	2	353475.85	4885223.84	48	83	28		INCORRECTLY CLASSIFIED 1:100K ROUTE
FB4-5	9/9/11	3	352618.94	4883883.77	48	83	28, 33	2	MECHANICALLY MAINTAINED
FB6	9/9/11	4	352956.24	4880674.91	47	83	9		INCORRECTLY CLASSIFIED 1:100K ROUTE
FB7-8	9/9/11	5	353042.22	4877473.92	47	83	21		INCORRECTLY CLASSIFIED 1:100K ROUTE
FB9	9/9/11	6	352494.81	4874938.52	47	83	28		INCORRECTLY CLASSIFIED 1:100K ROUTE
FB10-11	9/9/11	7	353618.45	4866208.69	46	83	22, 27	3	REPEATED USE 2-TRACK, TWO 2-TRACKS
FB12-13	9/9/11	8	353647.26	4864537.63	46	83	34	4	4 WHEELER TRACKS, RESERVOIR ON PRIVATE LANDS
FB14-16	9/9/11	9	351688.09	4865027.42	46	83	29	5	MECHANICALLY MAINTAINED

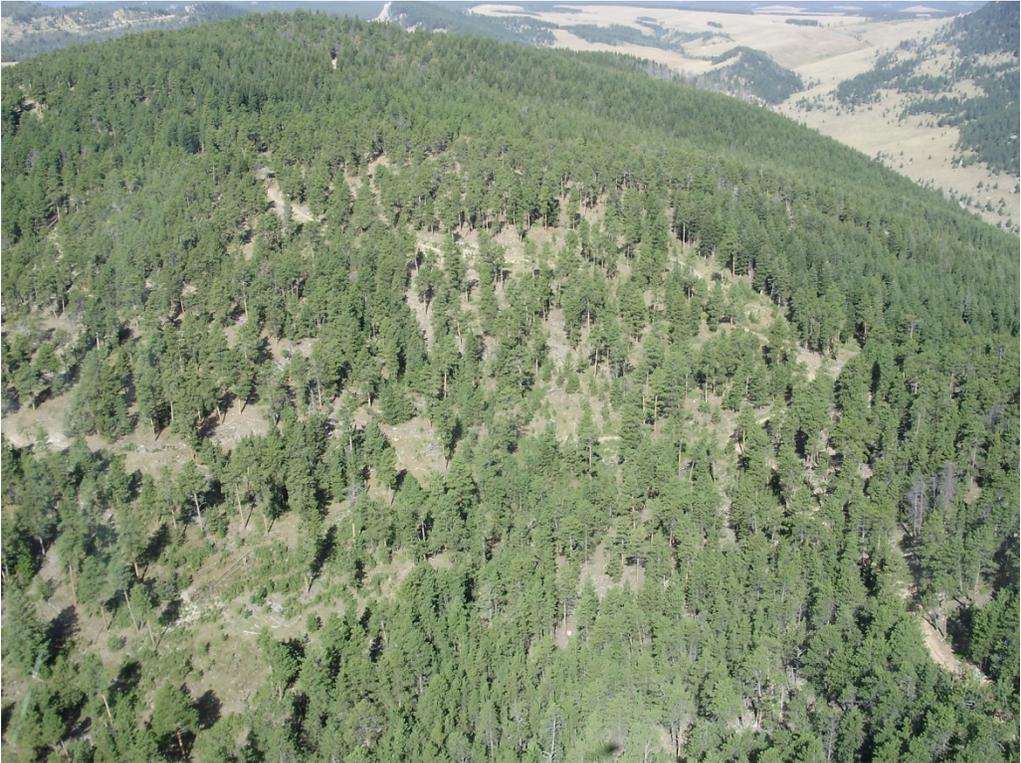
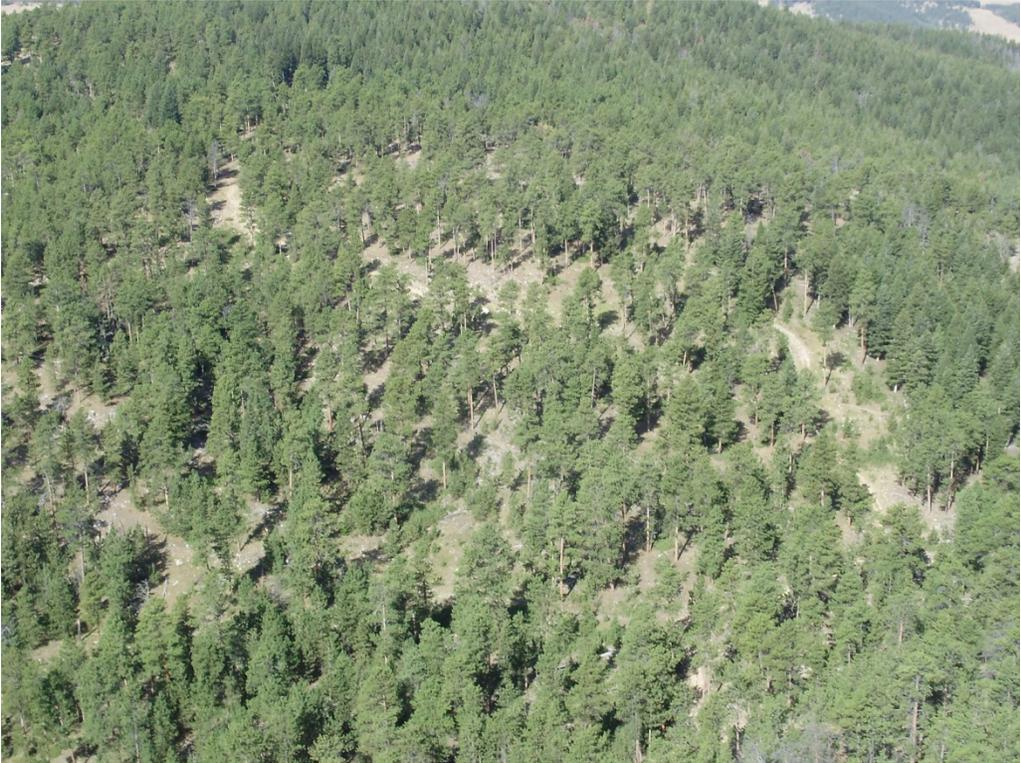
Figure 6. Frame FB 1.

The road appears to be used on a regular basis, from fly-over (Photos FB 1-2) and aerial photo interpretation.

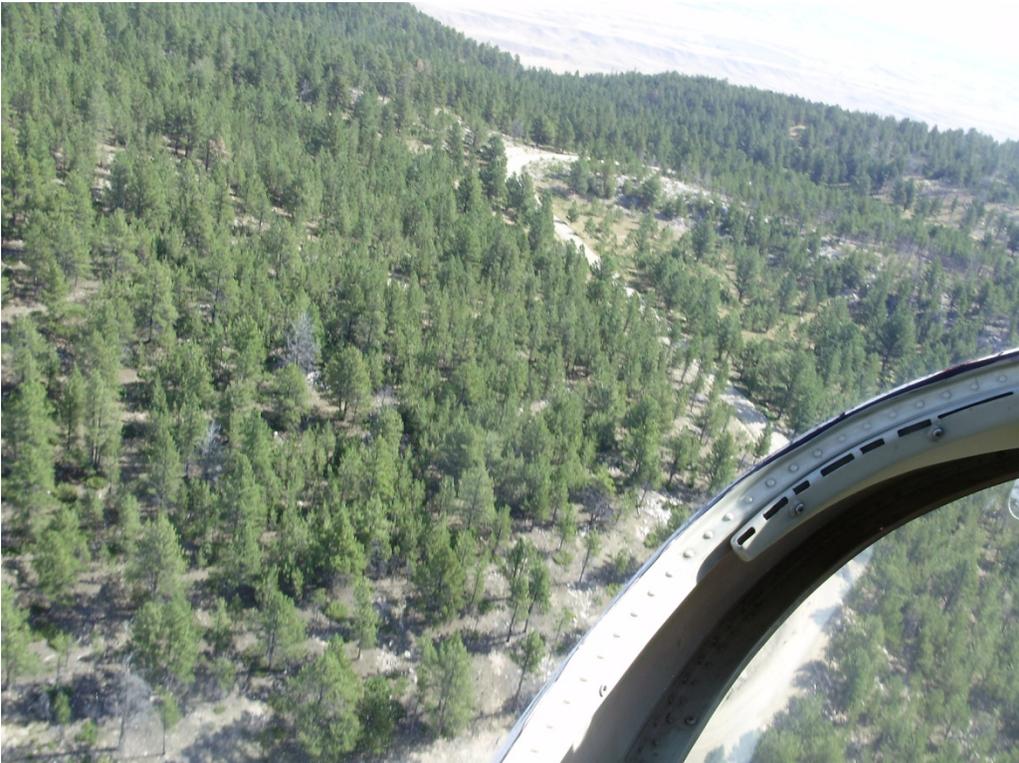
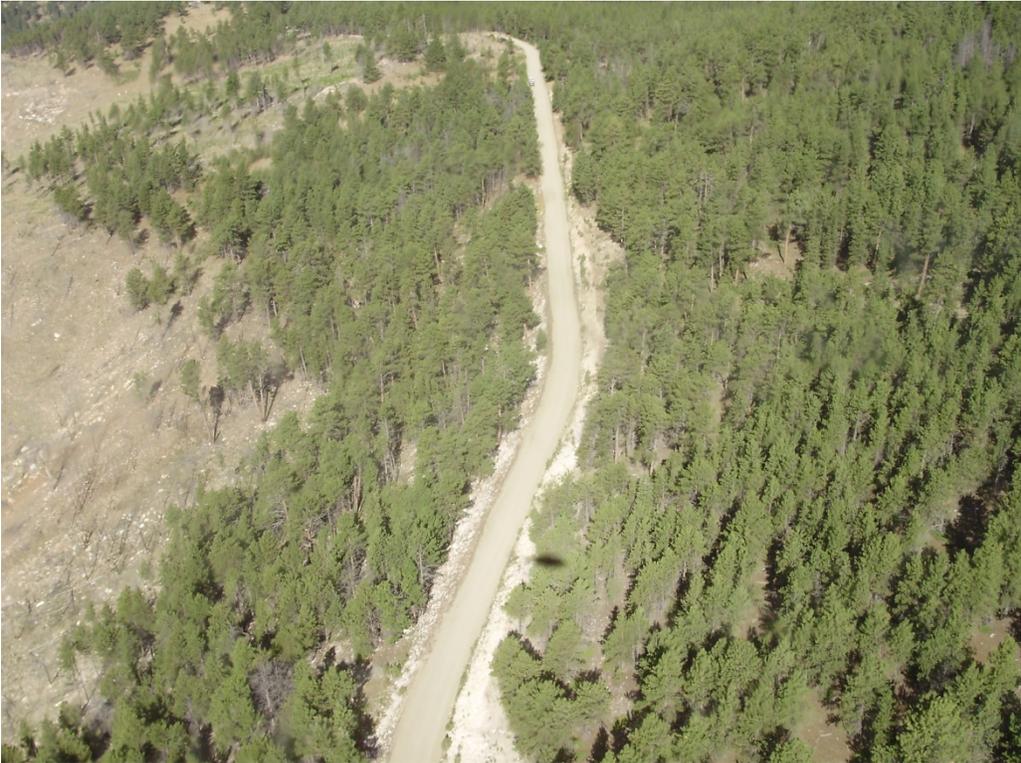
Figure 9. Frame FB 4.

Describe: This road is well constructed and maintained. Photos FB4-5 includes evidence of maintenance.

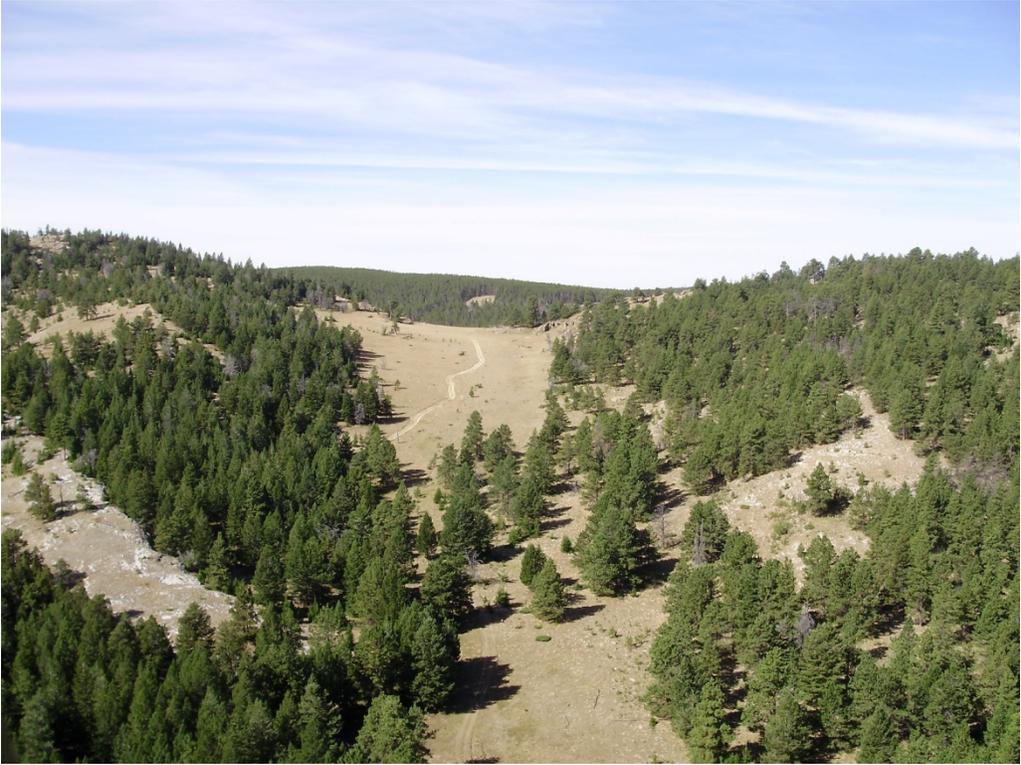
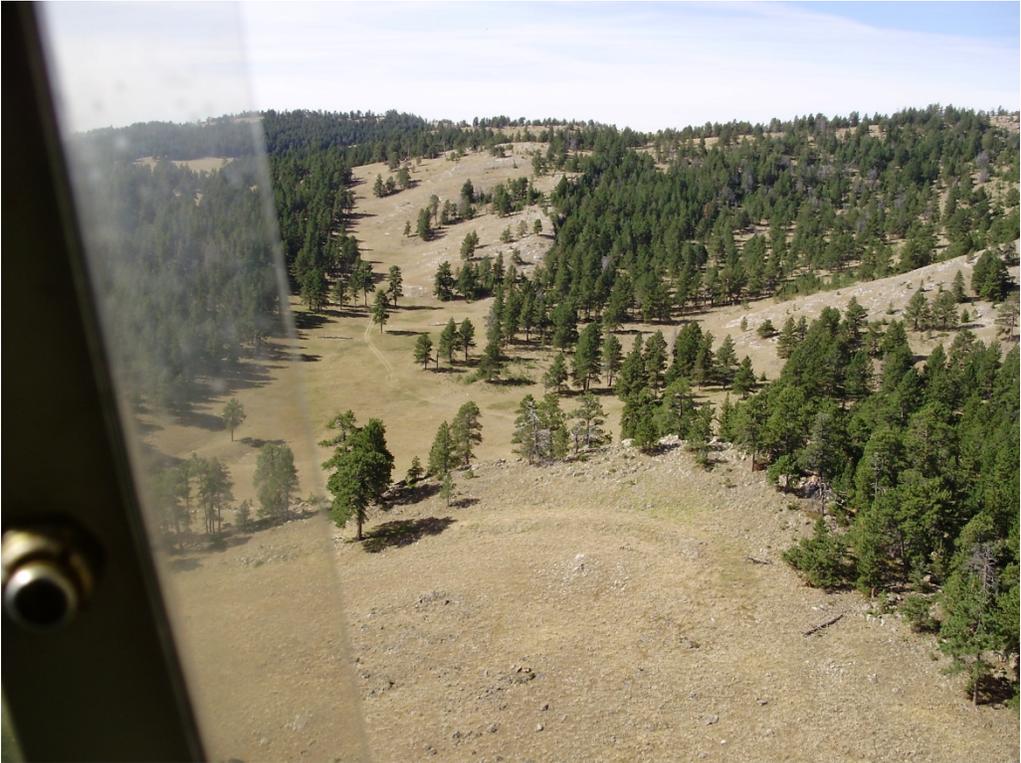
Figure 15. Frame FB 10.

Describe: See photos FB10-11.

Describe: Aerial imagery of the route indicates that it may have been bladed at some point, and a retired Wyoming Game & Fish employee indicated that the route had been bladed in the recent past. No documentation exists, and a helicopter survey did not yield conclusive evidence of blading.

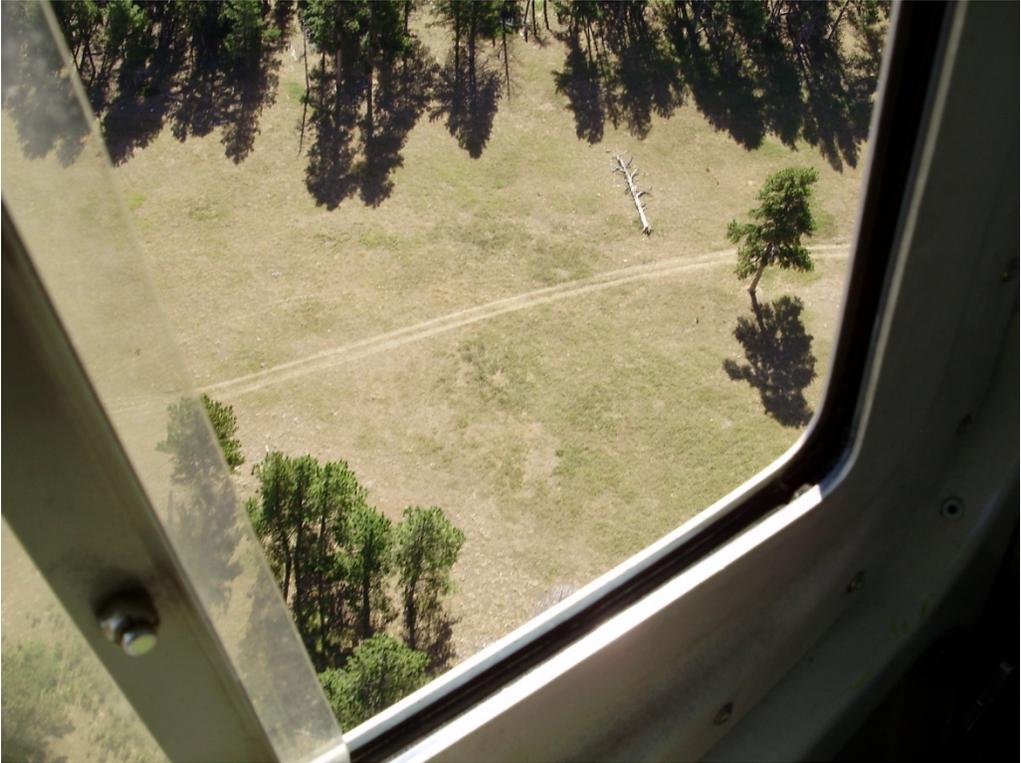
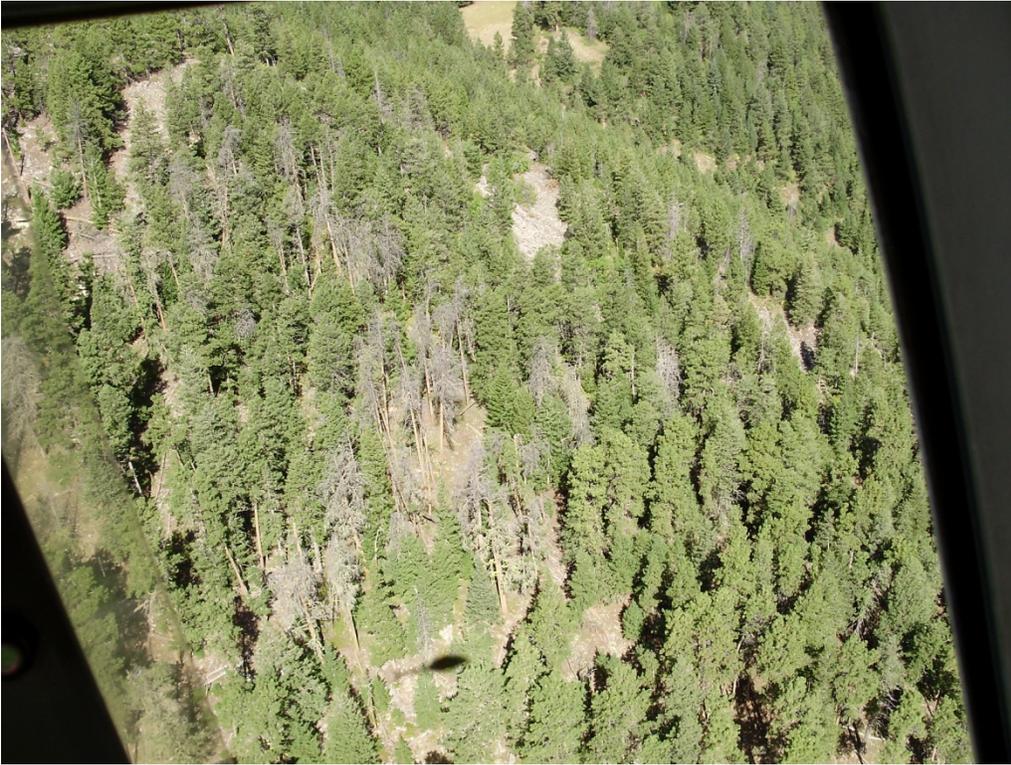
Figure 17. Frame FB 12.

Describe: See photos FB12-13.

Describe: Aerial imagery of the route indicates that the easternmost portion of the route on BLM surface may have been bladed at some point. The majority of the route crossing BLM lands does not appear to be mechanically maintained.
