Roadside Vegetation Health Condition and Magnesium Chloride (MgCl₂) Dust Suppressant Use in Two Colorado, U.S. Counties

Betsy A. Goodrich, Ronda D. Koski, and William R. Jacobi

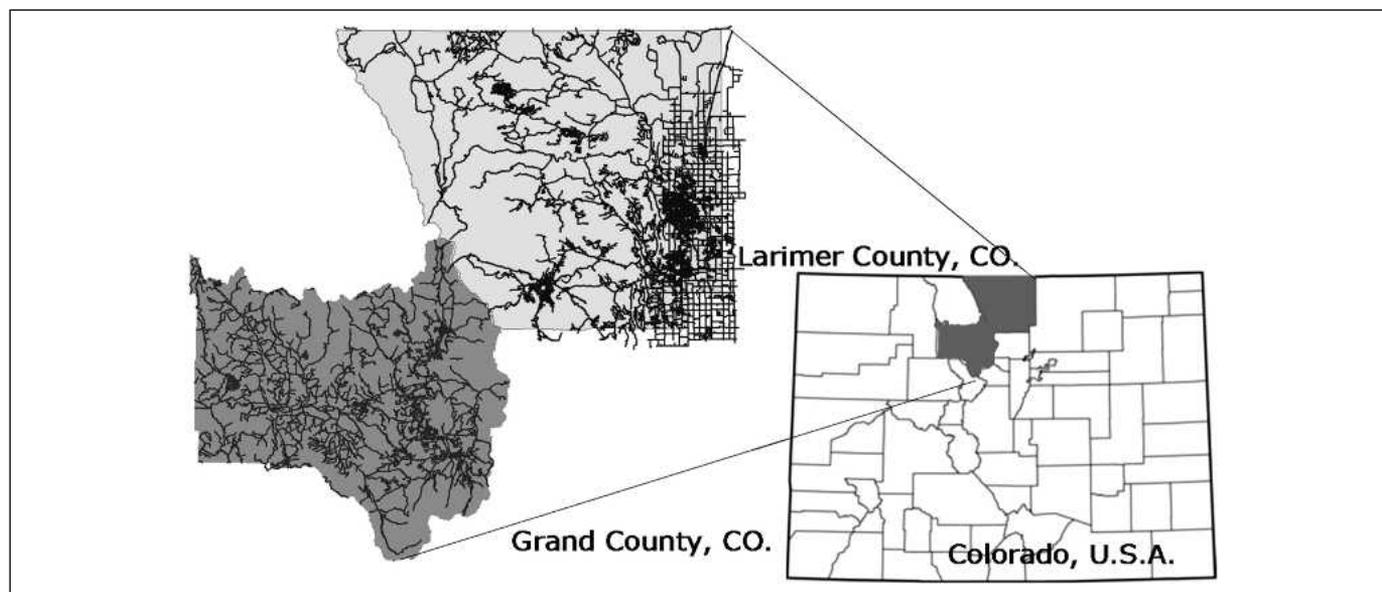
Figure 1. Borders and road networks of Grand and Larimer Counties, Colorado.

Larimer County is located in north central Colorado (Figure 1). Elevation along study roads ranged from 1,753 to 3,210 m (5,785 to 10,593 ft) and the dominant habitat types ranged from lowland shrub and grass cover to high-elevation mixed spruce and fir forests. Grand County is located in northwestern Colorado and study roads ranged in elevation from 2,484 to 2,780 m (8,197 to 9,174 ft) (Figure 1). In 2004, Larimer County had 938 km (563 mi) of nonpaved roads and 60% of these roads were treated with $MgCl_2$ -based dust suppression products (563 km [338 mi]) (D.L. Miller, Larimer County Road and Bridge Department, 2006, pers. comm.). Grand County had 1,143 km (686 mi) of nonpaved roads in 2004 and approximately 25% of these roads were treated with $MgCl_2$ -based dust suppression products (292 km [175 mi]) (A. Green, Grand County Department of Road and Bridge, 2006, pers. comm.).

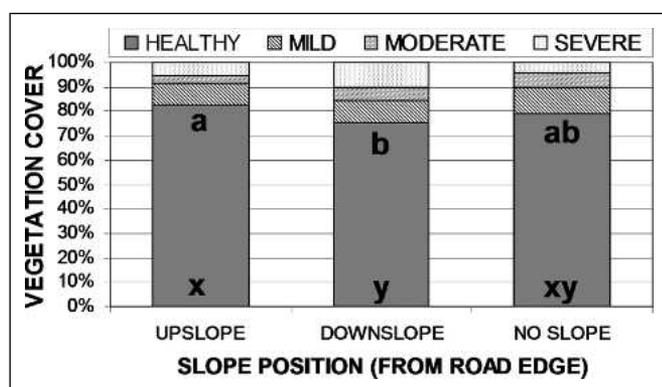
Figure 2. Roadside vegetation health condition adjusted means along nonpaved roads both treated and nontreated with $MgCl_2$ -based dust suppression products in Larimer and Grand Counties by slope position from road edge (healthy = less than 5% damage, mild = 5% to 25% damage, moderate = 26% to 50% damage, severe = greater than 50% damage to crown or stem; $n = 2,583$ plots including vegetation). Letters (a, b, ab) signify significant differences ($P < 0.05$) between percent of severely damaged vegetation among upslope, downslope, and no slope positions. Symbols (x, y, xy) signify significant differences ($P < 0.05$) between percent of healthy vegetation among upslope, downslope, and no slope positions.

The majority of roadside vegetation surveyed along nonpaved roads was considered healthy, depending on slope position from the road (72.3% to 79.3%). Proportions of severely damaged vegetation ranged in cover from 6.4% to 11.4% with the most severely damaged vegetation occurring downslope from the road (Figure 2). Although some proportion of severely damaged vegetation was observed at all slope positions from the road center, a larger percentage occurred downslope compared with upslope positions ($P < 0.0001$; Figure 2).

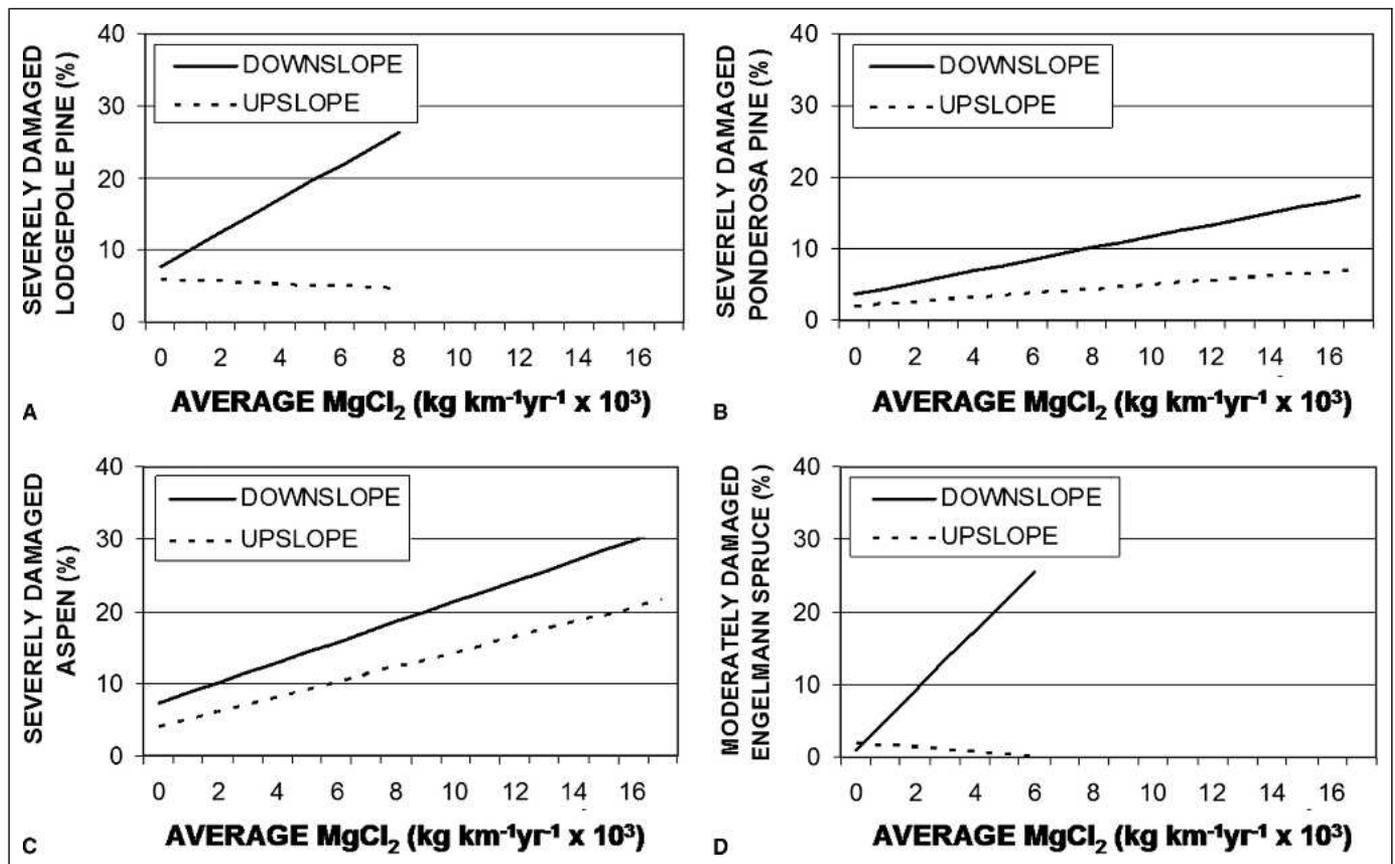
Figure 3. Modeled percent severely damaged lodgepole pine (A), ponderosa pine (B), and trembling aspen (C) and moderately damaged Engelmann spruce (D) adjusted means along nonpaved roads both treated and nontreated with MgCl₂-based dust suppression products in Larimer and Grand Counties by slope position and increasing amount of MgCl₂ applied per year (kg/km⁻¹/year⁻¹). The solution function in SAS 9.1 used to generate slopes for each species and slope position and only site factors that were significant at $P < 0.05$ are illustrated.

Ponderosa pine was also common along roadsides and was a species component in 10.3% of the 2,583 plots, but only occurred along Larimer County roads. Ponderosa pine grew along a range of treated and nontreated roads, up to $16,600 kg/km^{-1}/yr^{-1}$ ($59,000 lb/mi^{-1}/yr^{-1}$). A higher percentage of severely damaged ponderosa pine was observed along treated roads compared with nontreated roads (Table 3). The percent of severely damaged trees increased at both slope positions with an increase in average application rate (Figure 3B). The average percent of ponderosa pine with severe damage was higher downslope from the road (5.3%) compared with upslope from the road (2.2%), although the rate of increase with application rates was equal between slope positions (Figure 3B).

along nontreated roads through roads treated with approximately 16,600 kg/km⁻¹/yr⁻¹ (59,000 lb/mi⁻¹/yr⁻¹). A higher percentage of severely damaged aspen was observed along treated roads compared with nontreated roads (Table 3). Downslope habitats had a higher proportion of severely damaged aspen trees (10.9%) than upslope (6.7%), and the percentage of severely damaged aspen increased with the average amount of MgCl₂ applied at similar rates both upslope and downslope from the road (Figure 3C).

Engelmann spruce occurred as a component of 99 plots along roads ranging from no MgCl₂ application to approximately 5,900 kg/km⁻¹/yr⁻¹ (21,000 lb/mi⁻¹/yr⁻¹). No significant differences occurred between the percent of severely damaged Engelmann spruce on treated versus nontreated roads, although a lower percentage of nondamaged (healthy) Engelmann spruce was observed along treated roads (Table 3). More moderately damaged (26% to 50% damage) spruce occurred along treated roads (15.9%) compared with nontreated roads (0.3%) and also occurred downslope (7.2%) compared with upslope from the road (1.8%) (Figure 3D). A positive relationship occurred between moderately damaged Engelmann spruce and average application rates ($P = 0.002$), and the percent cover of spruce with 26% to 50% damage increased with average application rate of MgCl₂ in downslope trees (Figure 3D).
