THE ARCHEOLOGY AND STABILIZATION OF THE DOMINGUEZ AND ESCALANTE RUINS

BUREAU OF
LAND MANAGEMENT
COLORADO

Stabilization of Escalante Ruin 5MT2149
and
Dominguez Ruin 5MT2148
Dolores, Colorado

Colorado State Office
Bureau of Land Management
1979

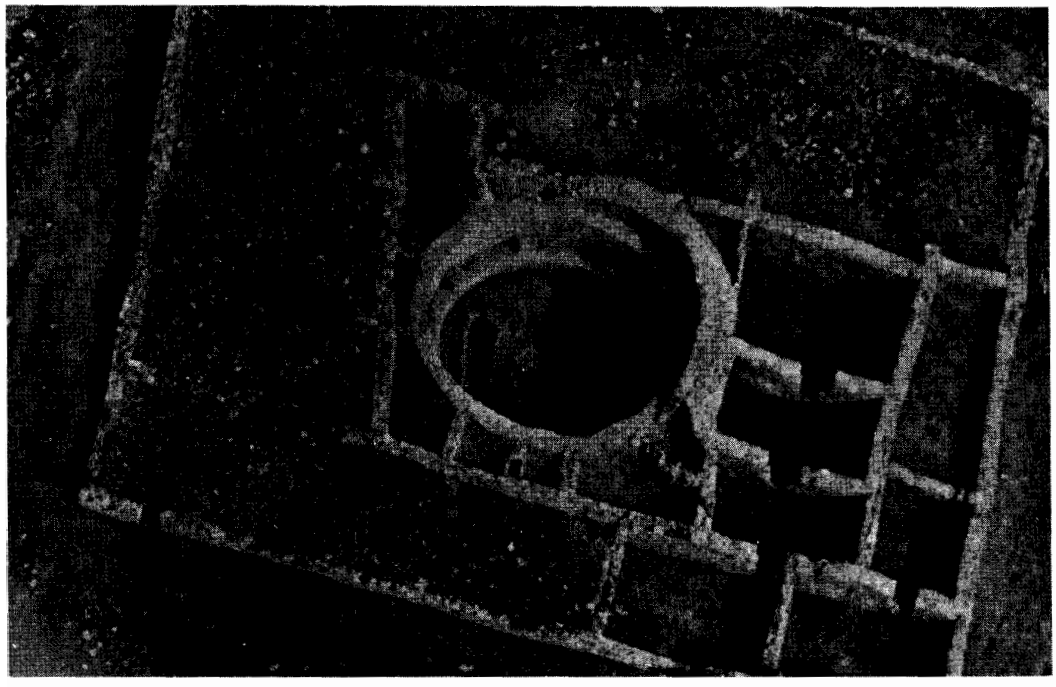
Figure 5: Aerial view of the Escalante Ruin, after stabilization.

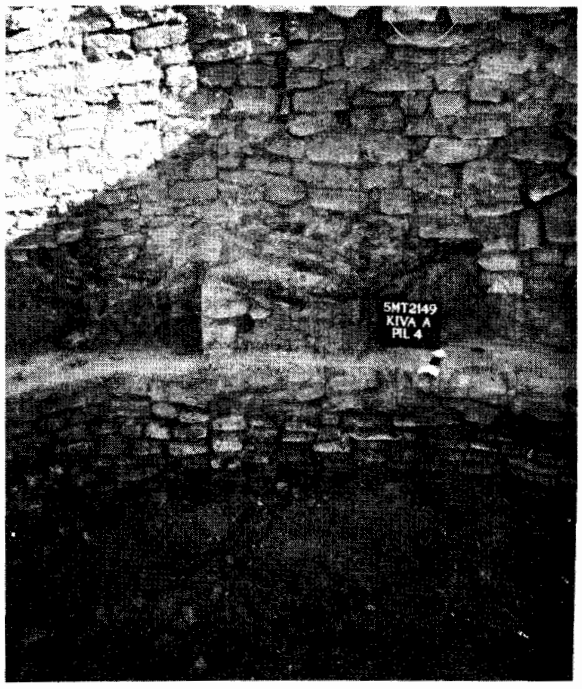
Figure 62: View in Kiva A of the remains of beams extending from the wall sockets and resting on Pilaster 4. The river cobble wall repair is seen in the wall.

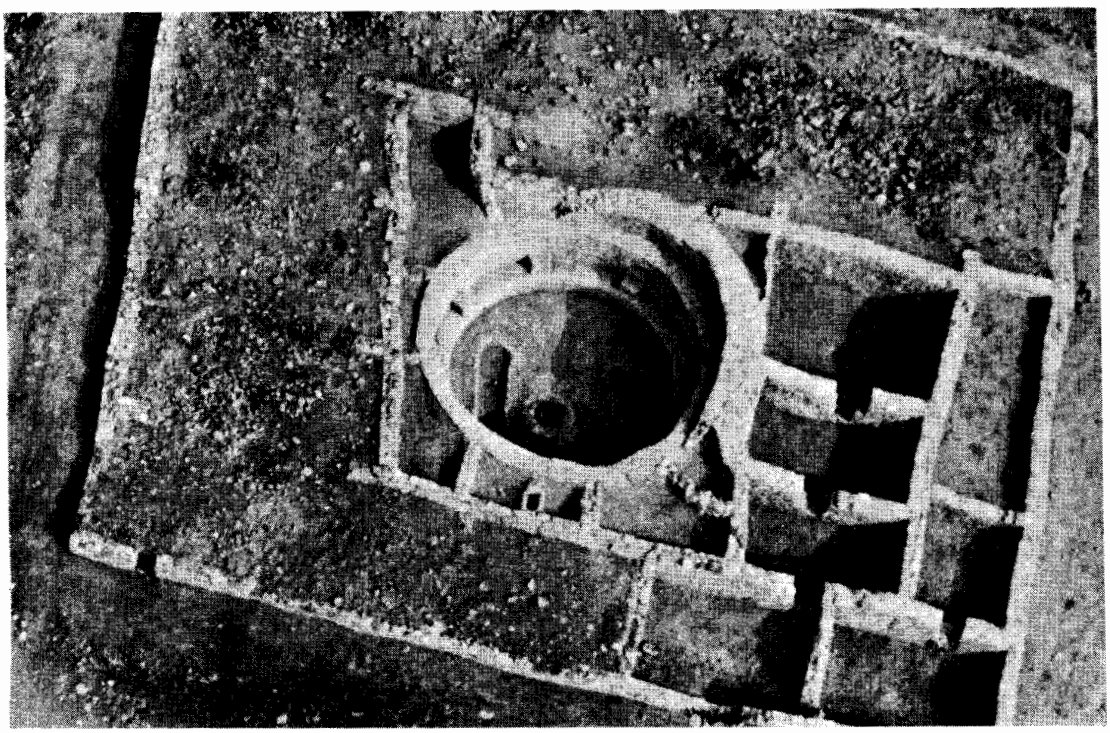
Figure 3. Escalante Ruin - 5MT 2149. After stabilization.

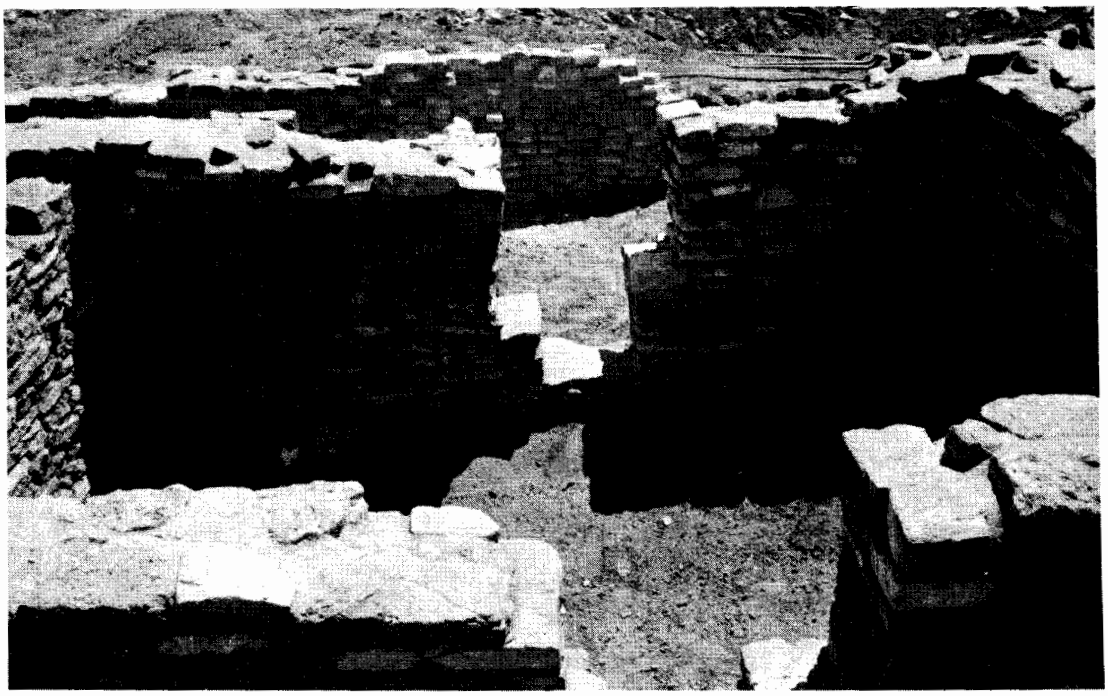
Figure 9. Drainage. a, view of rooms after surfaces have been contoured to drain water run-off to the center of the room; b, retaining wall above Kiva A.

Drainage is one of the most important problems associated with the stabilization of a prehistoric ruin. The construction of Escalante Ruin on a Pleistocine gravel deposit provided good drainage for the ruin as a whole. None of the walls we excavated are built on fill, they are built directly on the river cobbles and clay. Since the ruin as a whole has good drainage, our problems centered around surface run-off into open rooms and Kiva A. We filled all excavated rooms with 5-10 cm of soil above the original floor. Some of the soil was then banked against the walls, allowing all surface moisture to drain to the center of the room, and to either evaporate or sink down through the floor into the underlying river cobbles and clay (Fig. 9a).

Kiva A had more complex drainage problems. A high fill level in Room 3 created surface run-off down the north side of the Kiva wall, resulting in extensive mortar bleeding and loosened stones. To remedy this problem, we built a retaining wall that extends from the east wall of Room 1 eastward to the upper crescent wall of Kiva A. This wall

is not a prehistoric wall, but a necessary addition due to the drainage problems (Fig. 9b).

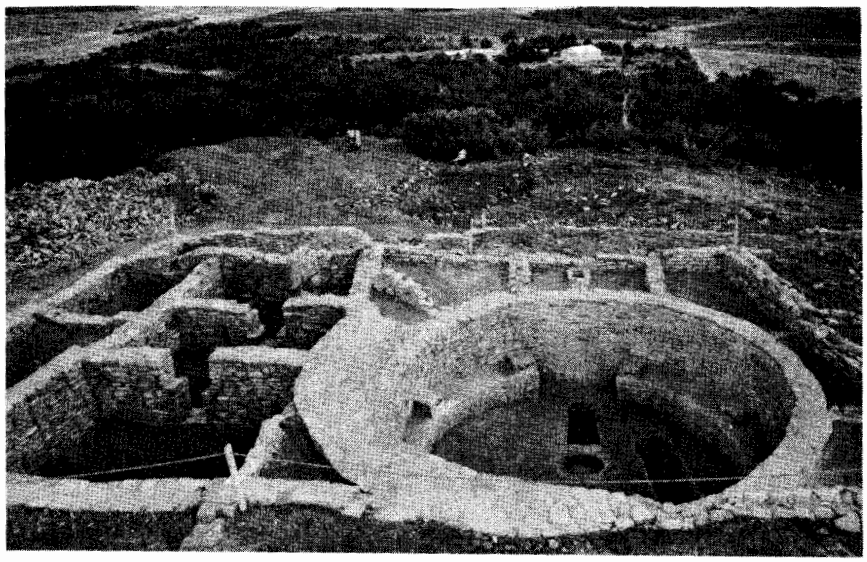
Figure 14. Escalante Ruin. a, after excavation; b, after contouring.

Due to post abandonment falling of walls, the amount of stone against the outer walls was substantial. When the outer walls were excavated the ruin gave the appearance of being built on a mound (Fig. 14a). This appearance was due to the fill against the outer walls gradually sloping onto the ground surface. To present a more realistic view to visitors, the ruin should look as if the walls were covered and continued down below the rubble area.

As first steps to determining how to contour Escalante Ruin, test pits were dug to determine the actual height of the wall to its footing. After learning the depth of the fill, a backhoe was used to fill the trenches with stone and fill to the stabilized areas of the walls. The surface adjacent to the exterior wall was leveled for a walkway. The rubble that sloped onto the ground surface was removed up to 3 m. of the walls. This lessened the effect that the ruin was built on a mound (Fig. 14b). The rubble on the west side is wider than on the north or east due to a higher surface indicated on this side. All loose or protruding stones were removed.

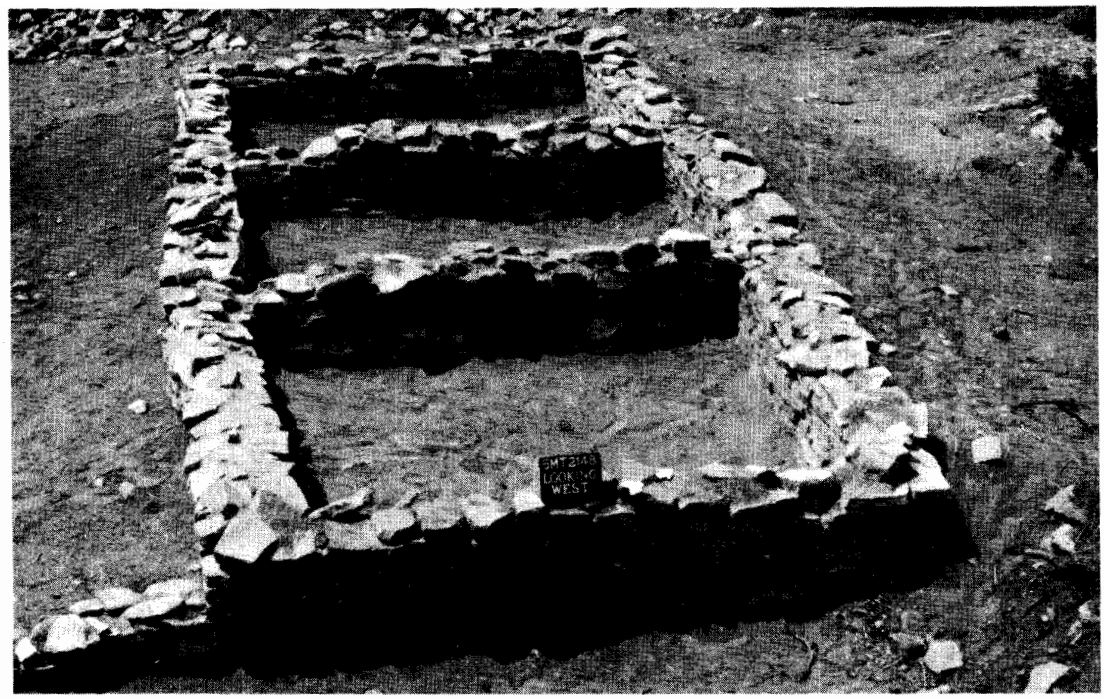
Figure 16. Dominguez Ruin. a, before excavation; b, after excavation.

Walls have some lateral separation with resulting bulges, but this is a minor problem at Dominguez Ruin. The main problems center around plant growth. Before the ruin was excavated, Gambel Oak covered the mound (Fig. 16a). The roots had wrapped around building stones and were impossible to remove without dislodging large areas of the walls (Fig. 16b).
