BLM-Alaska Open File Report 64
BLM/AK/ST-97/022+8111+040
April 1997

HISTORIC BUILDING SURVEY REPORT FLAT, ALASKA

by Rolfe G. Buzzell and Darrel L. Lewis

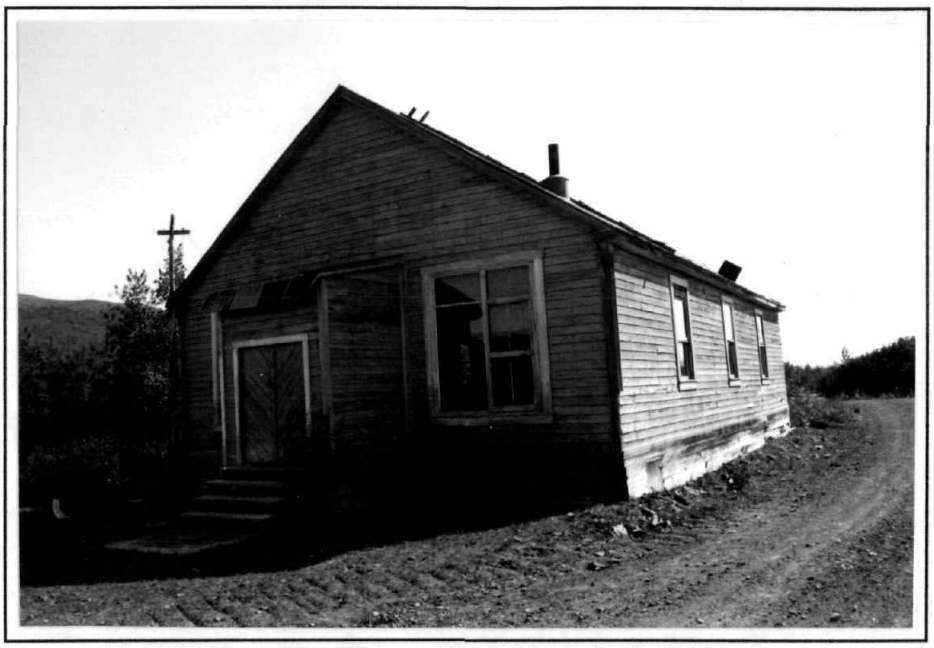
The **Community Hall (IDT-070)**, also known as the Moose Hall, is a rectangular, one-story, wood frame building (Figure 15). It measures 30'x47'7". The foundation is stacked wood blocks. The gable roof is felt (tar) paper covered with corrugated metal. Shiplap siding with corner boards covers the exterior walls. An arctic entry with double doors is centered on the west elevation and flanked on each side by a large four-light fixed sash window. The north and south elevations have three evenly spaced 1/1 double-hung windows on each side.

Figure 15. The west and south elevations of the Community Hall, 1993.

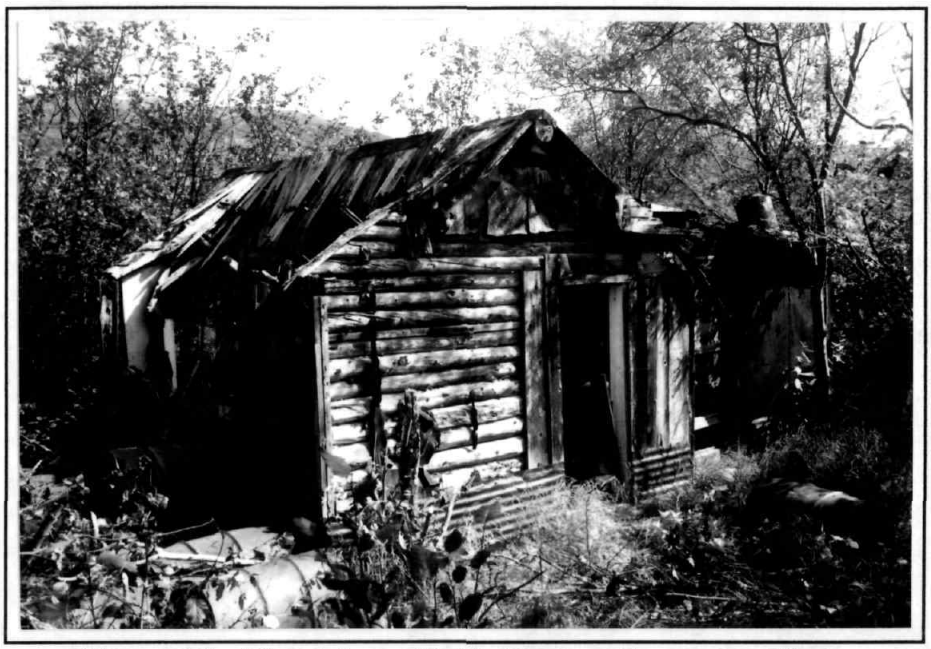
The **Adams Cabin/ Parker Generator Shed (IDT-073)** is a one-story, rectangular, log building with a shed addition on the east side (Figure 18). The building measures 13'x13'6". The foundation is not visible. The partially collapsed gable roof is covered with boards and felt paper. A door opening is located on the south elevation. There is a window opening on the north and west elevations. An east addition measuring 7'10"x 13'6" has a shed roof covered with felt paper. There is a five-panel door on the south elevation and a window opening on the north and east elevations. Corrugated metal covers the lower 2' of the exterior. Tar paper over wood planks covers the rest of the exterior. Artifacts in the building include a barber chair, a bench, shelving, a work bench, an electric heater, a cement generator stand, and chemical containers.

Figure 18. The Adams Cabin/Parker Generator Shed, 1993. The view is looking northeast.

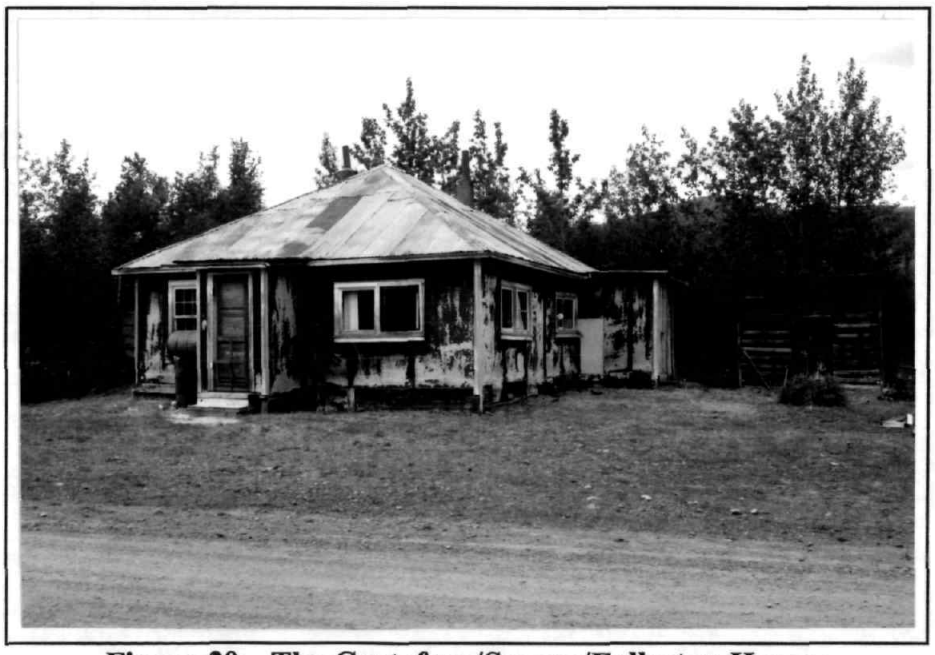
The **Gustafson/Savage/Fullerton House (IDT-075)** is a one-story, rectangular, wood frame building (Figure 20). It measures 20'1"x24'4". The hipped roof is covered with corrugated metal. The foundation consists of short vertical posts. The exterior

Figure 20. The Gustafson/Savage/Fullerton House, 1993. The view is looking northwest.

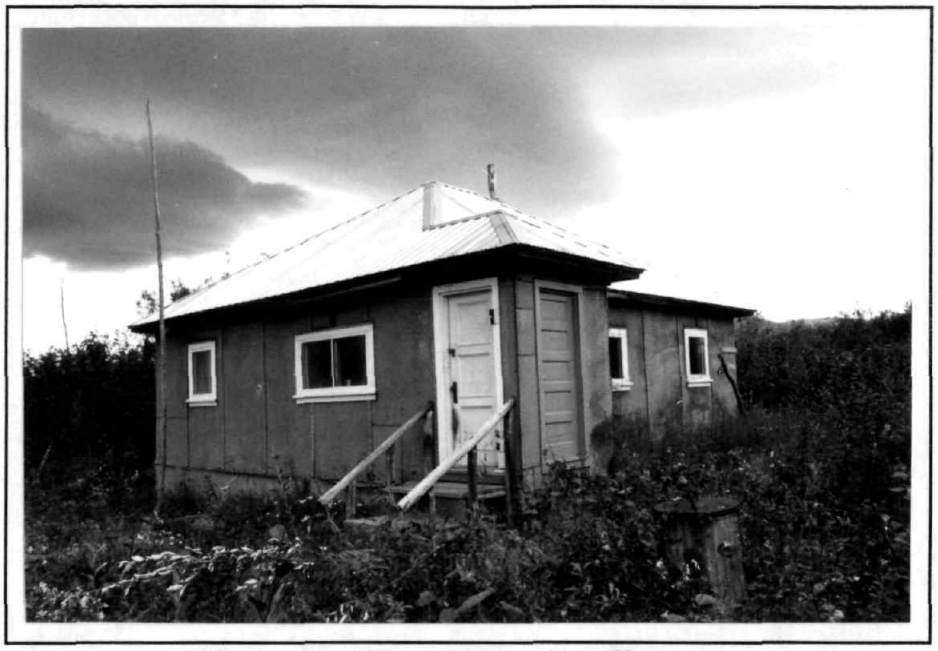
The **Hill/Day/Agoff House (IDT-122)** is a rectangular, one-story, wood frame building (Figure 22) measuring 24'5"x20'. Corrugated metal covers the hipped roof. The exterior is covered with celotex. The house has three arctic entries with corrugated metal roofs and celotex siding. The main entry faces north and has a single-light, fixed sash window and a two-light, fixed sash window. The west elevation has a single-light, fixed sash window and a two-light, fixed sash window. A hipped roof arctic entry measuring 4'x6' is located on the north end of the west elevation. A three panel door faces north and a five-panel door faces west. A six-light, fixed sash window faces south. The south elevation has a two-light, fixed sash window and a single-light, fixed sash window. A shed roof arctic entry is located on the east end of the south elevation. The arctic entry measures 6'x7' and has a five-panel door facing south and a four-light, fixed sash window facing west. The east elevation has three single-light, fixed sash windows and an arctic entry with a hipped roof. This 4'x4' arctic entry has a three panel door facing north and a single-light, fixed sash window.

Figure 22. The Hill/Day/Agoff House, 1993. The view is looking southeast.

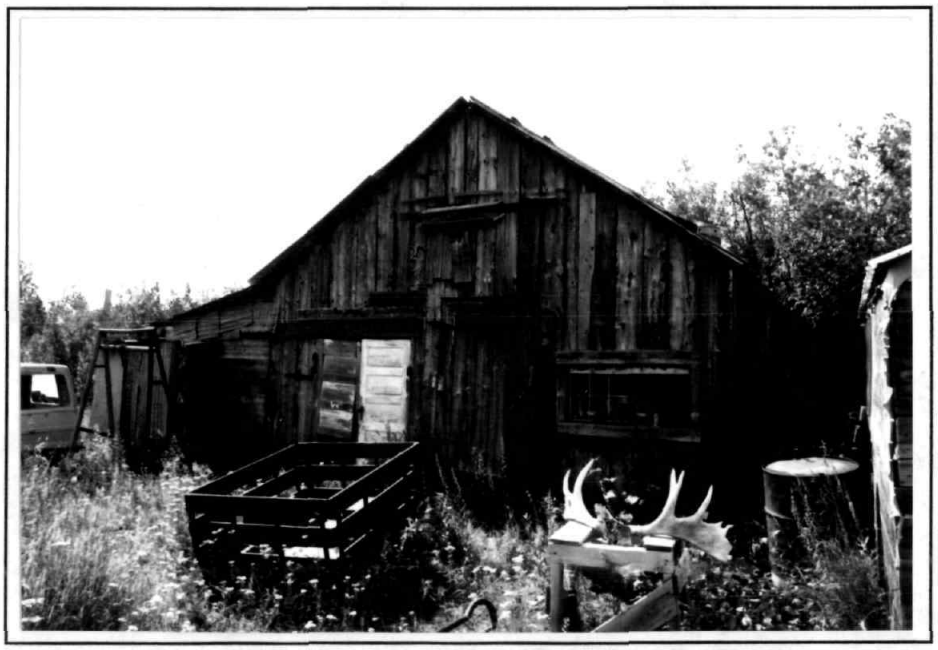
The **Miscovich House/Uotila Shop (IDT-243)** is a rectangular, 1.5 story building (Figure 24) located about 25' northwest of the Guggenheim Office/ Uotila House. The foundation consists of logs. The building is 20' square. It has a gable roof covered with corrugated metal and is sided with vertical lumber. The east

Figure 24. The Miscovich House/Uotila Shop, 1993. The view is looking southwest.

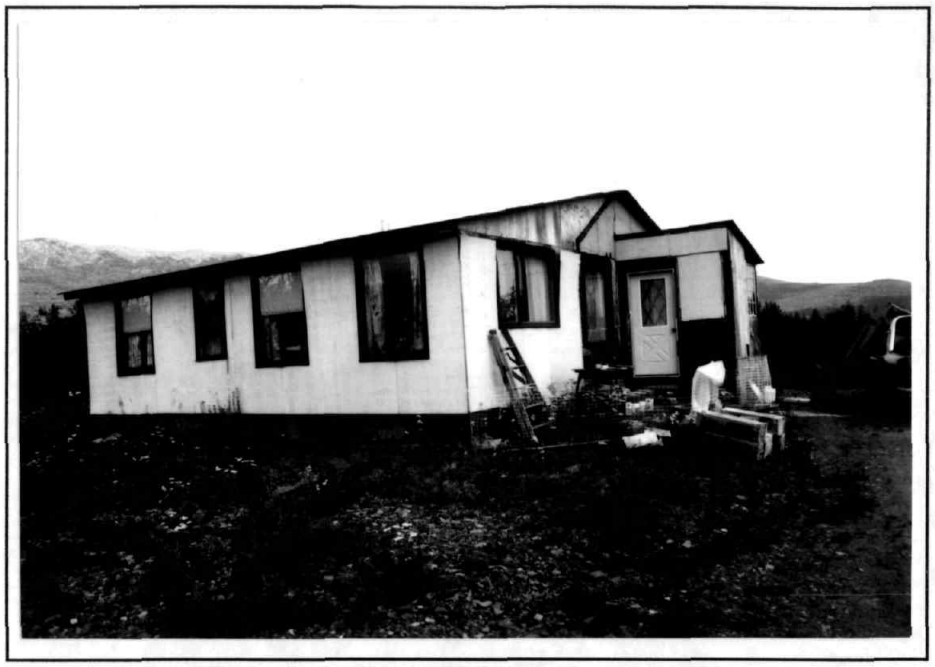
The **Williams House (IDT-101)** is a rectangular, one-story, wood frame building (Figure 33). The east portion measures 15'x46'4" and the west portion measures 18'x32'2". An arctic entry measuring 7'6"x7' is located on the south end of the east section and has a metal door. A gable roof with asphalt shingles covers the entire structure and runs north-south. Plywood and T1-11 cover the exterior walls. All windows are recent metal casement windows. A shed roof addition, measuring 12'x18', is located on the north end of the house. The roof is covered with aluminum siding and the exterior is covered with plywood.

Figure 33. The Williams House, 1993. The view is looking northeast.

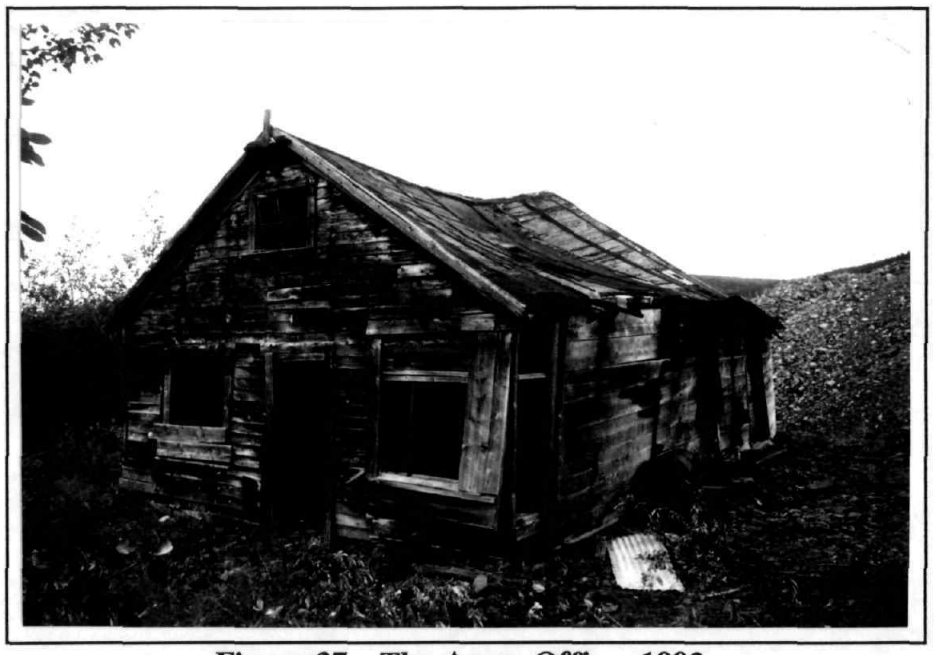
The **Assay Office (IDT-079)** is a rectangular, 1.5 story, wood frame building (Figure 37). The building is 20' square and the foundation is on grade. The gable roof is covered with roofing felt over wood decking. The exterior is covered with roofing felt over shiplap. The main entrance faces south and has a five-panel door flanked on each side by a large window opening. A six-light, fixed sash window is centered in the north and south gables. A two-light, fixed sash window is located in the south end of the east elevation. The west elevation has two boarded up windows. A shed addition measuring 12'x20' is located on the north side of the building. The roof and exterior siding of the addition are the same as the rest of the building.

The north elevation has a three panel door with one-light and a four-light, fixed sash window. The east elevation has a boarded up doorway. The west elevation has a window opening with no frame or lights. The interior of the building contains building debris, furniture and a number of containers with chemicals associated with assaying. The building is in poor condition. An outhouse measuring 4'2"x 4'7" is located 15'6" southwest of the Assay Office. The outhouse has a shed roof and walls covered with corrugated metal over wood siding.

Figure 37. The Assay Office, 1993. The view is looking northwest.

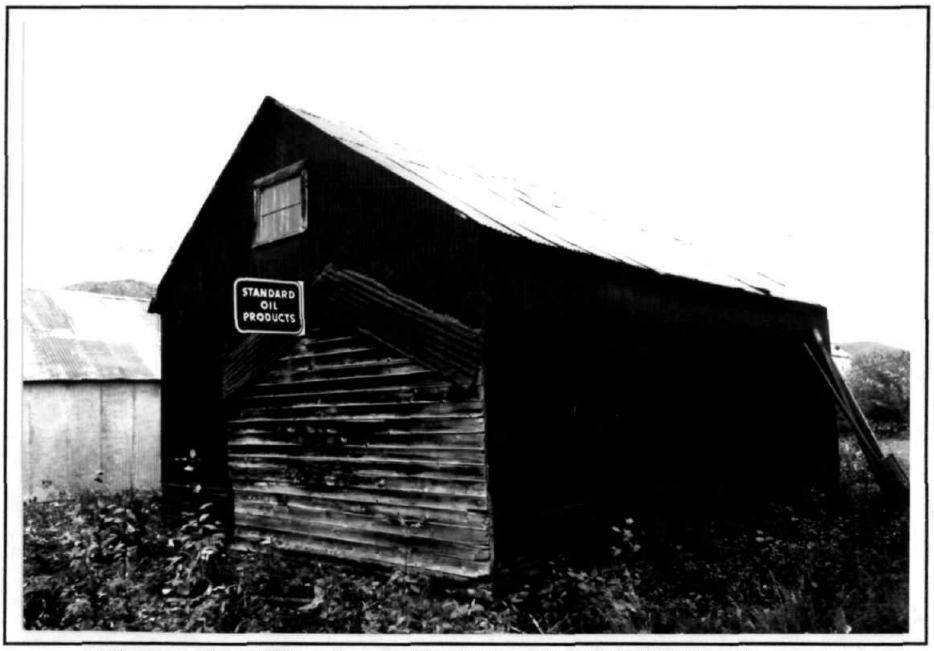
The **Donnelley/Standard Oil Warehouse (IDT-084)** is a rectangular, 1.5 story, wood frame building (Figure 42) measuring 20'x30'. The foundation consists of logs on grade. The gable roof and exterior walls are covered with corrugated metal. The west elevation has a six-light, fixed sash window centered in the gable and a "Standard Oil" sign on the upper part of the building. A six-light, fixed sash window located in the east gable and a door covered by corrugated metal is located at the south end of the of the east elevation.

Figure 42. The Donnelley/Standard Oil Warehouse, 1993. The view is looking northeast.

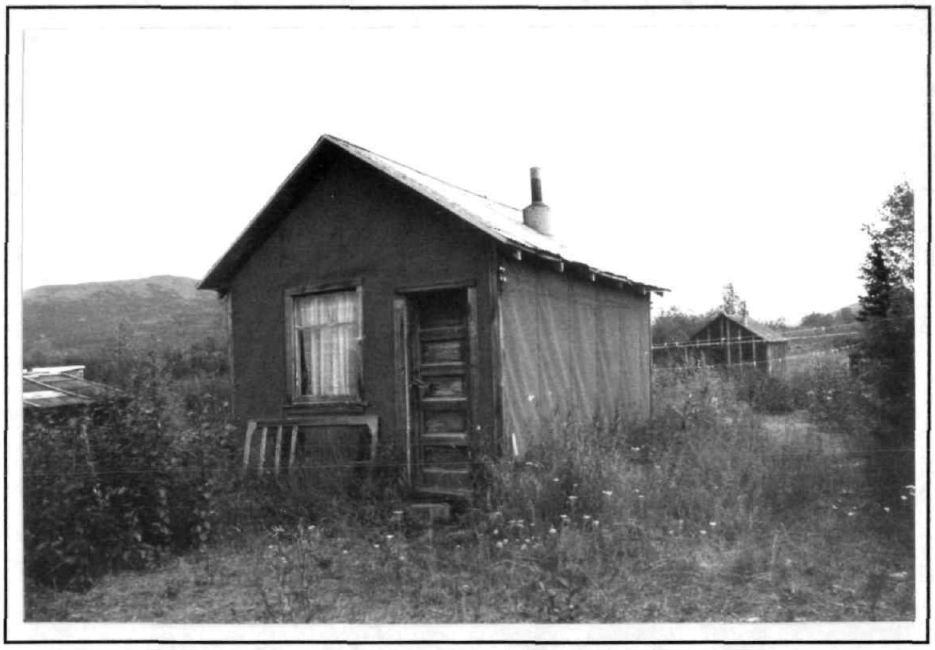
The **Matheson Guesthouse (IDT-103)** is a one-story, wood frame building (Figure 53) located 18'6" east of the Matheson rock garden. The foundation of the guesthouse consists of logs on grade. The gable roof is covered with corrugated metal. The guesthouse measures 12'5"x16'2". The exterior walls are covered with green asphalt roofing felt and have corner boards. The main entry is on the north elevation, which has a five-panel door and a four-light window. A screened window frame with no glass is centered on the south elevation.

Figure 53. The Matheson Guesthouse, 1993. The view is looking southeast.

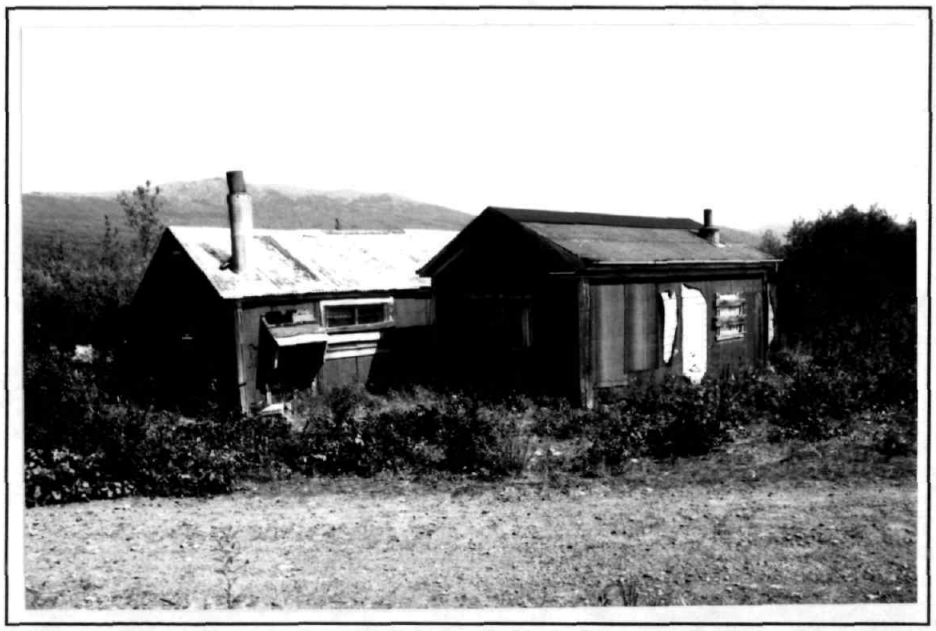
The **Matheson Mess Hall (IDT-104)** is a rectangular, one-story, wood frame building (Figure 55) with two additions. The foundation consists of logs. The gable roof is covered with corrugated metal and is oriented east-west. The building measures 18'3"x 26'5". Asphalt rolled roofing covers the ex-

Figure 55. The Matheson Mess Hall (left) and Cook's Quarters (right), 1993. The view is looking northeast.

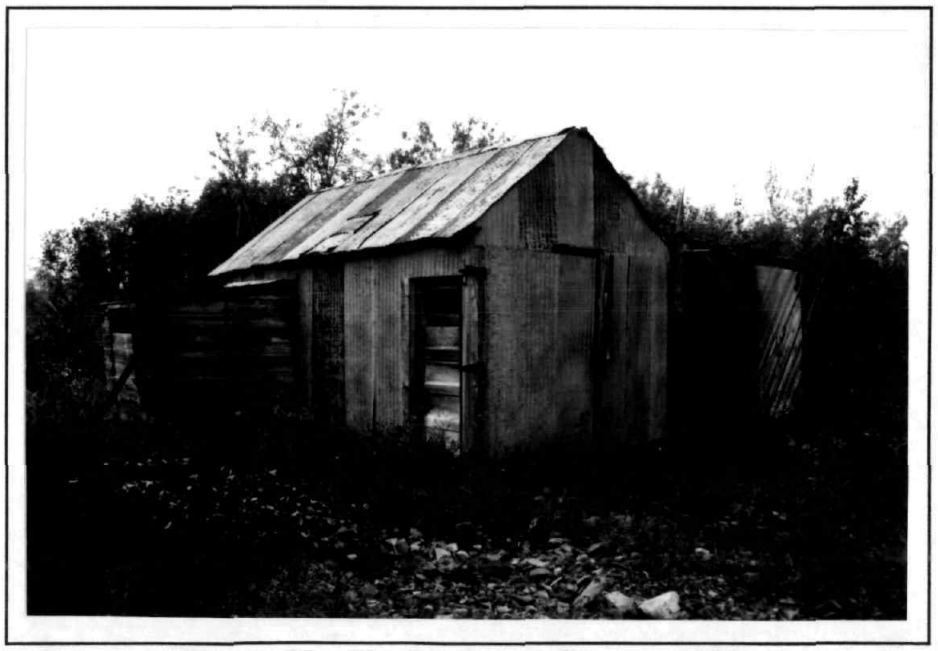
The **Matheson Garage (IDT-106)** is a rectangular, one-story, wood frame building (Figure 57) with two additions. The foundation consists of wood blocks. The gable roof and exterior walls are covered with corrugated metal. The garage measures 12'x18'8". A pair of side opening utility doors are centered on the north elevation. A shed addition measuring 8'8"x12'2" is located on the west side of the building. Corrugated metal covers the shed roof. The exterior walls are covered with shiplap. A pair of side opening utility doors are centered on the north elevation of this addition. A four-panel door with one light is located at the north end of the east elevation. At the south end of the east elevation is a small 6'x6' shed addition. Corrugated metal covers the shed roof. The exterior walls are

Figure 57. The Matheson Garage, 1993. The view is looking southwest.

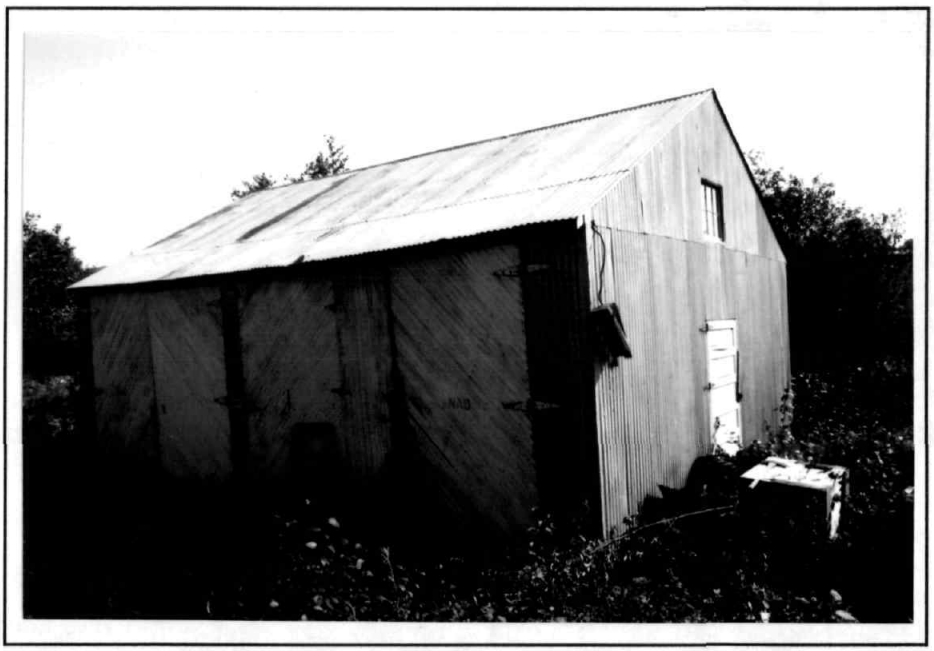
The **NADC Garage (IDT-111)** is a rectangular, one-story, wood frame building (Figure 62). The foundation is on grade. The gable roof and exterior walls are covered with corrugated metal. Two six-light, fixed sash skylights are evenly spaced on the south slope of the roof. The building measures 24'x29'3". The main entry is on the north elevation, which has two pairs of side opening utility doors. A five-panel door is centered on the west elevation and a six-light, fixed sash win-dow is centered in the gable. Two six-light, fixed sash windows are evenly spaced on the south elevation.

Figure 62. The NADC Garage, 1993. The view is looking southeast.

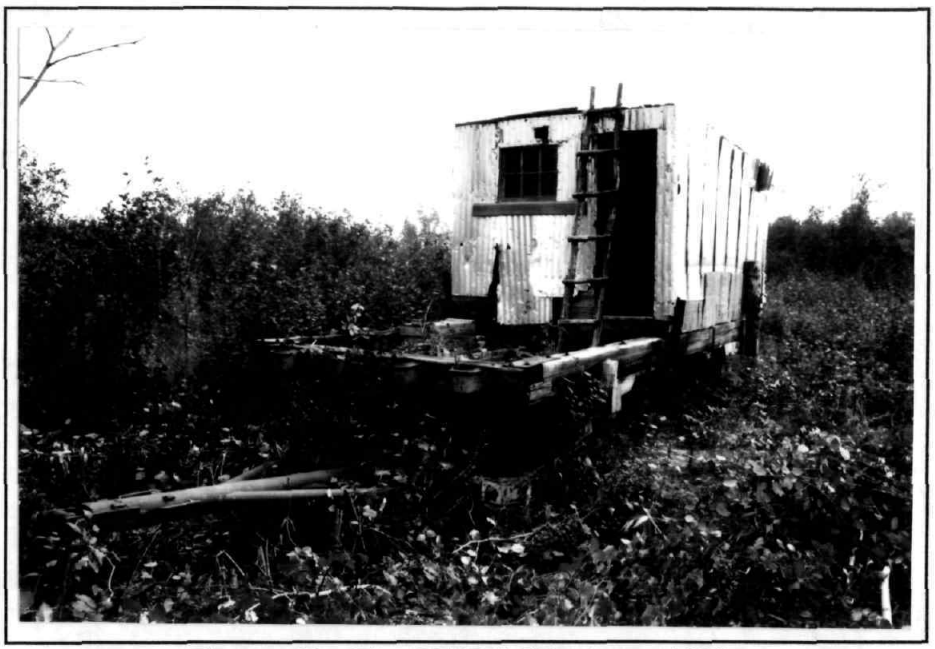
The **NADC Wanigan (IDT-112)** is a wood frame freight sled measuring 8'2"x 24'5" (Figure 63). The frame and floor are made of heavy timbers braced with metal plates. The tow bar is made of heavy metal pipe. A small rectangular, one-story, wood frame bunkhouse measuring 8'2"x16', is located on the back two-thirds of the sled. Corrugated metal covers the flat roof and exterior walls. A plank door and six-light, fixed sash window are located on the front (north) elevation of the bunkhouse. A four-light, fixed sash window is centered on the south elevation. A table, coffee pot, and bunks are located inside the structure. The sled is a

Figure 63. The NADC Wanigan, 1993. The view is looking southeast.

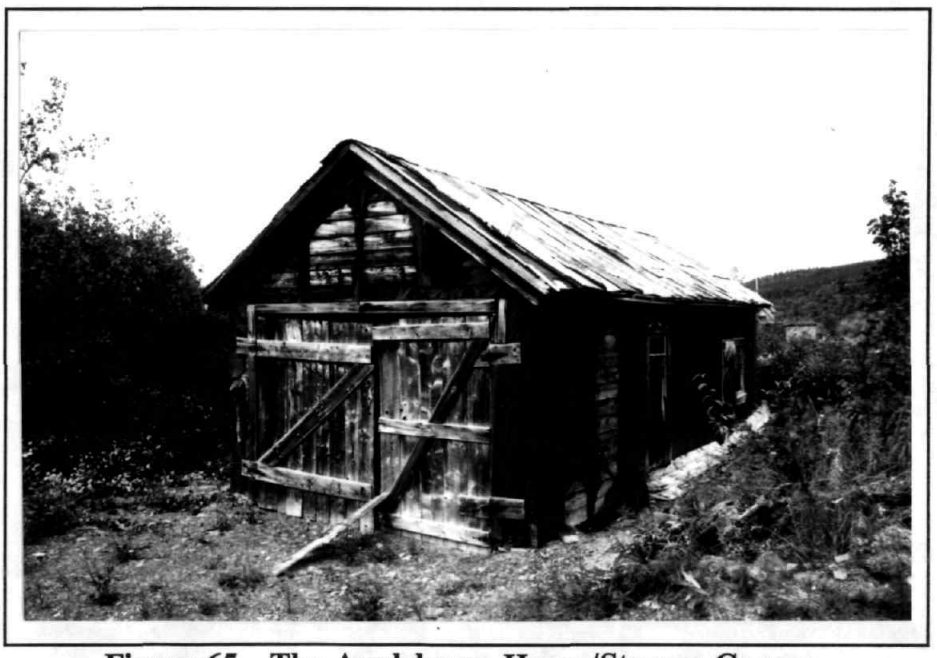
The **Applebaum House/Stevens Garage (IDT-114)** is a rectangular, one-story, wood frame building (Figure 65). The foundation is on grade. The gable roof is covered with corrugated metal. The culled (double) roof has 1"x1" sleepers between the decking. This is the only culled roof observed in Flat and one of only a handful of buildings (all residential) that have rain gutters. The

Figure 65. The Applebaum House/Stevens Garage, 1993. The view is looking northwest.

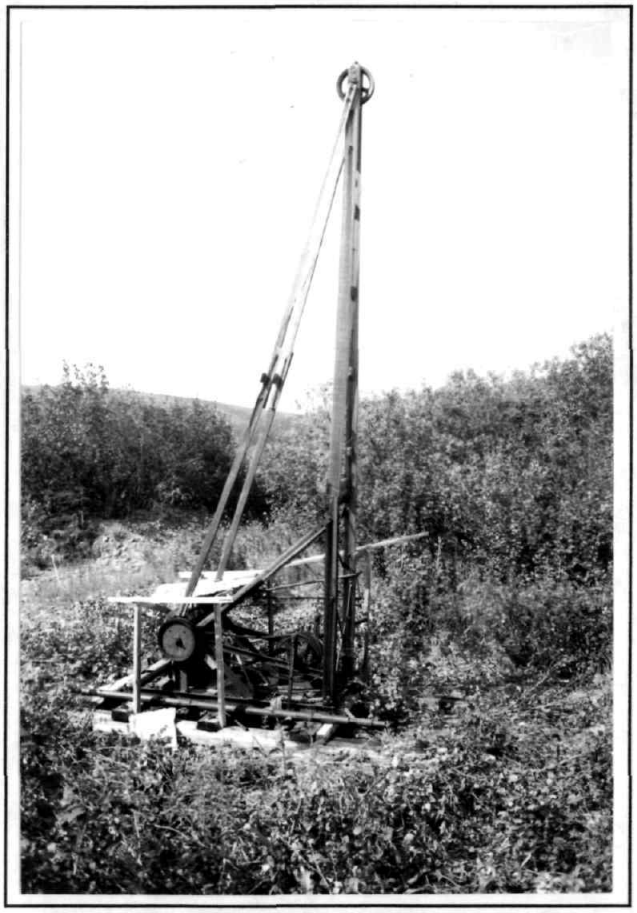
The **NADC Drill Rig (IDT-116)** is a wood frame drilling structure (Figure 67). The gantry is about 20' high. The base of the rectangular structure measures 5'8"x16' and the foundation consists of a pair of timber skids. A small shed roof covered with corrugated metal shelters the gears located inside the frame of the drill rig. The rig was manufactured by the Twin Disk Clutch Company. Drilling pipe is laying across the frame of the rig. Three large piles of 8" and 16" hydraulic pipe measuring 20' long are located about 30' northeast of the drill rig.

Figure 67. The NADC Drill Rig, 1993. The view is looking northwest.

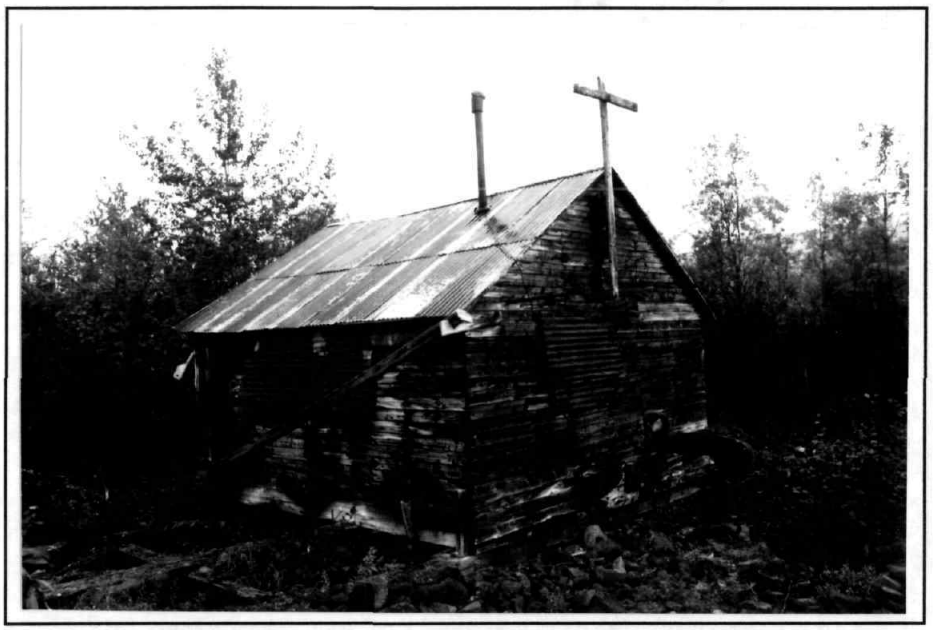
The **Jensen/NADC Pump House (IDT-119)** is a rectangular, one-story, wood frame building (Figure 71) located on the south bank of Otter Creek. The foundation consists of four 12"x12" skids. Corrugated metal covers the gable roof. The building measures 16'8"x 16'11", while the skid frame structure extends another 19' to the south. The exterior walls are covered with shiplap. The south elevation includes a five-panel door and a pair of single-light windows that are covered with corrugated metal. A six-light, fixed sash window is centered on the west elevation. The north elevation has a pair of boarded up single-light, fixed sash windows and a five-panel door. A boarded up two-light, fixed sash window is centered on the east elevation. A 12" metal water pipe extends from the east side of the building. A Washington Diesel engine is located in the center of the building. A large belt connects the engine to a drive shaft that turns the pump. A work bench is located along the south wall.

Figure 71. The NADC Pump House, 1993. The view is looking northwest.

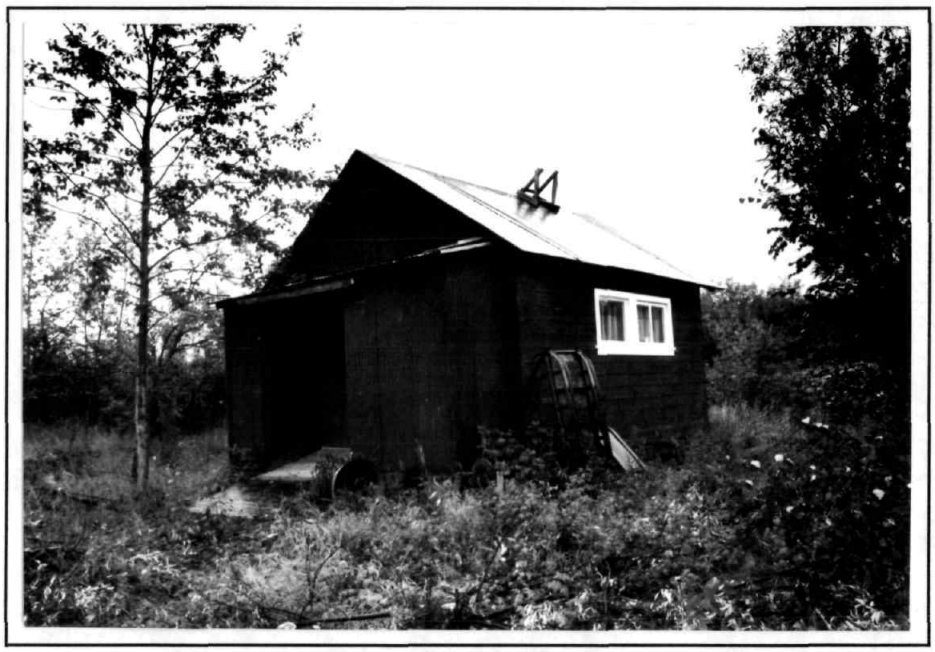
A rectangular, one-story, wood frame workshop building (Figure 74) is located 52'6" east of the wood shed. The foundation is not visible. Roofing felt covers the gable roof. The building measures 16'1"x18'1" and the exterior is covered with wood siding. The main entry is the north elevation, which has a pair of side opening doors covered with celotex. The north elevation is covered by an enclosed porch. The shed roof and exterior walls of the porch are covered with corrugated metal. A ramp measuring 3'6"x15' extends through the porch to the doors. The east elevation has two single-light, fixed sash windows. The south elevation has a two-light, fixed sash window. The west elevation has a pair of fixed sash windows, one with two lights and the other with one light.

Figure 74. Dave Wintz's Workshop, 1993. The view is looking southeast.

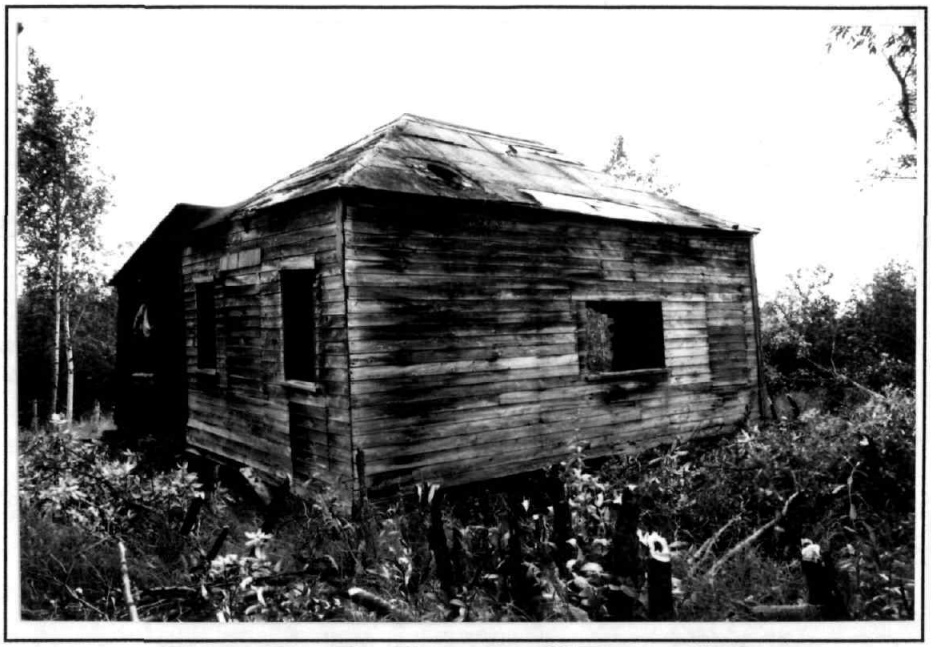
The **Harry Agoff House (IDT-135)** is a rectangular, one-story, wood frame building (Figure 78). The foundation is log and wood blocks on grade. Roofing felt covers the hipped roof. The building measures 15'10"x24'5". The exterior is covered with shiplap and features corner boards. The main entry is on the west elevation, which includes a decorative single-light, fixed sash window and a shed roof arctic entry. The roof of the arctic entry is covered with roofing felt and the exterior is covered with horizontal wood siding. The south wall of the arctic

entry is missing. A two-light, decorative fixed sash window is on the west elevation. The upper light is a band of diamond lights. The north elevation of the house has a window opening with no frame and another window that has been permanently boarded up. The east elevation has two window openings. One was formerly a door and a third window has been permanently boarded up.

A 14'11"x24'5" addition on the south side of the house rests on a wood block foundation. The shed roof is covered with roofing felt over wood decking. The exterior is sided with roofing felt over shiplap. A window opening is present on the east, west and south elevations. A door opening is located near the middle of the wall between the house and the addition. The building is in poor condition.

Figure 78. The Harry Agoff House, 1993. The view is looking northwest.

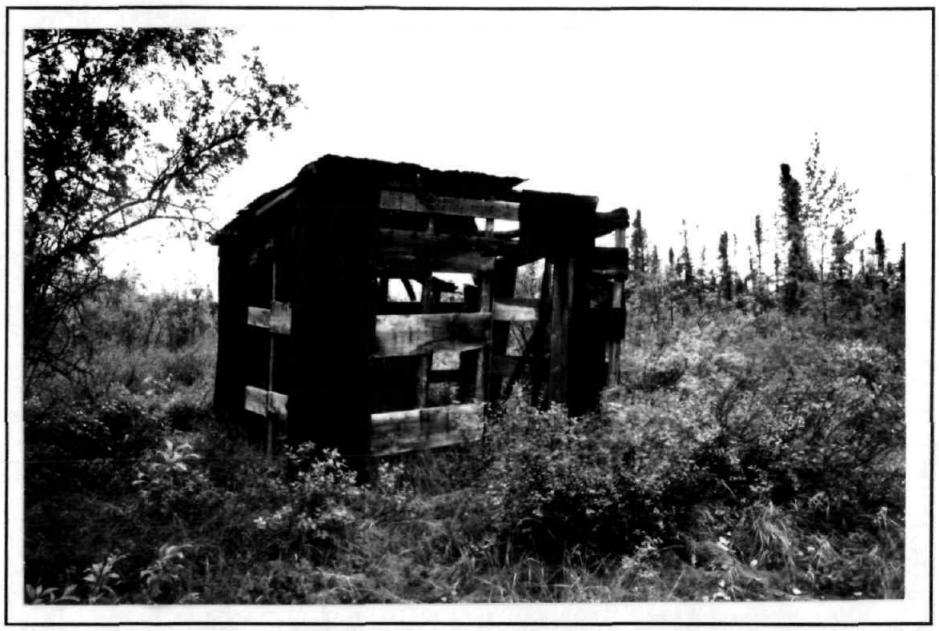
A rectangular pole and wood frame shed is located south and west of the Becker House ruins and 80' west of Flat Creek Road (Figure 85). The foundation is on grade. Corrugated metal covers the exterior walls. The building measures 7'2"x10'6". The shed roof is covered with corrugated metal, but the west half of the roof is missing. A screen mattress frame and an enamelware pitcher are located inside the building. A four-panel door is laying on the ground northwest of the building. A scatter of scrap metal, gas cans and barrels are located east of the building.

Figure 85. Cap Becker's log and wood frame shed, 1993. The view is looking northeast.

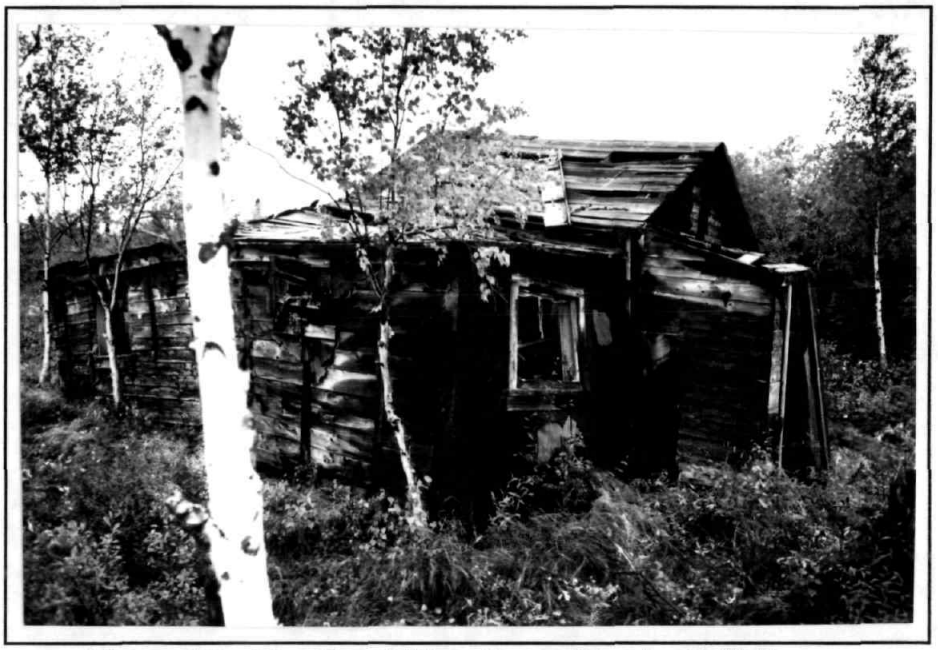
The **Crook/ Caughrean/Demientieff House (IDT-140)** is a rectangular, one-story, log and wood frame building with five additions (Figure 86). The foundation consists of beams on grade. The gable roof and exterior siding is covered with roofing felt over wood siding, although most of the roofing felt on the roof is missing. The house measures 12'x 15'. The main entry is on the east elevation, which includes a window opening and a 4'x5'10" shed roof arctic entry. The arctic entry has a doorway facing east. A shed addition on the south side of the house measures 7'7" x12'. Unlike the roof of the house and other additions, the roof addition is covered with corrugated metal. A single-light, fixed sash window faces east and a small boarded up window faces south. Another shed addition is located on the west end of this addition and measures 7'7"x 12'. A window opening faces south. Another shed addition is located on the west end of the house. This

Figure 86. The Crook/Caughrean/Demientieff House, 1993. The view is looking northwest.

addition measures 7'x11'10". The west wall is made of logs and has a window opening. A shed addition on the north side of the building measures 10'6"x14'7". A window opening is located on the north and east elevations. At the west end of this addition is another shed roof addition measuring 10'5"x10'6". A doorway faces north, and most of the wood siding has been removed from the north, west and south walls. The house is in poor condition.

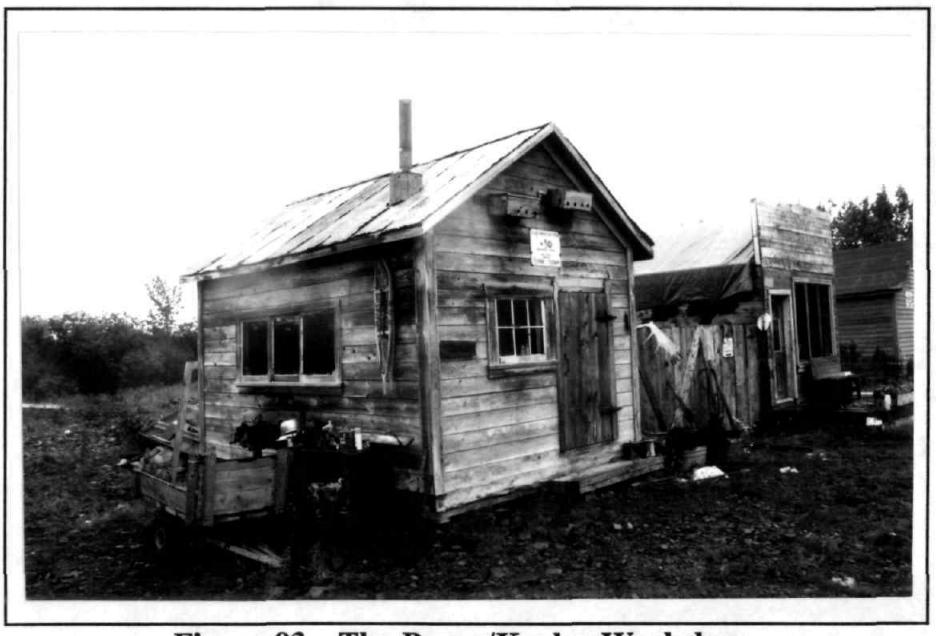
The **Burns/ Kepler Workshop (IDT-126)** is a rectangular, one-story, wood frame, building (Figure 93). The foundation is wood blocks on grade. Corrugated metal and roofing felt cover the gable roof. The building measures 12'3"x 16'3". The exterior walls are covered with shiplap with corner boards. The main entry is on the east elevation, which has a plank door and a six-light, fixed sash window. The south elevation has a three-light, fixed sash window.

Figure 93. The Burns/Kepler Workshop, 1993. The view is looking southwest.

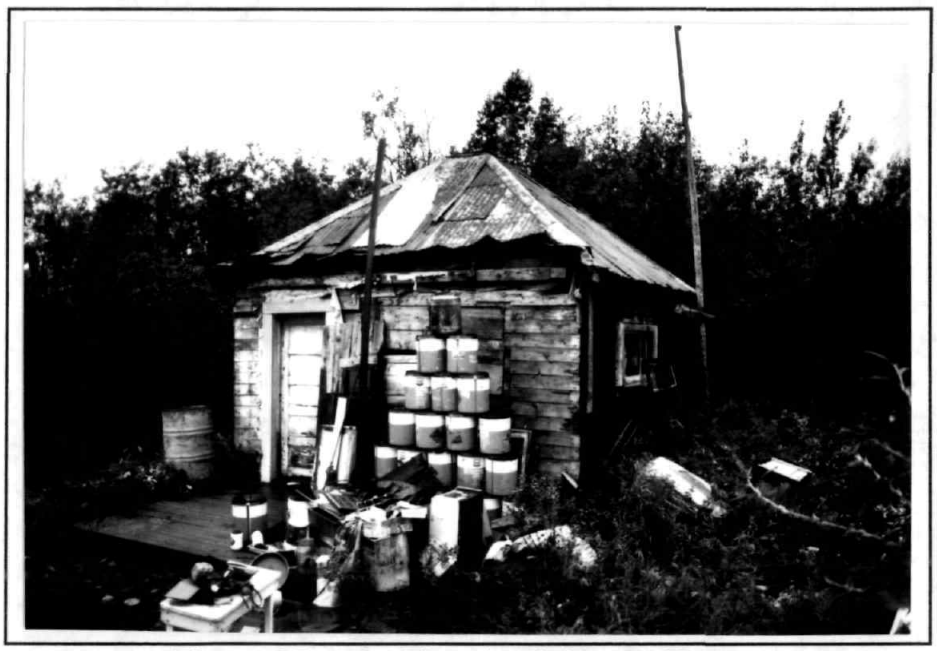
The **Finn Annie/Burns House (IDT-128)** is a square, one-story, wood frame building (Figure 95). The foundation consists of wood beams on grade. Corrugated metal covers the hipped roof. The building measures 14'3" per side. The exterior walls are covered with shiplap and roofing felt. The main entry is on the east elevation, which has a five-panel door and a boarded up window. A pair of single-light, fixed sash windows are located on the north elevation. A three-light, fixed sash window is located on the west elevation. An open porch measuring 4'5"x14'3" is located on the east side of the house. This deck is made of tongue and groove flooring. A 55 gallon barrel, about 20 round metal fuel cans, and a number of boxes are stacked on the deck. A snow machine, a stove, stove pipe, window frames, and various domestic items are located outside of the building. A large cleared area measuring 70'x70' is located south and east of the building.

Figure 95. The Finn Annie/Burns House, 1993. The view is looking southwest.

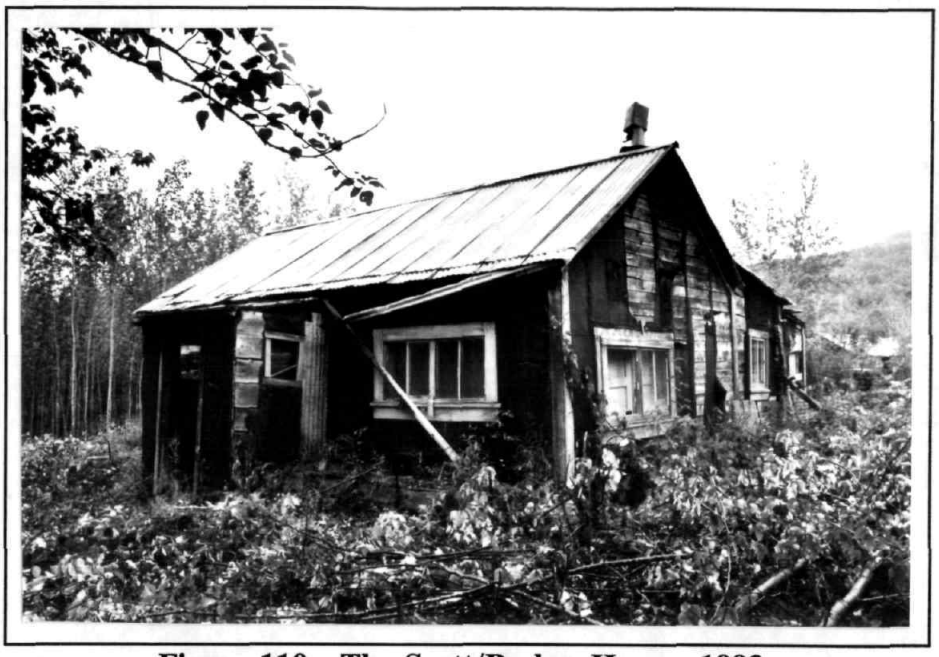
The **Scott/Parker House (IDT-154)** is a rectangular, one-story, wood frame building with three shed roof additions (Figure 110). The foundation is not visible. The gable roof and shed roofs are covered with corrugated metal. The house measures 16'x23'10". The exterior

Figure 110. The Scott/Parker House, 1993. The view is looking northwest.

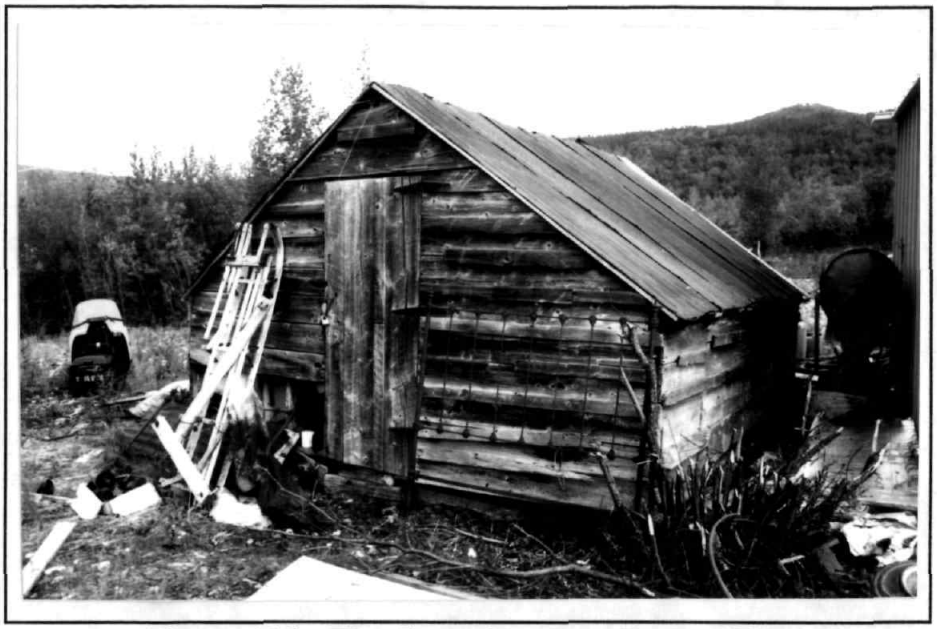
Figure 116. The Cummings Dog Barn, 1993. The view is looking northwest.

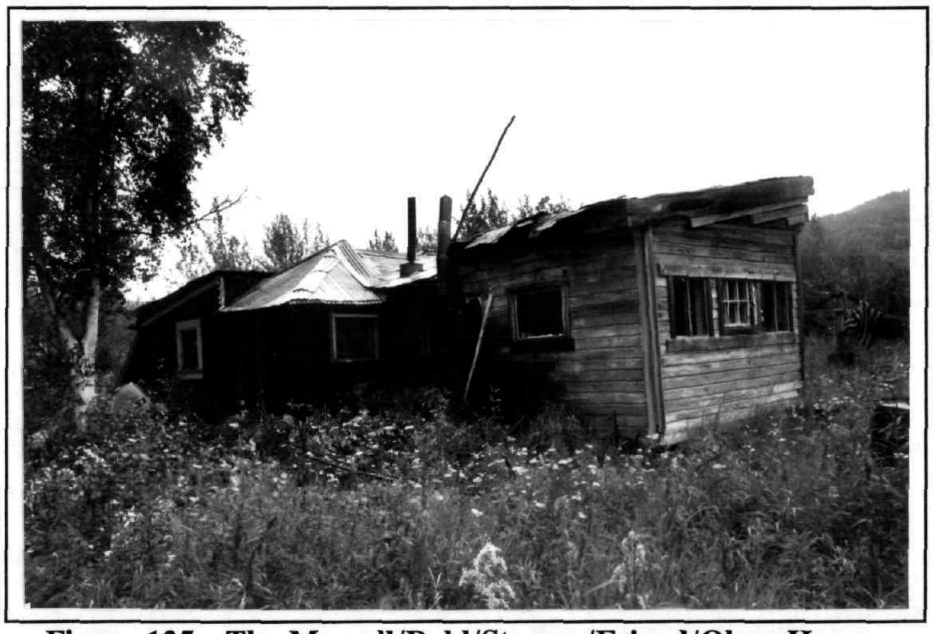
The **Marcell/Dahl/Stevens/Friend/Olsen House (IDT-168)** is an irregular shaped, one-story, wood frame building with four additions (Figure 125). The foundation consists of wooden blocks on grade. The roofs of the house and the four additions are covered with corrugated metal. The oldest section of the house measures 12'x12'8" and had a gable roof. The original house appears to have been "L" shaped with a shed roof addition in the northeast corner. Roofing felt covers the exterior walls. The main entry is on the south elevation, which includes a one-light, fixed sash window and a hipped roof addition measuring 6'5"x8'. The exterior of the addition is covered with roofing felt. The south addition has a two-panel door with one light facing south and a six-light, fixed sash window facing east. A shed roof addition on the west side of the house measures 11'5"x18'4". Roofing felt covers the exterior walls. The south elevation has a single-light, fixed sash window and the west elevation has two six-light, fixed sash windows. A shed addition on the north side of the house measures 7'1"x23'9" and the exterior is covered with roofing felt. The north addition has a single-light, fixed sash window on the west side, and a door way and a six-light, fixed sash window on the north elevation. On the east side of the building is an addition with a shed roof. The east addition measures 10'11"x13' and the exterior is sided with scalloped shiplap with corner boards. The south elevation has a single-light, fixed sash window and the north elevation has a four-panel door. The east elevation has a six-light, fixed sash window flanked on each side by a two-light, fixed sash window.

Figure 125. The Marcell/Dahl/Stevens/Friend/Olsen House, 1993. The view is looking northwest.

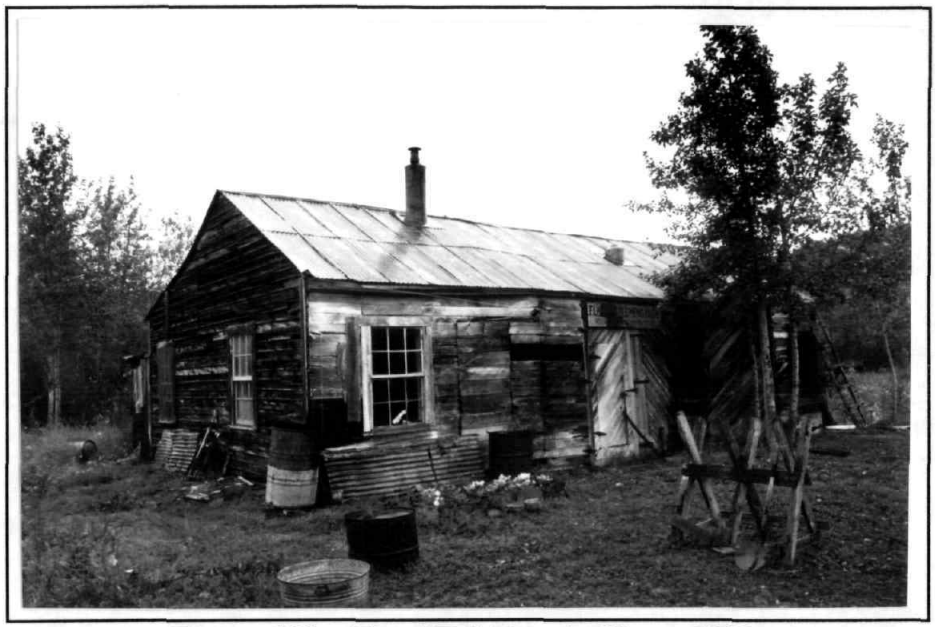
The **Alaska Road Commission (ARC) Repair Shop (IDT-171)** is a "L" shaped, one-story, wood frame building (Figure 129). The foundation is not visible. Corrugated metal covers the gable roof. The building measures 19'10"x39'10". The exterior walls are covered with shiplap except the north wall which is covered with corrugated metal. The main entry is on the south elevation, which features two pairs of large, side opening plank doors, a 6/6 single-hung window, and a boarded over door. A 6/6 single-hung window is located on the south elevation and a six-light, fixed sash window is located on the north elevation. A small 6'8"x8'10" shed roof addition is located on the north end of the west elevation. The roof is covered with corrugated metal and the exterior is sided with shiplap. This addition has a six-light, fixed sash window facing north. A plank door and a six-light, fixed sash window faces west. A 5'1"x6'4" shed roof addition is located on the south end of the west elevation of the building. The roof is covered with corrugated metal and the exterior is sided with shiplap. A 6/6 single-hung window faces south. A large gable roofed addition on the west side of the building gives the complex an "L" shape. The west addition measures 18'x31'7". Corrugated metal covers the roof and exterior walls. The addition has a two-light, fixed sash window facing south and a window frame with no glass facing west. An arctic entry measuring 5'2"x6'4" is located on the east end of the south side of this addition. The arctic entry has a shed roof

Figure 129. The ARC Repair Shop, 1993. The view is looking northwest.

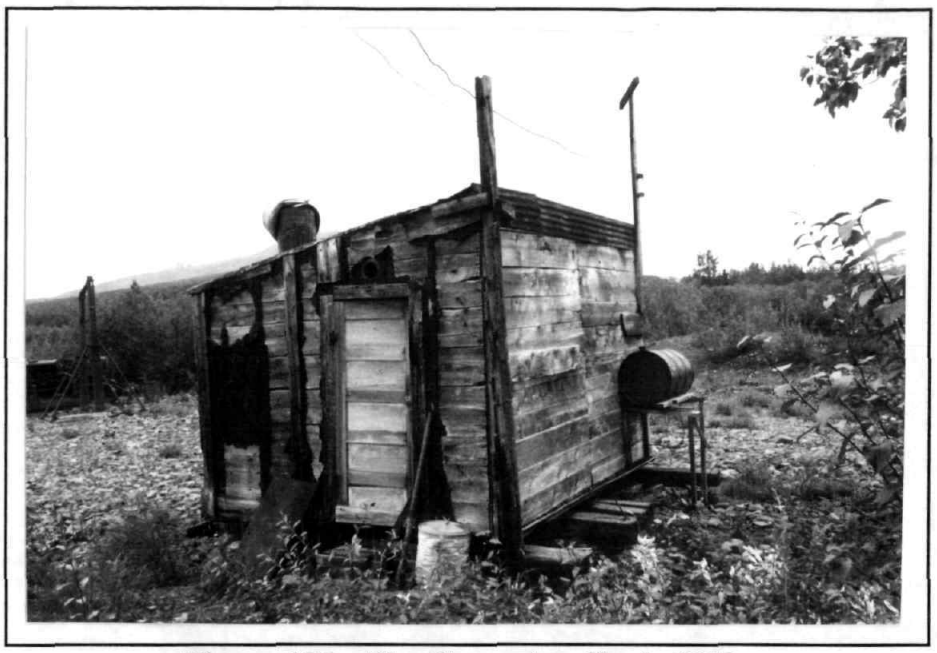
The **Generator Shed (IDT-204)** is a rectangular, one-story, wood frame building (Figure 136) located 25' northwest of the Pomgran/Aiken/Miscovich Guesthouse (IDT-203). The foundation is logs. The shed roof is covered with corrugated metal. The Generator Shed measures 10'10"x12'4". The exterior is covered with roofing felt over wood decking. A five-panel door is located on the south elevation. A six-light, fixed sash window is located on the north elevation. A window covered with corrugated metal is located on the west elevation. A cable attached to the foundation on the north side indicates that the shed is made to be towed. A generator is located inside the shed.

Figure 136. The Generator Shed, 1993. The view is looking northeast.
