BLM-Alaska Open File Report 64
BLM/AK/ST-97/022+8111+040
April 1997

HISTORIC BUILDING SURVEY REPORT FLAT, ALASKA

by Rolfe G. Buzzell and Darrel L. Lewis

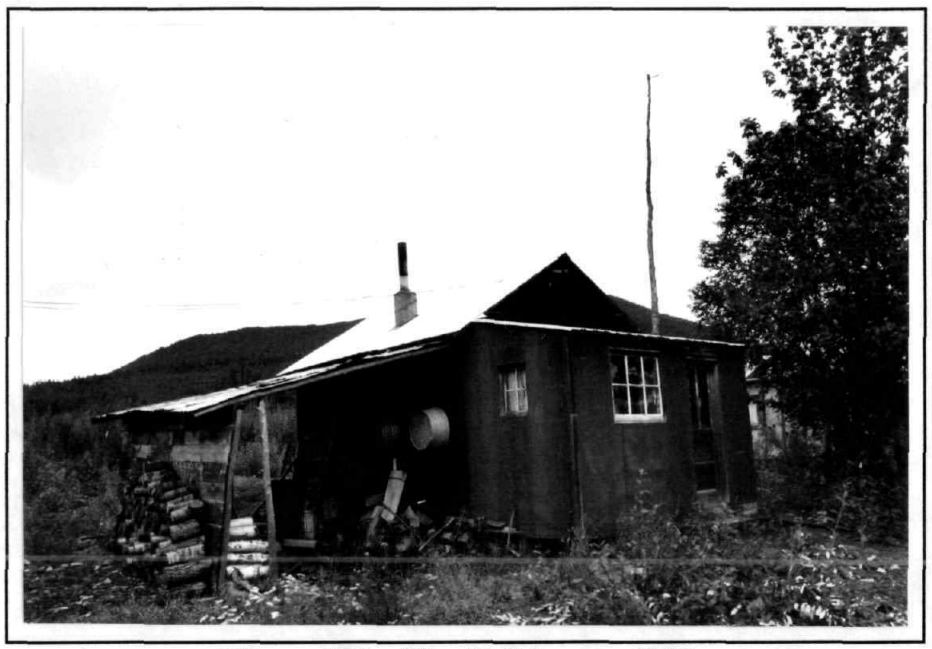
The **Bathhouse (IDT-206)** is a rectangular, one-story, wood frame building (Figure 138). The foundation is logs and beams on grade. The gable roof is covered with corrugated metal. The building measures 21'6"x23'2". The siding is roofing felt, except the west elevation which is covered with shiplap. The main entry is on the south elevation, which is covered by a shed roof addition measuring 5'6"x12'6". The roof of the addition is covered with corrugated metal. A two-panel door with six-lights and a six-light, fixed sash window face south. A four-light, fixed window faces west. The east elevation of the Bathhouse has a two-light, fixed sash window. An addition on the north side of the building has a shed roof covered with corrugated metal. The addition measures 10'2"x16'. The addition is open on the south side and has wood siding on the north and west sides.

Figure 138. The Bathhouse, 1993. The view is looking northeast.

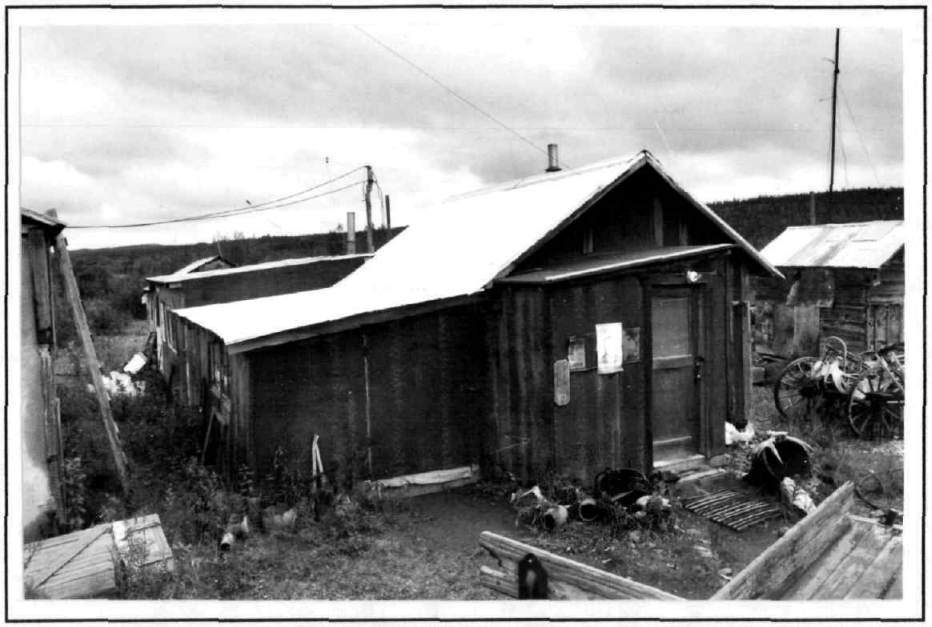
The **Office and Workshop (IDT-209)** is a rectangular, one-story, wood framed building with four additions (Figure 141). The office measures 14'x16'4". The foundation is logs and beams on grade. The gable roof is made of corrugated metal. The siding consists of roof-

Figure 141. The Office and Workshop Building, 1993. The view is looking southeast.

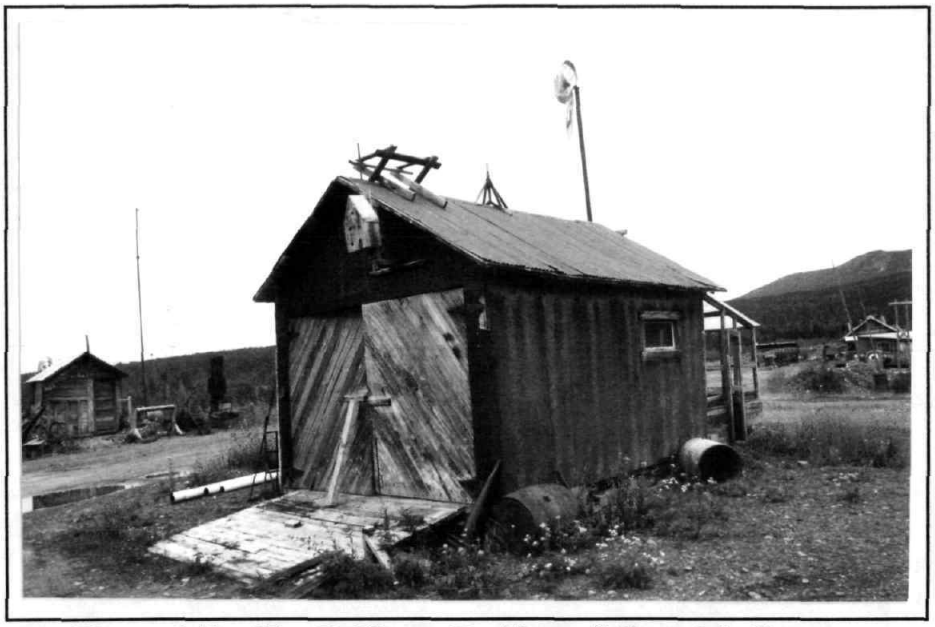
The **DeHouse Residence/Miscovich Garage (IDT-211)** is a rectangular, one-story, wood frame building (Figure 143). The foundation is wood blocks on grade. The gable roof is covered with corrugated metal. The garage measures 12'6"x24'6". Roofing felt over horizontal wood siding covers the exterior walls. The main entry is on the north elevation, which contains a pair of large diagonal plank doors. A ramp leads from the doors to the ground. The east elevation has a boarded up door. A single-light, fixed sash window is located in the west elevation. A shed roof greenhouse addition is centered on the south elevation. The roof of the addition is covered with fiberglass. The addition measures 8'4"x12'6".

Figure 143. The DeHouse Residence/Miscovich Garage. 1993. The view is looking southeast.

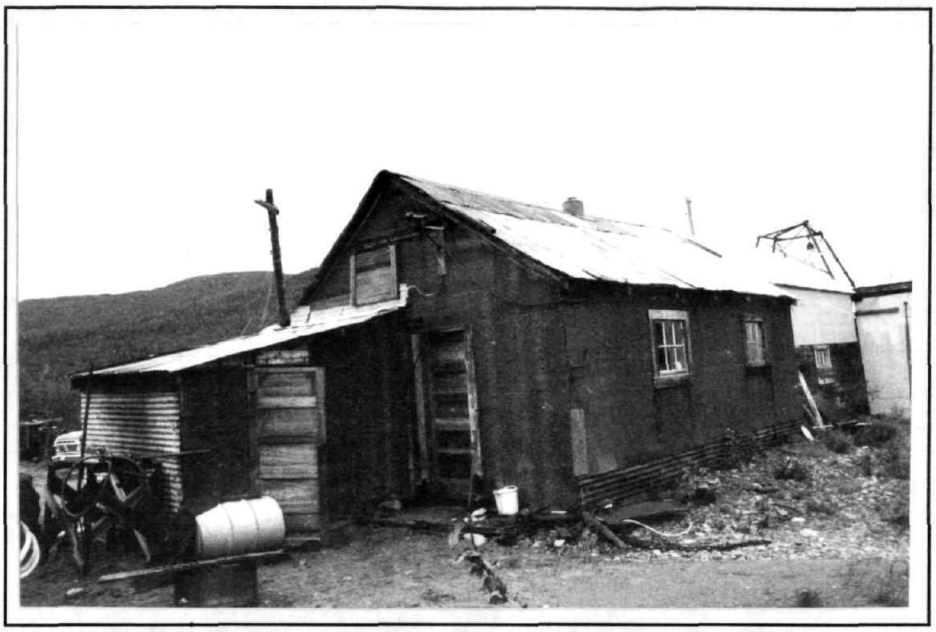
The **Machine Shop (IDT-213)** is a rectangular, 1.5 story, wood frame building with three additions (Figure 144). The foundation is horizontal timbers on grade. The gable roof is corrugated metal over shiplap. The shop measures 16'5"x23'11" and the exterior is covered with roofing felt over shiplap. The south elevation has two six-light, fixed sash windows and the north elevation has a two-light, fixed sash window. A small boarded up window is located under each gable. The west elevation has a five-panel door and a shed addition measuring 8'2"x10'. The addition, which houses a generator, has a shed roof covered with corrugated metal over wood decking. A five-panel door faces south.

Figure 144. The Machine Shop (center) and additions, 1993. The view is looking northeast.

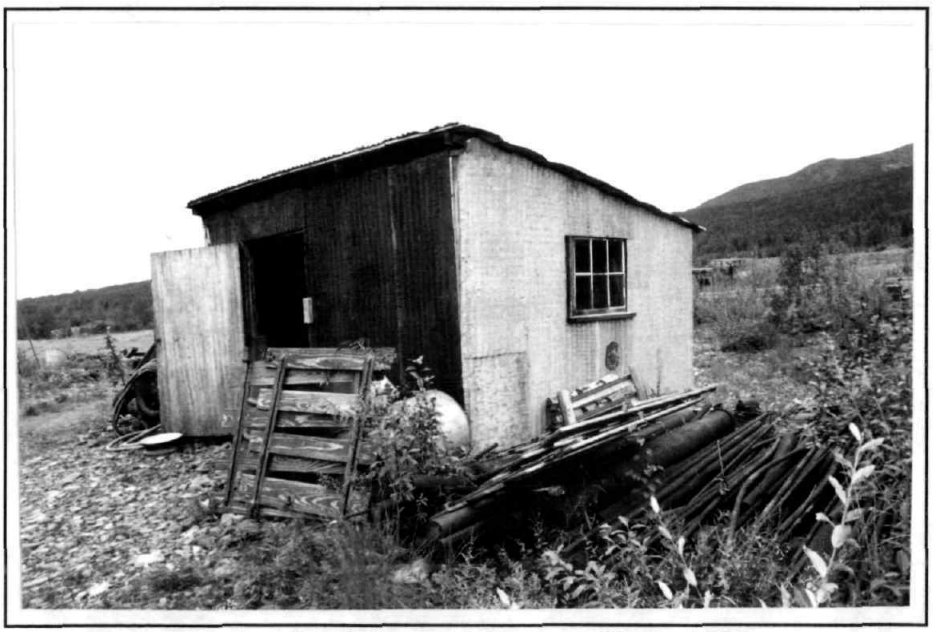
The **Fuel Storage Shed (IDT-214)** is a square, one-story, wood frame building (Figure 145) located 25' southwest of the Machine Shop. The foundation is on grade. The shed roof and exterior are covered with corrugated metal. The shed measures 11'2"x13'2". The main entry is on the north elevation, which has a plank door. A six-light, fixed sash window is located on the west elevation.

Figure 145. The Fuel Storage Shed, 1993. The view is looking southeast.

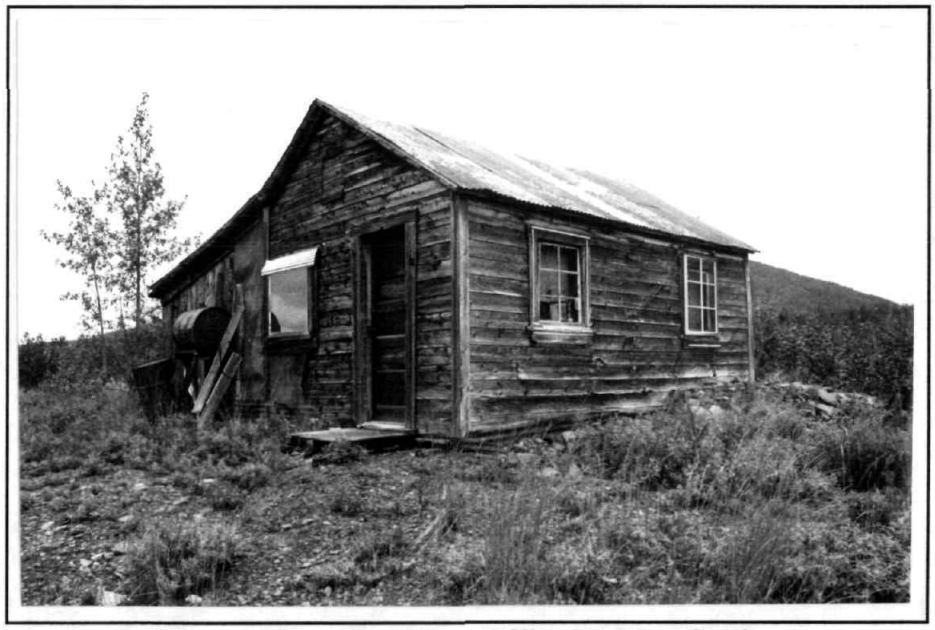
The **Riley Office/Kobler Cabin (IDT-215)** is a rectangular, one-story, wood frame building (Figure 146). The foundation is horizontal timbers. The gable roof is covered with corrugated metal over wood decking. The building measures 18'3"x24'9" and shiplap siding covers the exterior walls. The main entry is on the south elevation, which has a five-panel door and a single-light, fixed sash window. The east elevation has a six-light, fixed sash window and a single-light, fixed sash window covered by a six-light storm window. The north elevation has a two-light, fixed sash window and a six-light, fixed sash window. A rectangular, one-story addition on the west elevation has a shed roof covered with corrugated metal and measures 13'1"x14'4". The north and south walls are covered with shiplap and the west wall is covered with horizontal wood siding. A four-light, fixed sash window is located on the west side of the addition.

Figure 146. The Riley Office/Kobler Cabin, 1993. The view is looking northwest.

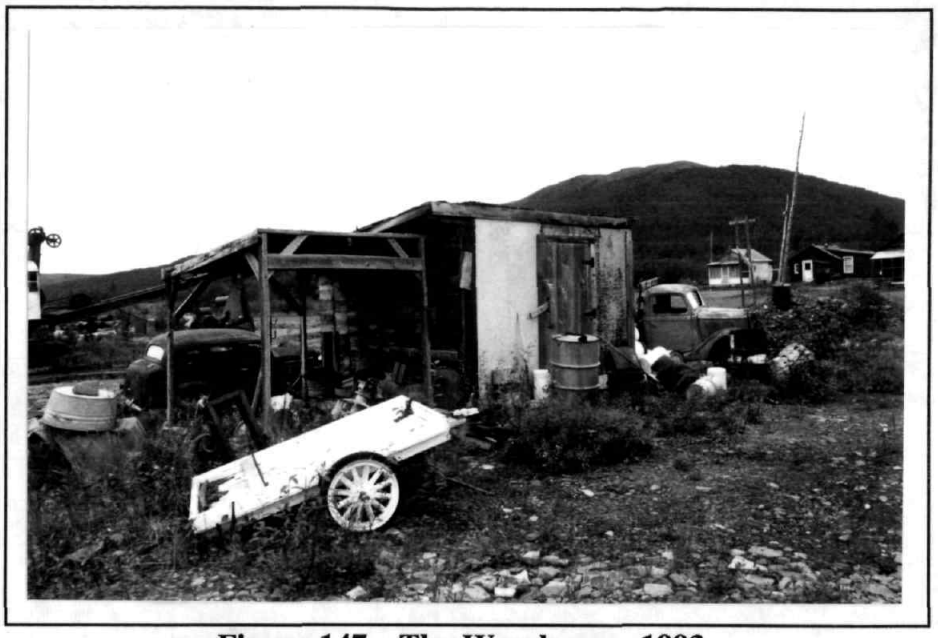
The **Warehouse (IDT-216)** is a rectangular, one-story, log framed building (Figure 147). The foundation consists of beams and logs on grade. The building measures 10'5"x11' and the shed roof is covered with corrugated metal. The exterior siding is celotex and batten boards. The main entry is on the east elevation, which has a plank door. A six-light, fixed sash window is located on the north elevation. A shed roof lean-to measuring 6'8"x10'1" is located on the south side of the shed. It is supported by corner posts and has no walls.

Figure 147. The Warehouse, 1993. The view is looking northwest.

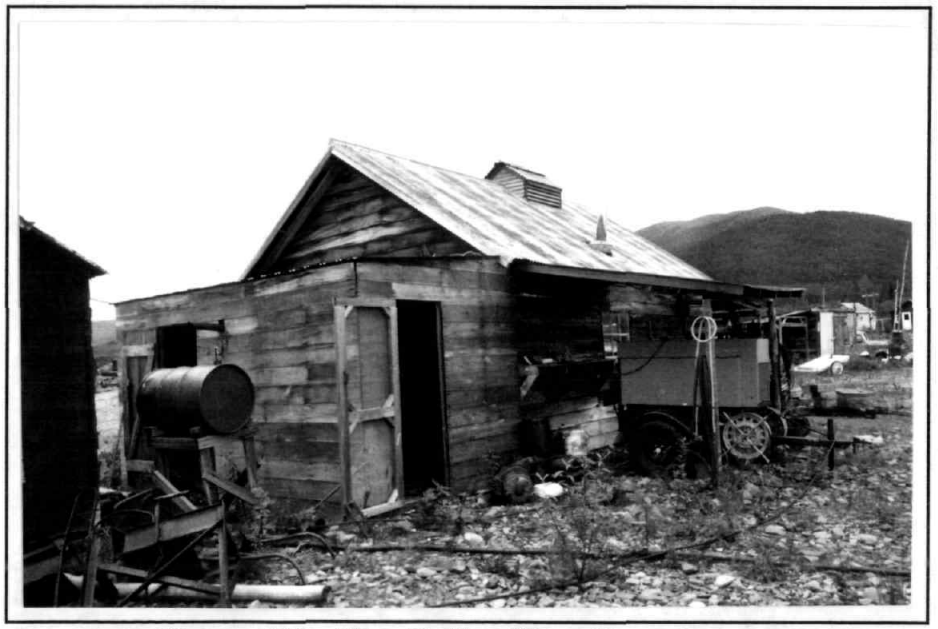
Figure 148. The Golden Horn Powerhouse, 1993. The view is looking northwest.

The **Golden Horn Powerhouse (IDT-217)** is a rectangular, one-story, wood frame building (Figure 148). The foundation consists of

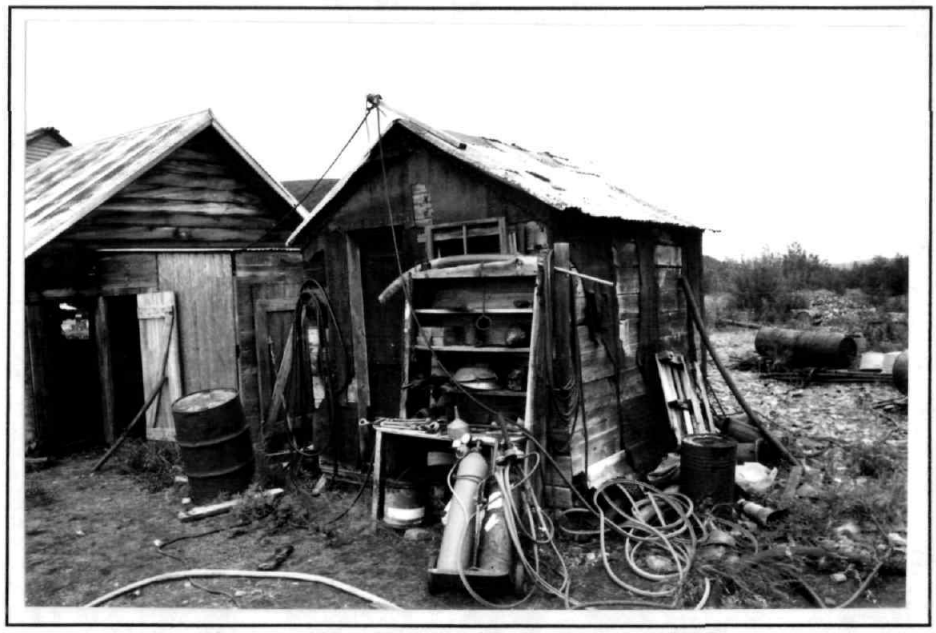
The **Drilling Shack on Skids (IDT-218)** is a rectangular, one-story, wood frame building (Figure 149) located about 8' south of the Golden Horn Powerhouse. The foundation is timber skids. The gable roof is covered with corrugated metal. The shack measures 8'2"x10'2". The exterior is covered with roofing felt over wood siding. The main entry is on the west elevation, which has a plank door and a single-light, fixed sash window.

Figure 149. The Drill Shack on Skids, 1993. The view is looking northeast.

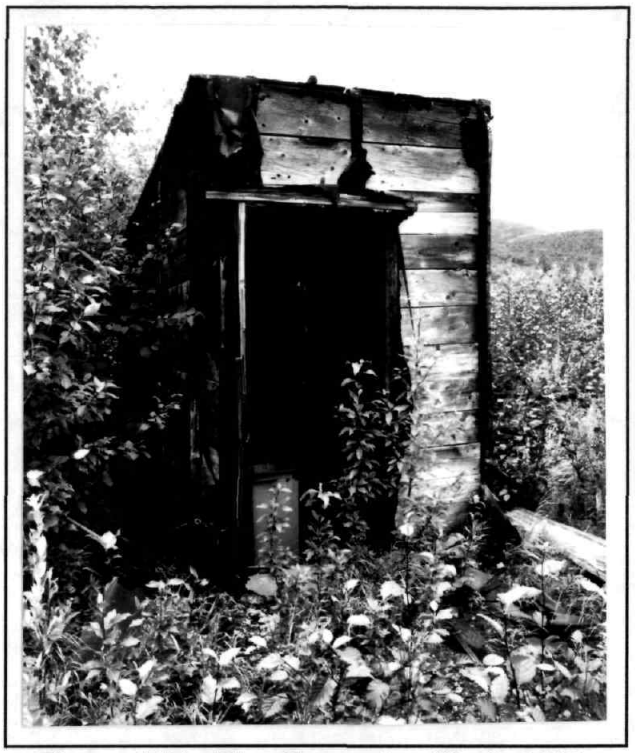
The **Generator Shed (IDT-225)** is a rectangular, one-story, wood frame building (Figure 157). The foundation is on grade. The shed roof and exterior walls are covered with roofing felt over wood decking. The main entry is on the south elevation, which contains a door opening but no door. The building sheltered a generator.

Figure 157. The Generator Shed, 1993. The view is looking north.

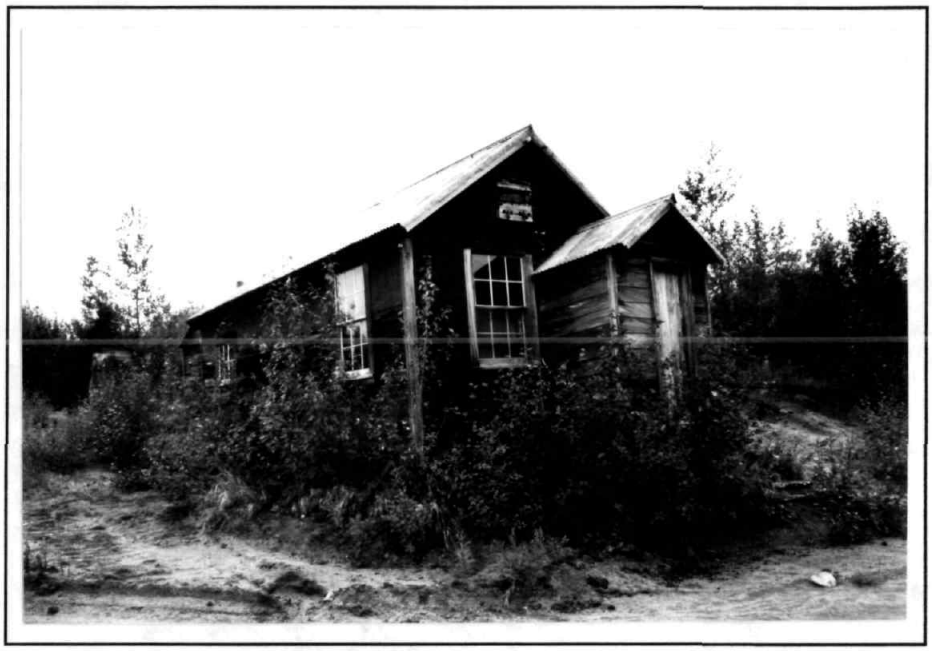
The **Golden Horn Assay Office (IDT-233)** is a rectangular, one-story, wood frame building (Figure 161). The foundation is timbers on grade. The gable roof is covered with corrugated metal. Shiplap siding covered by roofing felt covers the exterior walls of the building. An arctic entry with shiplap siding and a plank door is on the eastern half of the north elevation. Corrugated metal covers the gable roof. A 6/6 double-hung window is located west of the arctic entry. A 6/6 double-hung window and a six-light, fixed sash window are located on the east elevation of the building. A six-light, fixed sash window, a 6/6 double-hung window, and a five-panel door are on the west elevation. A shed roof addition on the south elevation has shiplap siding. The roof is covered with corrugated metal. A single-light, fixed sash window faces south.

Figure 161. The Golden Horn Assay Office, 1993. The view is looking southwest.

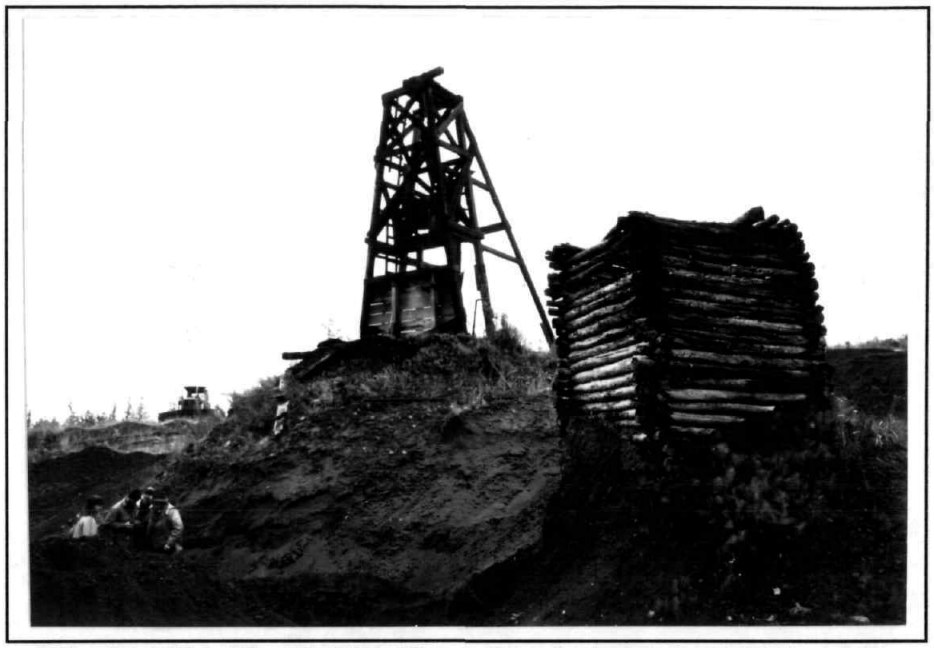
The **Golden Horn Log Cribbed Vertical Shaft (IDT-229)** of the Golden Horn Mine Complex is a log structure made with double-notched logs (Figure 163, right foreground). The depth of the shaft is unknown.

The **Golden Horn Wood Framed Vertical Shaft (IDT-230)** is a wood frame structure constructed with planks and timbers (Figure 163, center). The shaft is framed with vertical timbers and the interior is sided with horizontal wood planking. The vertical shaft extends down through four levels. The depth of the shaft is unknown (Bundtzen *et al.* 1992:22).

Figure 163. The Golden Horn Wood Framed Shaft (center) and Log Cribbed Shaft (right), 1993. The view is east.

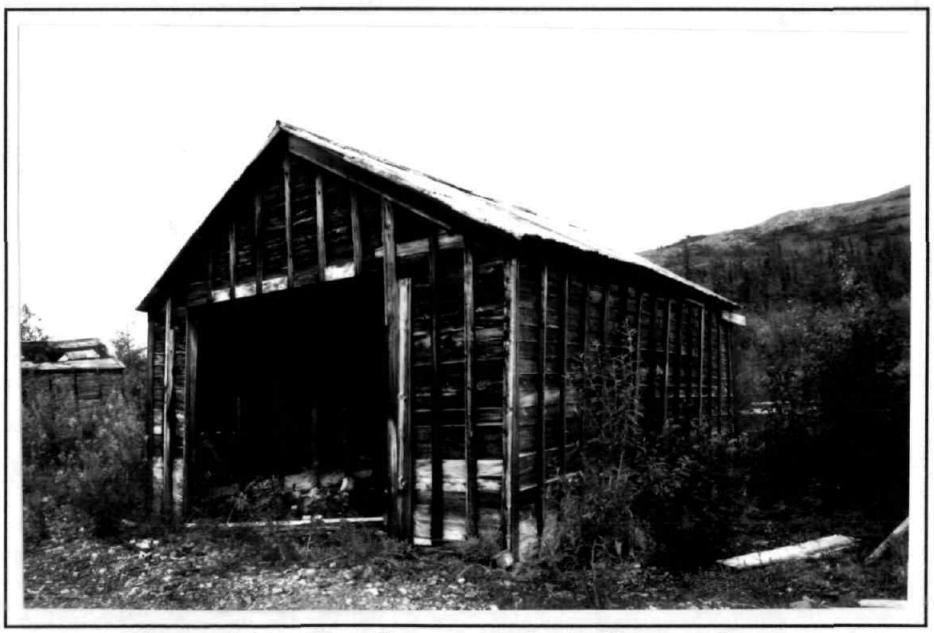
The **Garage (IDT-238)** is a rectangular, one-story, wood frame building (Figure 166). The foundation is on grade. The gable roof is covered with corrugated metal. The exterior is covered with roofing felt and battens over shiplap. Most of the roofing felt is missing from the walls. The building measures 17'4"x 20'7" and the gable roof is oriented east-west. The garage has large door openings on the east and west elevations, but the double

Figure 166. The Garage at the Fullerton Camp, 1993. The view is looking northeast.

doors are missing. Most of the interior of the garage is flooded by water from a beaver pond located immediately to the east.
