United States Department of the Interior

December 30, 2025

Subject: Stream focused data collection in and around the Salmon River watershed in 2025 to guide fish passage issue resolution and support future stream reclamation planning at the Platinum mine site.

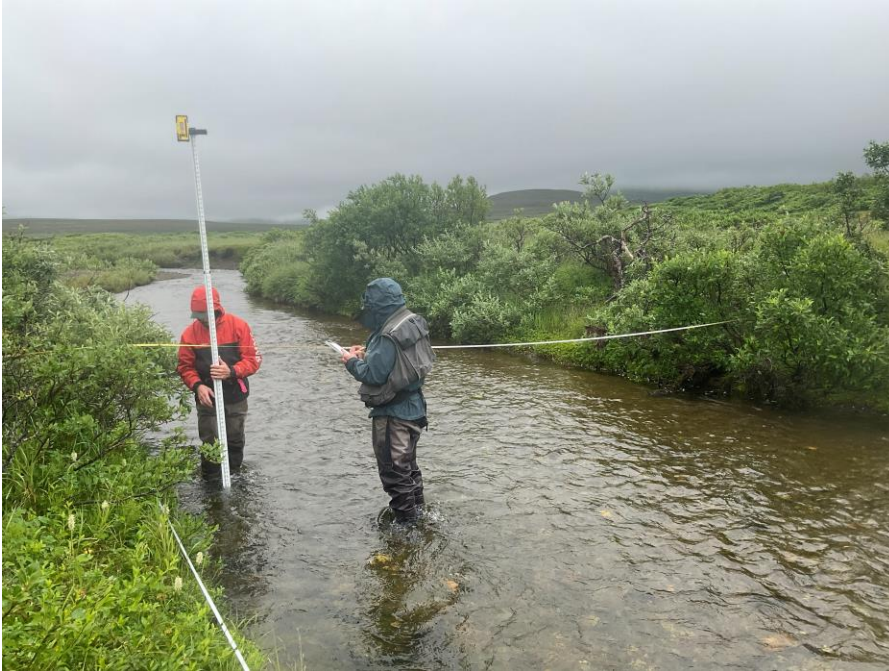
Photograph 1. BLM fisheries biologists collecting cross section survey data on Smalls Creek to understand stream characteristics at minimally disturbed sites in the area.

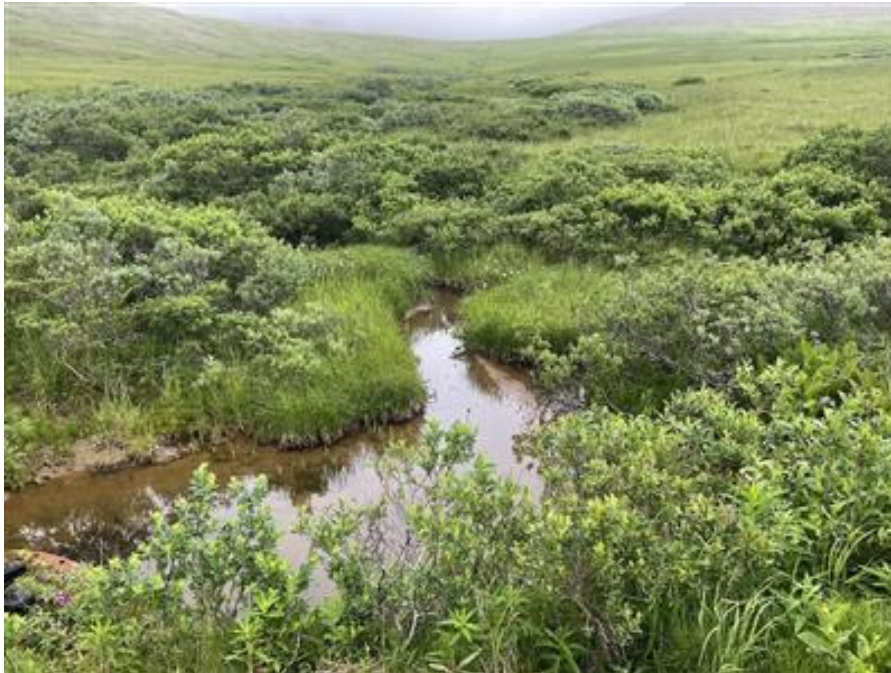
Like Boulder Creek, this small stream that drains from the east side of Red Mountain didn't have obvious signs of human impact beyond the area near the road.

Photograph 7. Last Chance Creek

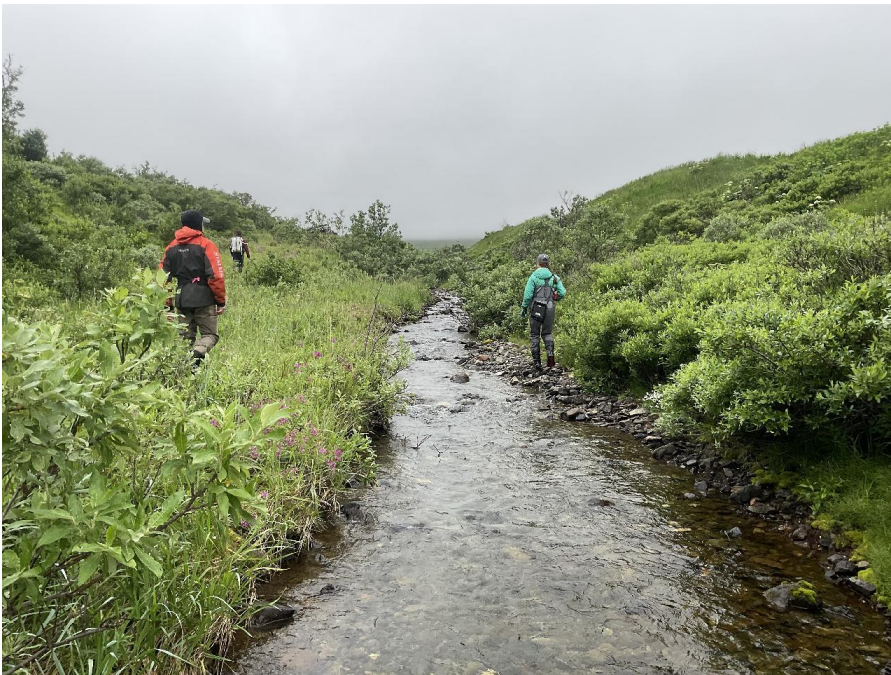
Photograph 12. Lower Platinum Creek showing accessible and well vegetated floodplain benches.

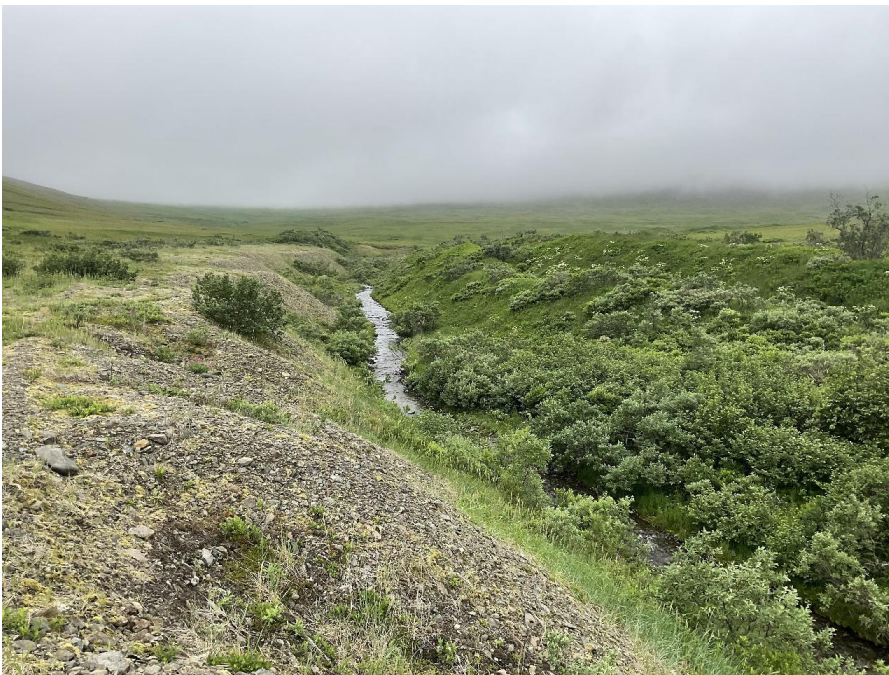
Photograph 14. Upstream view of the middle portion of Platinum Creek.

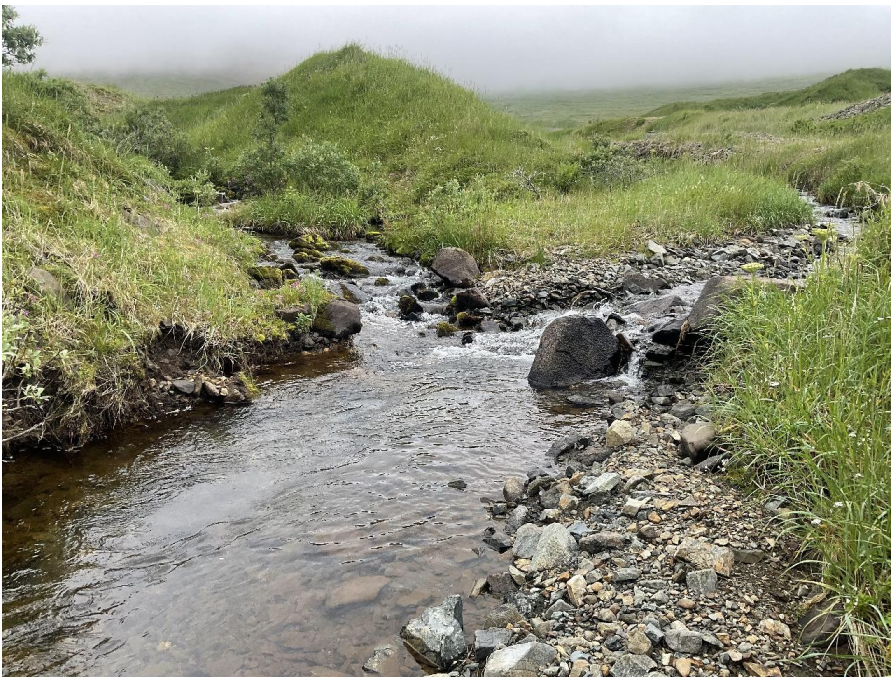
Photograph 16. Fox Gulch (right) joining Platinum Creek (left).

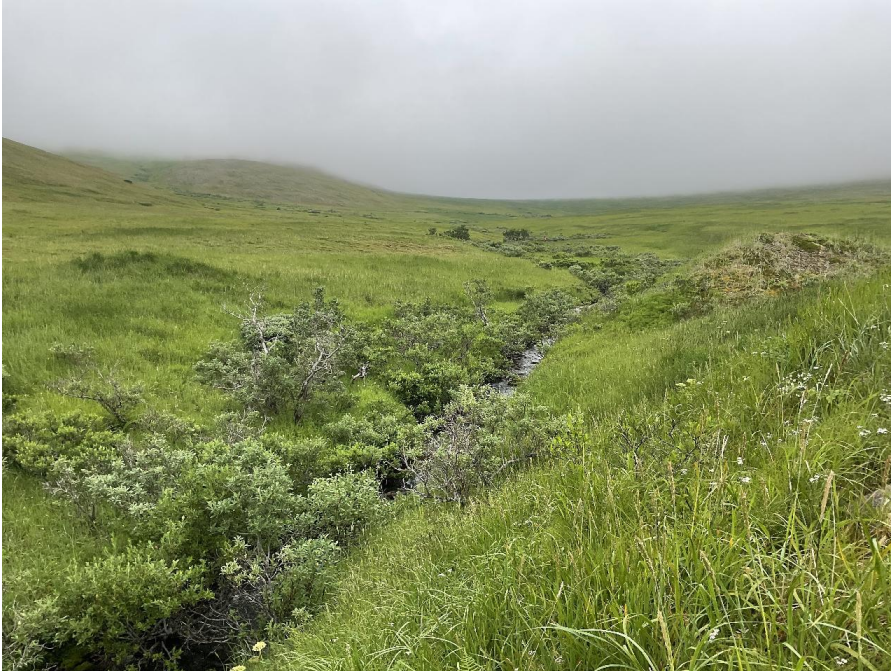
Photograph 17. Upper Platinum Creek

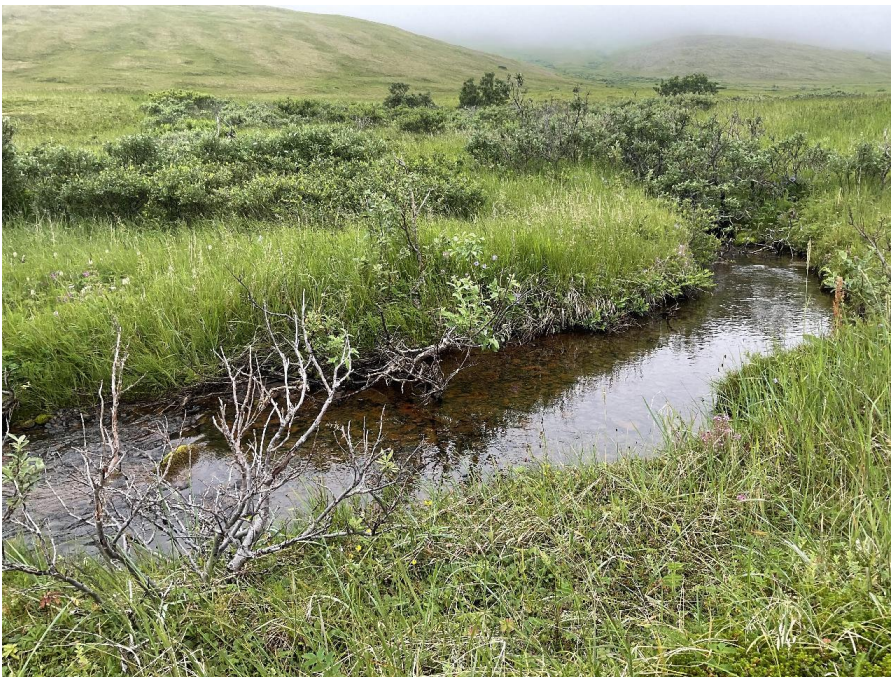
Photograph 18. Upper Platinum Creek with well-connected and vegetated floodplains and a mix of pools and riffles. This upper section is likely in reference condition and worth additional surveys.

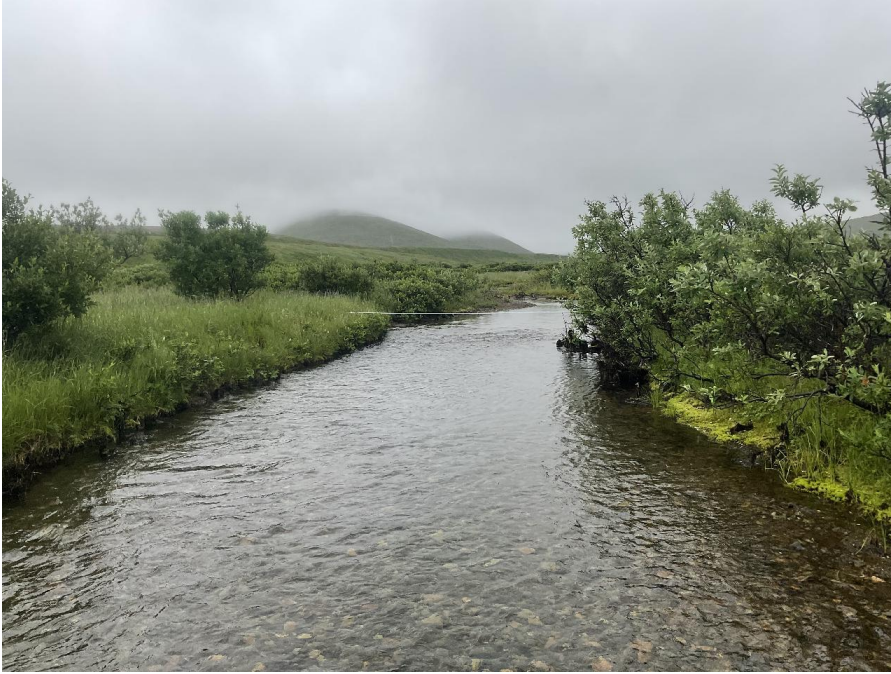
The section of Smalls River from its mouth to the area near the gravel pit is included in ADFG's Anadromous Waters Catalog (AWC) as coho (*Oncorhynchus kisutch*) and sockeye (*O. nerka*) rearing habitat; however adult chum (*Oncorhynchus keta*) and sockeye salmon were noted in several locations during geomorphic assessments. Chum salmon were noted well upstream of the current extent of anadromy described in the AWC. These observations will be shared with ADFG so that they can plan future fish surveys to update the catalog.

Photograph 25. Upper site on Smalls River where adult chum salmon were observed.
