BLM Alaska Open File Report 121
BLM/AK/GI-10/006+8340+F000
April 2010

Impacts of Truck Traffic across Unfrozen Tundra near Toolik Lake, Alaska

Martha K. Raynolds, Tim Craig, and Zachary Meyers

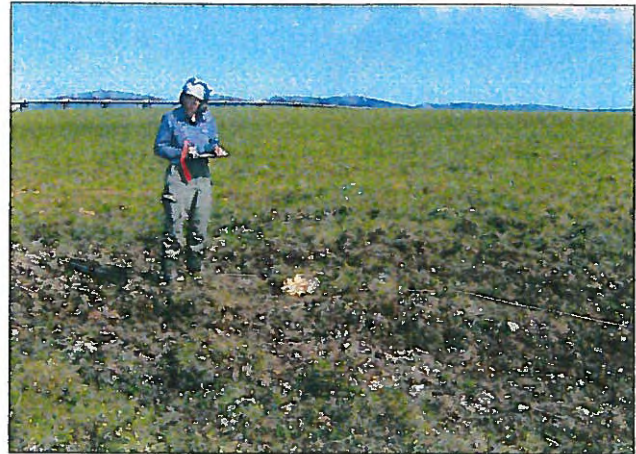
Figure 2. Martha Raynolds mapping the footprint of the excavation at the Close Truck site, 1 year after unauthorized trucks were driven over unfrozen tundra, Toolik Lake ACEC, Alaska, 6 July 2007.

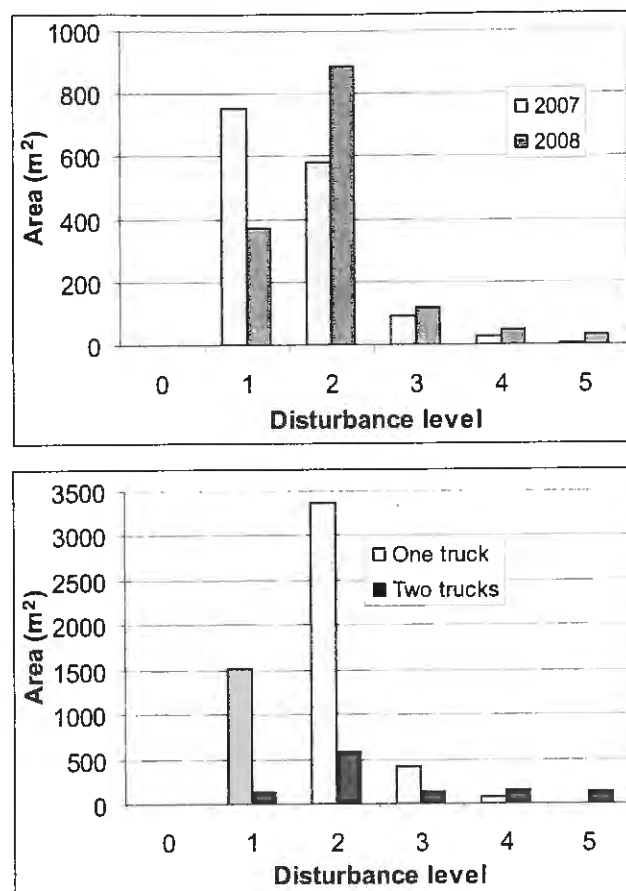
In 2008 most (61%) of the disturbance we detected along the tracks was Level 2, an increase from 40% found in 2007 (Table 3). We also observed an increase in areas with Levels 3–5 disturbance, along with a commensurate decrease in areas with Level 1 disturbance (Figure 5). Overall, disturbance levels were significantly greater in 2008 than 2007 ($p < 0.001$).

Figure 5. Area of different disturbance levels caused when 2 pickup trucks traveled on unfrozen tundra in September 2006, Toolik Lake ACEC, Alaska. Top – all trails evaluated in July 2007 and 2008. Bottom – trails caused by a single truck compared to trails caused by 2 trucks, evaluated in July 2008. Differences in distributions are significant (chi-square test, $p < 0.001$).

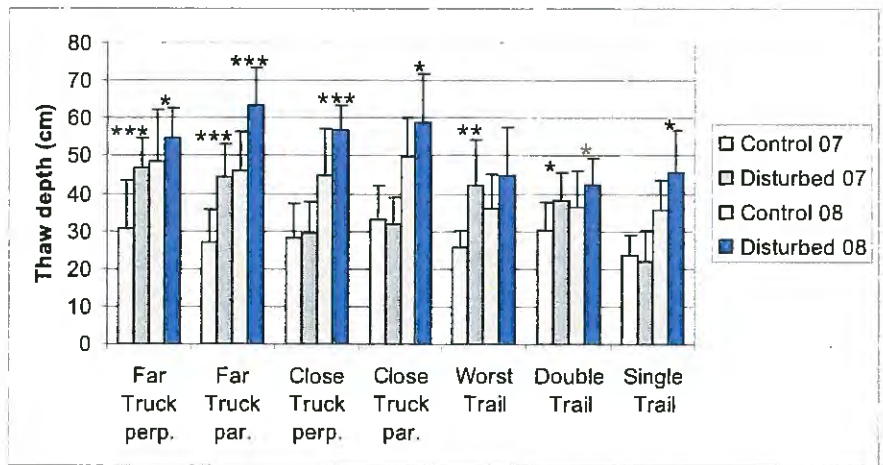
Thaw depths in disturbed areas were significantly deeper than in control areas at all but the worst trail, where 2 trucks had traveled (Figure 8). Thaw depths were deeper in 2008 than in 2007 (35–60 cm compared to 25–45

Figure 8. July 2007 and July 2008 thaw depths measured along 7 transects where habitat was disturbed by 2 pickup trucks that traveled on unfrozen tundra in September 2006, Toolik Lake ACEC, Alaska. One transect was perpendicular (perp.) and one parallel (par.) to the direction of travel at the Far Truck and Close Truck excavation sites, and 3 transects were perpendicular to trails where different disturbance levels occurred (Worst Trail, Double Trail, Single Trail). T-test significance of difference between disturbed and control in each year: * = $p < 0.05$, ** = $p < 0.01$, *** = $p < 0.001$.

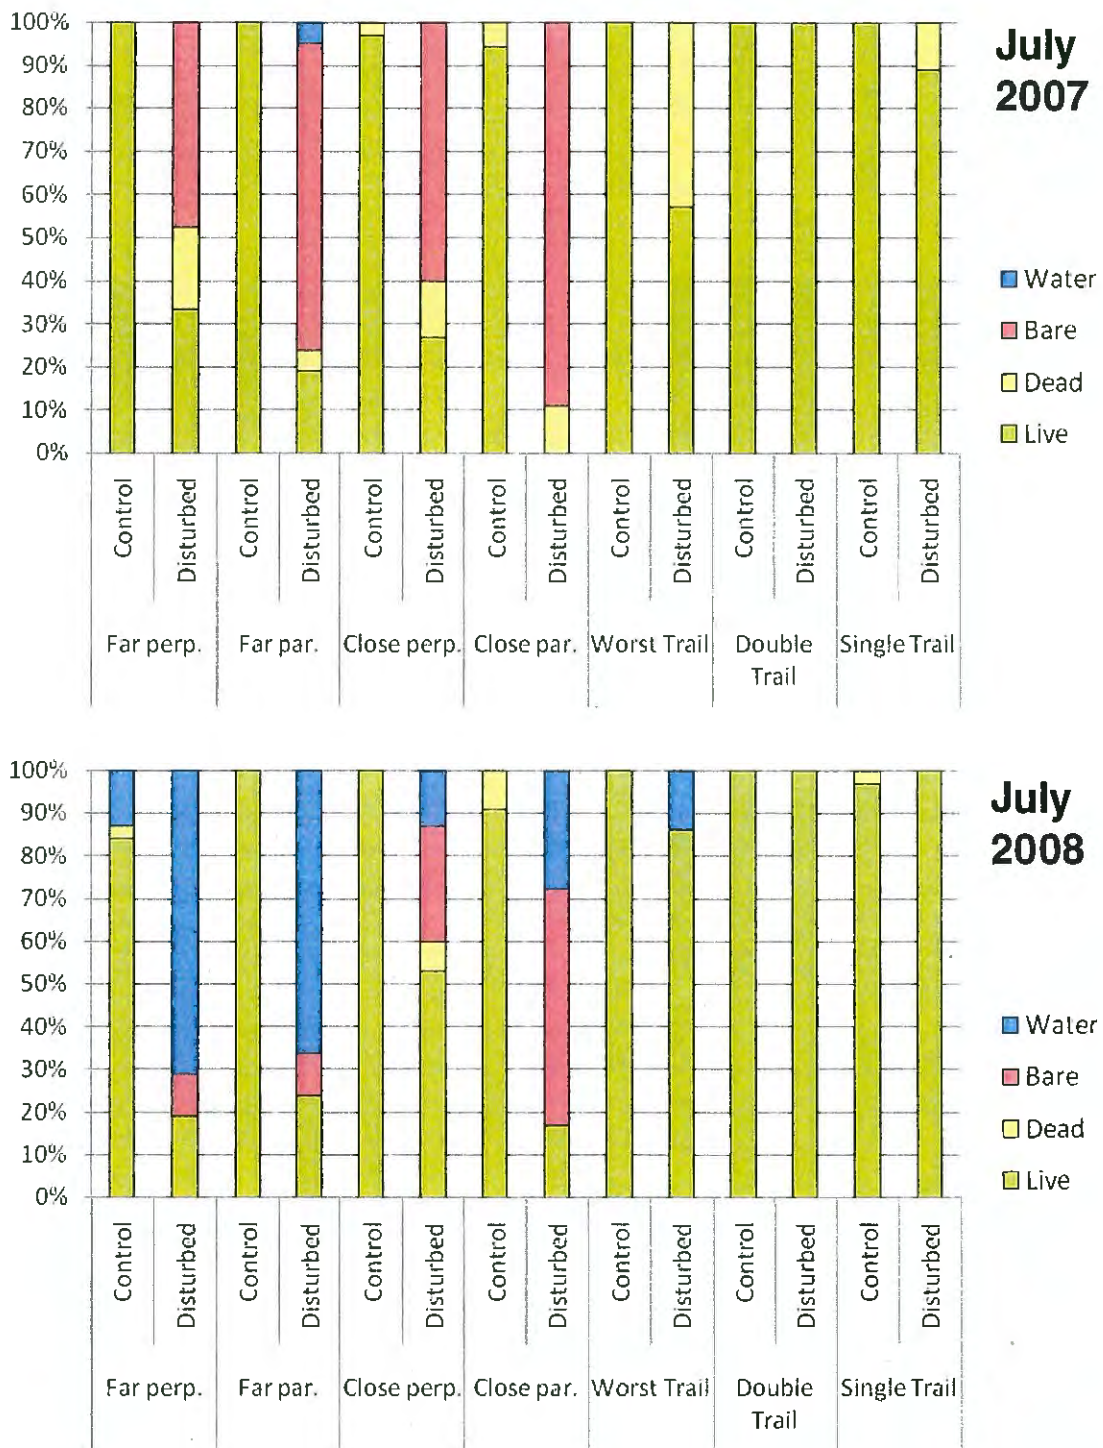
cm). We observed little change between years in the amount of vegetative cover on portions of the transects crossing trails compared to adjacent control areas (Figure 9). The excavation sites, on the other hand, had less live vegetation and more soil and water cover than control areas. Elevations were significantly lower in the disturbed areas than in the control areas for most transects (Figure 10). Elevations of the disturbed section were lower in 2008 than in 2007 for all 4 excavation transects.

Figure 9. Percent cover of live vegetation, dead vegetation, bare soil or peat, and water measured in July 2007 and July 2008 on control and disturbed sections of 7 transects where habitat was disturbed by 2 pickup trucks that traveled on unfrozen tundra in September 2006, Toolik Lake ACEC, Alaska. One transect was perpendicular (perp.) and one parallel (par.) to the direction of travel at the Far Truck and Close Truck excavation sites, and 3 transects were perpendicular to trails where different disturbance levels occurred (Worst Trail, Double Trail, Single Trail).

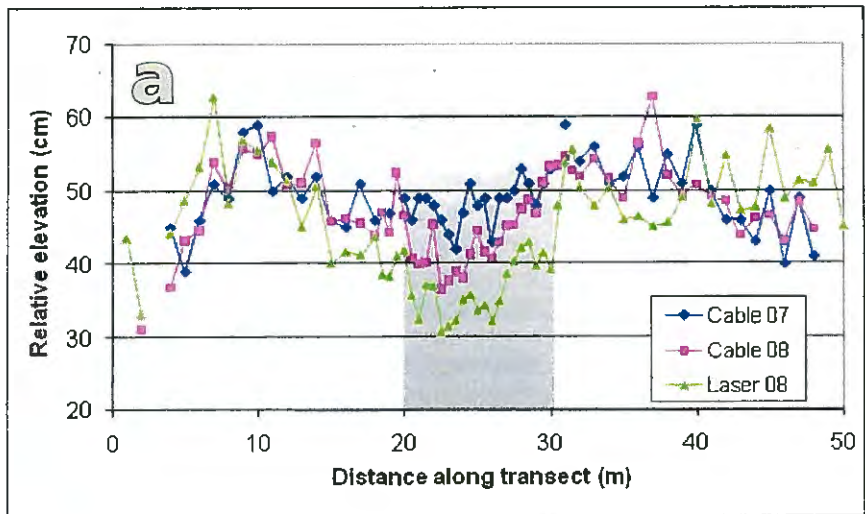
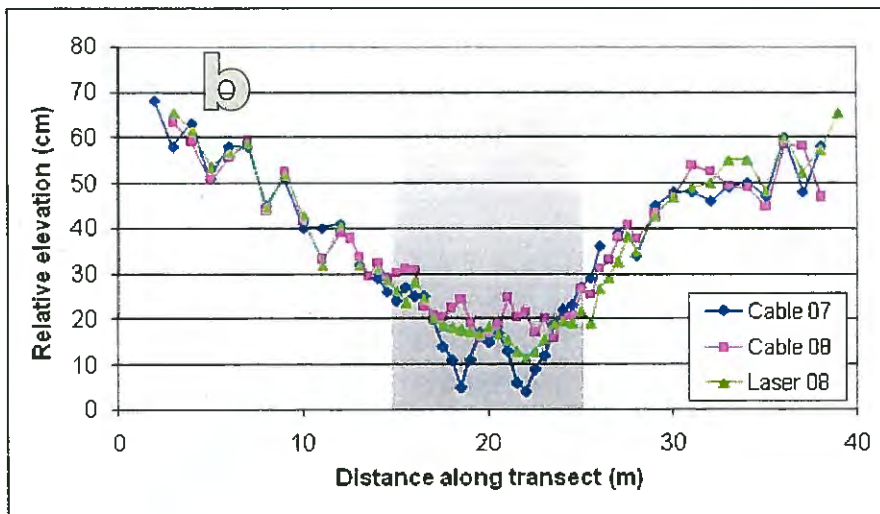
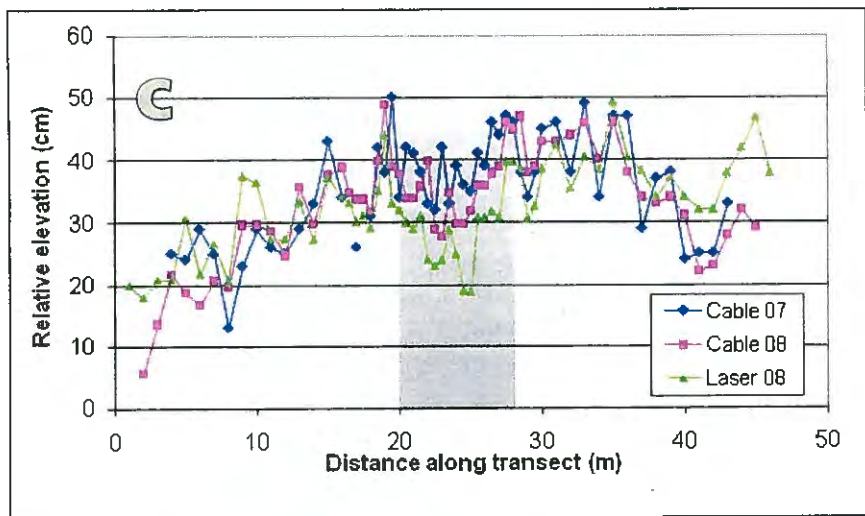
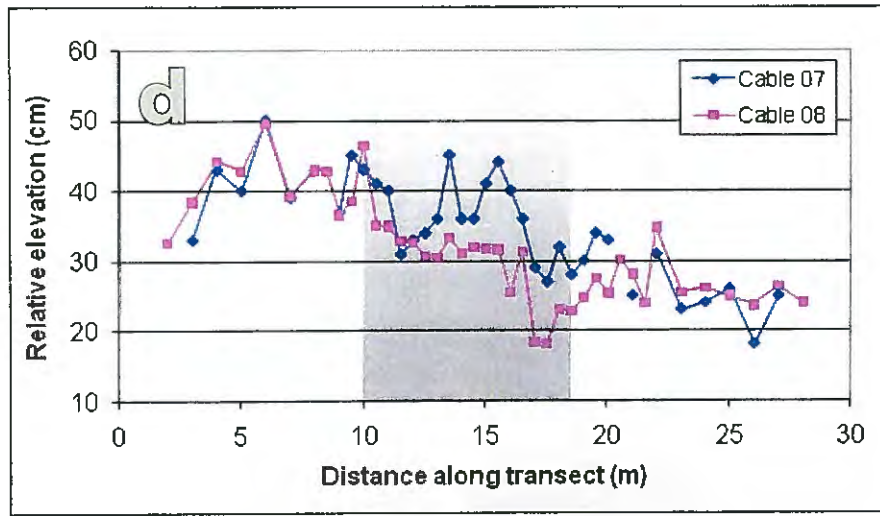
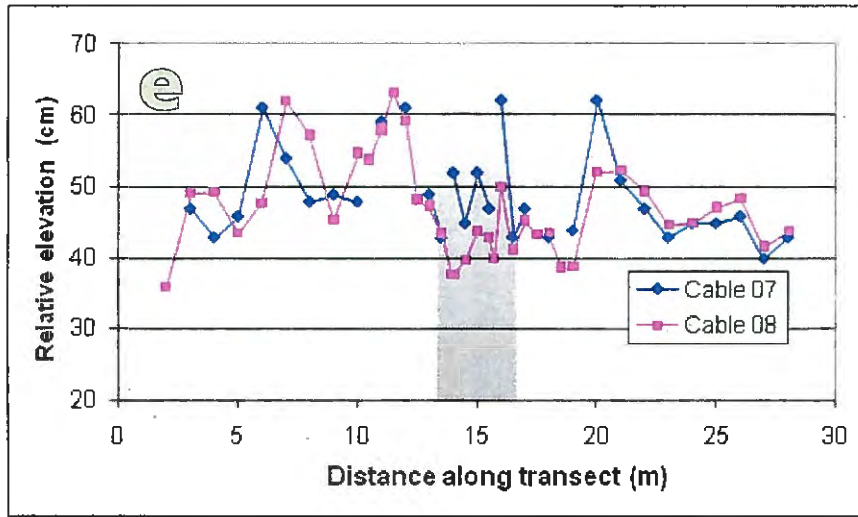
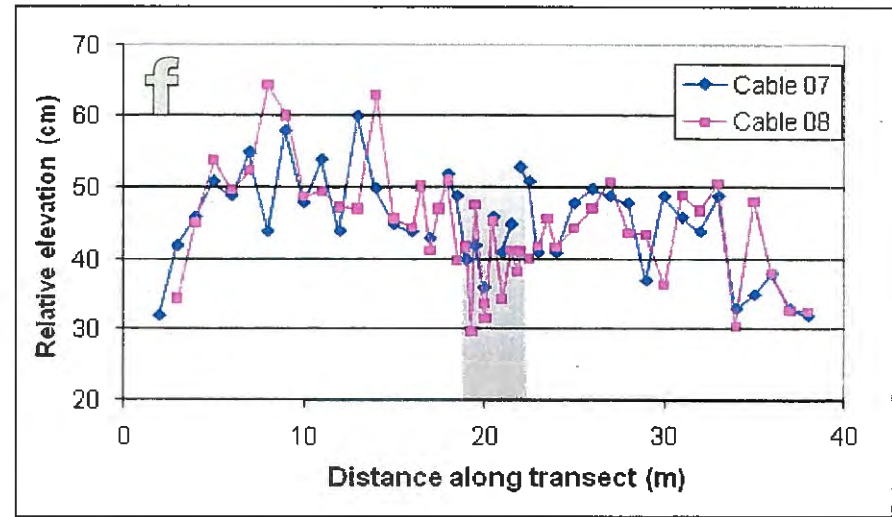
Figure 10. Elevation profiles of transects established across trails and truck excavation sites resulting from unauthorized truck travel over unfrozen tundra in September 2006, Toolik Lake ACEC, Alaska. Data were collected in July 2007 and July 2008. Transects: a) perpendicular to the Far Truck excavation, b) parallel to the Far Truck excavation, c) perpendicular to the Close Truck excavation, d) parallel to the Close Truck excavation, e) perpendicular to Worst Trail (Disturbance Level 5), f) perpendicular to the Double Trail (Disturbance Level 2), g) perpendicular to the Single Trail (Disturbance Level 1). The disturbed area is in the middle of each transect, shown with gray shading. See Table 5 for t-test analysis of differences.
