Appendix B

2010 EE/CA Field Investigation

Photograph Log

**Site Features
 Chicago Research Site
 Lake County, California**
 Engineering Evaluation/Cost Analysis Report
 The Chicago Research Site

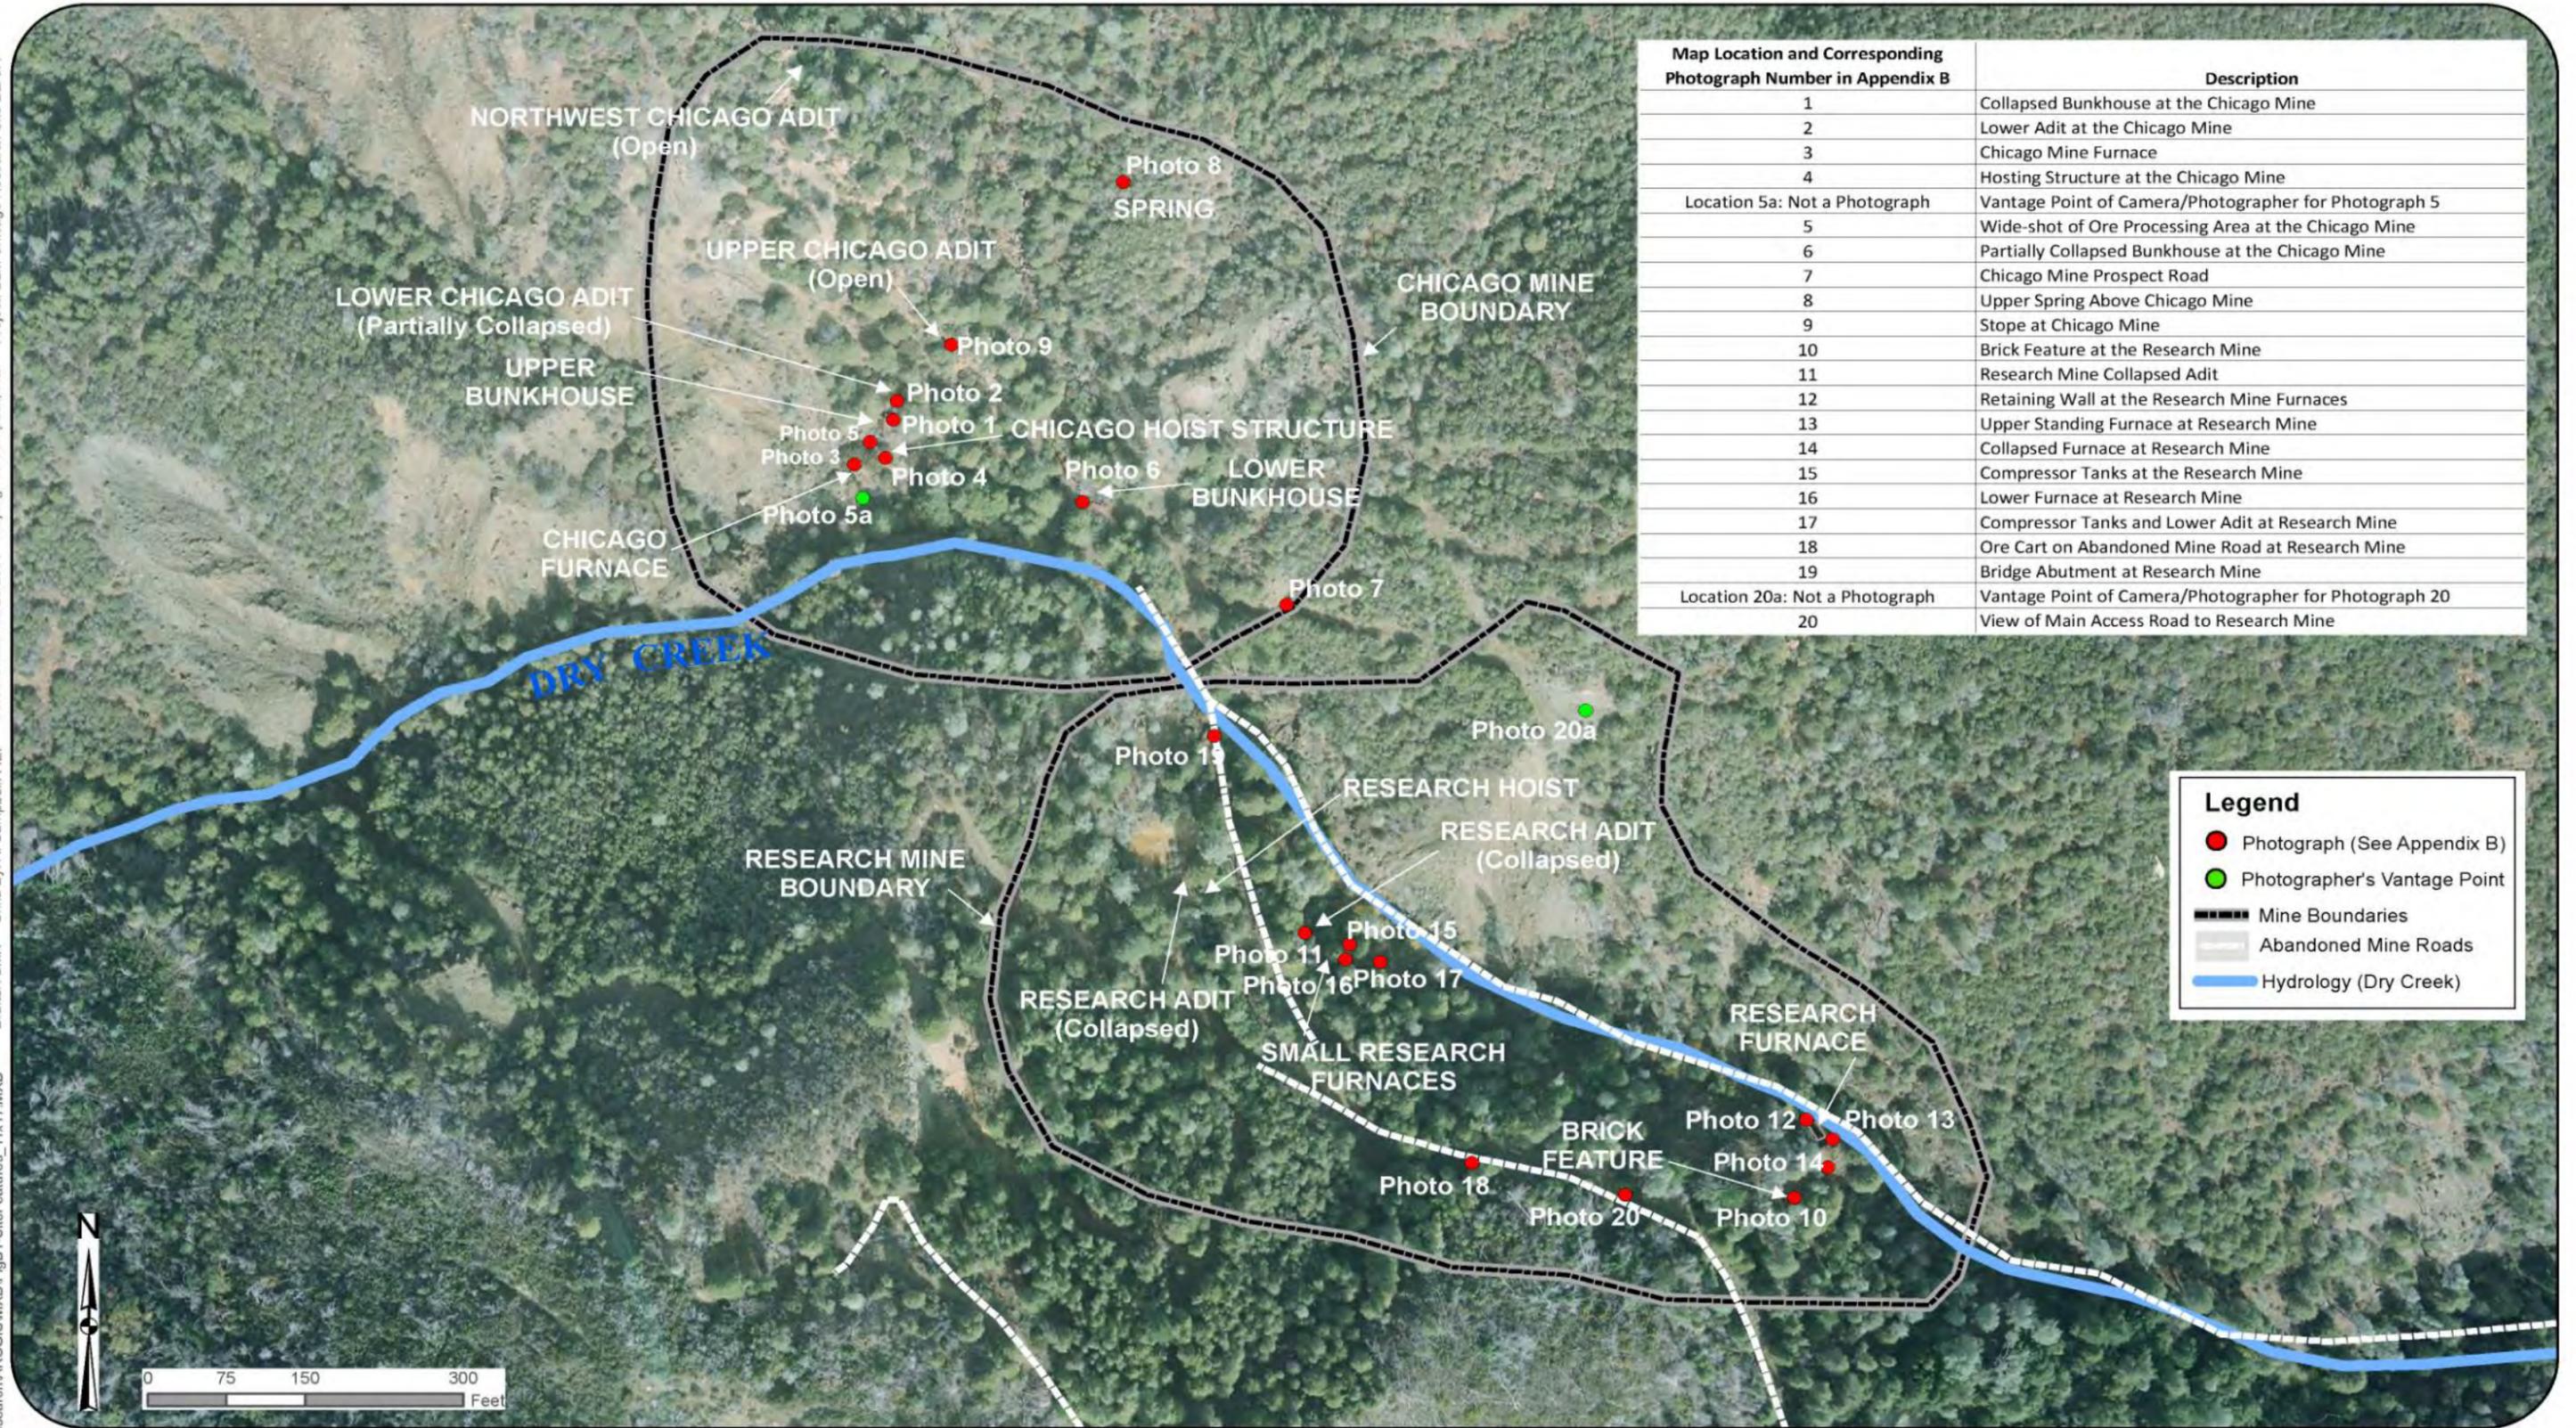
Figure
B-1

Map Location and Corresponding Photograph Number in Appendix B	Description
1	Collapsed Bunkhouse at the Chicago Mine
2	Lower Adit at the Chicago Mine
3	Chicago Mine Furnace
4	Hosting Structure at the Chicago Mine
Location 5a: Not a Photograph	Vantage Point of Camera/Photographer for Photograph 5
5	Wide-shot of Ore Processing Area at the Chicago Mine
6	Partially Collapsed Bunkhouse at the Chicago Mine
7	Chicago Mine Prospect Road
8	Upper Spring Above Chicago Mine
9	Stope at Chicago Mine
10	Brick Feature at the Research Mine
11	Research Mine Collapsed Adit
12	Retaining Wall at the Research Mine Furnaces
13	Upper Standing Furnace at Research Mine
14	Collapsed Furnace at Research Mine
15	Compressor Tanks at the Research Mine
16	Lower Furnace at Research Mine
17	Compressor Tanks and Lower Adit at Research Mine
18	Ore Cart on Abandoned Mine Road at Research Mine
19	Bridge Abutment at Research Mine
Location 20a: Not a Photograph	Vantage Point of Camera/Photographer for Photograph 20

20	View of Main Access Road to Research Mine
