Alternatives

Arena/Stable Rehabilitation Meadowood Special Recreation Management Area Lorton, Va

April, 2008

OC Project Number
AE-ES-007

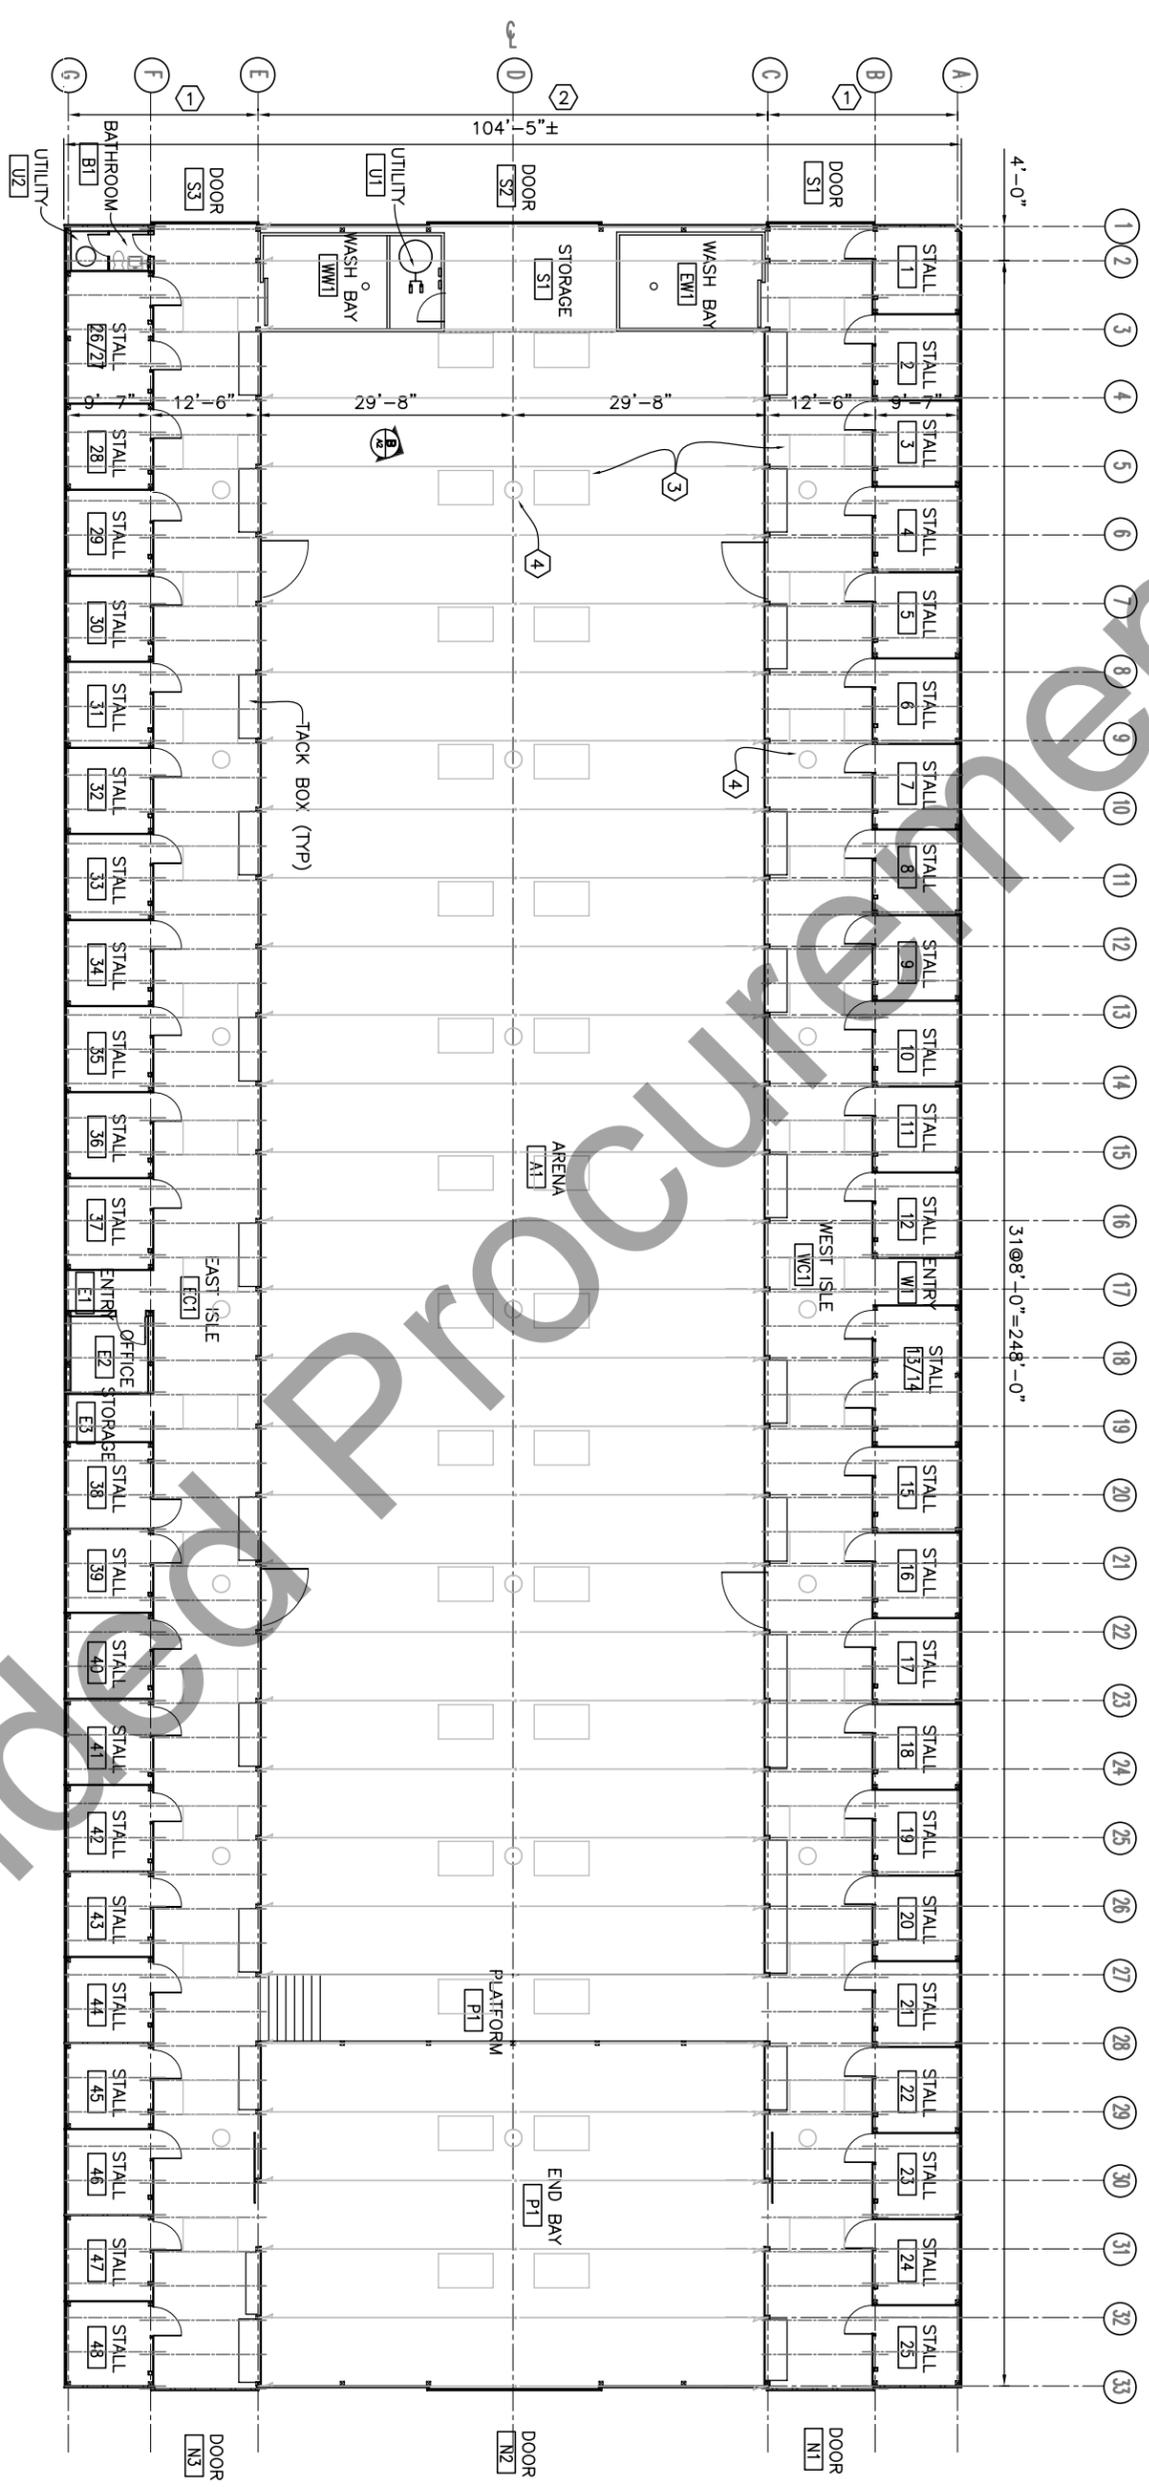
A ROOF FRAMING PLAN
SCALE (A)

Structural: The roof framing has some deficiencies, but in general the structure appears adequate to support current loads as well as the new sprinkler piping. The arena roof joists (2X4's) should be doubled, additional bracing should be applied to the arena trusses and some of the truss anchor points require additional blocking which is in place at most areas, but for some reason left off at others.
