Missouri River PFC Assessment

Past...Present...Future

Step 2 – Field Evaluation

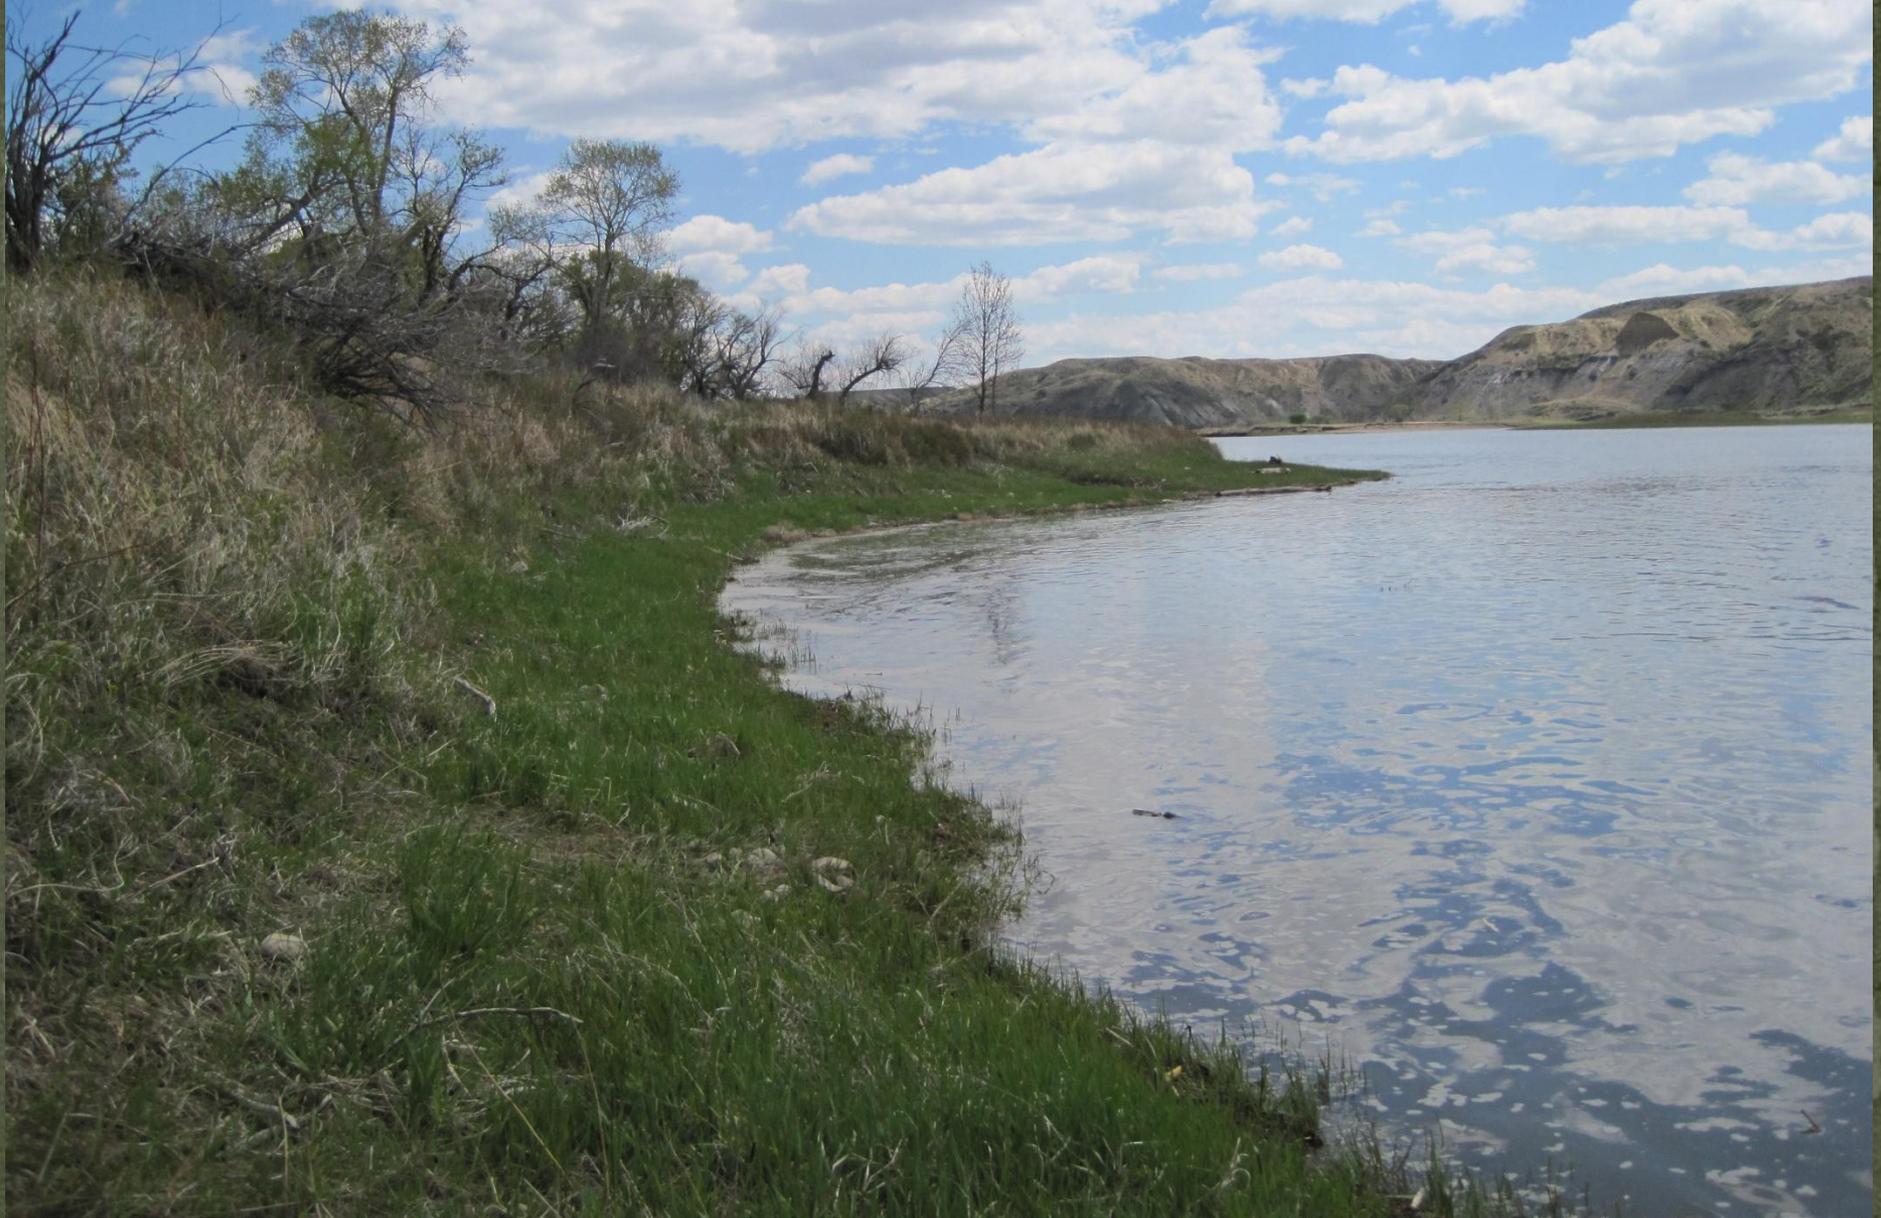
Above O'Hanlon Coulee

- Gravel and cobble common in Zones 1 and 2
- Trees and shrubs in Zones 1 and 2 showed damage from ice and water scouring
- More trees and shrubs present in back channel areas
- No unusual bank erosion or bare areas
- Noxious weeds, non-native grasses, including reed canarygrass, common in Zone 2

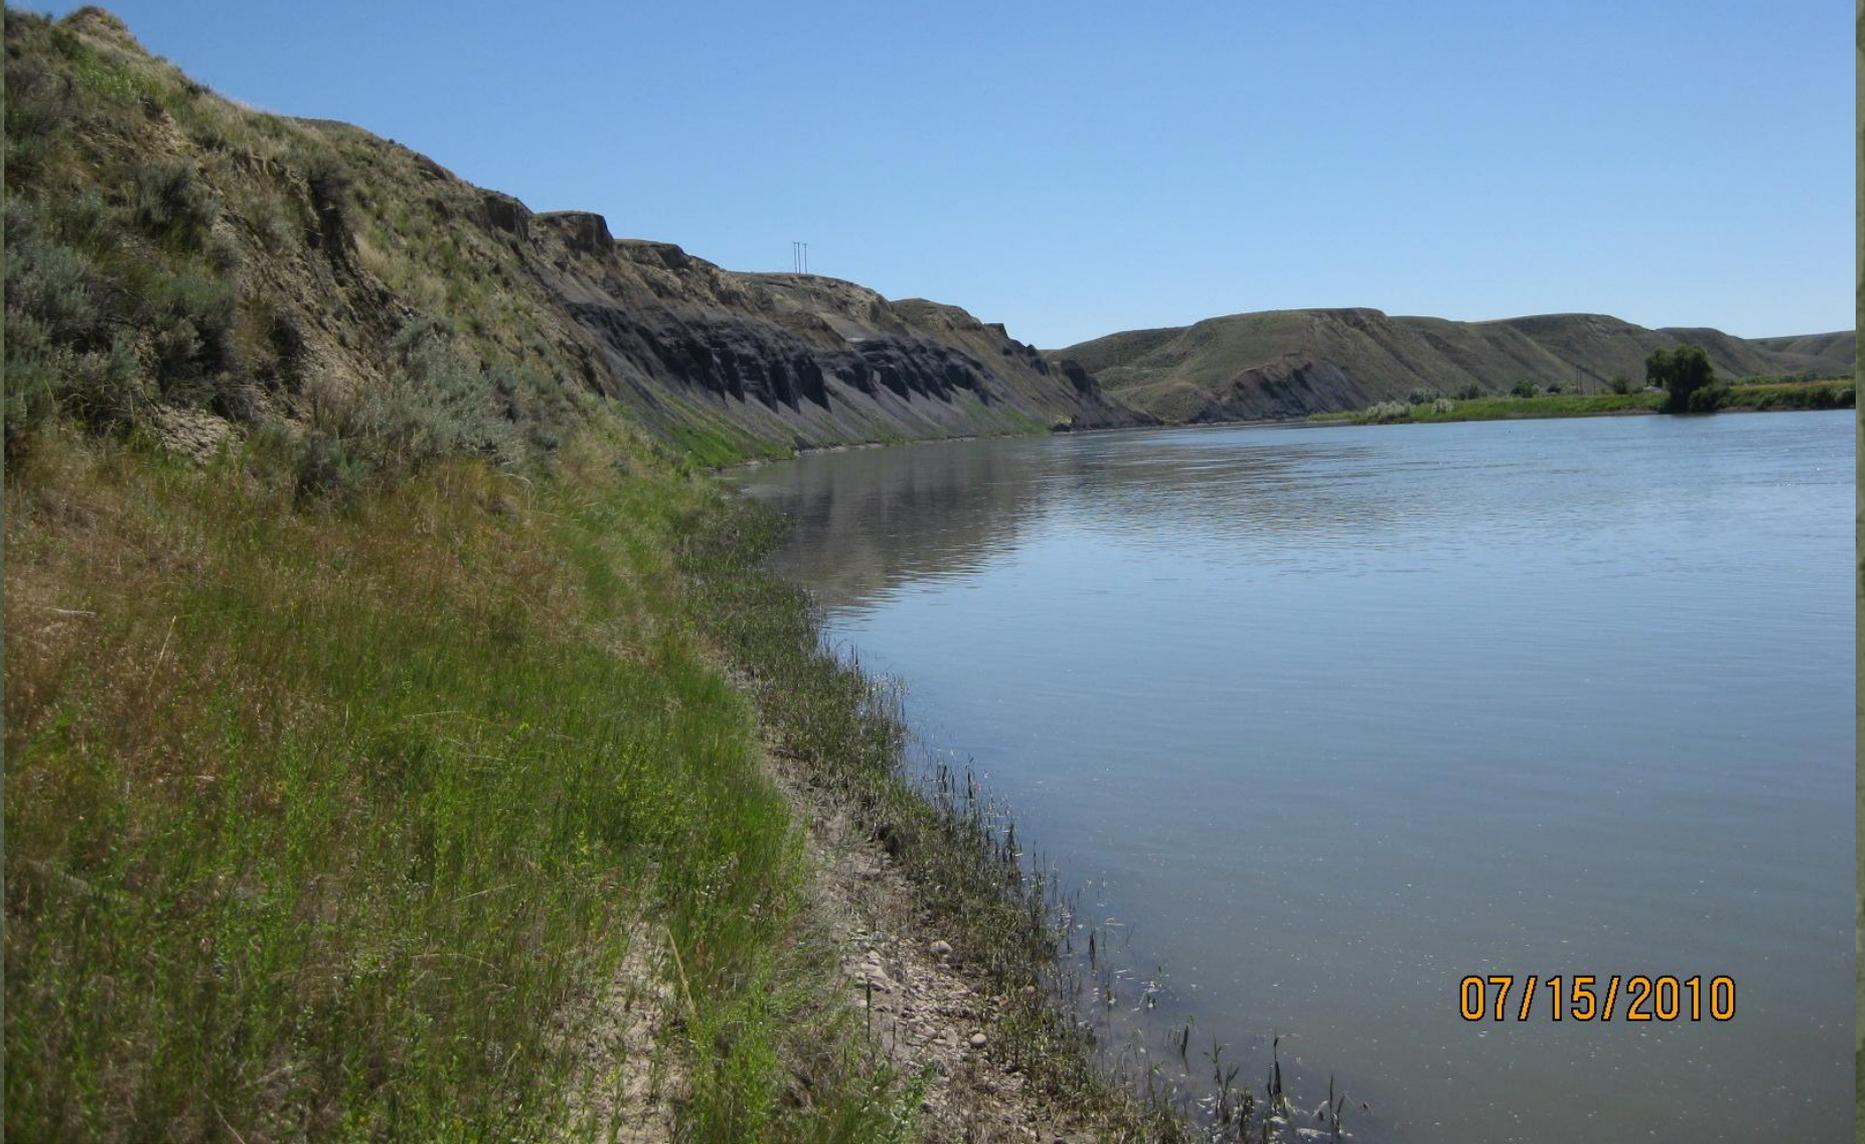
Churchill Bend

- No unusual signs of bank erosion, exposed banks or sparsely vegetated areas
- Non-native grasses, Russian olive, reed canarygrass and noxious weeds were common
- Woody plants severely impacted by beavers and ice; affecting tree and shrub survival
- Largest deposition areas at tributary junctions

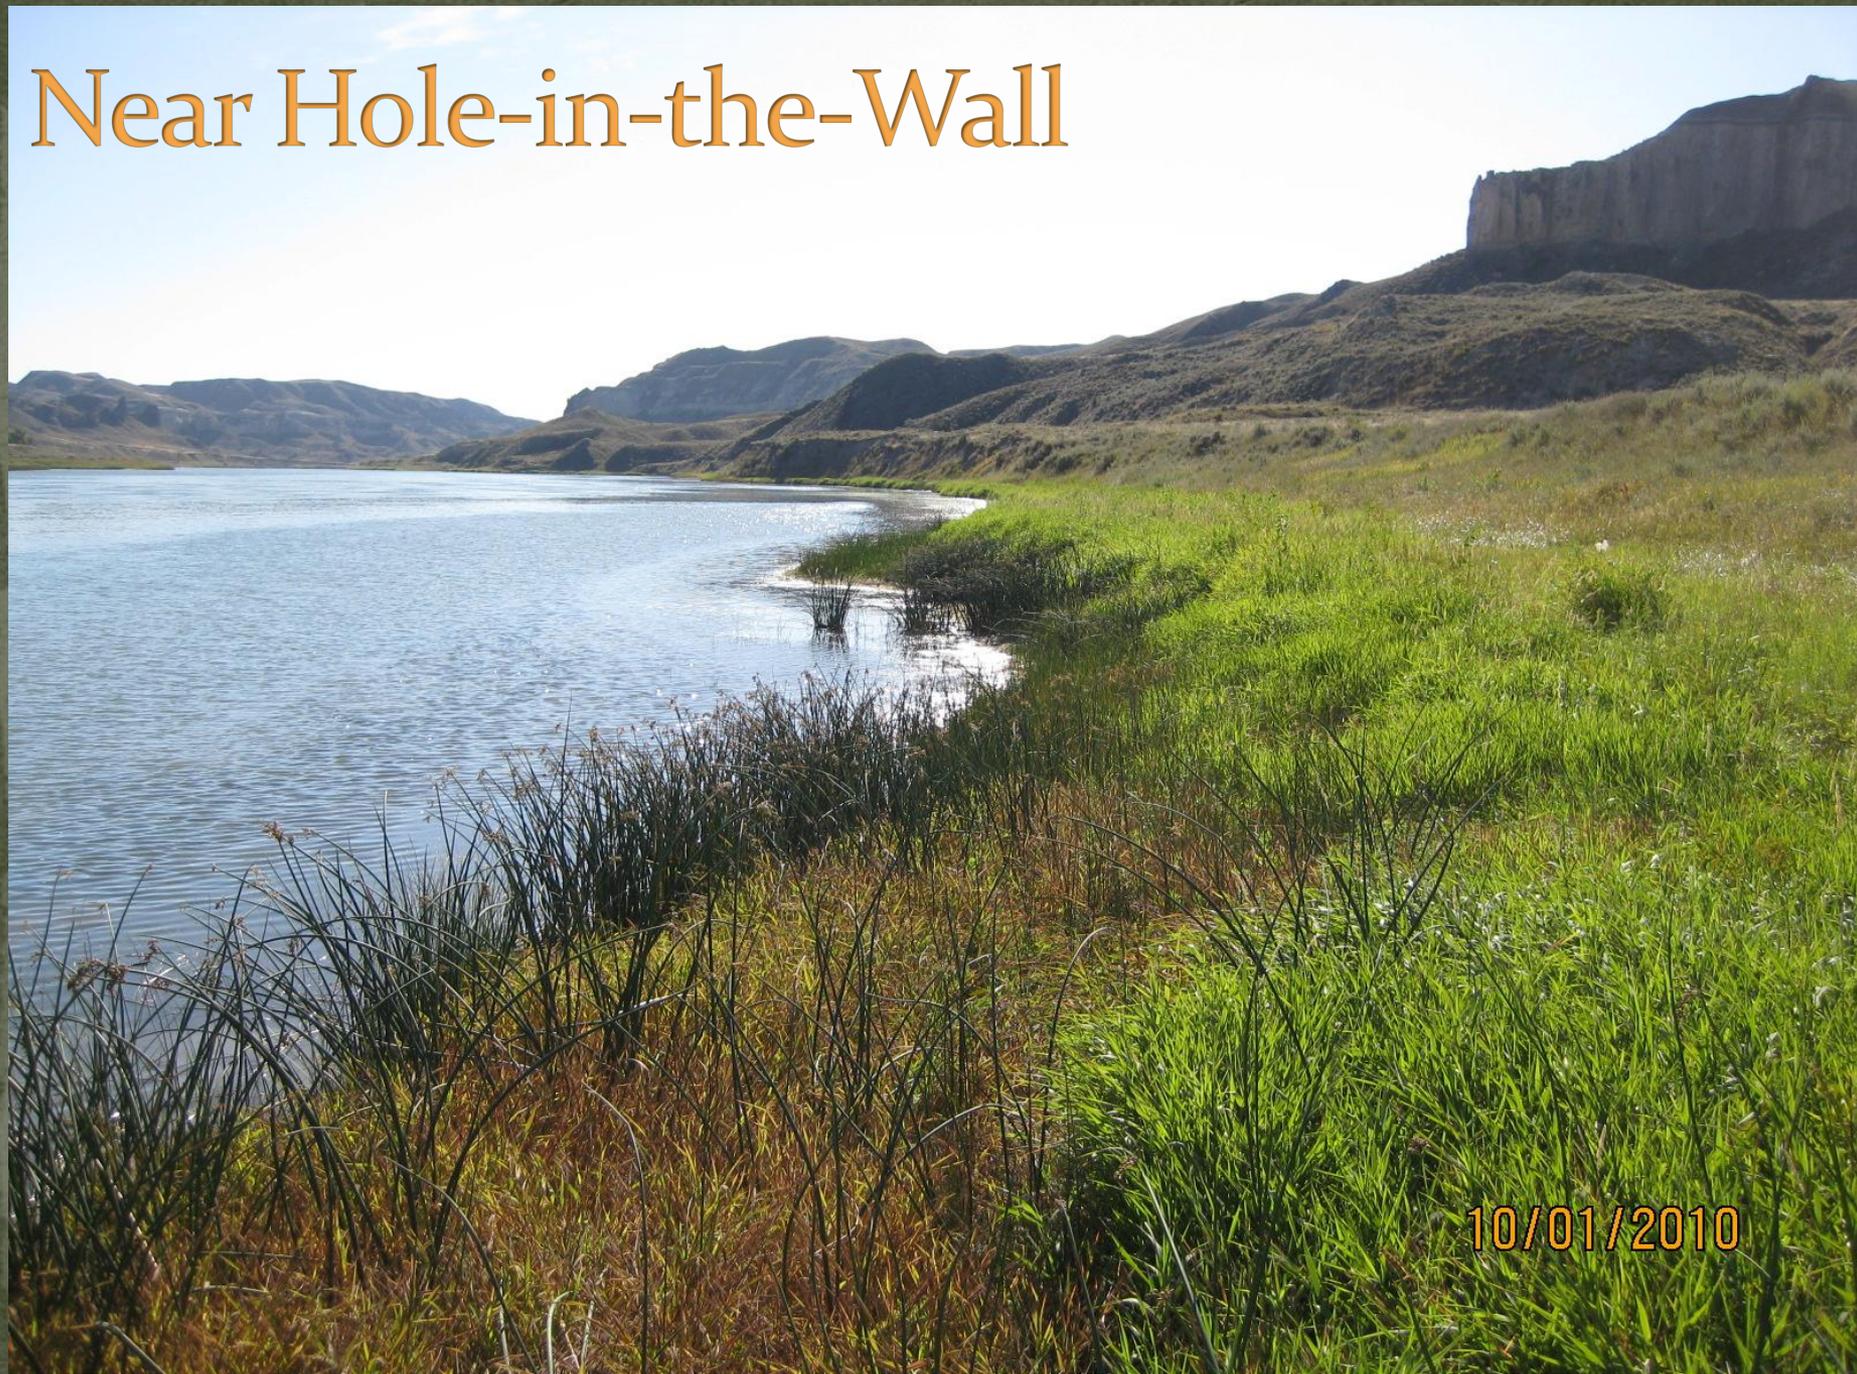
Near Hole-in-the-Wall

- Tributary junctions forming larger deposition areas
- Reed canarygrass, yellow sweetclover, noxious weeds, and Russian olive present in Zone 2
- Trees and shrubs in trace amounts, re-sprouting from the base following ice & beaver damage
- Mechanical ice drives strongly influencing vegetation through reach

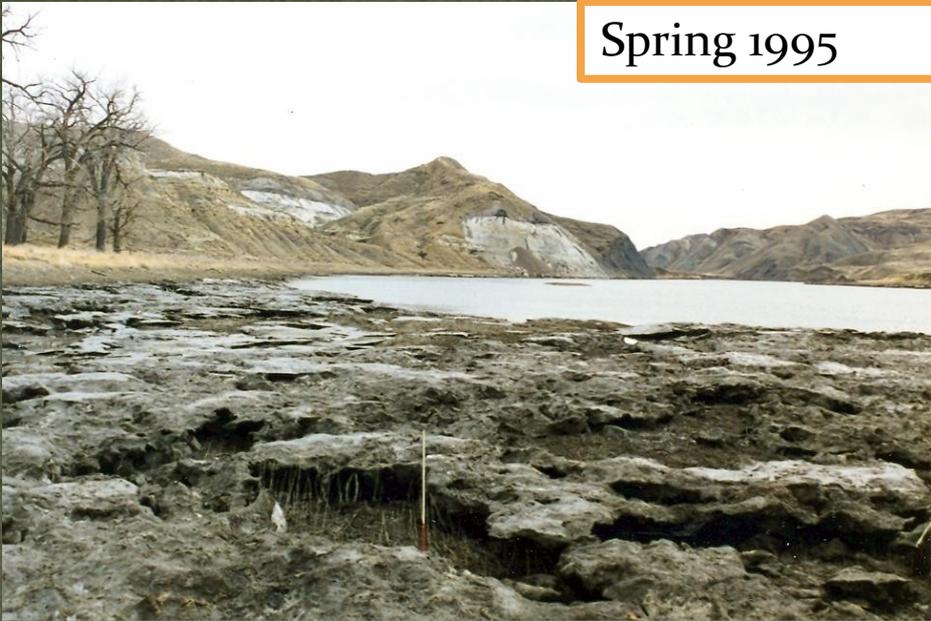
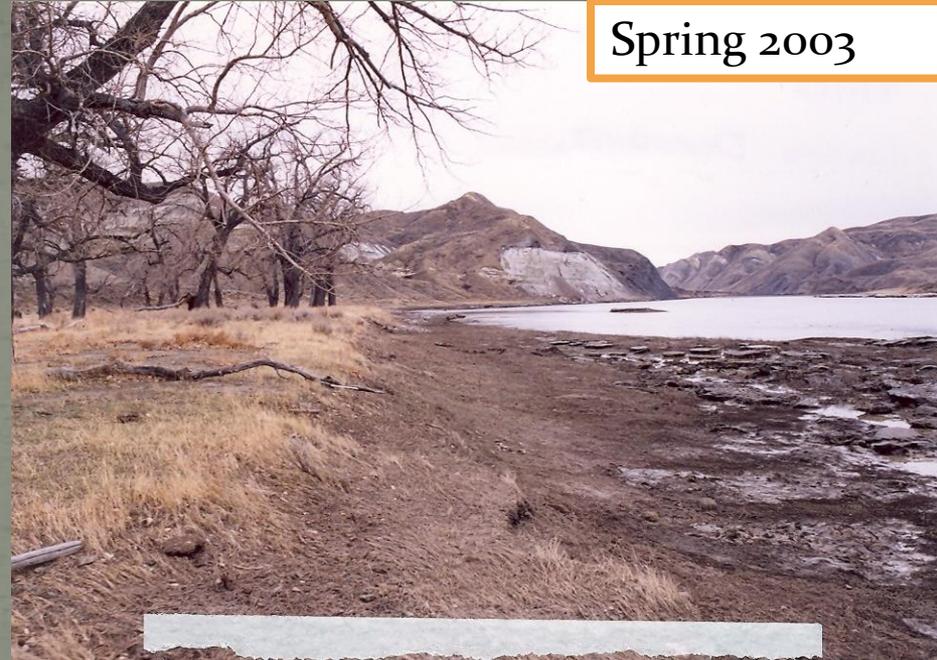
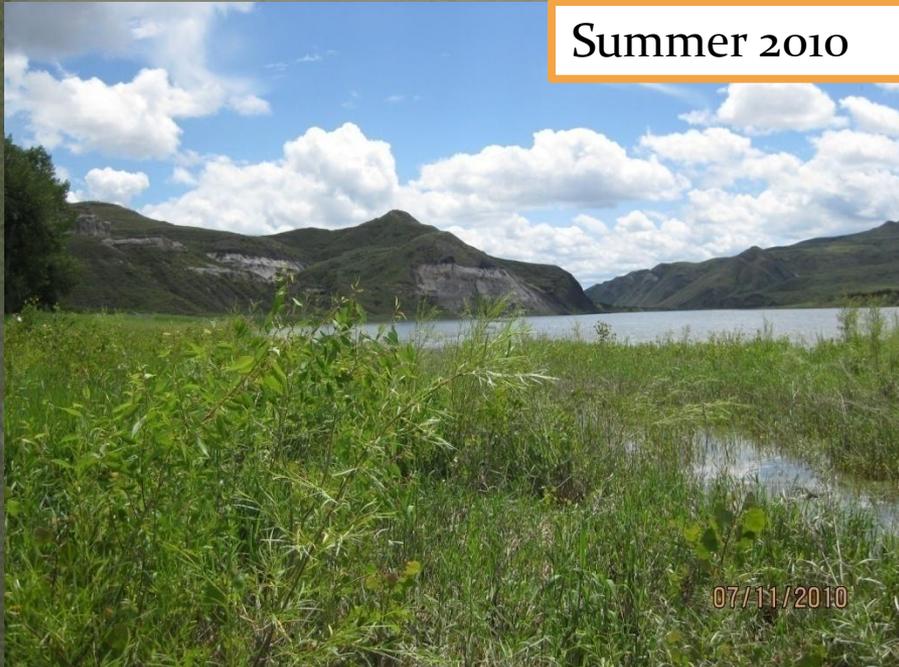
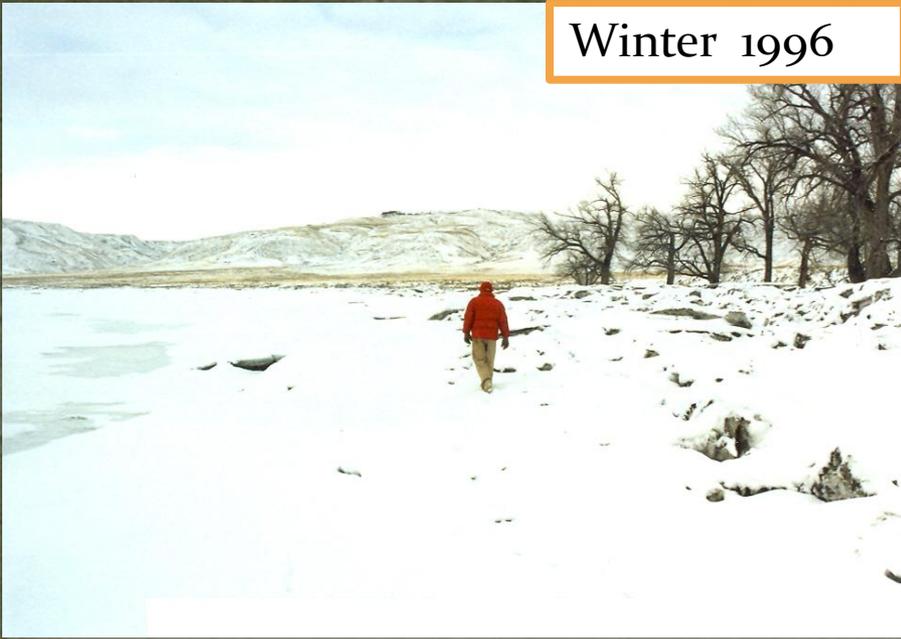
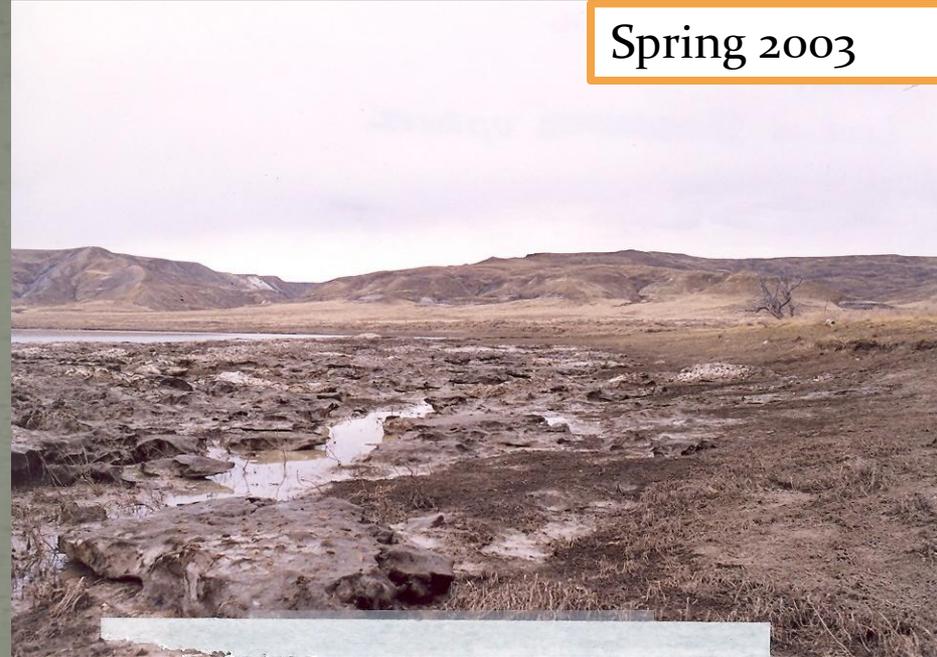
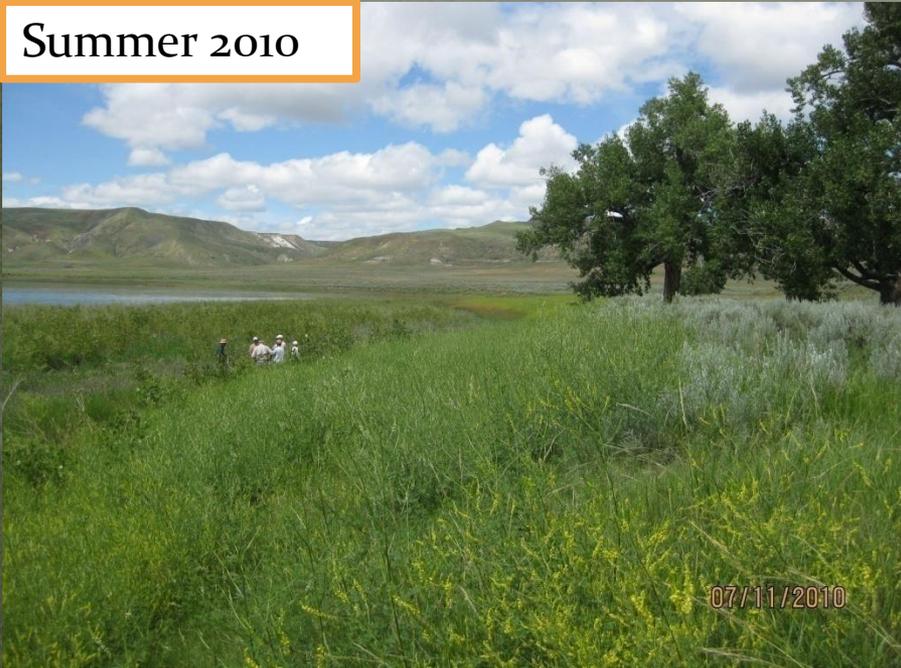
Pablo Rapids

Response of vegetation following high water

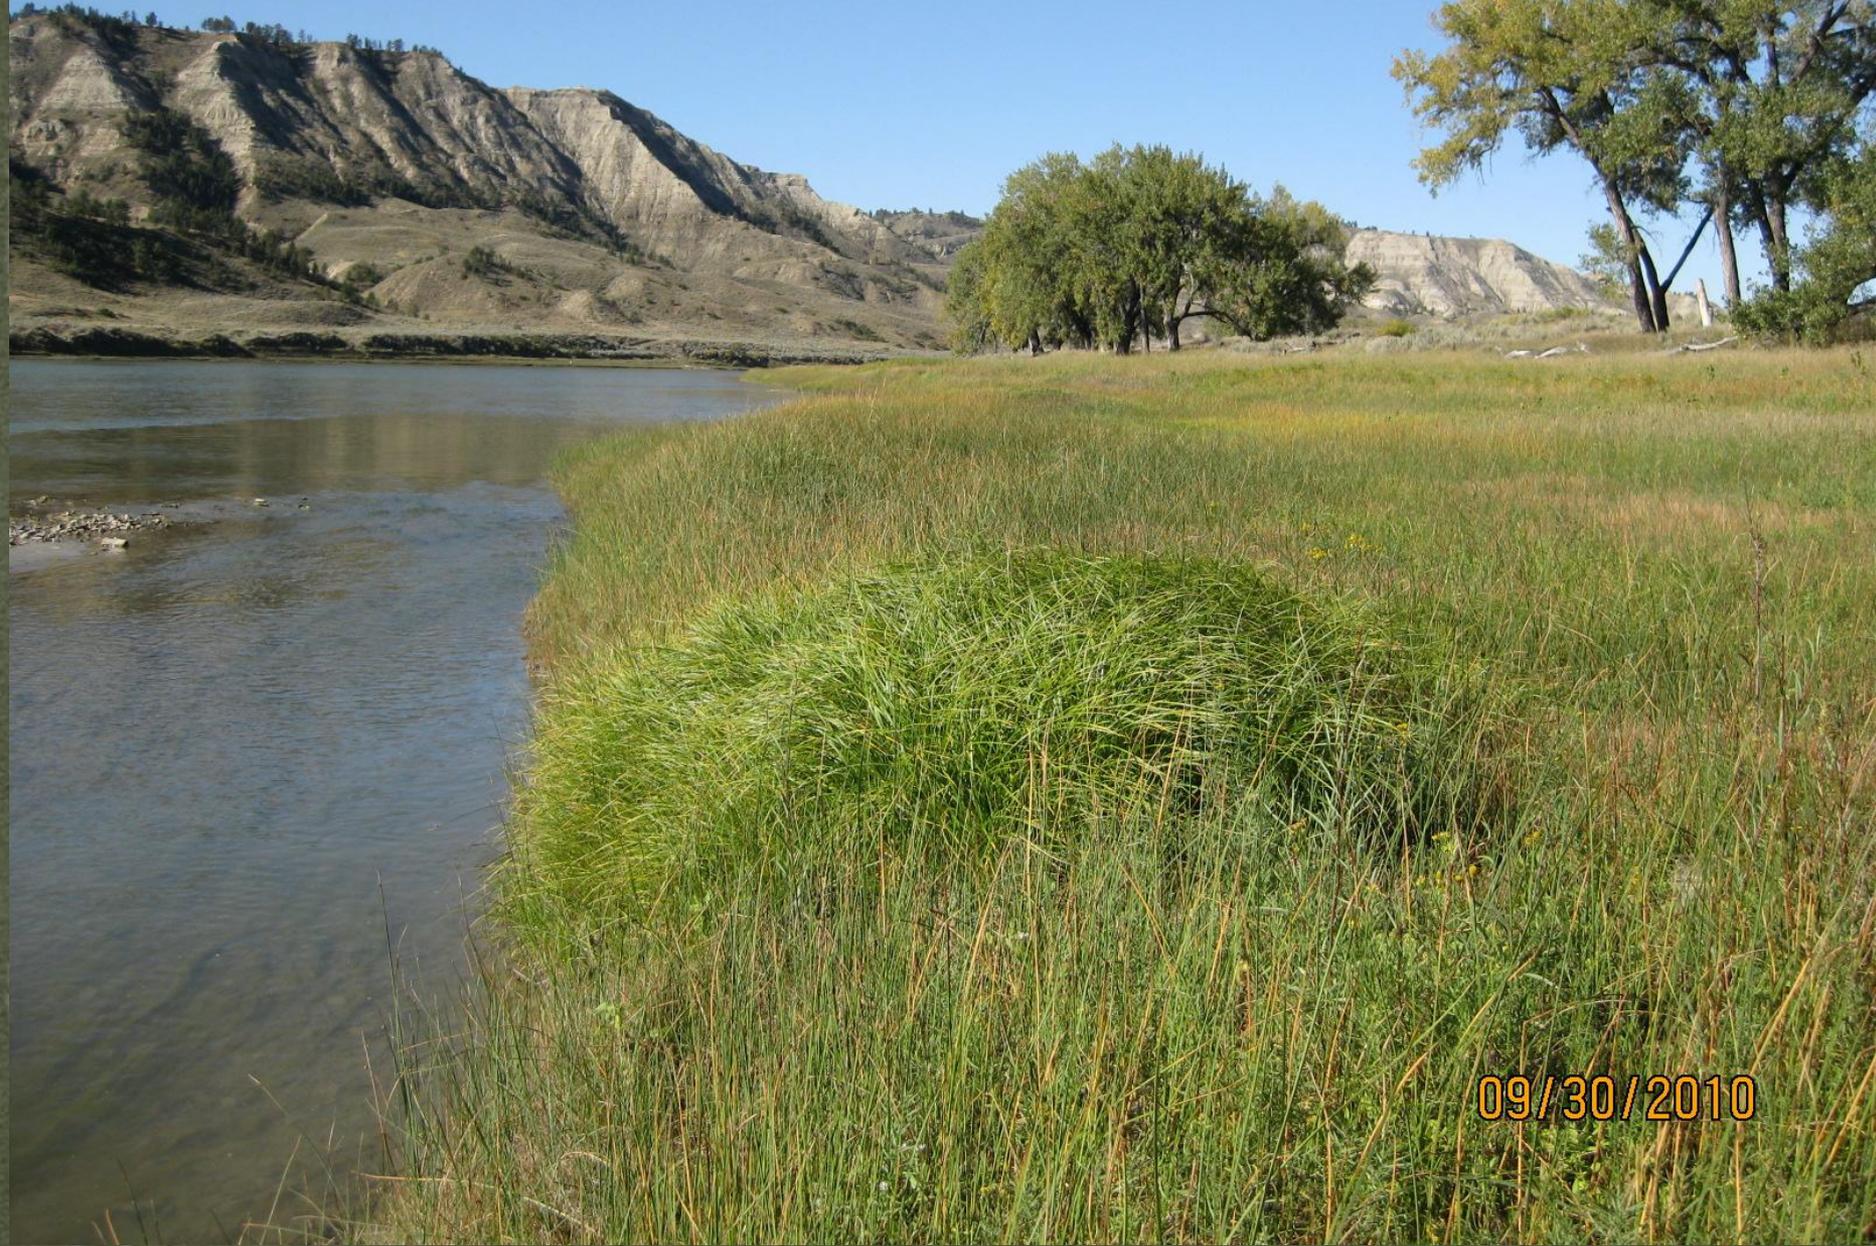
Gallatin Rapids

UNSTABLE BANK

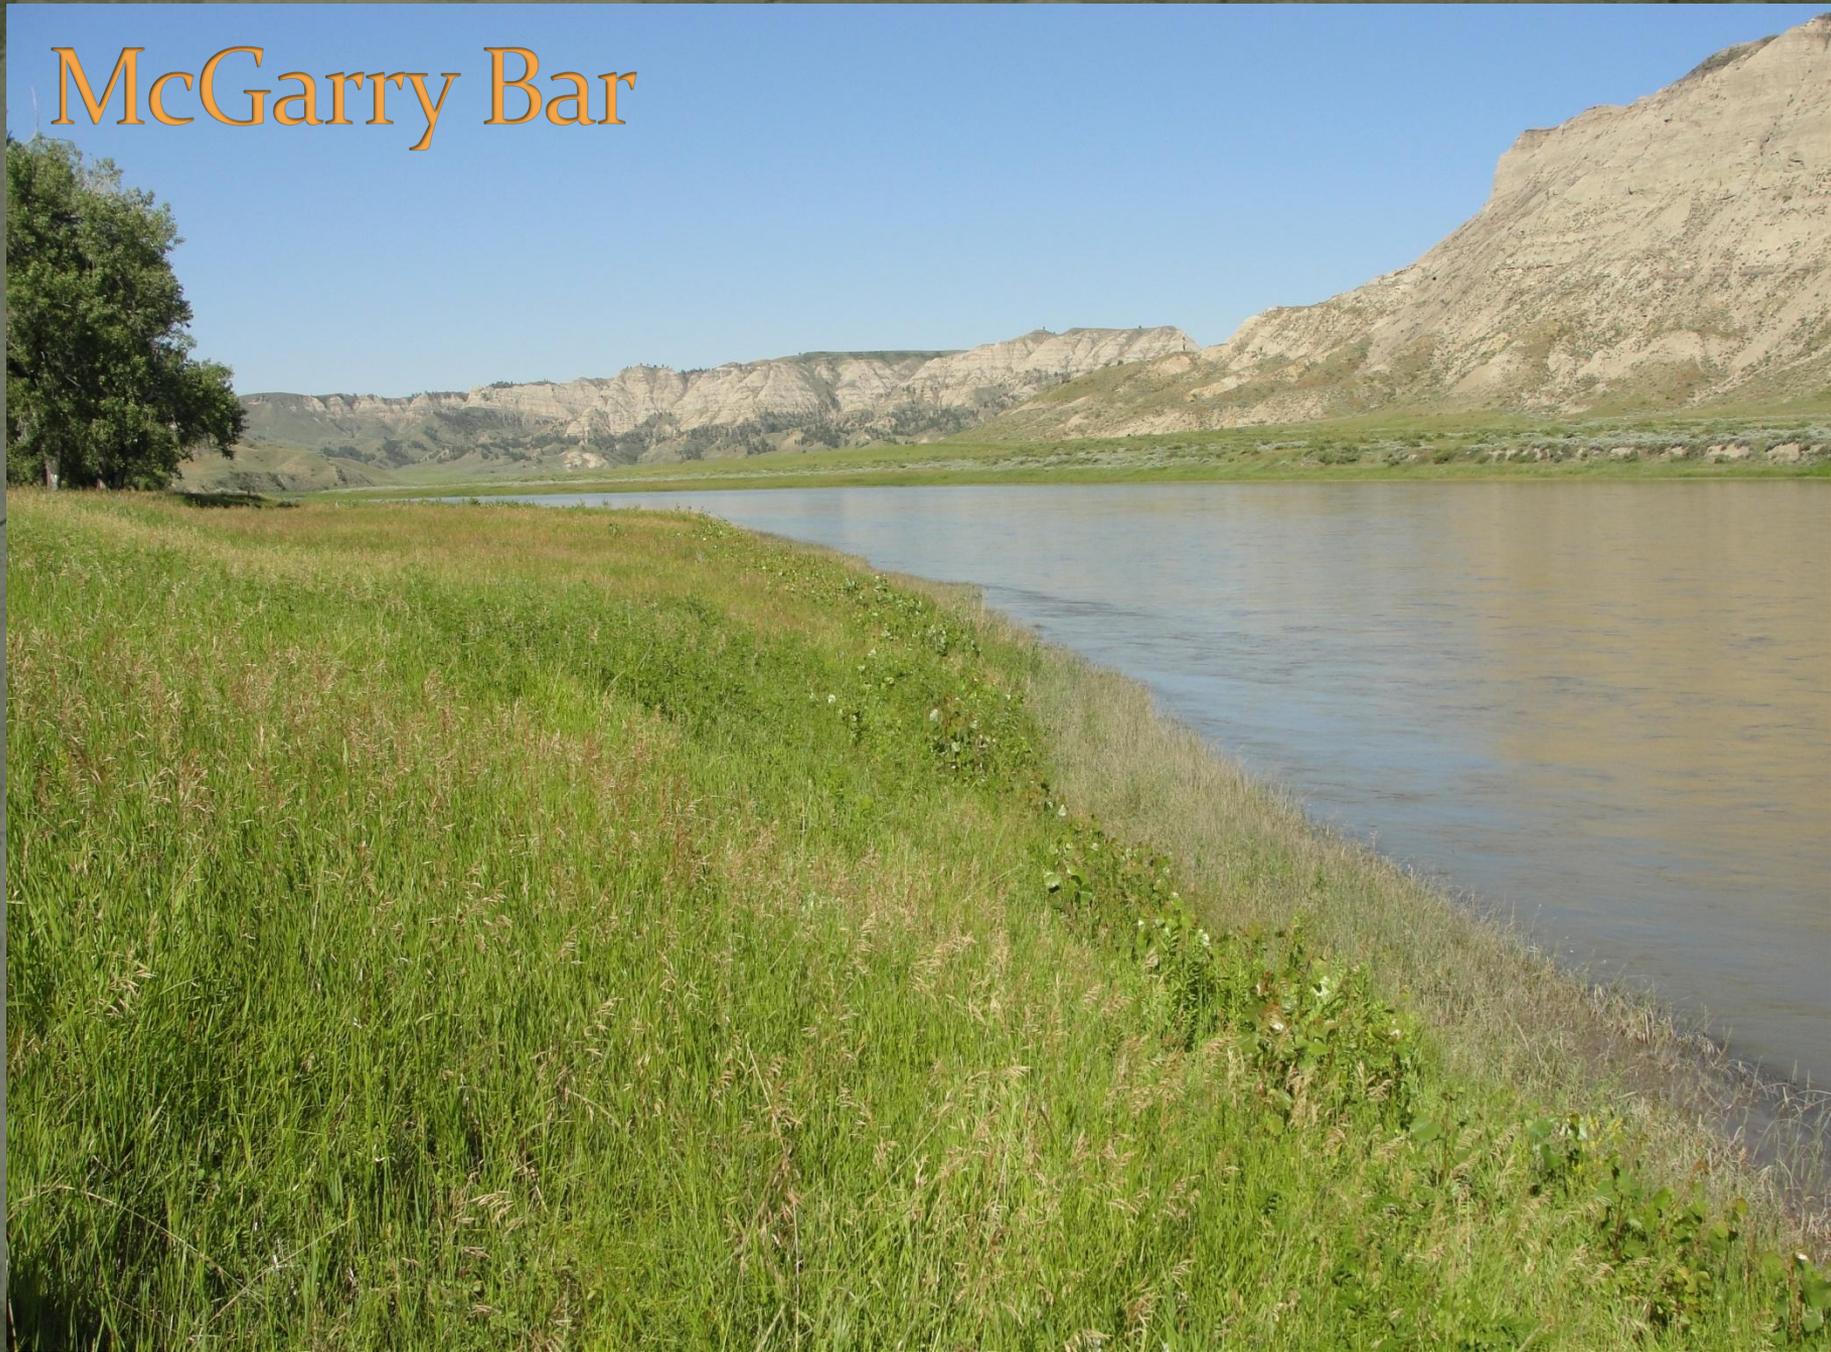
McGarry Bar

Developing Lateral Bar
