APPENDIX G—Example Greenlines

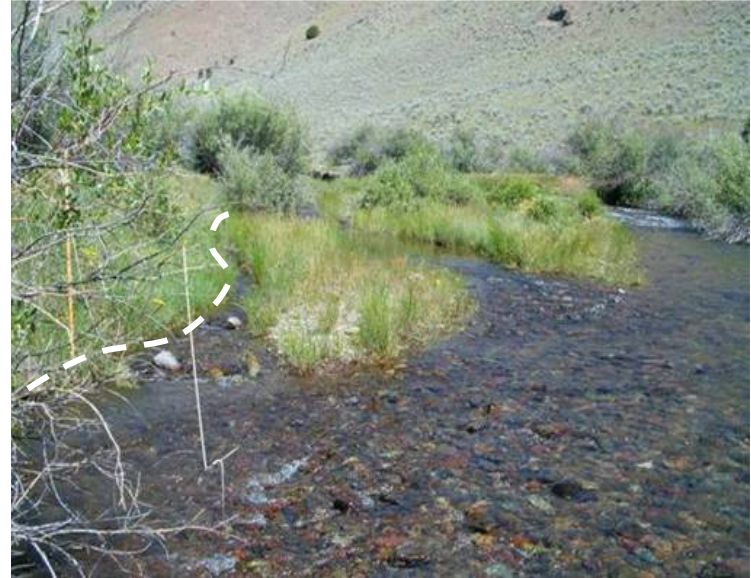
Figure 9—the greenline follows the outer streambank at bankfull. It does not cross a channel to the island. A small channel runs along the island on the left. Photo - PIBO, U.S. Forest Service

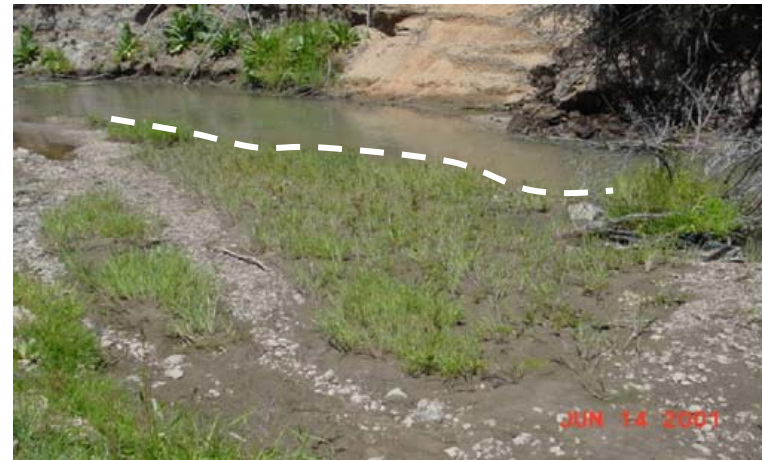
Figure 10—colonizing species short-awned fox tail (*Alopecurus aequalis*) forming a lineal grouping of vegetation with at least 25% foliar cover; it is at least 6 inches (15 cm) wide and 19.6 inches (50 cm) long.

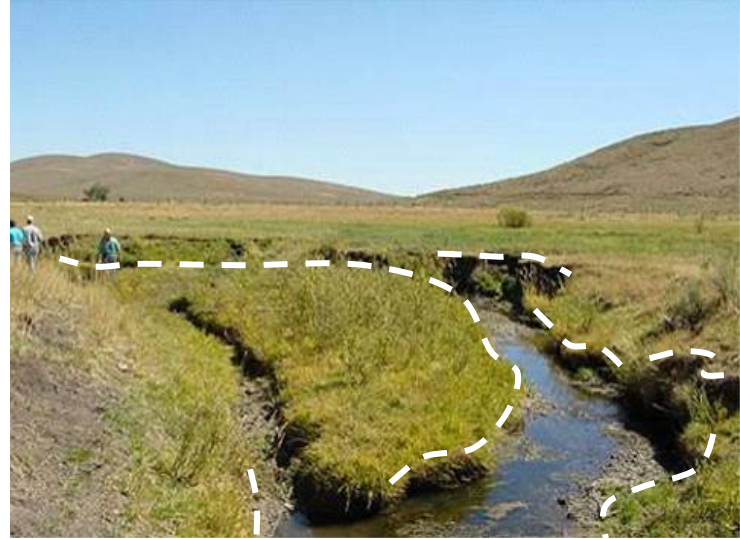
Figure 11—in the case of a peninsula, or back-water channel, the greenline jumps across the backwater channel to the inner bank of the peninsula.

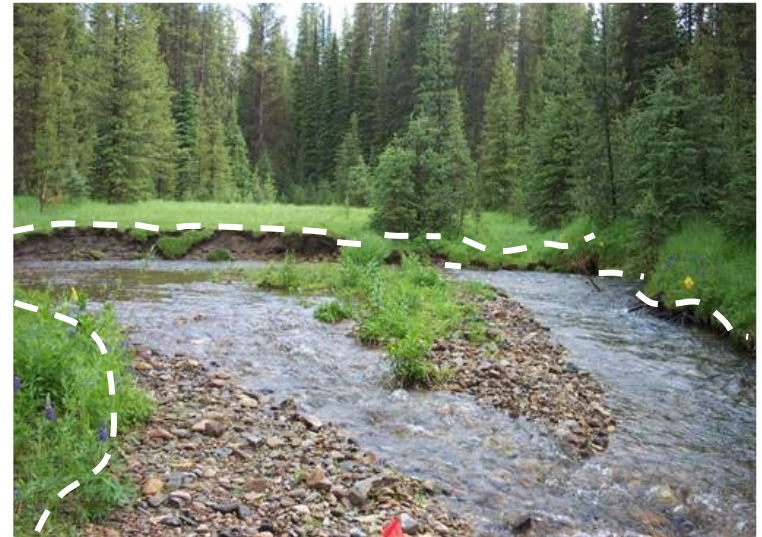
Figure 12—the island, even with vegetation, is not part of the greenline.

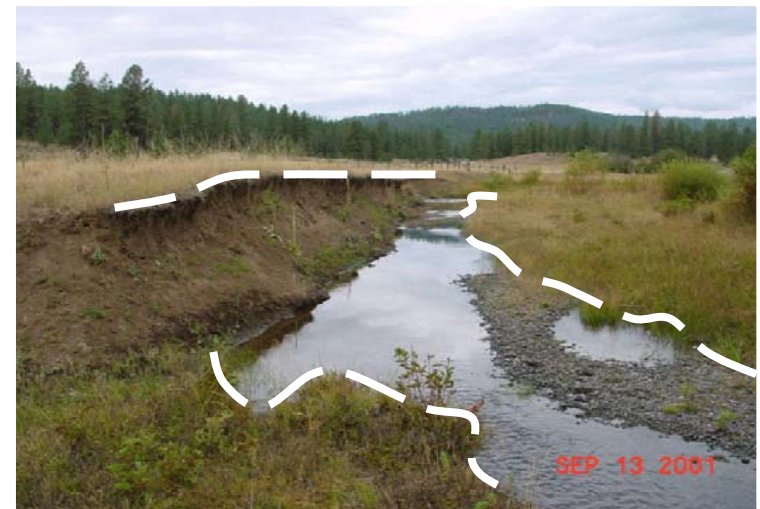
Figure 13—greenline on the left side of the photo is in two segments, the lower segment near the water's edge and the upper segment along the edge of the terrace with upland vegetation. The greenline on the right side of the stream is continuous along the perennial vegetation.

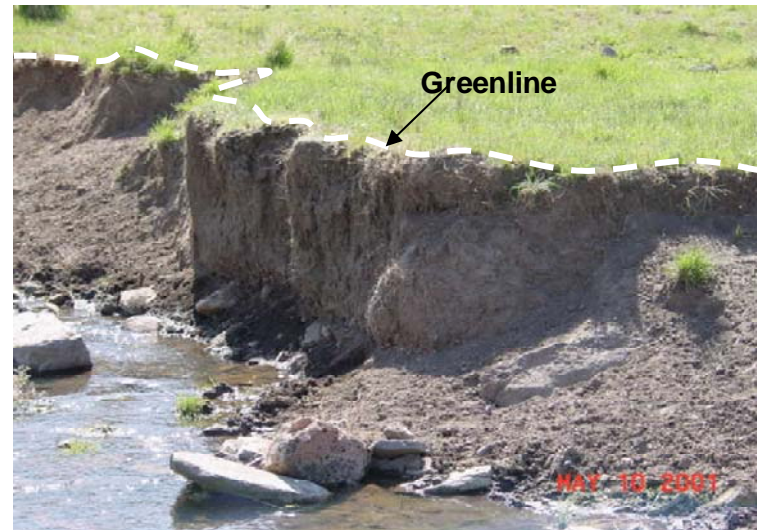
Figure 14—for steep, bare banks, the greenline is at the top. Vegetation does not have to be “hydraulic” to be included as part of the greenline.

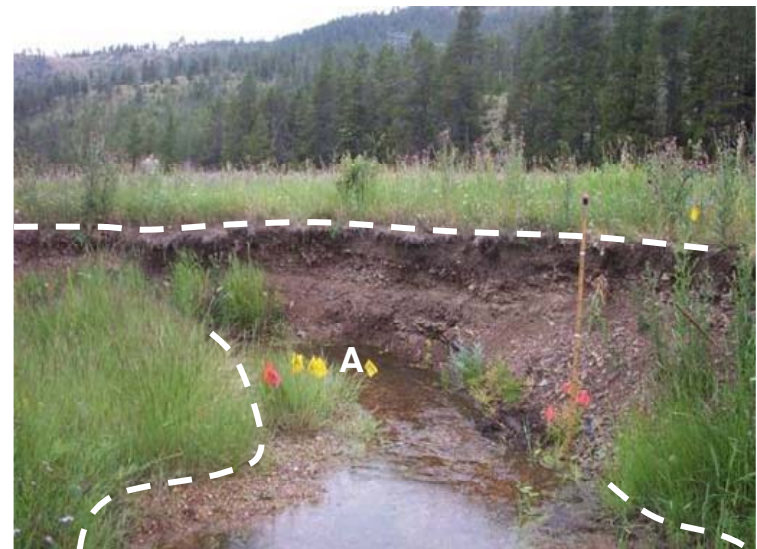
Figure 15—the greenline follows the relatively continuous line of vegetation. The vegetation near “A” does not meet the greenline criteria of being at least 50 cm long. Photo - PIBO, U.S. Forest Service

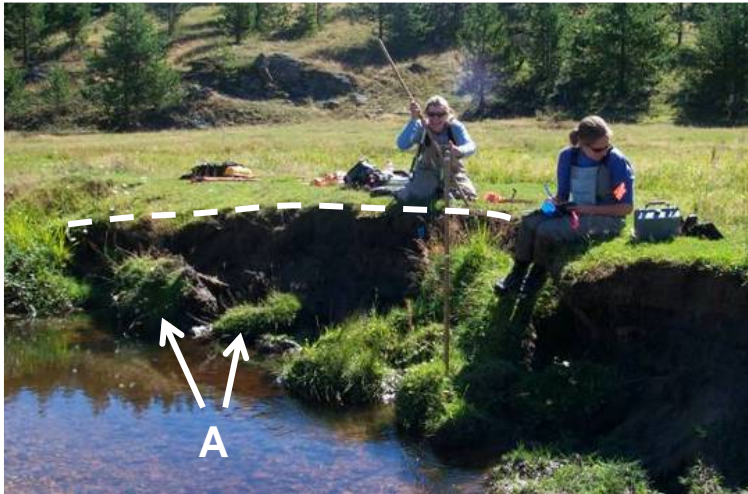
Figure 16—slump blocks “A” are detached and not considered part of the greenline. The dashed line shows greenline. Photo - PIBO, U.S. Forest Service

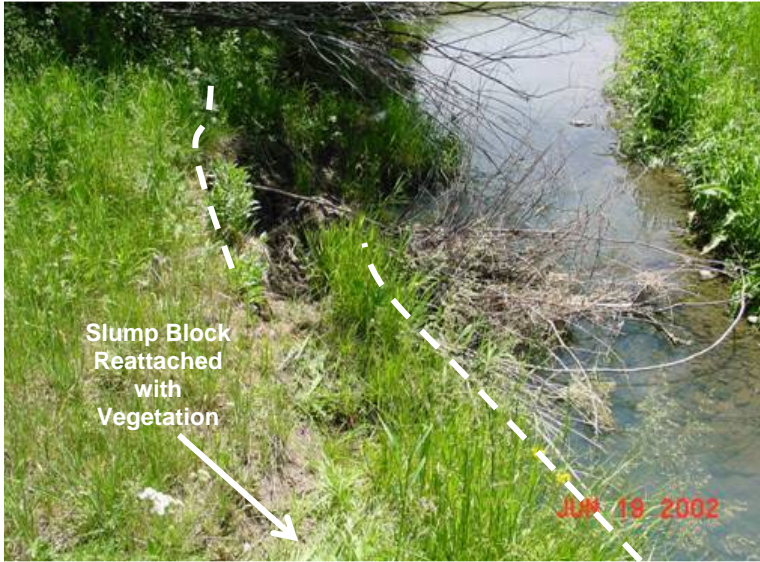
Figure 17—slump block re-attached to the bank with vegetation.

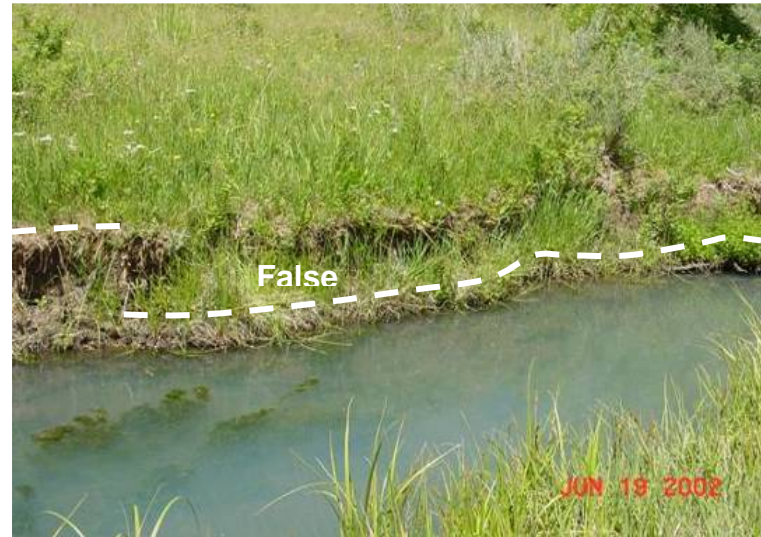
Figure 18—false bank is an old slump block with vegetative cover. The slump feature is reattached to the streambank. The greenline follows edge of the false bank.

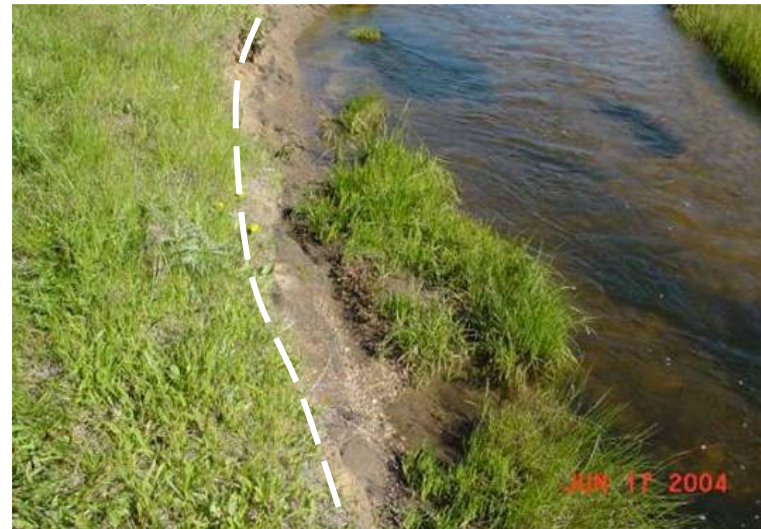
Figure 19—vegetation is not well established between the slump block and the terrace; thus, the greenline follows the bank behind it.
