APPENDIX J—Streambank Alteration

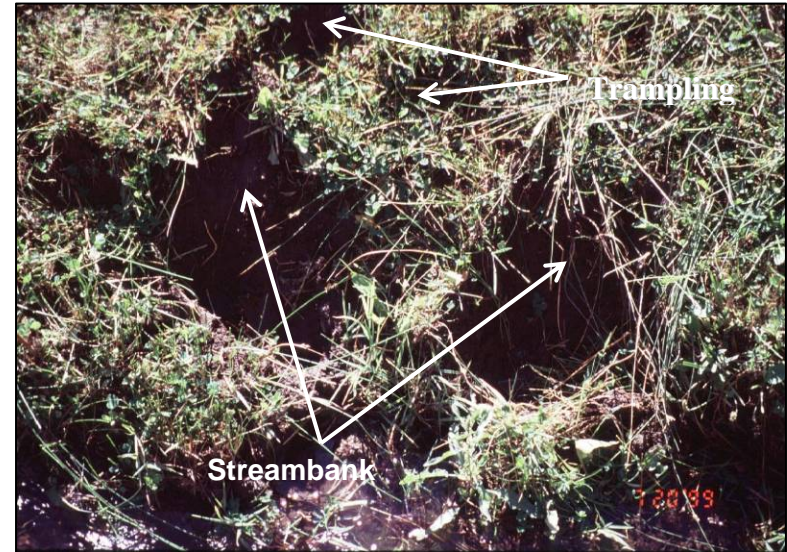
Figure 1—disturbance is considered trampling when a track caused by a large herbivore exposes at least $\frac{1}{2}$ inch of bare soil. Streambank shearing is the physical displacement of part of the streambank downward toward the stream channel.

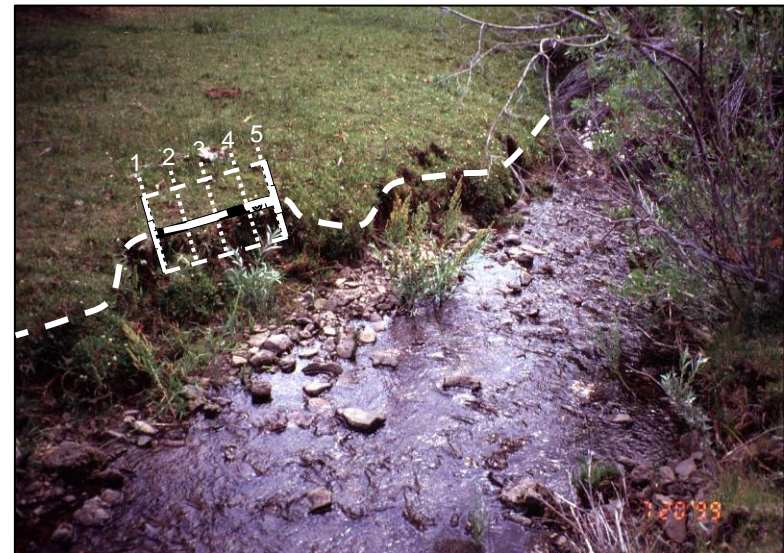
Figure 2—the monitoring frame is centered on the greenline and the number of lines (0 to 5) that intersect streambank alteration (trampling or shearing) is counted and recorded. Lines 1, 2, 4, and 5 intersect streambank alteration. Four is recorded.

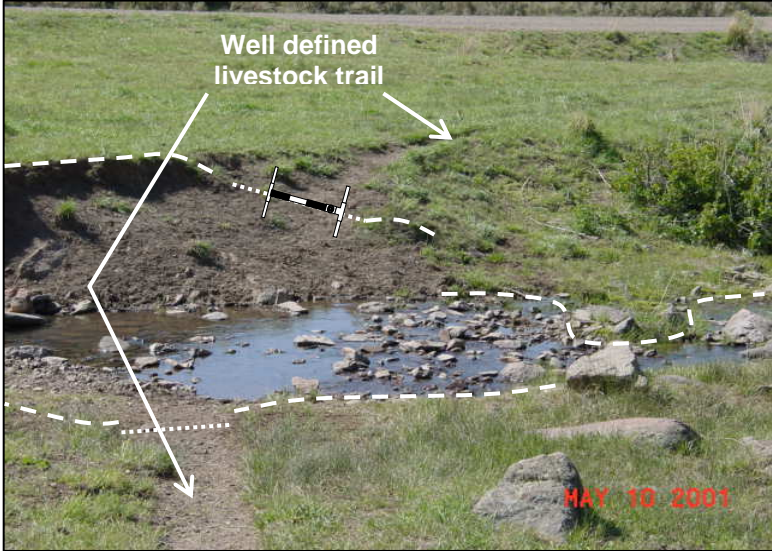
Figure 3—while livestock trails are not considered part of the greenline, they are considered for streambank alteration. The frame is placed on a line that joins the greenline on either side of the trail. The example above shows the frame on a livestock trail that has been used during the current grazing season since all five lines intersect streambank alteration, five is recorded.

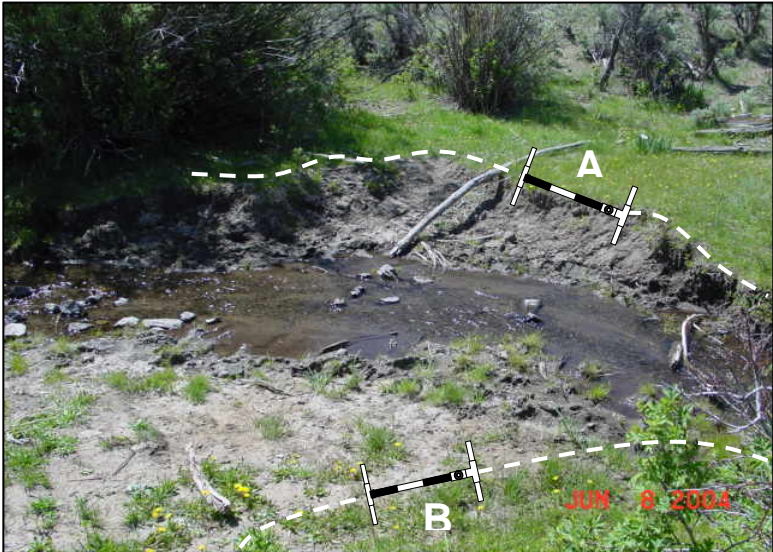
Figure 4—example A is heavily trampled and all five lines intersect streambank alteration. B shows no evidence of current year's trampling that displaces soil at least ½ inch deep. Five is recorded for A and zero for B.
