APPENDIX J—Streambank Alteration

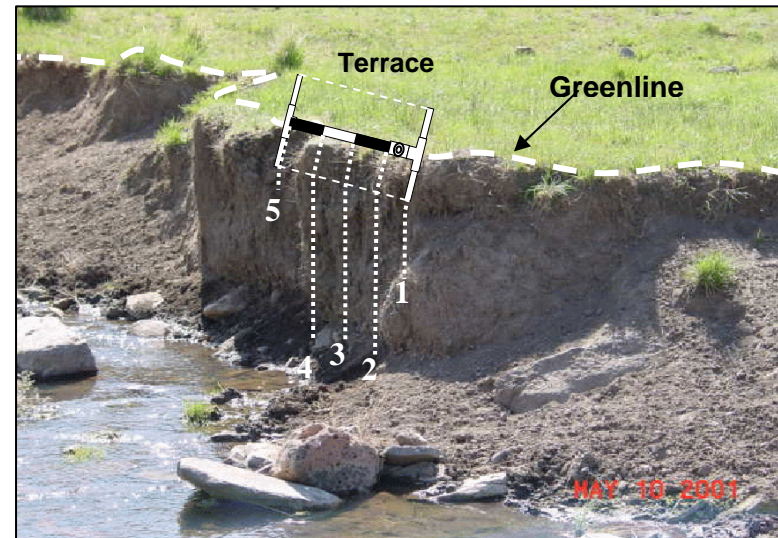
Figure 5—trampling on the terrace is not recorded as streambank alteration. Alteration is only recorded if it occurs on the steep face of the bank. The lines are projected for the greenline down the bank, within the quadrat, to the water line. In the example above, line 1, nearest the handle, does not intersect alteration. Lines 2 through 5 intercept shears. A total of 4 is recorded.

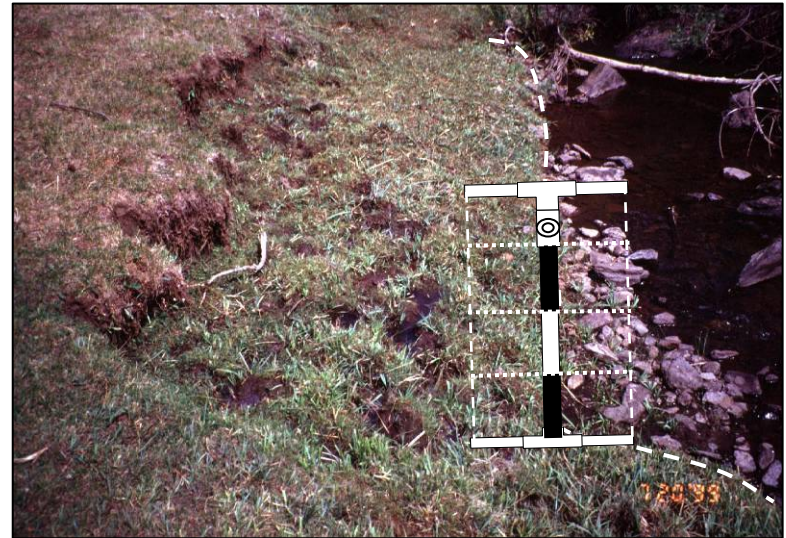
Figure 6—no evident streambank alteration intersects any of the lines within the plot. Zero is recorded.

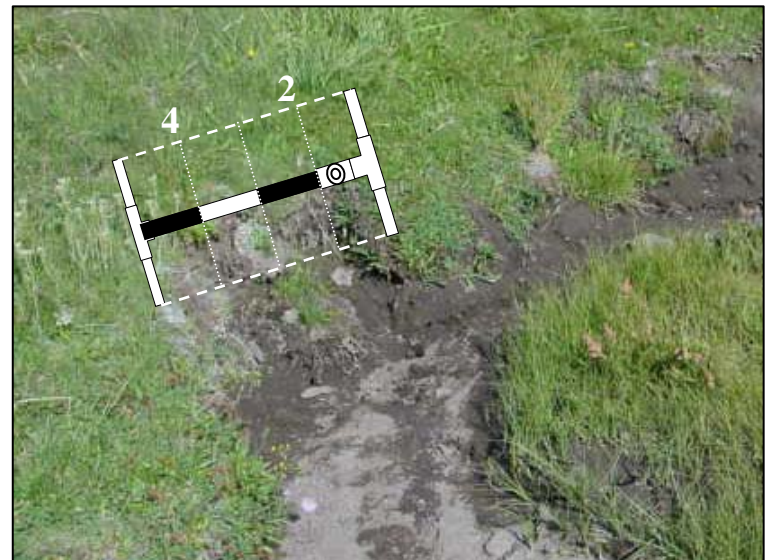
Figure 7—lines 2 and 4 intersect streambank alteration caused by livestock. Two is recorded.

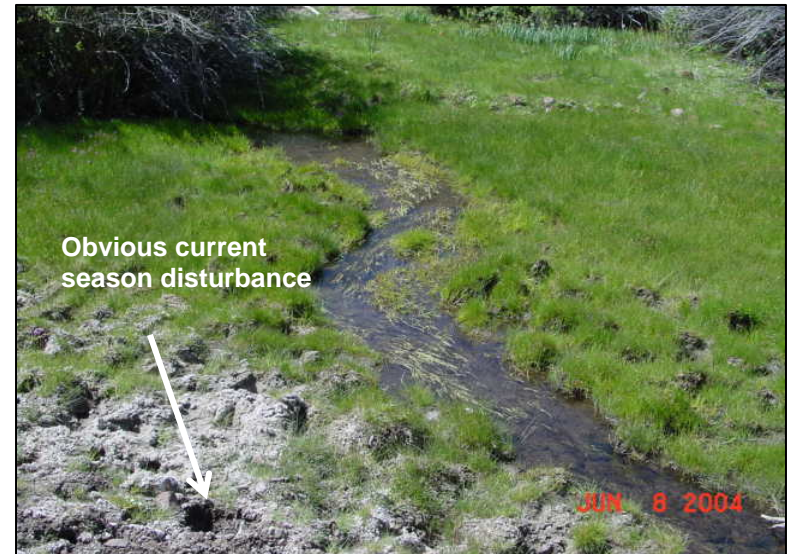
Figure 8—current streambank alteration can be difficult to distinguish from previous season's use. Streambank alteration measurements should be made while livestock are still in the pasture or within two weeks of use. Streambank alteration should not be conducted on a site such as this where the current season's impacts are difficult to distinguish from previous seasons.
