APPENDIX K—Streambank Stability

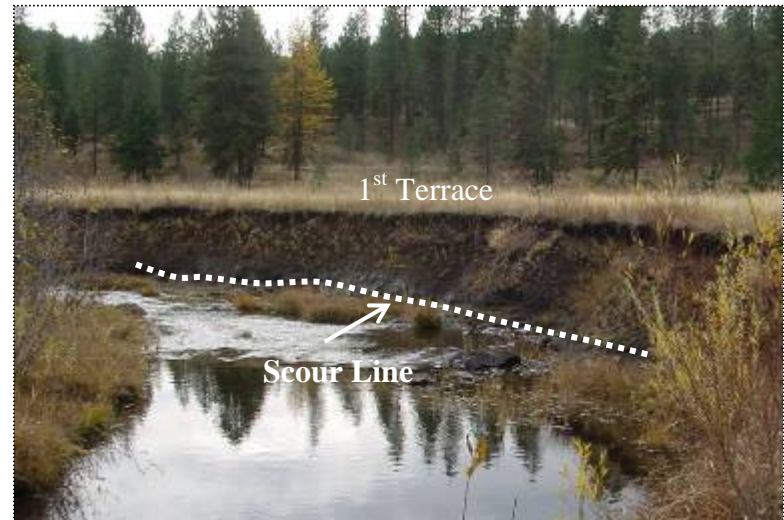
Figure 2—the 1st terrace is the first relatively flat area above the scour line or edge of the water. An abrupt steep face from the edge of the terrace to the scour line is a characteristic of a terrace. Slough from the terrace wall has direct access to the stream.

1st Terrace: The first relatively flat area adjacent to and above the scour line or at the edge of the water. It may be an active floodplain or an area too high for the water to reach under the current climate and channel conditions (see Figures 1 and 2).

2nd Terrace: The next elevated relatively flat area above the 1st terrace, with a distinctly steeper slope facing the stream (see Figure 2).

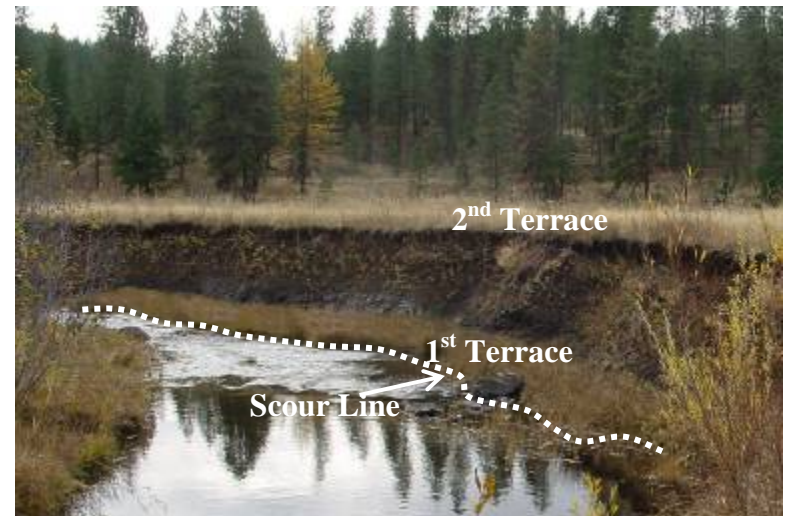
Figure 3—a new floodplain has developed creating the 1st terrace at a lower elevation. Slough from the 2nd terrace does not go directly into the stream as it is filtered by the 1st terrace.

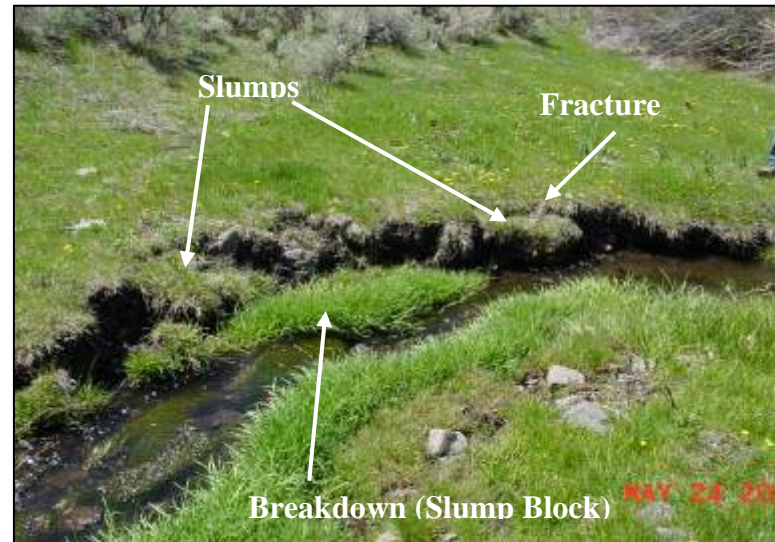
Figure 4—Erosional features help determine the stability of a streambank. Breakdown or slump blocks that are detached from the streambank are not considered part of the streambank. Slumps must be obviously sliding down of a part of the streambank. Fractures are obvious breaking of a portion of the streambank (see Illustrations 3, 4, 6 and 7 above).

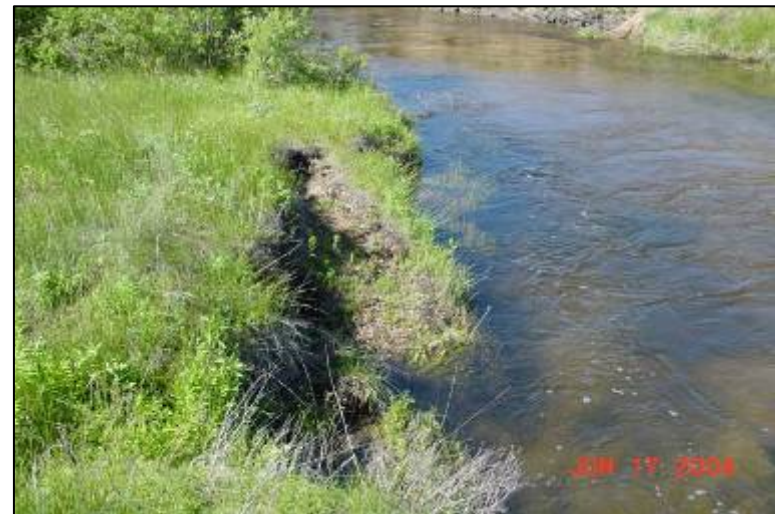
Figure 5—the photo above shows a fracture and a large slump that is still attached to the streambank. Vegetation cover is at least 50 percent cover and is classified as covered/unstable (CU). (See Illustration 4.)

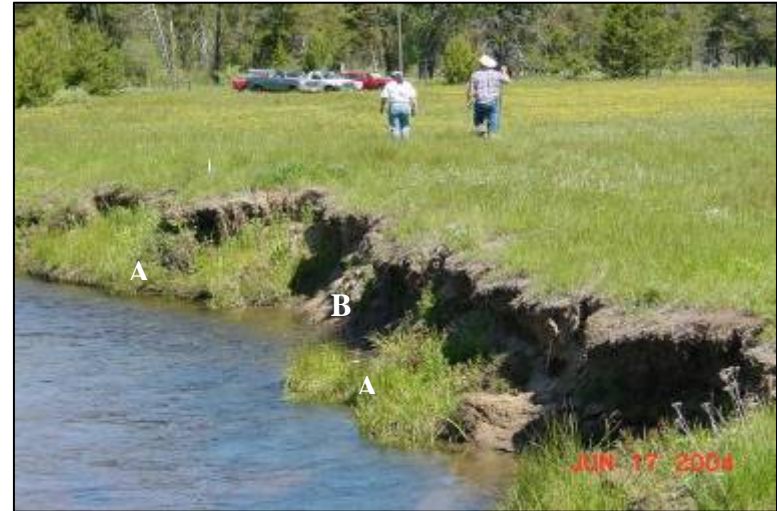
Figure 6—the stream in this photo is flowing at the scour line. Slumps “A” are still attached to the bank above the scour line and would be classified as covered/unstable (CU) (see Illustration 4). “B” has no vegetation along the streambank and is uncovered/unstable (UU) (see Illustration 3).

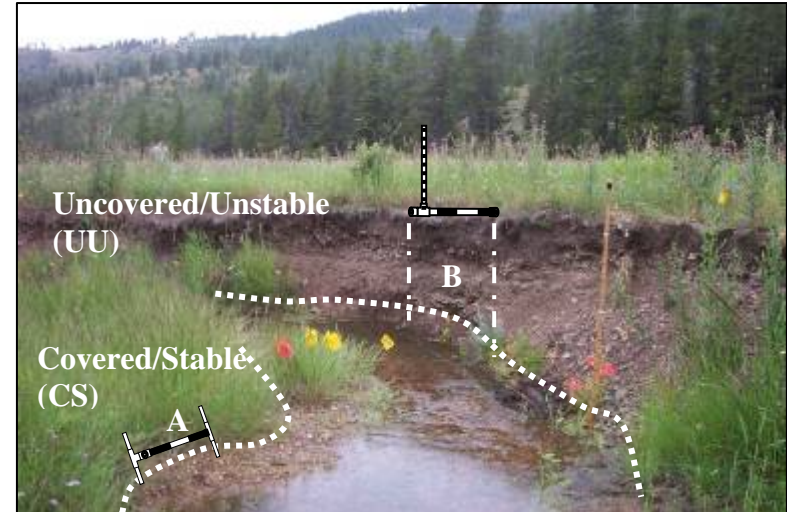
Figure 7—the dotted line represents the scour line. “A” shows a monitoring frame placed on the greenline, just above the scour line. The streambank is covered/stable (CS). Frame at “B” is located on the greenline. Since it is not usually practical to pace along or near the scour line, the length of the frame is projected to the scour line and the streambank is classified. At “B” the streambank is uncovered/unstable (UU). Photo - PIBO, U.S. Forest Service

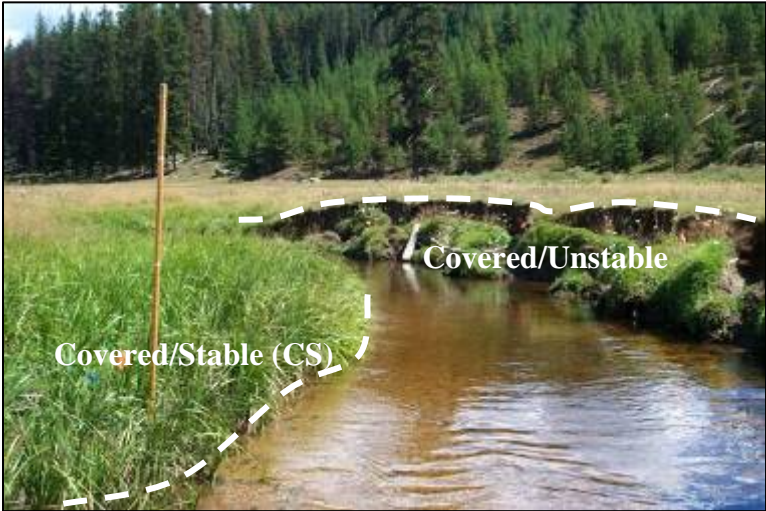
Figure 8—slump banks “A” are still attached to the streambank above the scour line and is classified as cover/unstable (CU). The dashed line is the greenline. Photo - PIBO, U.S. Forest Service

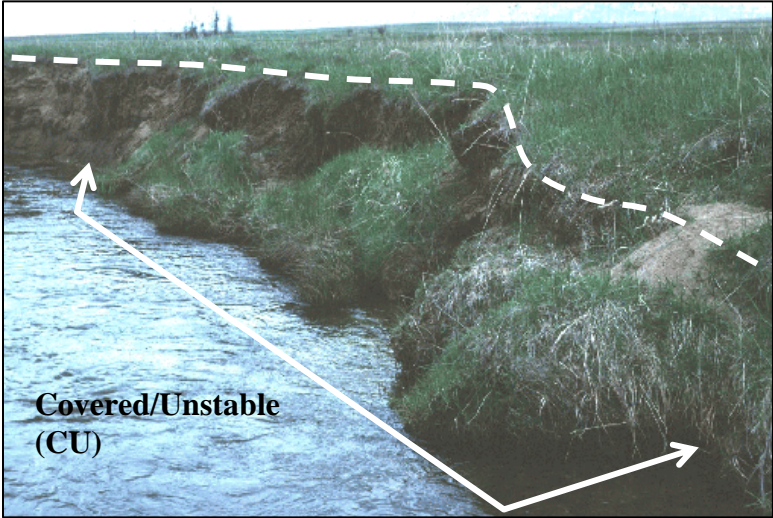
Figure 9—slump blocks and slumping banks with the blocks and attached bank above the scour line are covered/unstable (CU).

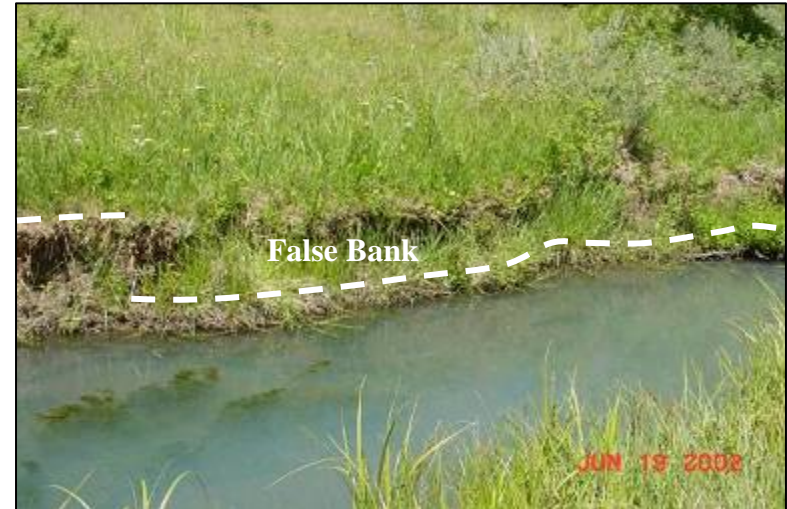
Figure 9—false banks (FB) are reattached slump features covered with deep-rooted vegetation. They are an indicator of recovery and are considered stable.

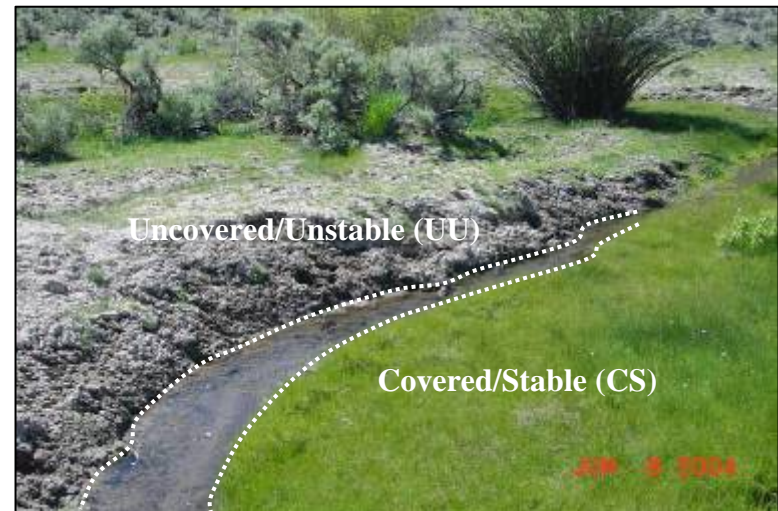
Figure 11—the streambank on one side of the stream is uncovered/unstable (UU) and the other side is covered/stable (CS).

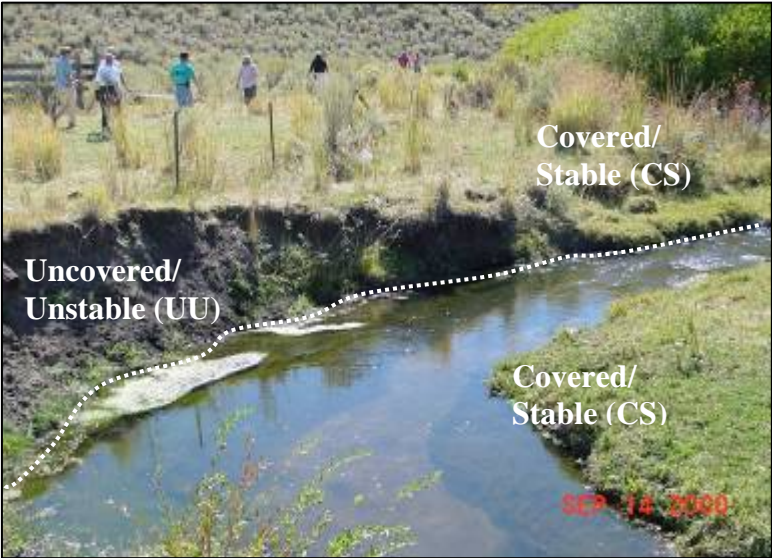
Figure 12—the scour line is near the current water level. The streambank classification reflects the bank from scour line to first terrace. The bar is covered, therefore stable.

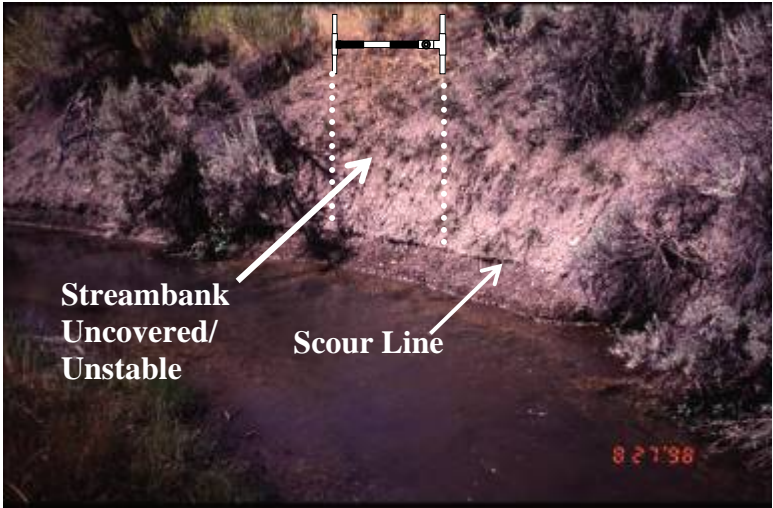
Figure 13—the streambank has an obvious scour line. The streambank is above the scour line to the first terrace and is uncovered/unstable (UU).
