**VISUAL ASSESSMENT REPORT  
FOR THE TRI-STATE MONTROSE-NUCLA-CAHONE  
TRANSMISSION LINE IMPROVEMENT PROJECT  
SOUTHWEST COLORADO**

# Tri-State Montrose-Nucla-Cahone Transmission Line Improvement Project Colorado

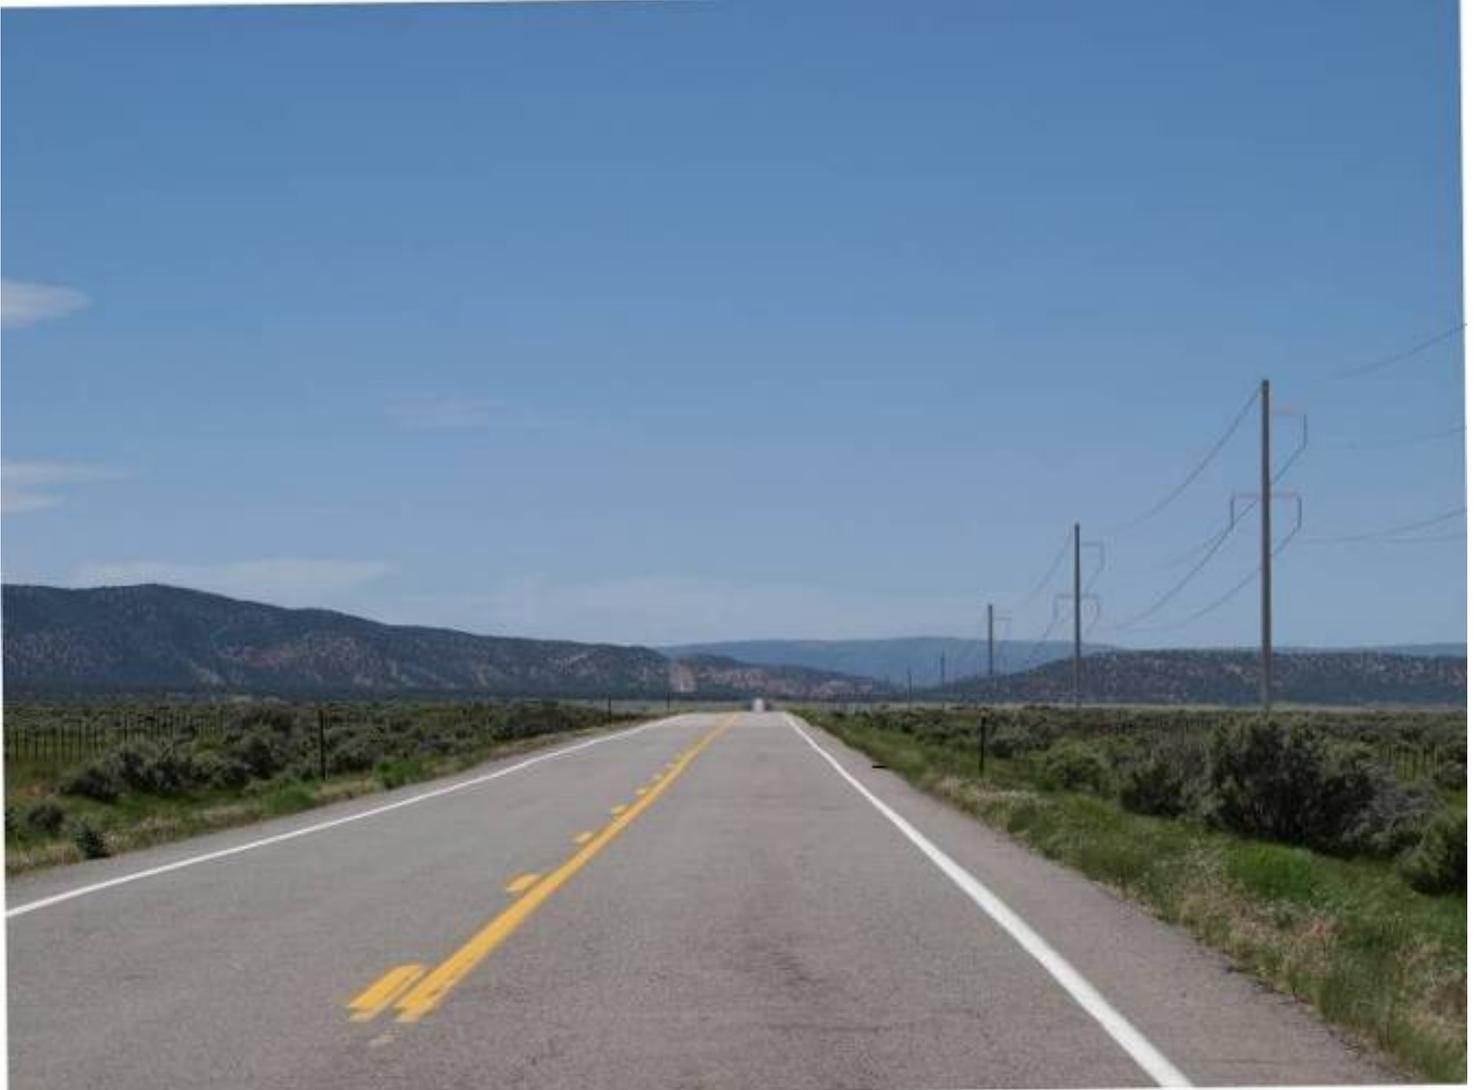
**Photo 6b. KOP6, Alternative C: Combinations that include Dry Creek Basin Routing Option (Realignment) with the Transmission Line on the West Side of SH141 (View South)**

**Alternative C: Combinations that include Dry Creek Basin Routing Option (Realignment along SH 141) (Photo 6b and 6c)** – Because the proposed transmission line would be located adjacent, and parallel to either side of SH 141, the conductors and structures would be highly visible to travelers on SH 141 in both directions, and therefore impact views in both directions of travel. Views from the private roads and structures near the Town of Basin, including the BLM Kiosk, would also include the proposed conductors and structures in close proximity to all observation points in the vicinity of KOP 6. Therefore, effects to visual resources from SH141 would be high because the conductors and structures would be highly visible, in high contrast with the existing landscape, partially-obstruct some views, and be visible for the entire duration of the drive through the basin. Effects to visual resources from the Town of Basin and the BLM kiosk would also be high for the same reasons.

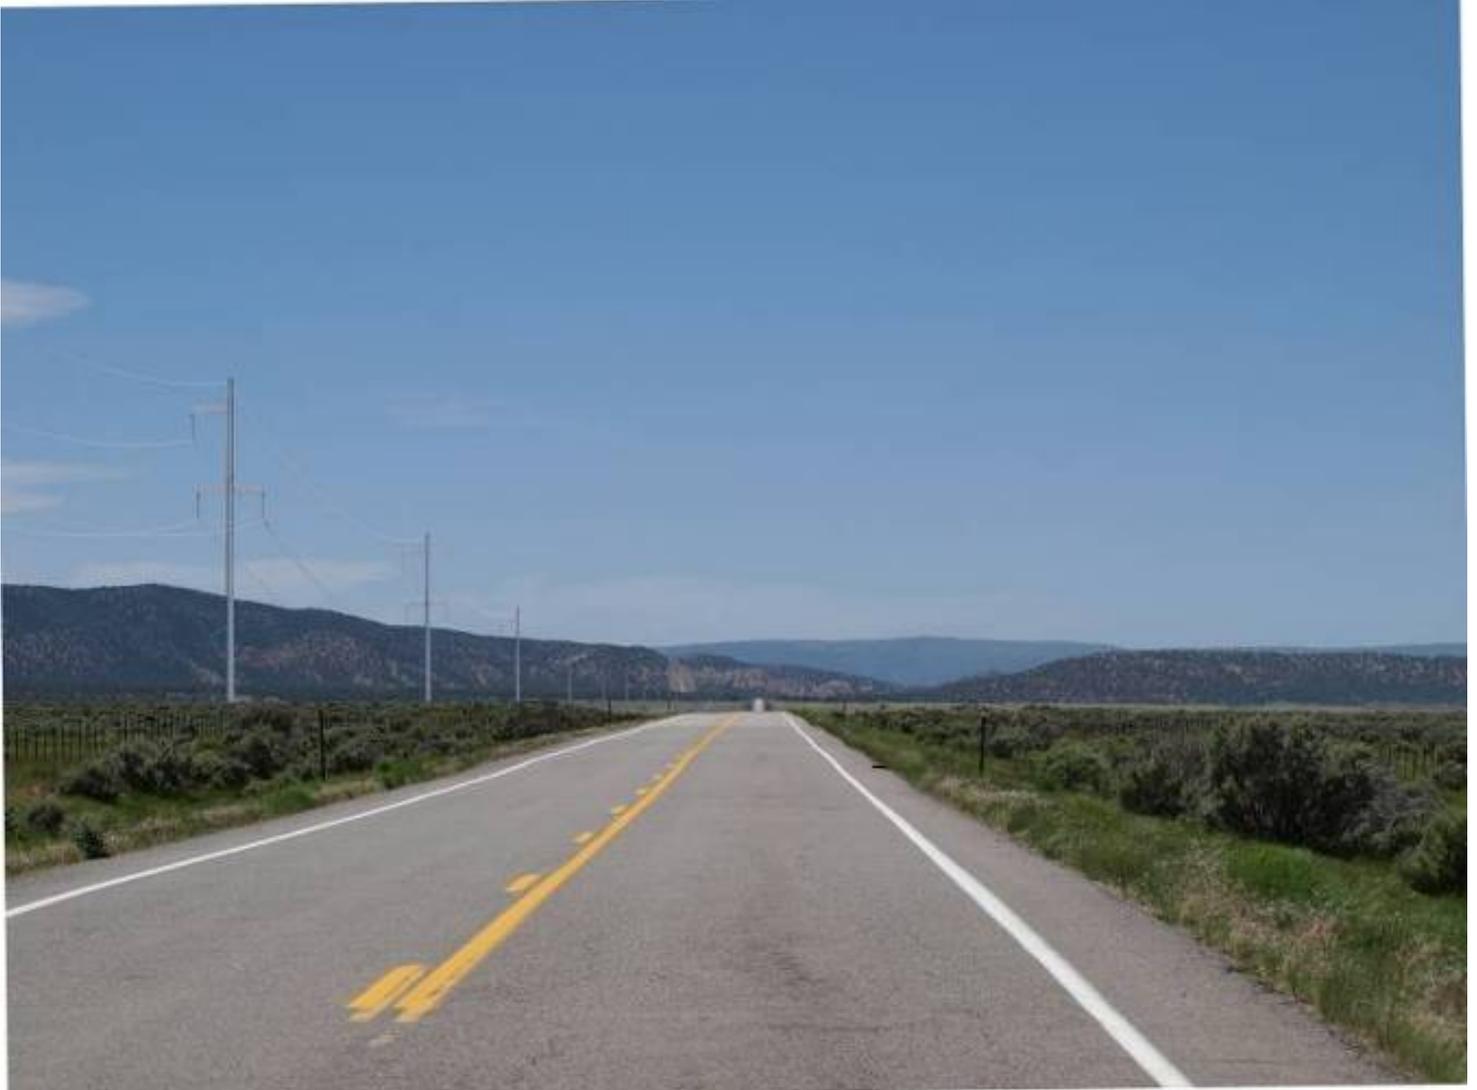
**Photo 6c. KOP6, Alternative C: Combinations that include Dry Creek Basin Routing Option (Realignment) with the Transmission Line on the East Side of SH141 (View South)**

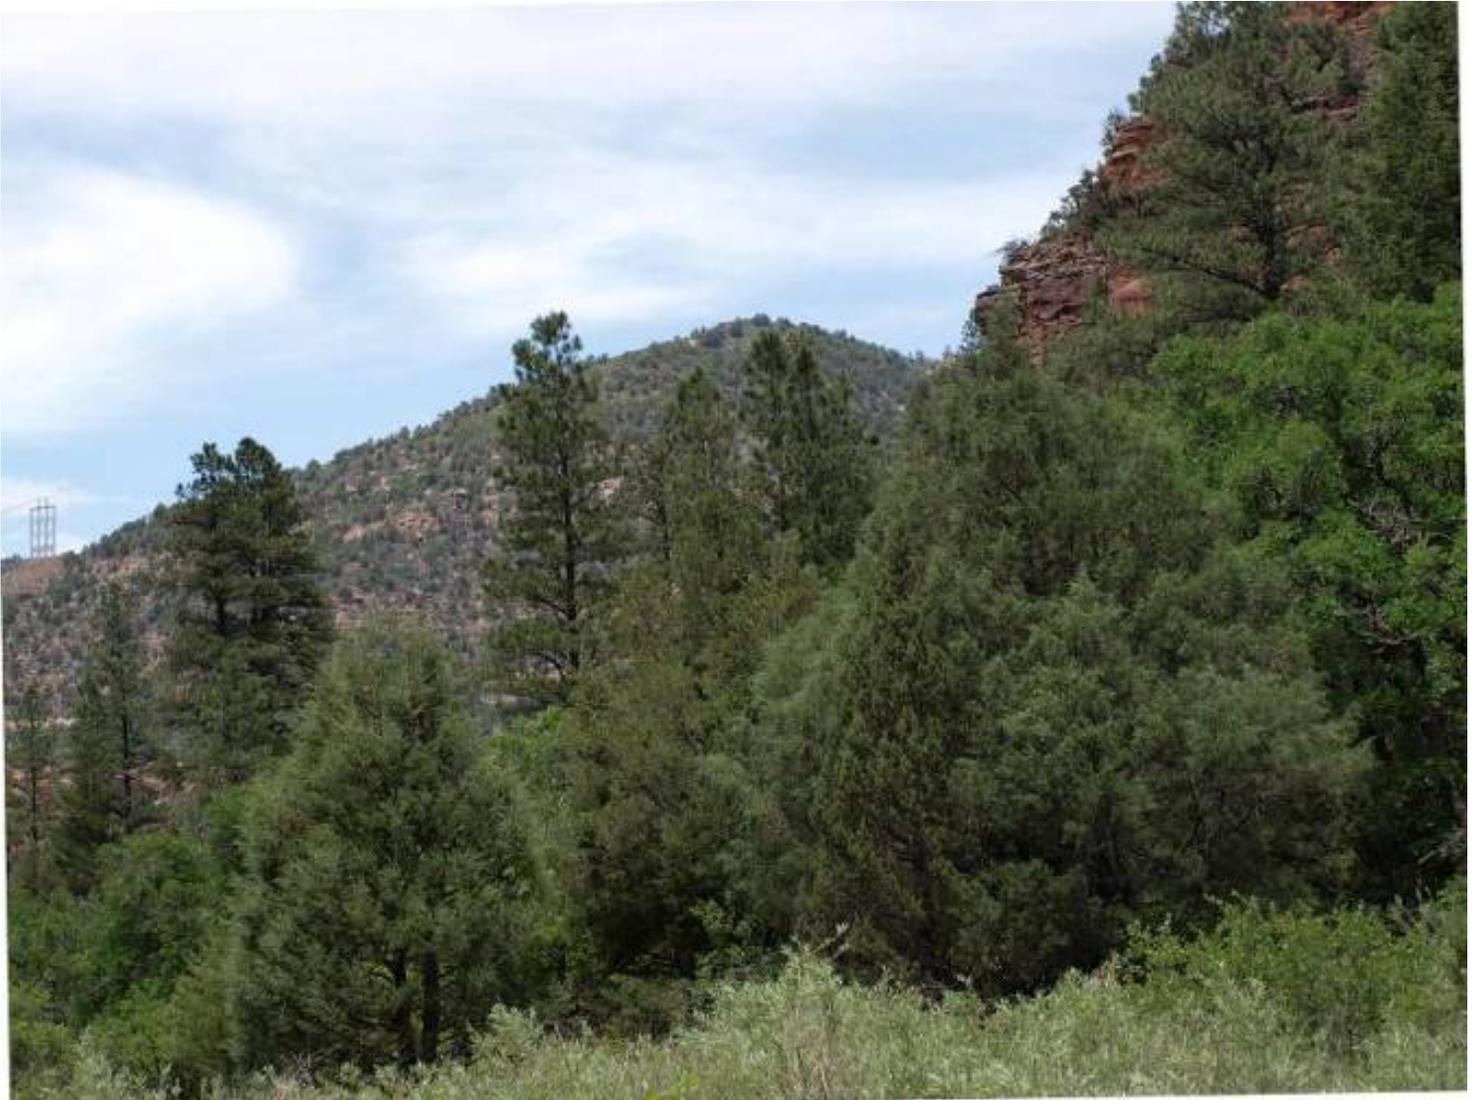
**Photo 10a. KOP10, Alternatives A and C-Dolores River Crossing Realignment Option**

**Alternative A: Proposed Action and Alternative C-Dolores River Crossing Realignment Option (Photo 10a)** – Although the proposed transmission line would be approximately 1.0 mile farther north from the KOP, the proposed structure is more visible than the existing structure due to taller height and more structural members, creating more contrast against a background of sky. However, the view of the proposed structure and conductors would be in one direction, downstream and upward from the KOP, and be relatively small in the view. If the viewer were camping in, or hiking through the trees adjacent to the KOP, the proposed structure would be completely obscured by the trees. Effects would be offset by removal of the existing structure upstream. Tri-State would provide revised mapping and brochures for river users due to the change in transmission line location, because the existing structures and crossing are used as a frame of reference for river users. The transmission line is an expected component of the landscape. Overall, effects to visual resources would be low.

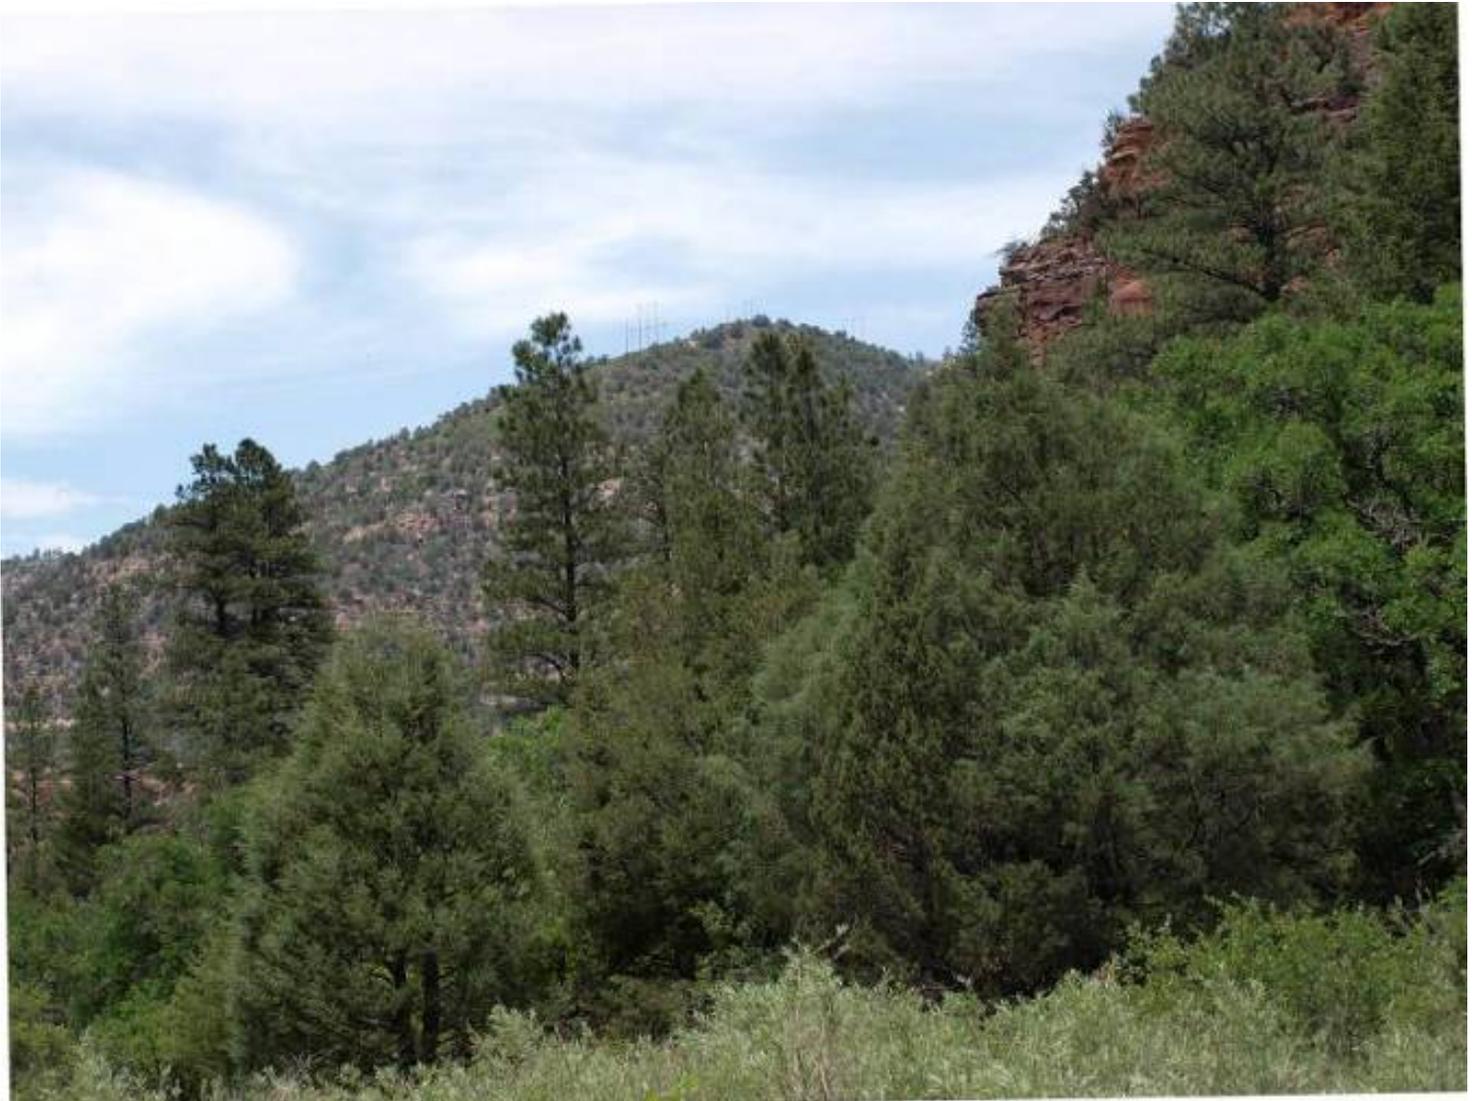
**Photo 10b. KOP10, Alternative B**

**Alternative B: No Action (Photo 10b)** – Because the existing transmission line would remain unchanged, there would be no effect to visual resources.

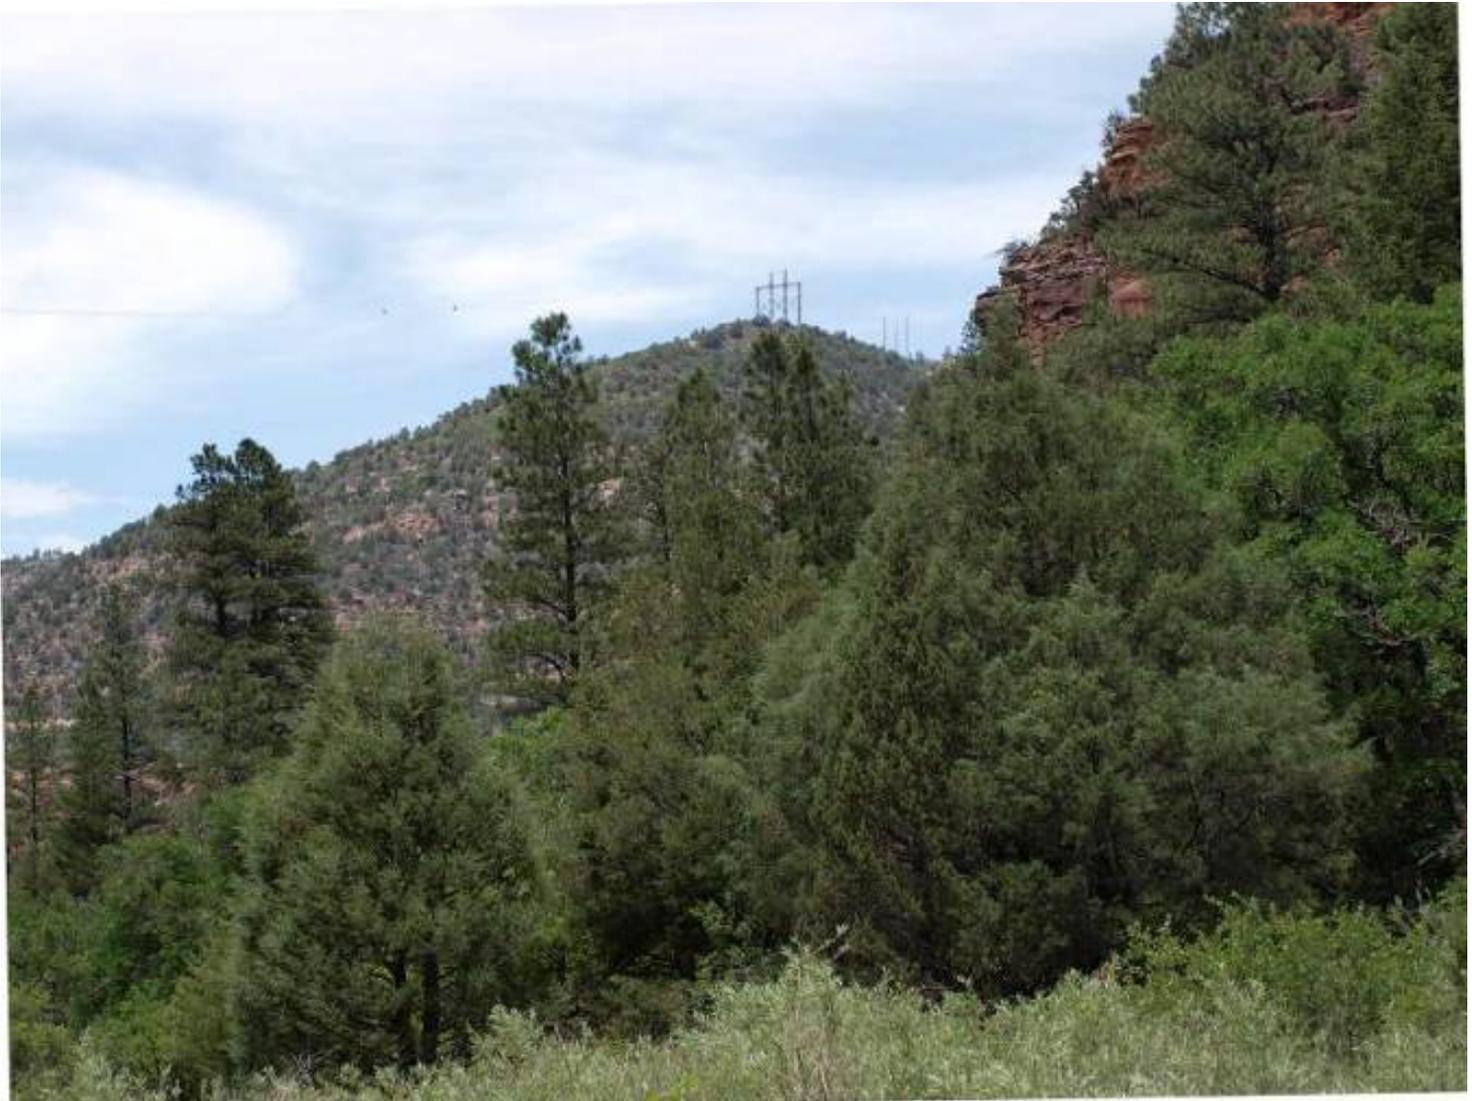
**Photo 10c. KOP10, Alternative C: Combinations that include the Dolores River Crossing Routing Option (upgrade-in-place)**

**Alternative C: Combinations that include Dolores River Crossing Routing Option (upgrade-in-place) (Photo 10c)** – The existing structure would move farther away from the canyon rim, and therefore be less visible. However, the taller structures near, but not on, the canyon rim with more structural members would create more contrast with the background of sky. Therefore, effects to visual resources would be low.

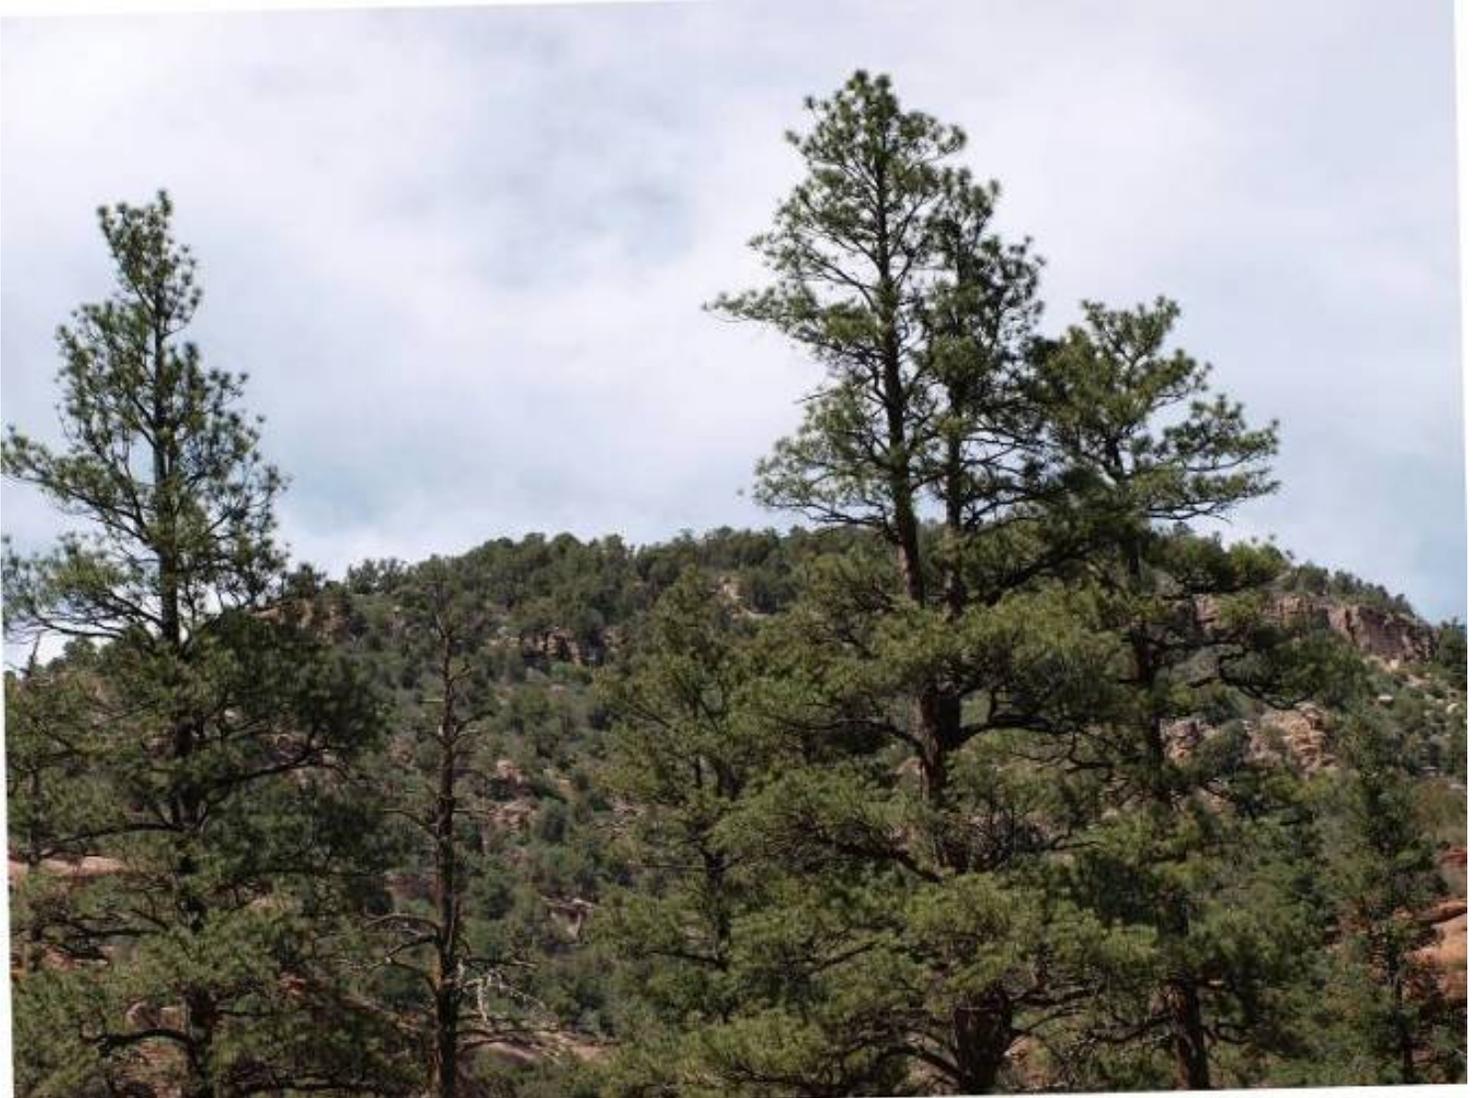
**Photo 11a. KOP11, Alternatives A and C- Dolores River Crossing Realignment Option**

**Alternative A: Proposed Action and Alternative C- Dolores River Crossing Realignment Option (Photo 11a)** – The proposed transmission line would be approximately 1.0 mile farther north of the existing transmission line location, but would remain visible from KOP 11. Therefore, contrasts of the existing

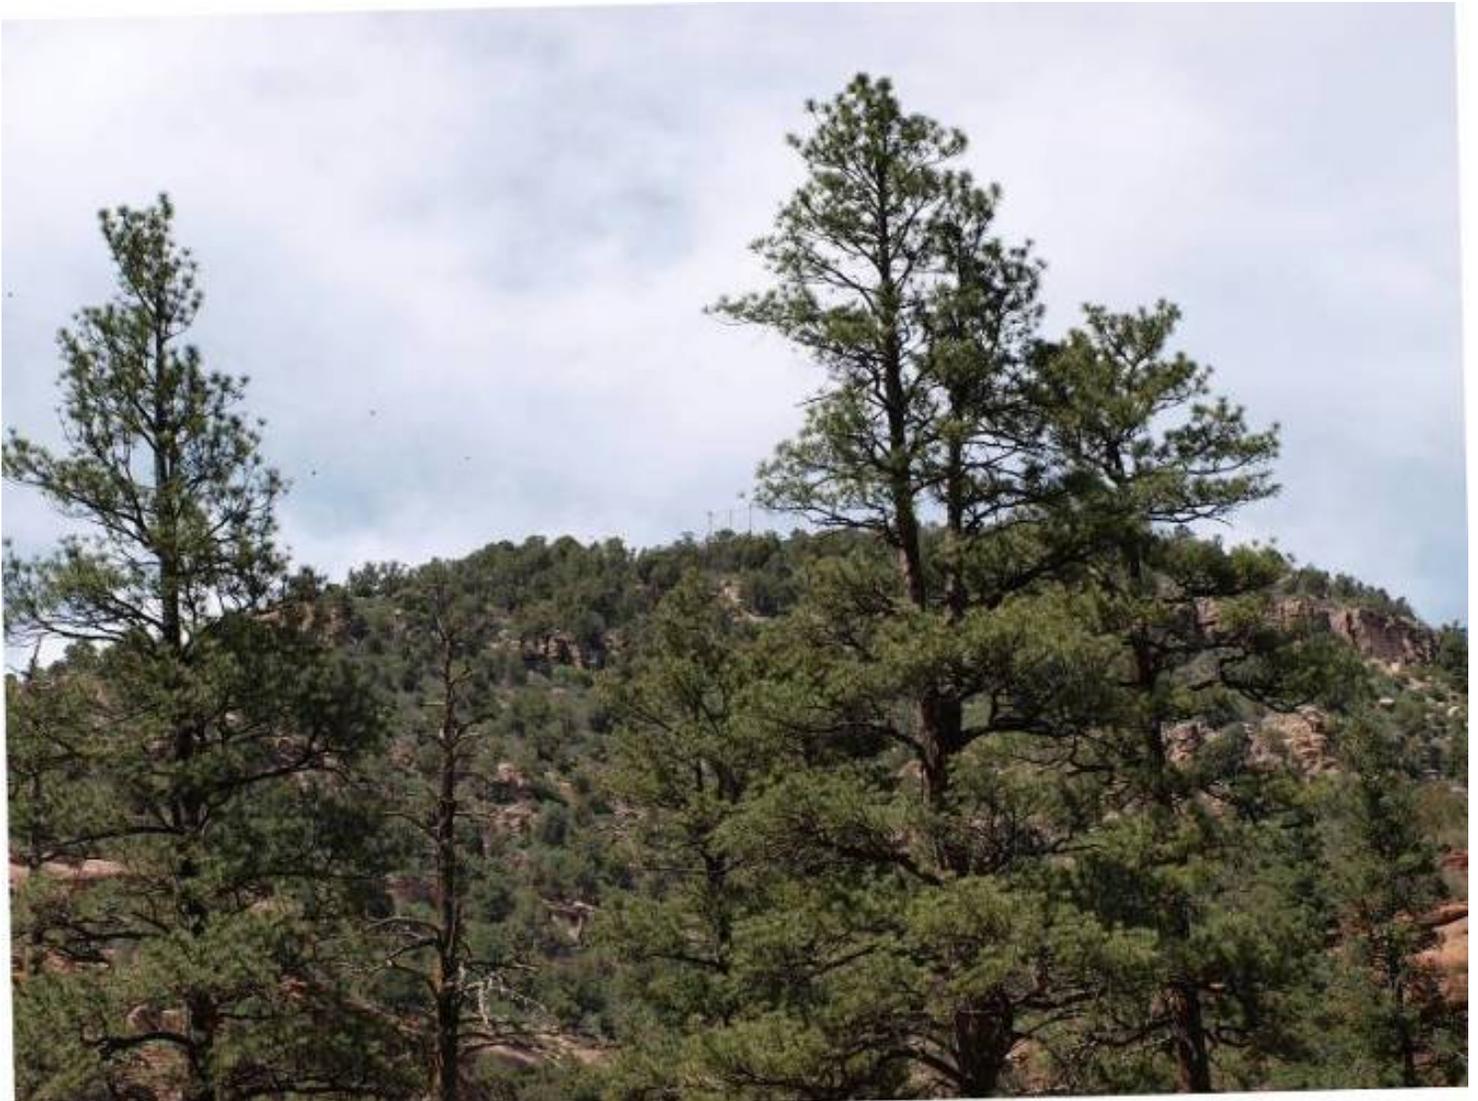
**Photo 11b. KOP11, Alternative B**

**Alternative B: No Action (Photo 11b)** – Because the existing transmission line would remain unchanged, there would be no effect to visual resources.

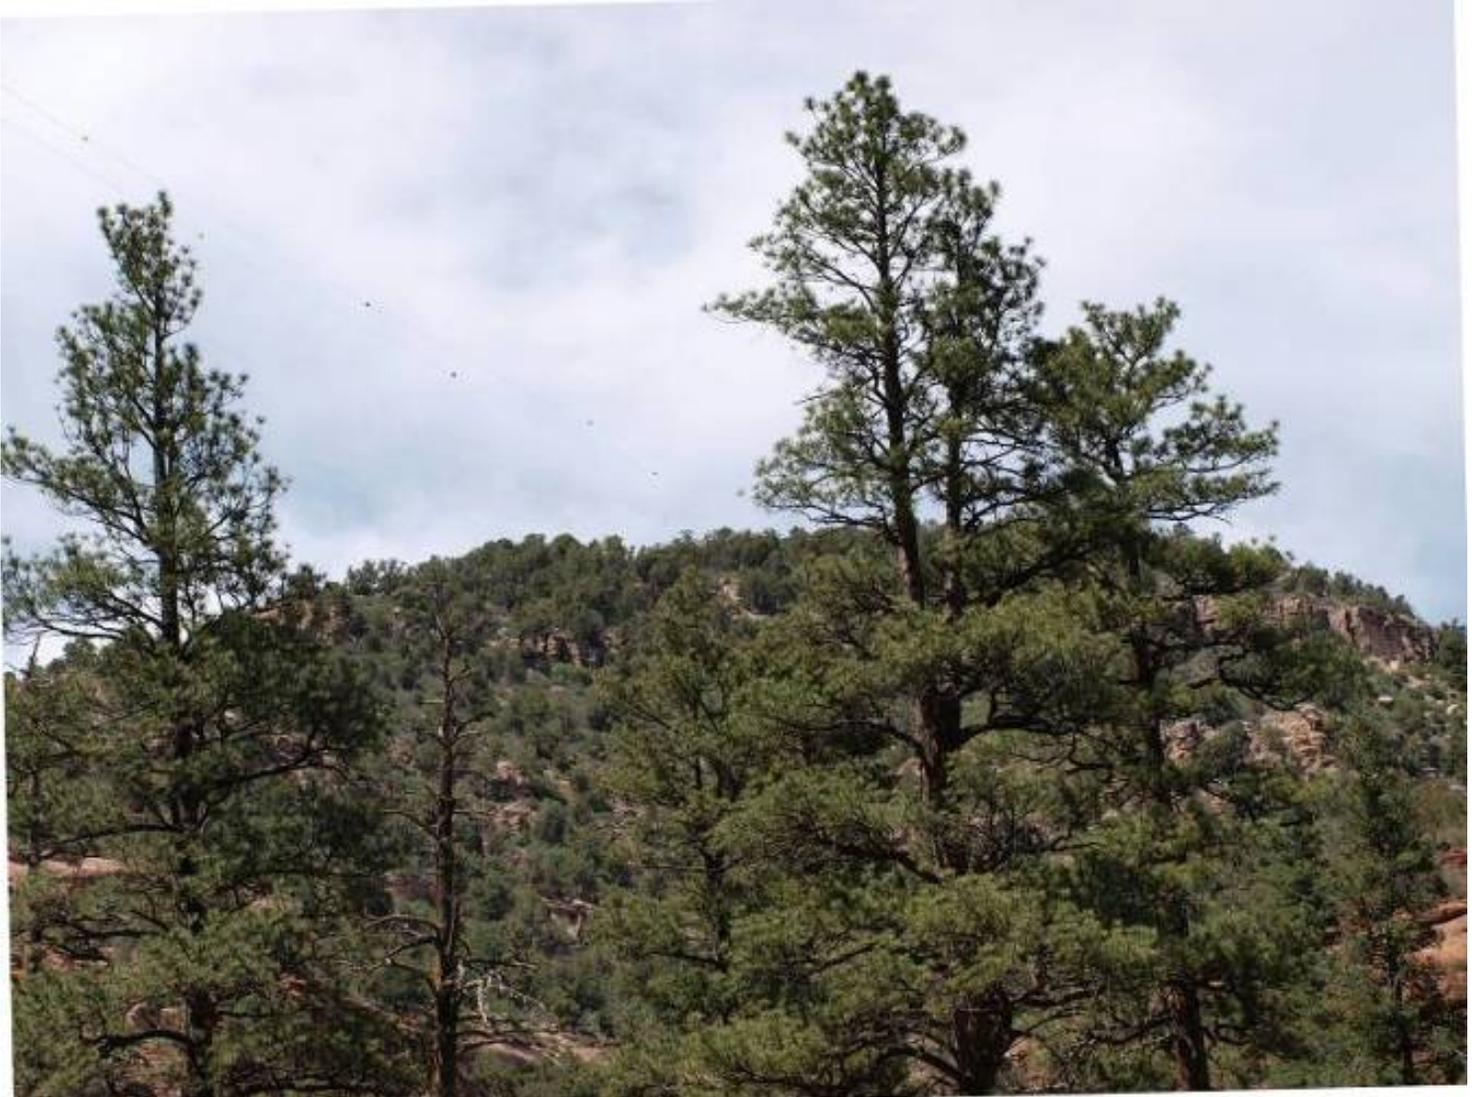
**Photo 11c. KOP11, Alternative C: Combinations that include Dolores River Crossing Routing Option (Upgrade-in-Place)**

**Alternative C: Combinations that include Dolores River Crossing Routing Option (Upgrade in Place) (Photo 11c)** – Because the proposed structure would be located farther from the canyon rim, it would not be visible in the photo simulation frame due to the screening effects of topography. The conductors would remain visible. Therefore, contrasts of the existing structure with the surrounding landscape and sky would be removed from the existing view within the photo simulation frame. There would be fewer structural elements remaining in the viewshed from this KOP with the setback of the pole structures. However, in general from the canyon bottom at this location, the structure would be more visible. Effects are offset by the fact that the existing structures and crossing are used as a frame of reference for river users, and the transmission line is an expected component of the landscape.

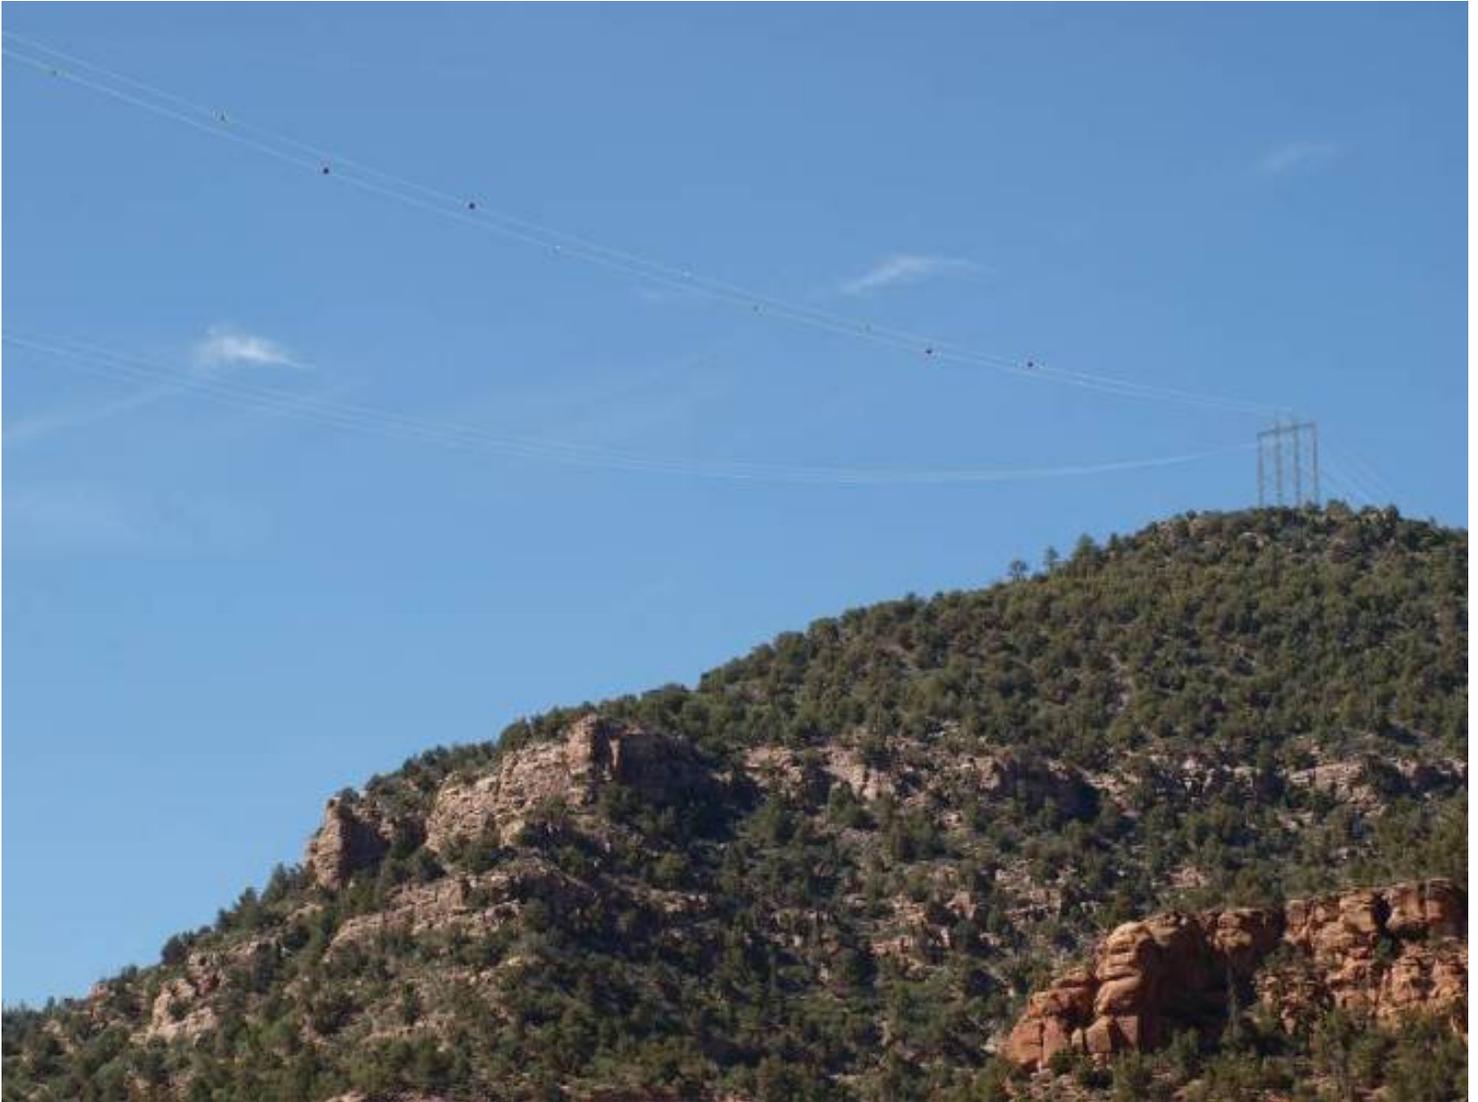
**Photo 12a. KOP12, Alternatives A and C- Dolores River Crossing Realignment Option  
(View of the North Rim)**

**Alternative A: Proposed Action and Alternative C- Dolores River Crossing Realignment Option (Photos 12a and 12c) –** Impacts to visual resources, would vary dependent upon the direction of the view. In views to the east and west, effects to

visual resources would be low, because the crossing would be north of the KOP, and therefore not visible in any other direction. There would be a high level of visual contrast in views to the north compared to existing conditions because the north rim structure and most of the conductors would be highly visible without obstruction (Photo 12a). Also, views to the north, above the canyon bottom, would include views of the south rim structure and conductors peripherally. Views to the south would become more naturalized because the existing structure would be removed and the area reclaimed (Photo 12c). Effects would be offset by removal of the existing structure upstream; effects would effectively move from one location to another. Tri-State would provide revised mapping and brochures for river users due to the change in transmission line location, because the existing structures and crossing are used as a frame of reference for river users. The existing transmission line is an expected component of the landscape.

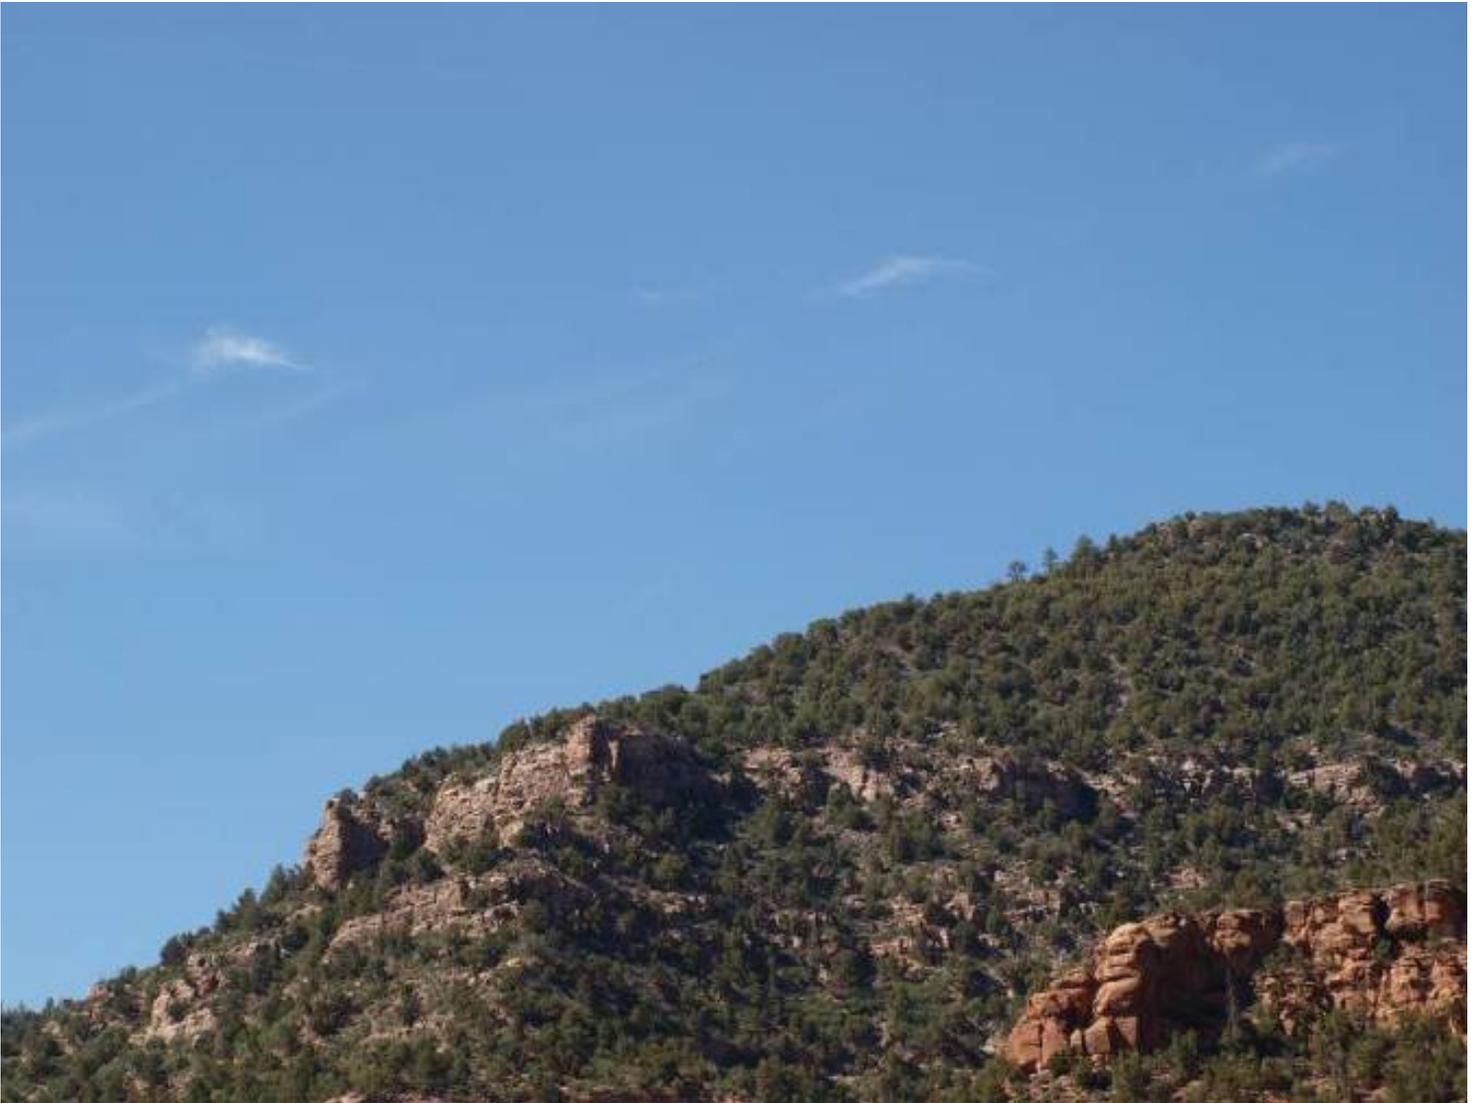
**Photo 12b. KOP12, Alternative B and Alternative C: Combinations that include Dolores River Crossing Routing Option (Upgrade-in-Place) (View of the North Rim; the Existing Transmission Line is Behind the Viewer)**

**Alternative B: No Action (Photo 12b and 12d):** Because the existing transmission line would remain unchanged, impacts to visual resources would be the same.

**Alternative C: Combinations that include the Dolores River Crossing Routing Option (upgrade-in-place) (Photos 12b and 12e)** Impacts to visual resources would be the same as in Alternative B in views to the north; there would be no visible structures. Views to the south (Photo 12e) indicate a larger structure moderate change in visibility. The structure is set back from the canyon rim slightly from the existing position. Effects are offset by the fact that the existing structures and crossing are used as a frame of reference for river users, and the transmission line is an expected component of the landscape.

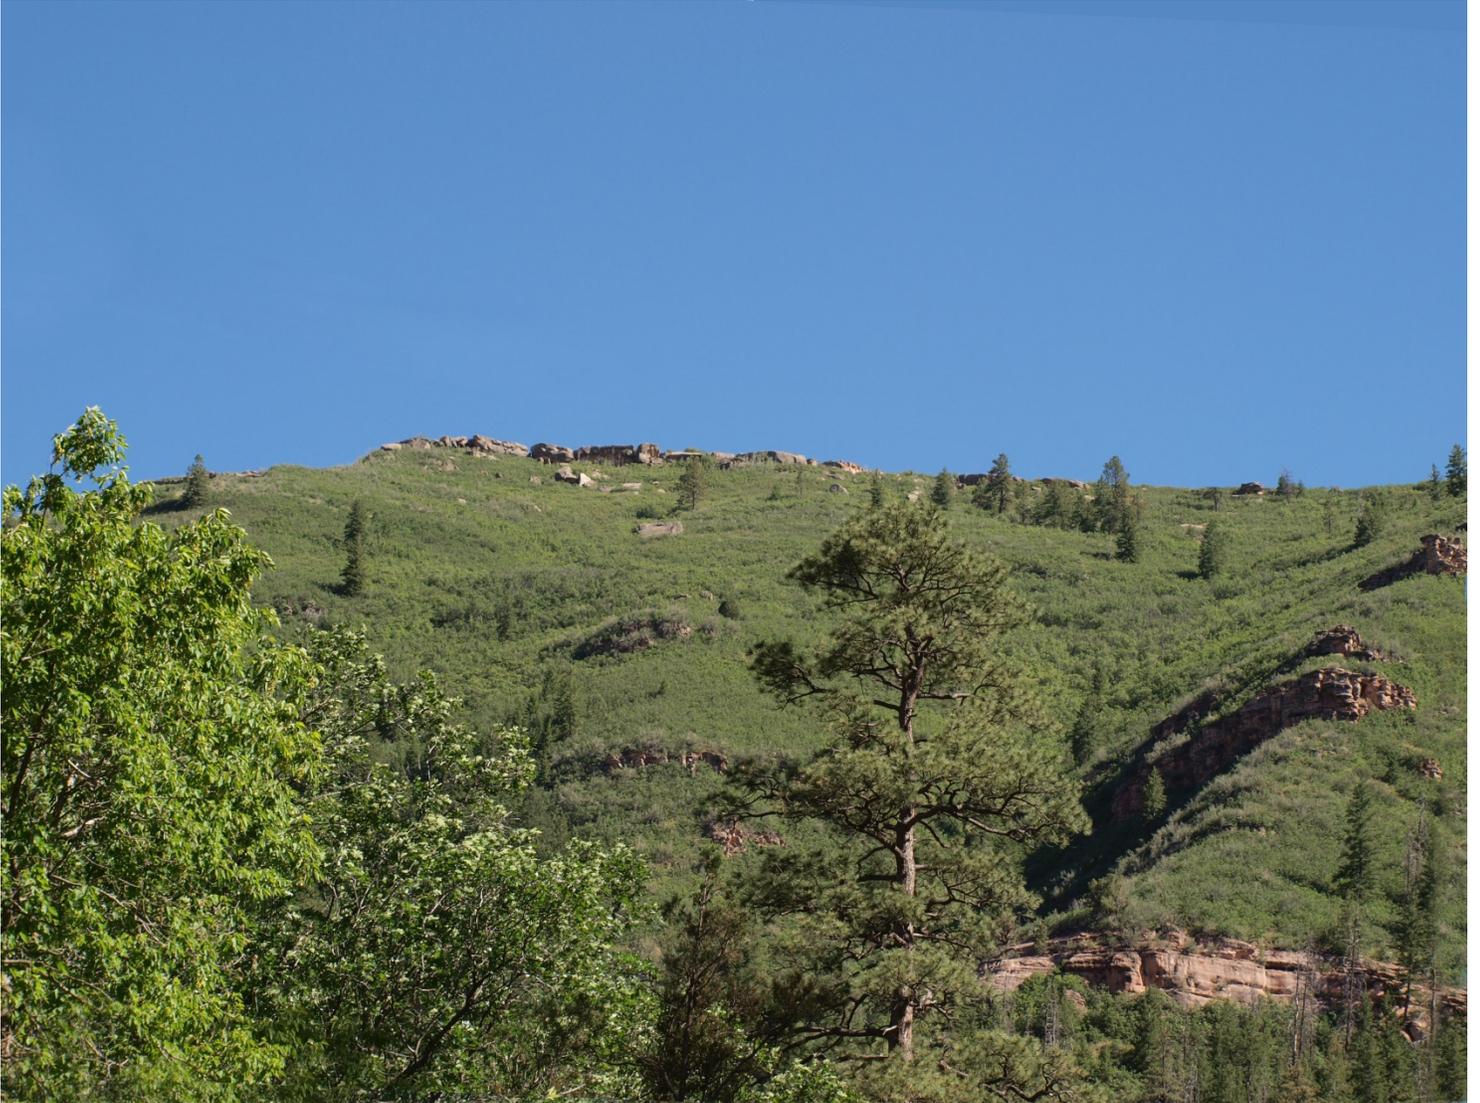
**Photo 12c. KOP12, Alternatives A and C- Dolores River Crossing Realignment Option (View South)**

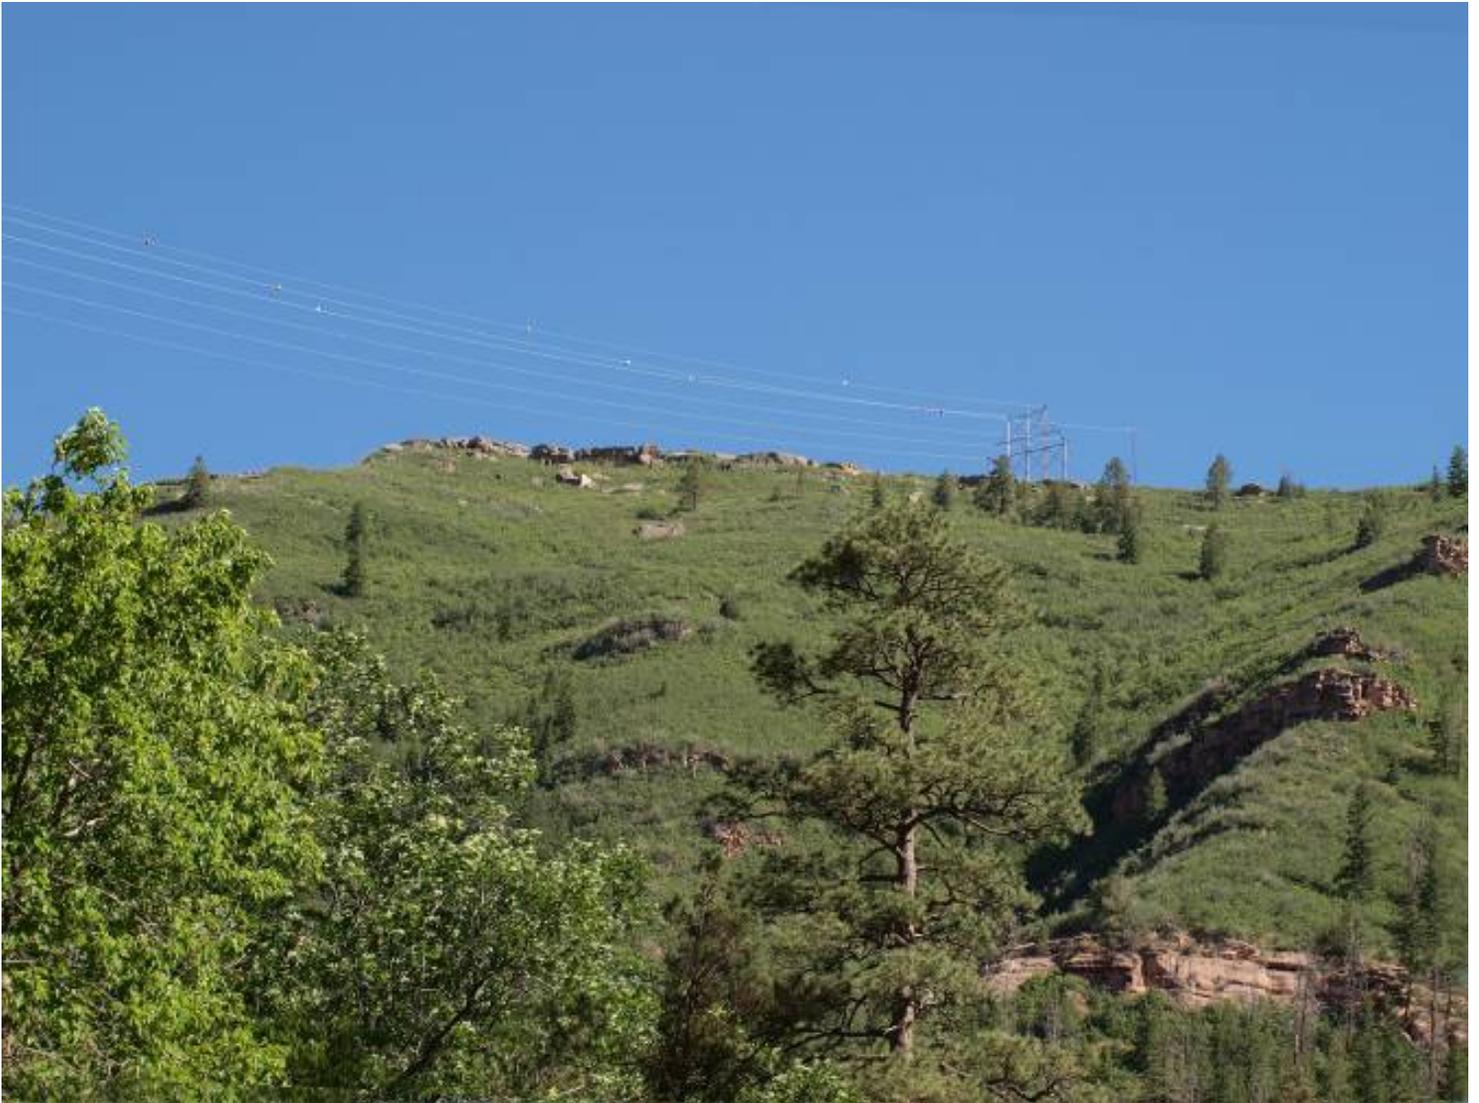
**Photo 12d. KOP12, Alternative B (View South)**
