**VISUAL ASSESSMENT REPORT  
FOR THE TRI-STATE MONTROSE-NUCLA-CAHONE  
TRANSMISSION LINE IMPROVEMENT PROJECT  
SOUTHWEST COLORADO**

# Tri-State Montrose-Nucla-Cahone Transmission Line Improvement Project Colorado

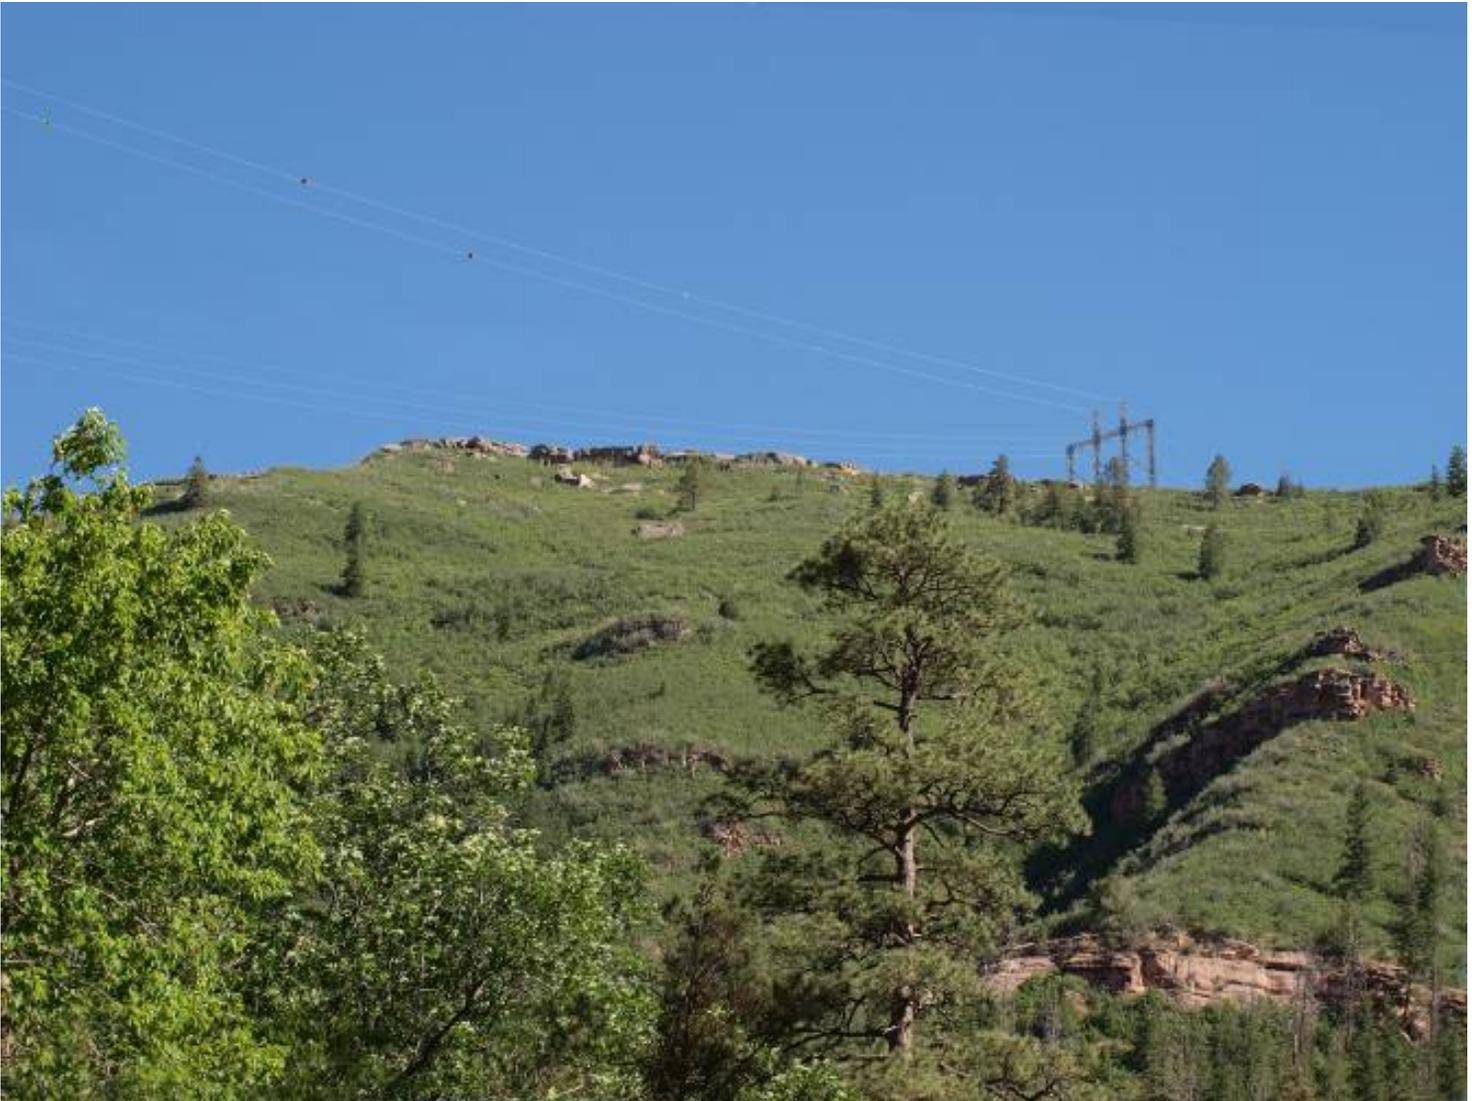
**Photo 12e. KOP12, Alternative C: Combinations that include Dolores River Crossing Routing Option (Upgrade-in-Place) (View South)**

**Alternative C: Combinations that include the Dolores River Crossing Routing Option (upgrade-in-place) (Photos 12b and 12e)** Impacts to visual resources would be the same as in Alternative B in views to the north; there would be no visible structures. Views to the south (Photo 12e) indicate a larger structure moderate change in visibility. The structure is set back from the canyon rim slightly from the existing position. Effects are offset by the fact that the existing structures and crossing are used as a frame of reference for river users, and the transmission line is an expected component of the landscape.

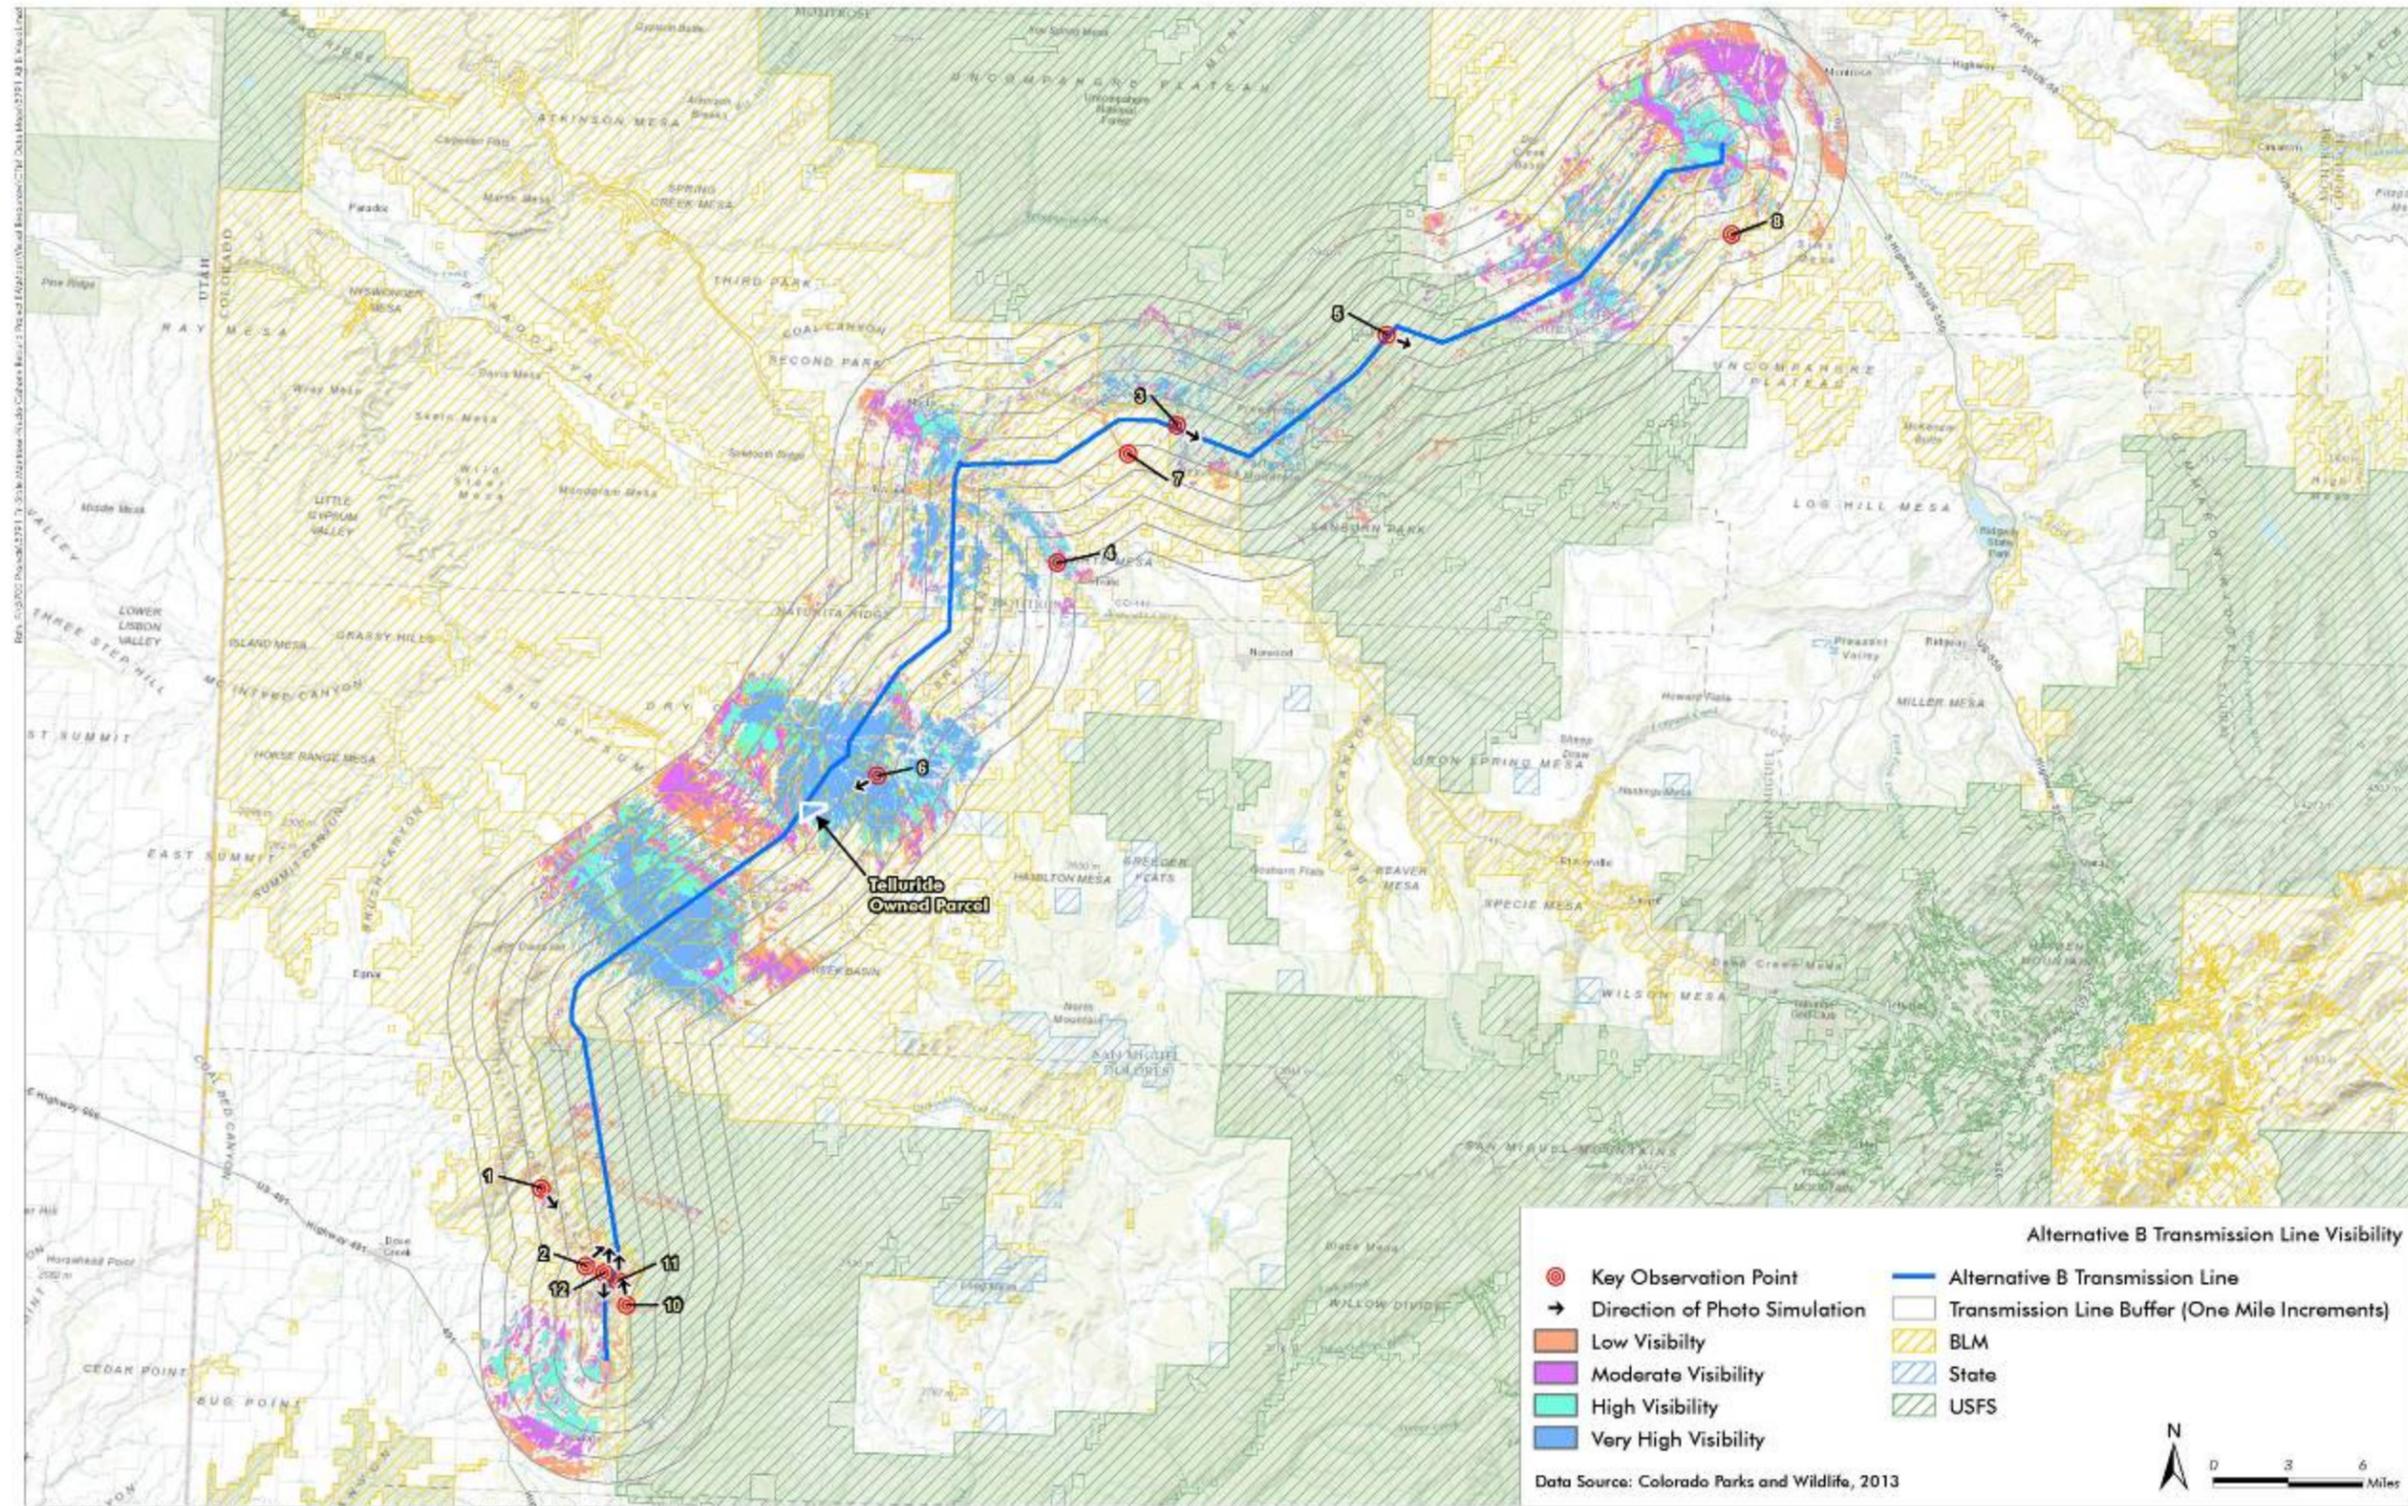
FIGURE 3. EXISTING VISIBILITY OF TRANSMISSION LINE/ALTERNATIVE - NO ACTION ALTERNATIVE

Areas with visibility of the transmission line alternatives were identified by two digital viewshed analyses. One viewshed analysis was performed from the existing transmission line (Figure 3), and the other analysis from the proposed line and alternatives (Figures 4 and 5). The digital viewshed analysis program for this project was written to use the transmission line structure tops for observation points. Therefore, the top of each connects direct lines of sight to the modified digital terrain model in all directions and at multiple elevations, within a distance of 5 miles from each structure. Tree coverage was included in the analysis by adding an average tree height to the digital terrain model. Digital polygons were created to represent the shape of the tree clearing areas required for the lines, structures, and access roads. The digital viewshed analyses were used to accurately calculate the length of each transmission line alternative visible from each KOP. The total length of transmission line alternative visible from each KOP was measured using GIS data. Twelve KOPs were selected for this assessment by the BLM and USFS visual resource specialists and HLA during site visits in June and July 2014. KOP selection

Figure 3. Existing Visibility of Transmission Line/Alternative - No Action Alternative

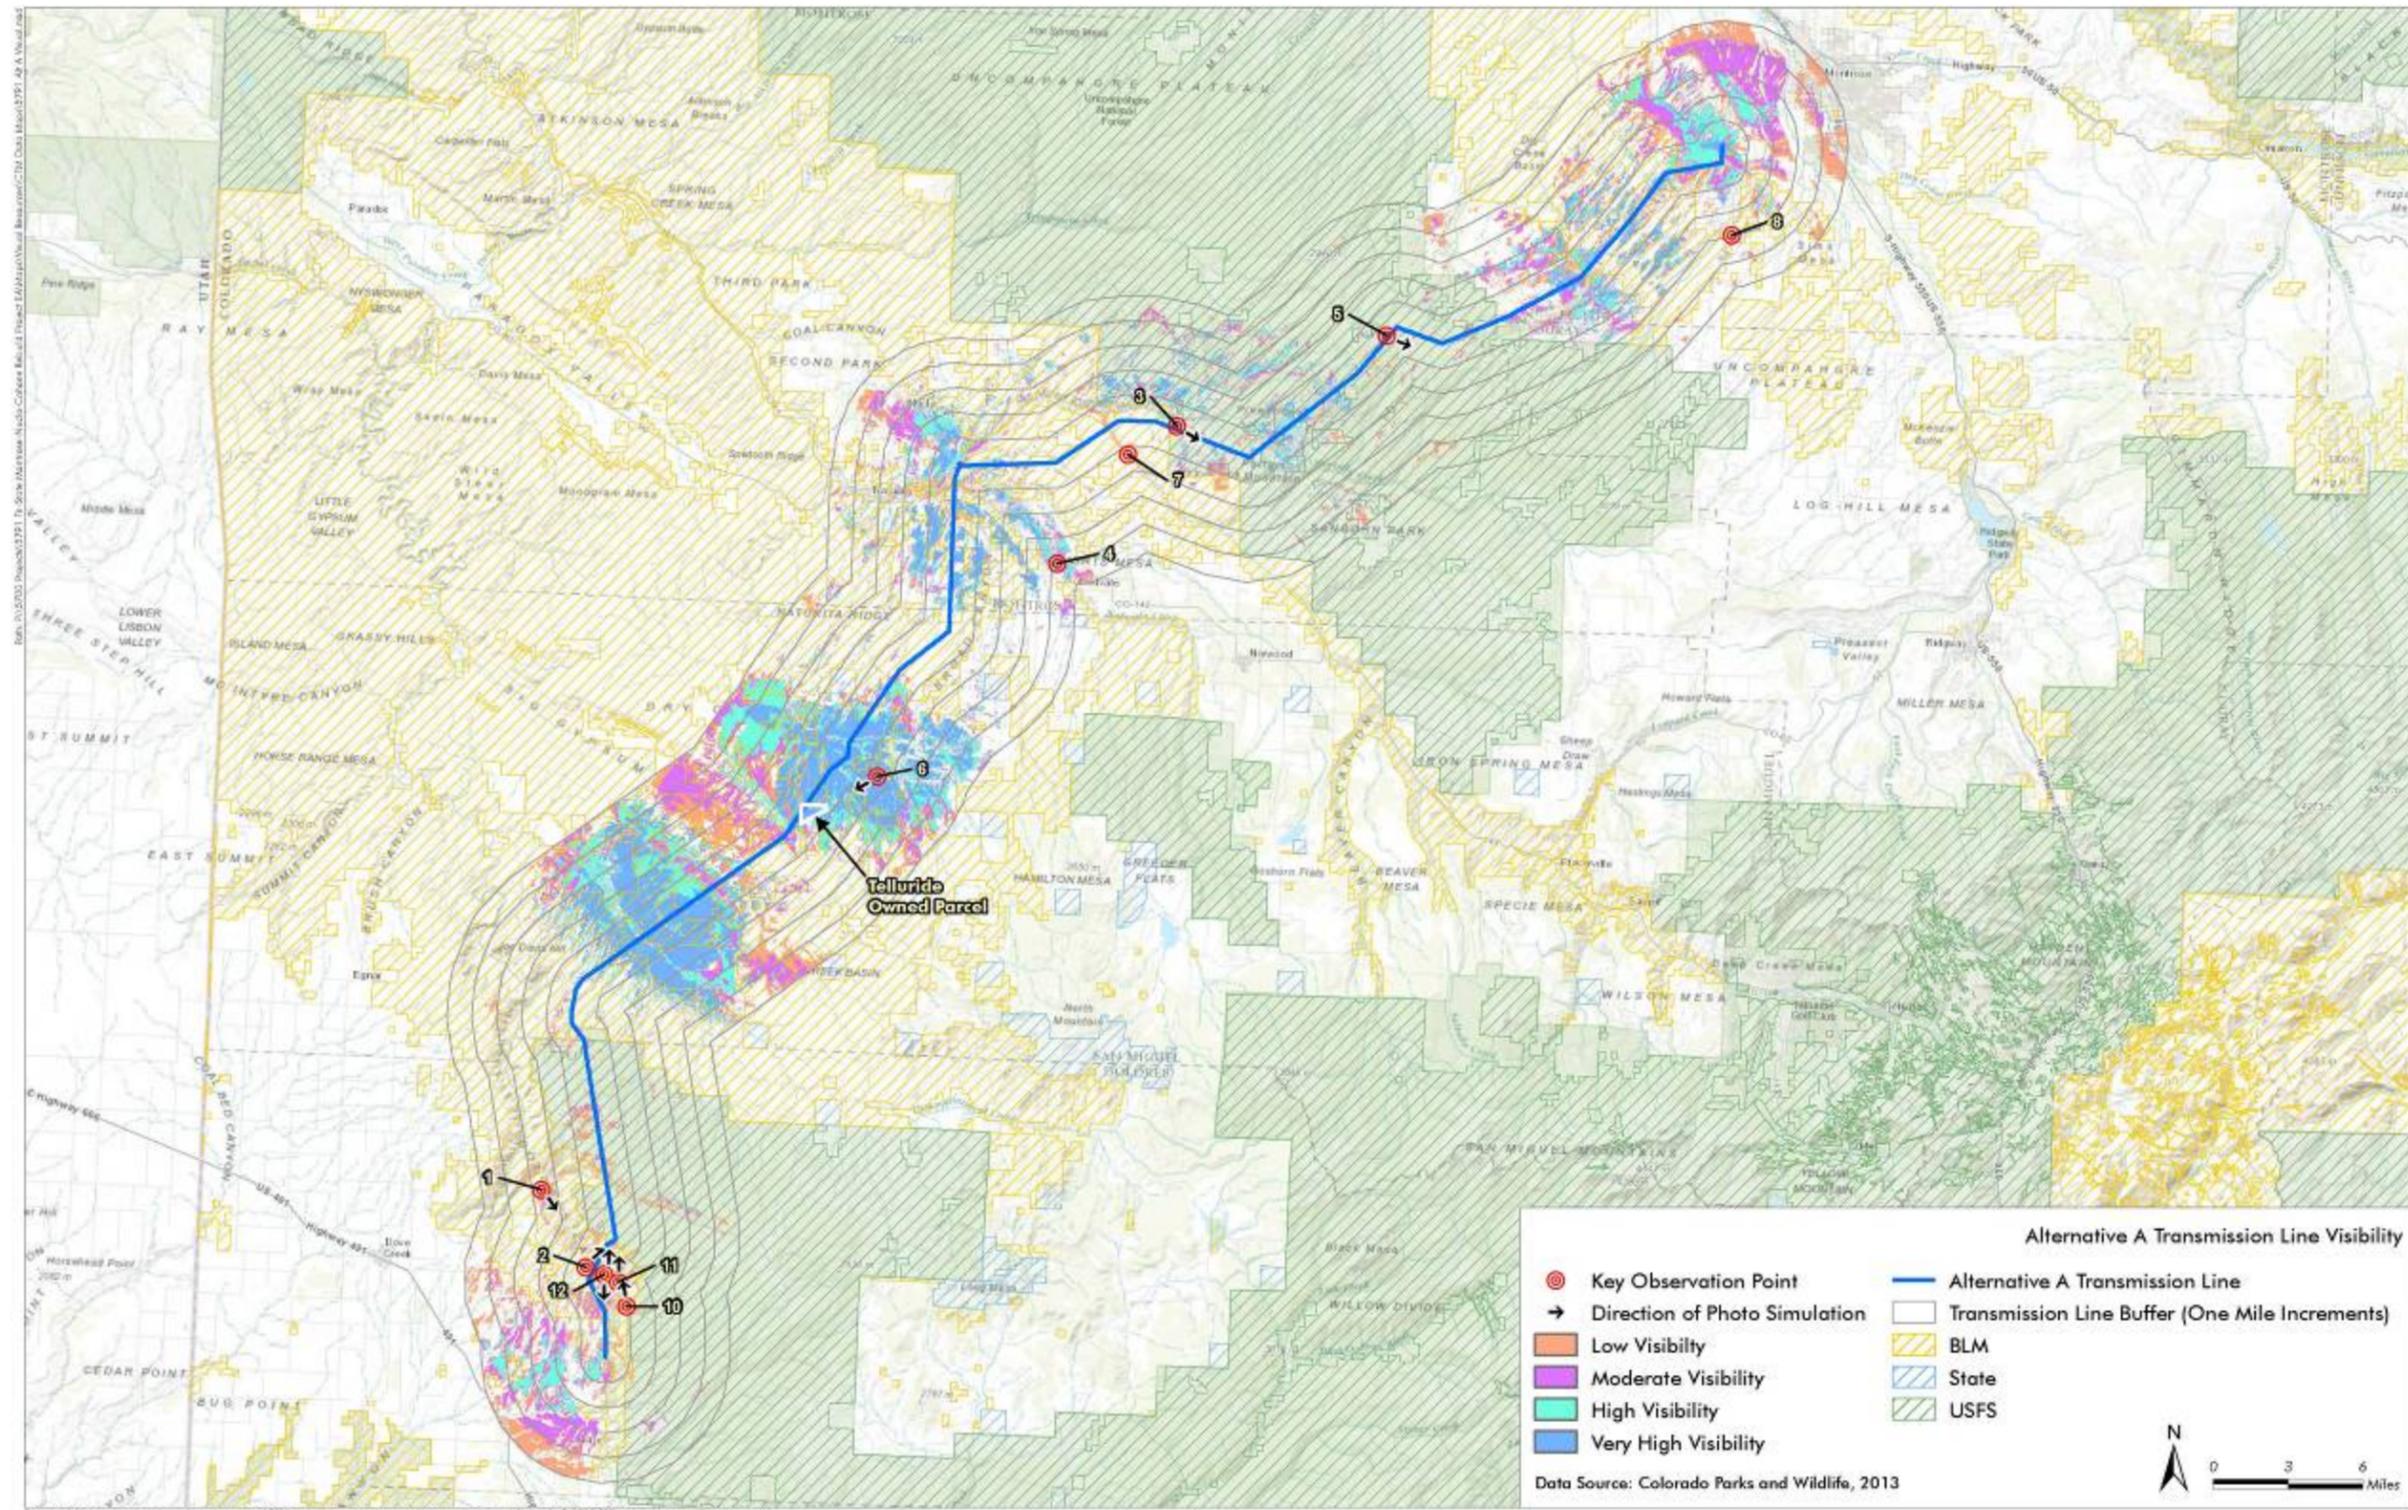
FIGURE 4. VISIBILITY OF TRANSMISSION LINE FROM ALTERNATIVE A - PROPOSED ACTION ALTERNATIVE

Figure 4. Visibility of Transmission Line from Alternative A - Proposed Action Alternative

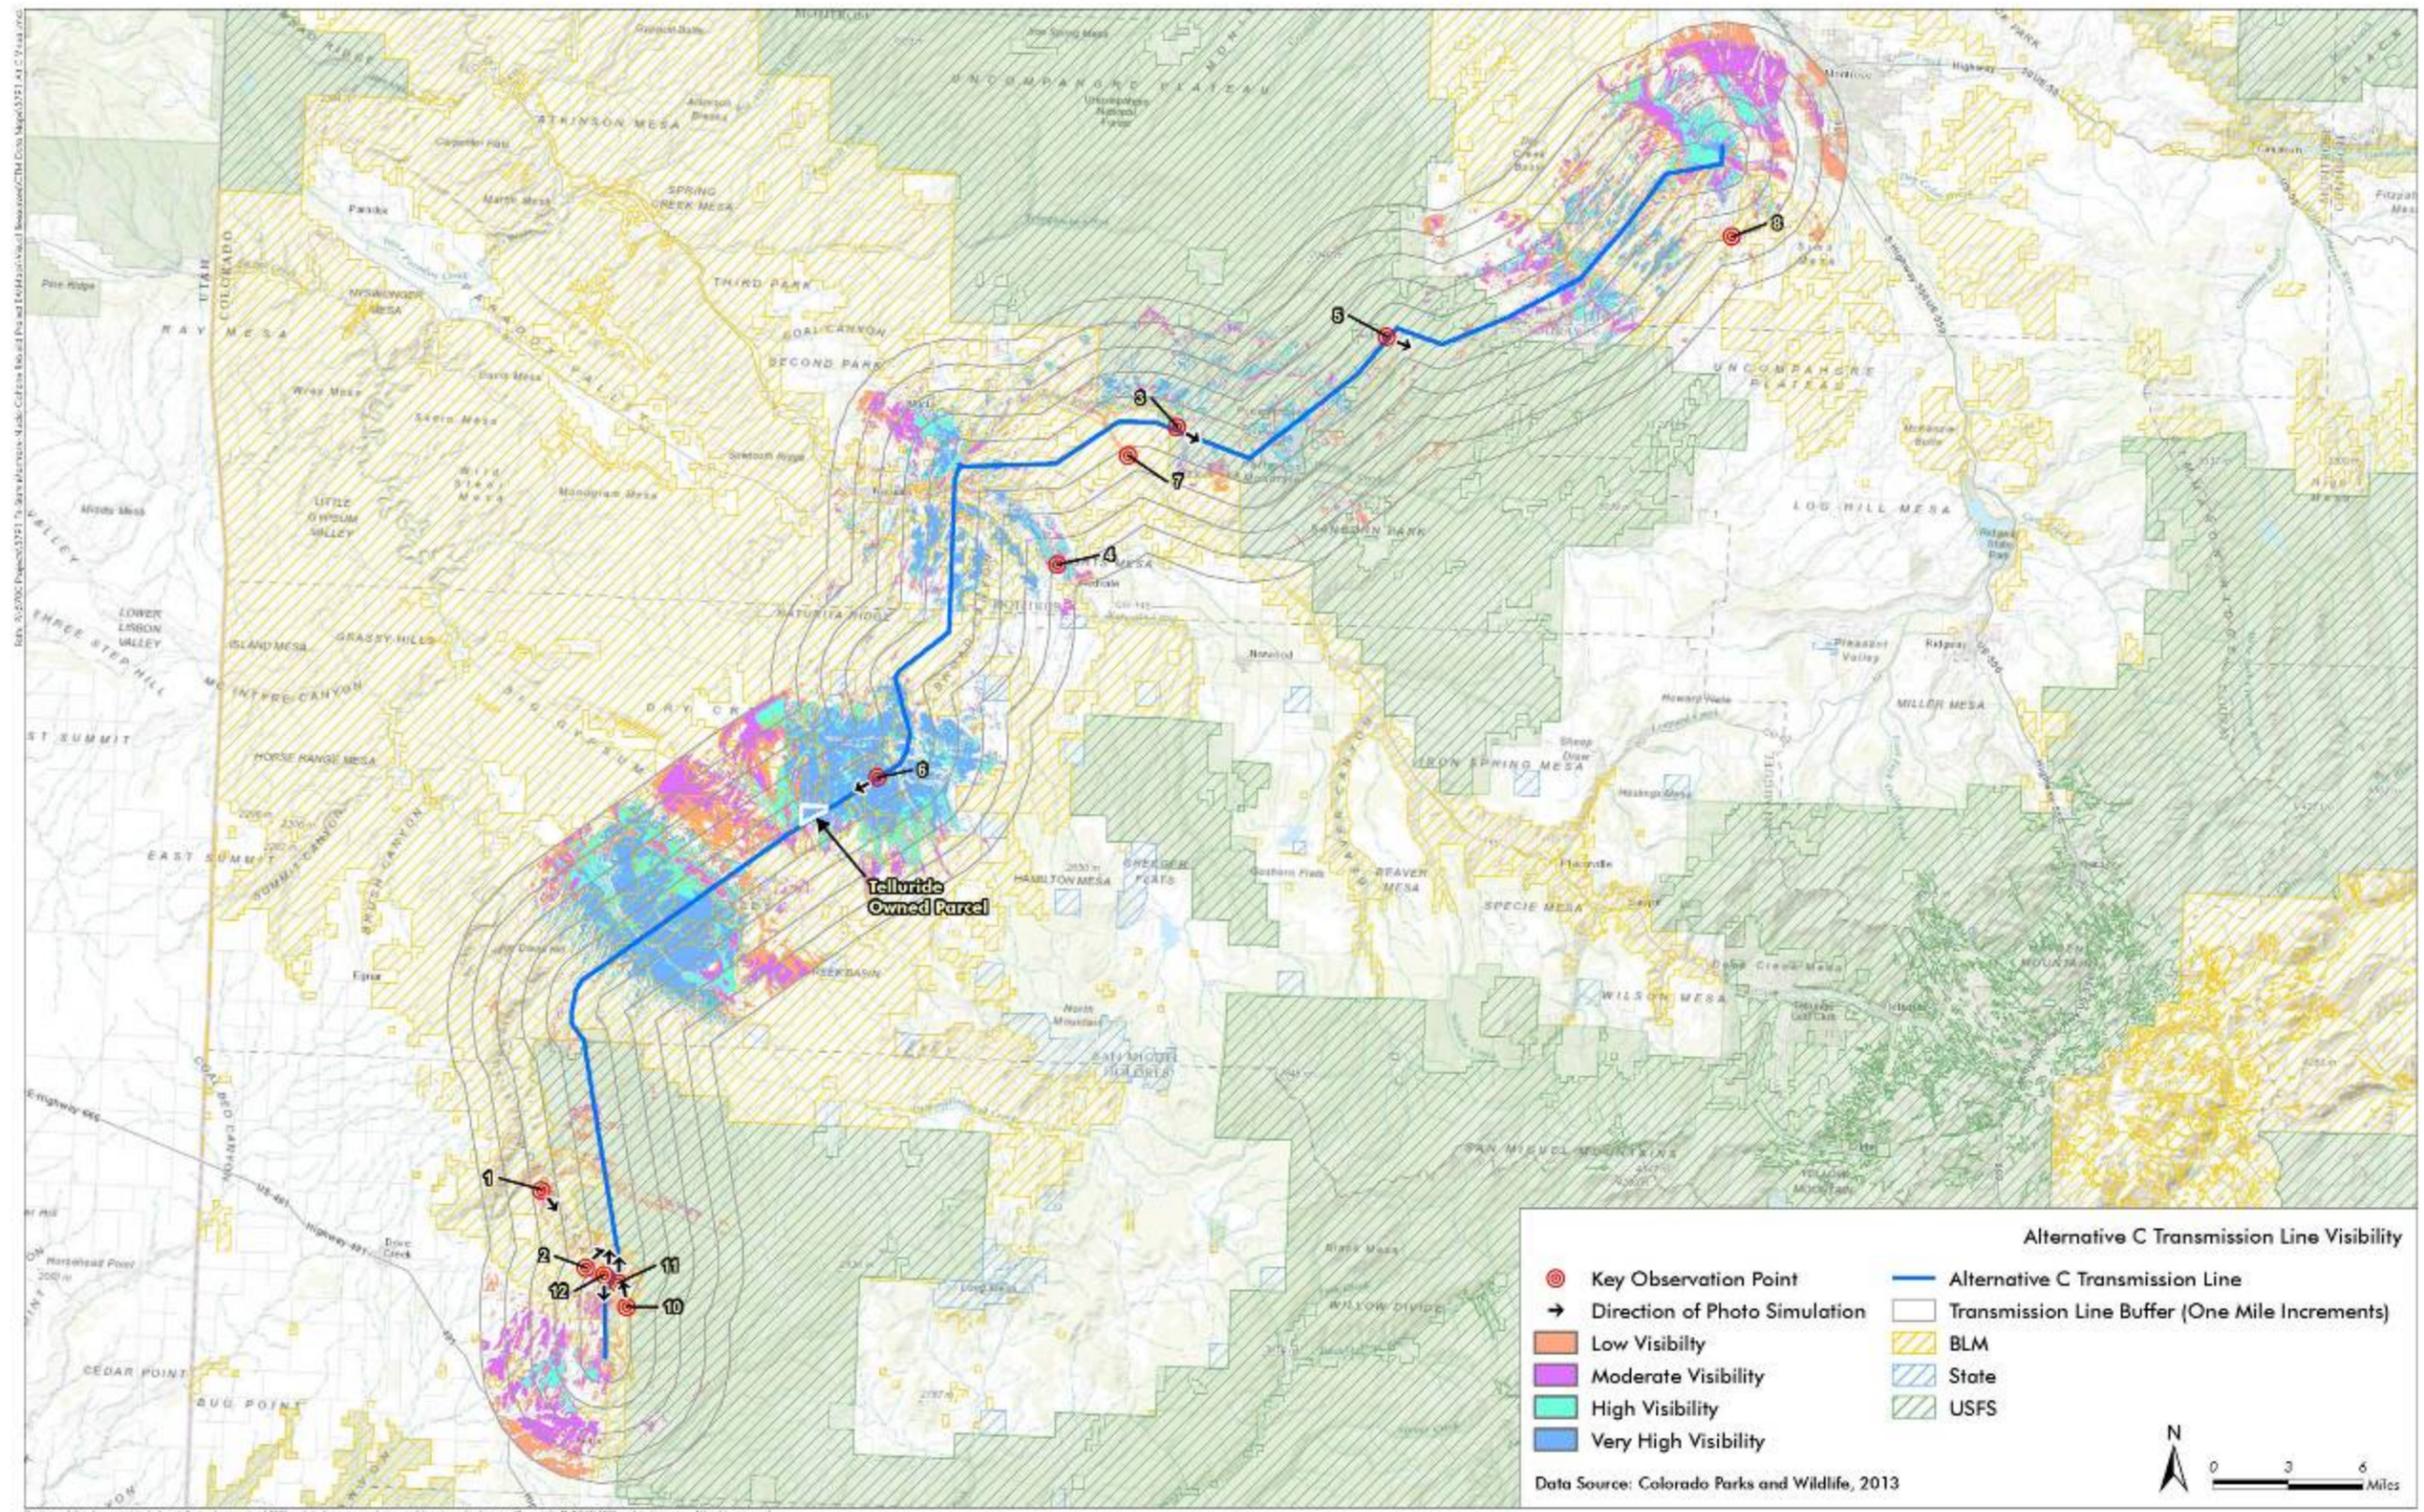
FIGURE 5. VISIBILITY OF TRANSMISSION LINE FROM ALTERNATIVE C – OTHER ACTION ALTERNATIVE

Figure 5. Visibility of Transmission Line from Alternative C – Other Action Alternative (BLM routing options)
