**KOP 2  
 Geologic Feature**

Figure 3.9-3

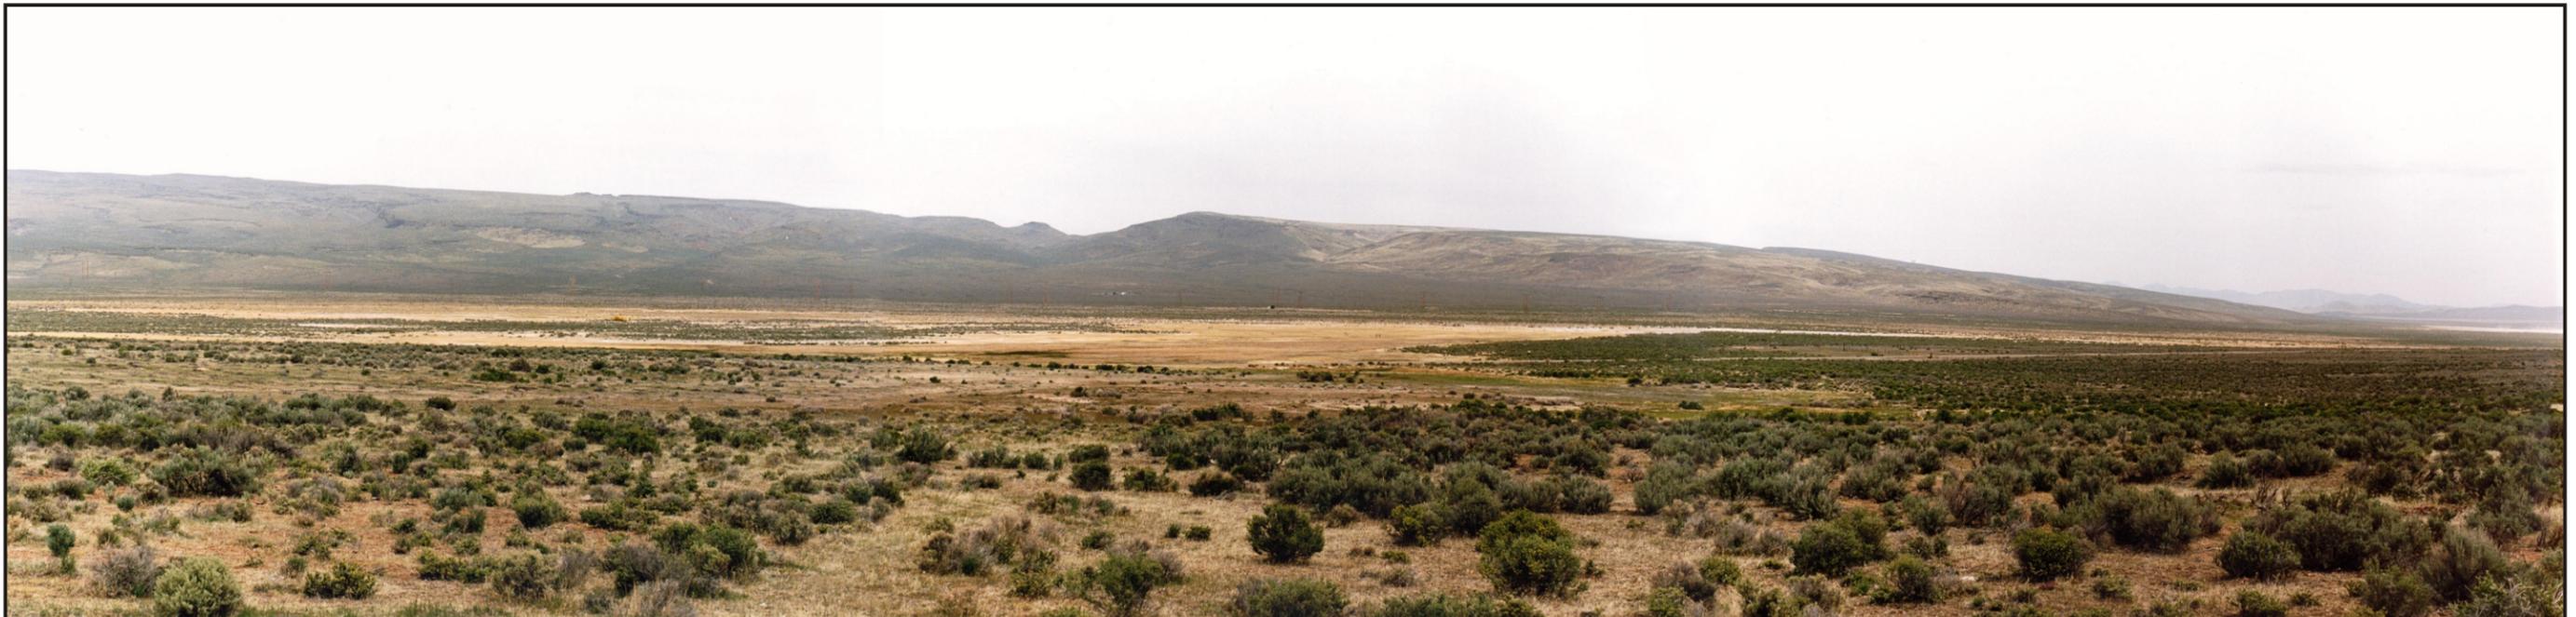
**Future Conditions**

Note: Proposed transmission line is located on the east side of Whirlwind Valley and is obscured by atmospheric conditions and mountain backdrop.

**Volume of Users:** Low - relatively few  
**T/L Distance from Viewer:** Middleground - approximately one mile  
**T/L Prominence in Landscape:** Low - seen against near to distant landforms  
**Existing Modifications:** Two existing wood pole transmission lines and small building near the proposed T/L location; substantial road cut (behind this viewpoint)

**Contrast Rating:** Moderate  
**VRM Class:** IV  
**Visual Impact Rating:** Low
