Appendix H
Bureau of Land Management
Visual Contrast Rating Worksheet

UNITED STATES
DEPARTMENT OF THE INTERIOR
BUREAU OF LAND MANAGEMENT
VISUAL CONTRAST RATING WORKSHEET

1. Project Name Toquop Energy Project	4. Location Township <u>13S</u>	5. Location Sketch See attached Figure 1 showing the location of KOP 1
2. Key Observation Point <u>1</u>	Range <u>69E</u>	
3. VRM Class <u>III</u>	Sections <u>5,8,16,17,20,28,29</u>

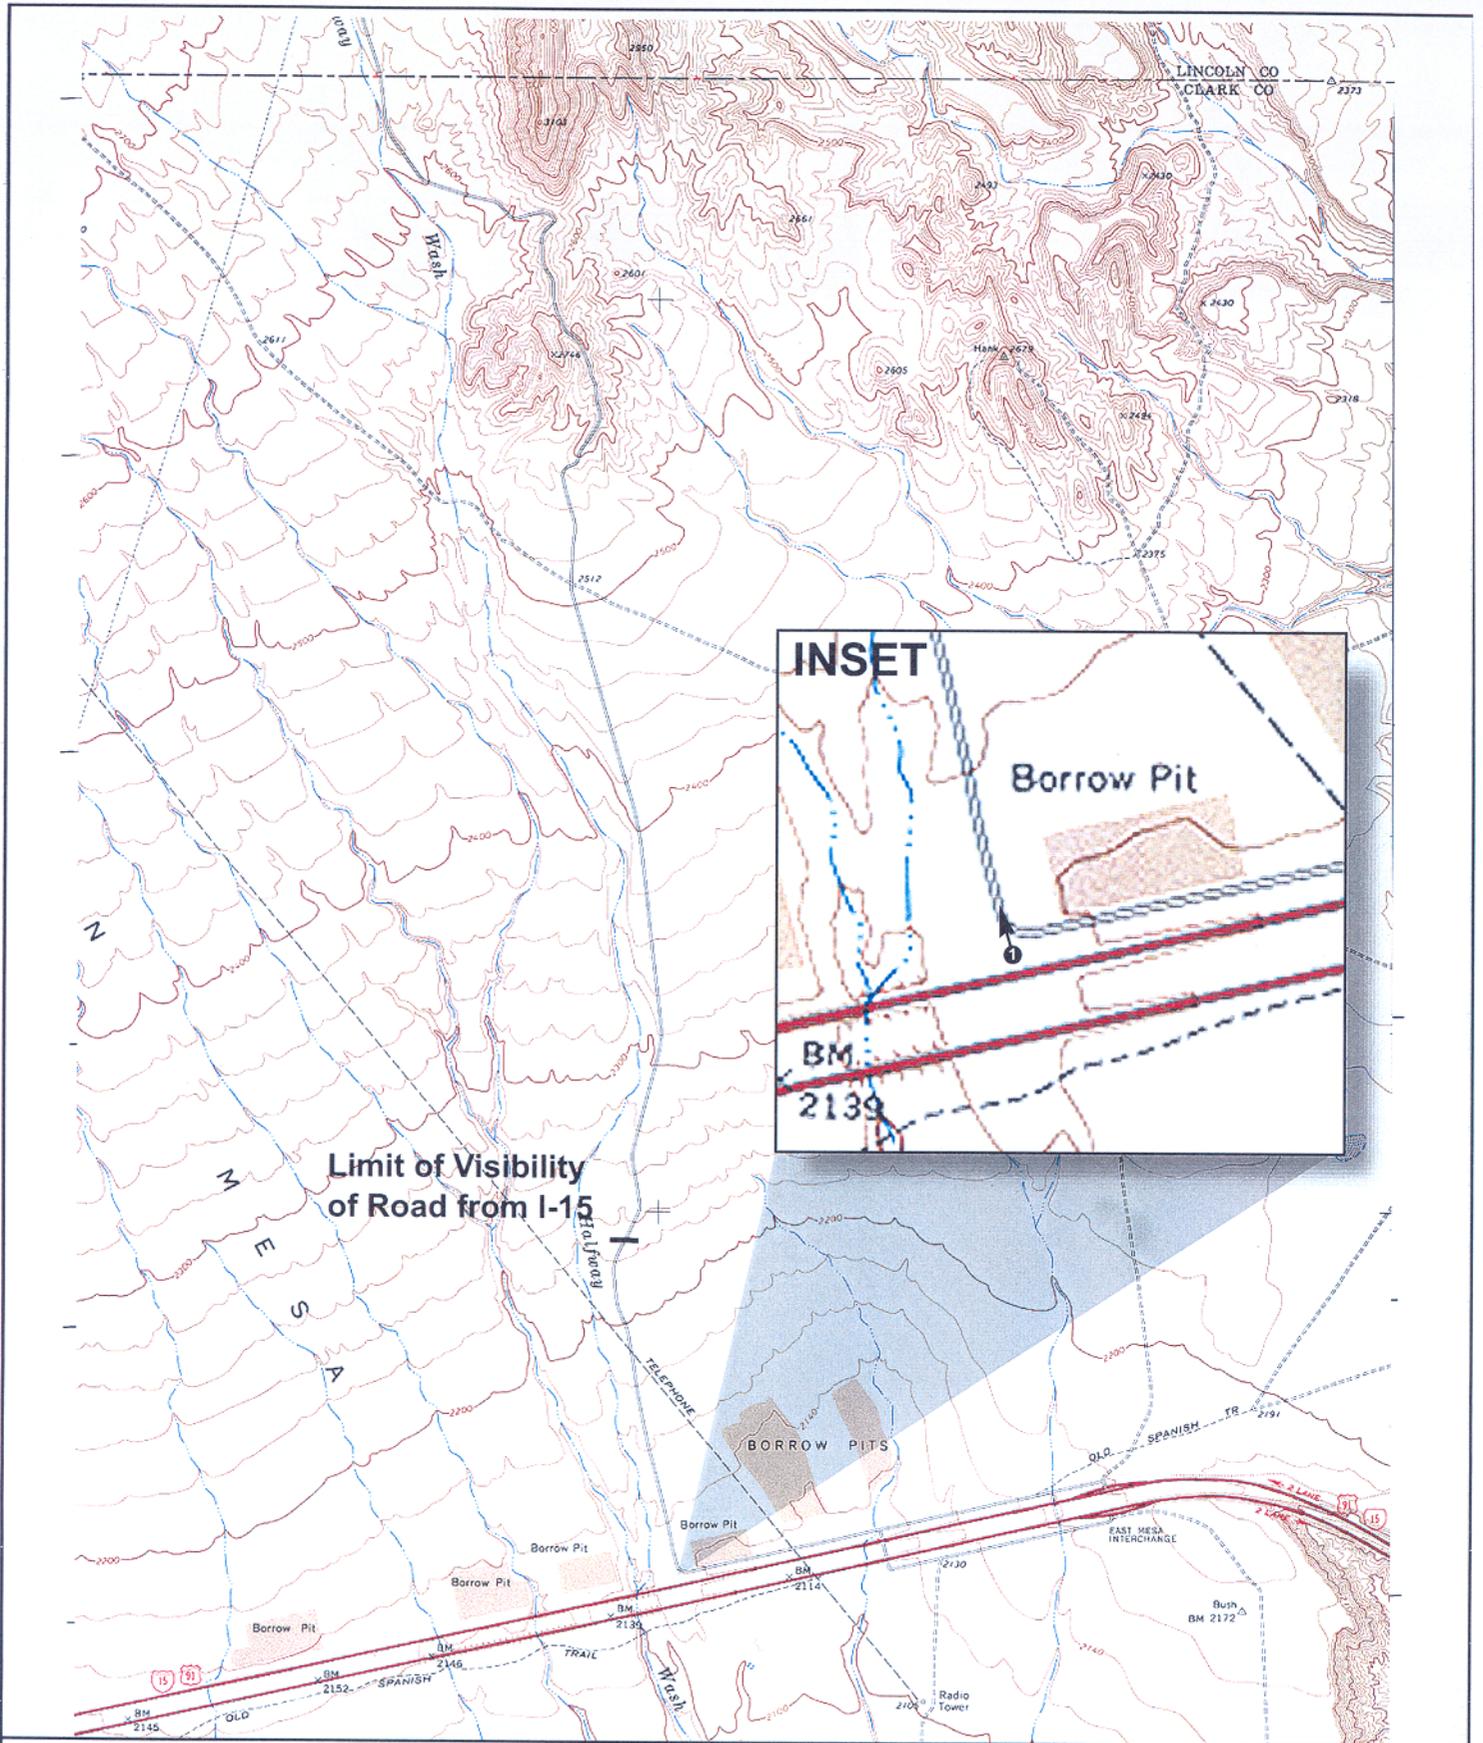
Figure 1

1 = Key Observation Point (KOP)

Location of Key Observation Point

The northbound portion of the access road (See Figure 1) is only visible from I-15 when either northbound or southbound vehicles are passing by the frontage road where it turns northward. Visibility of the northbound dirt road is limited to approximately 0.4 mile from I-15. When vehicles are past it in either direction, it is screened from view due to the existing dirt/gravel roadbed being a little lower in elevation than the surrounding ground surface and low-lying desert vegetation.

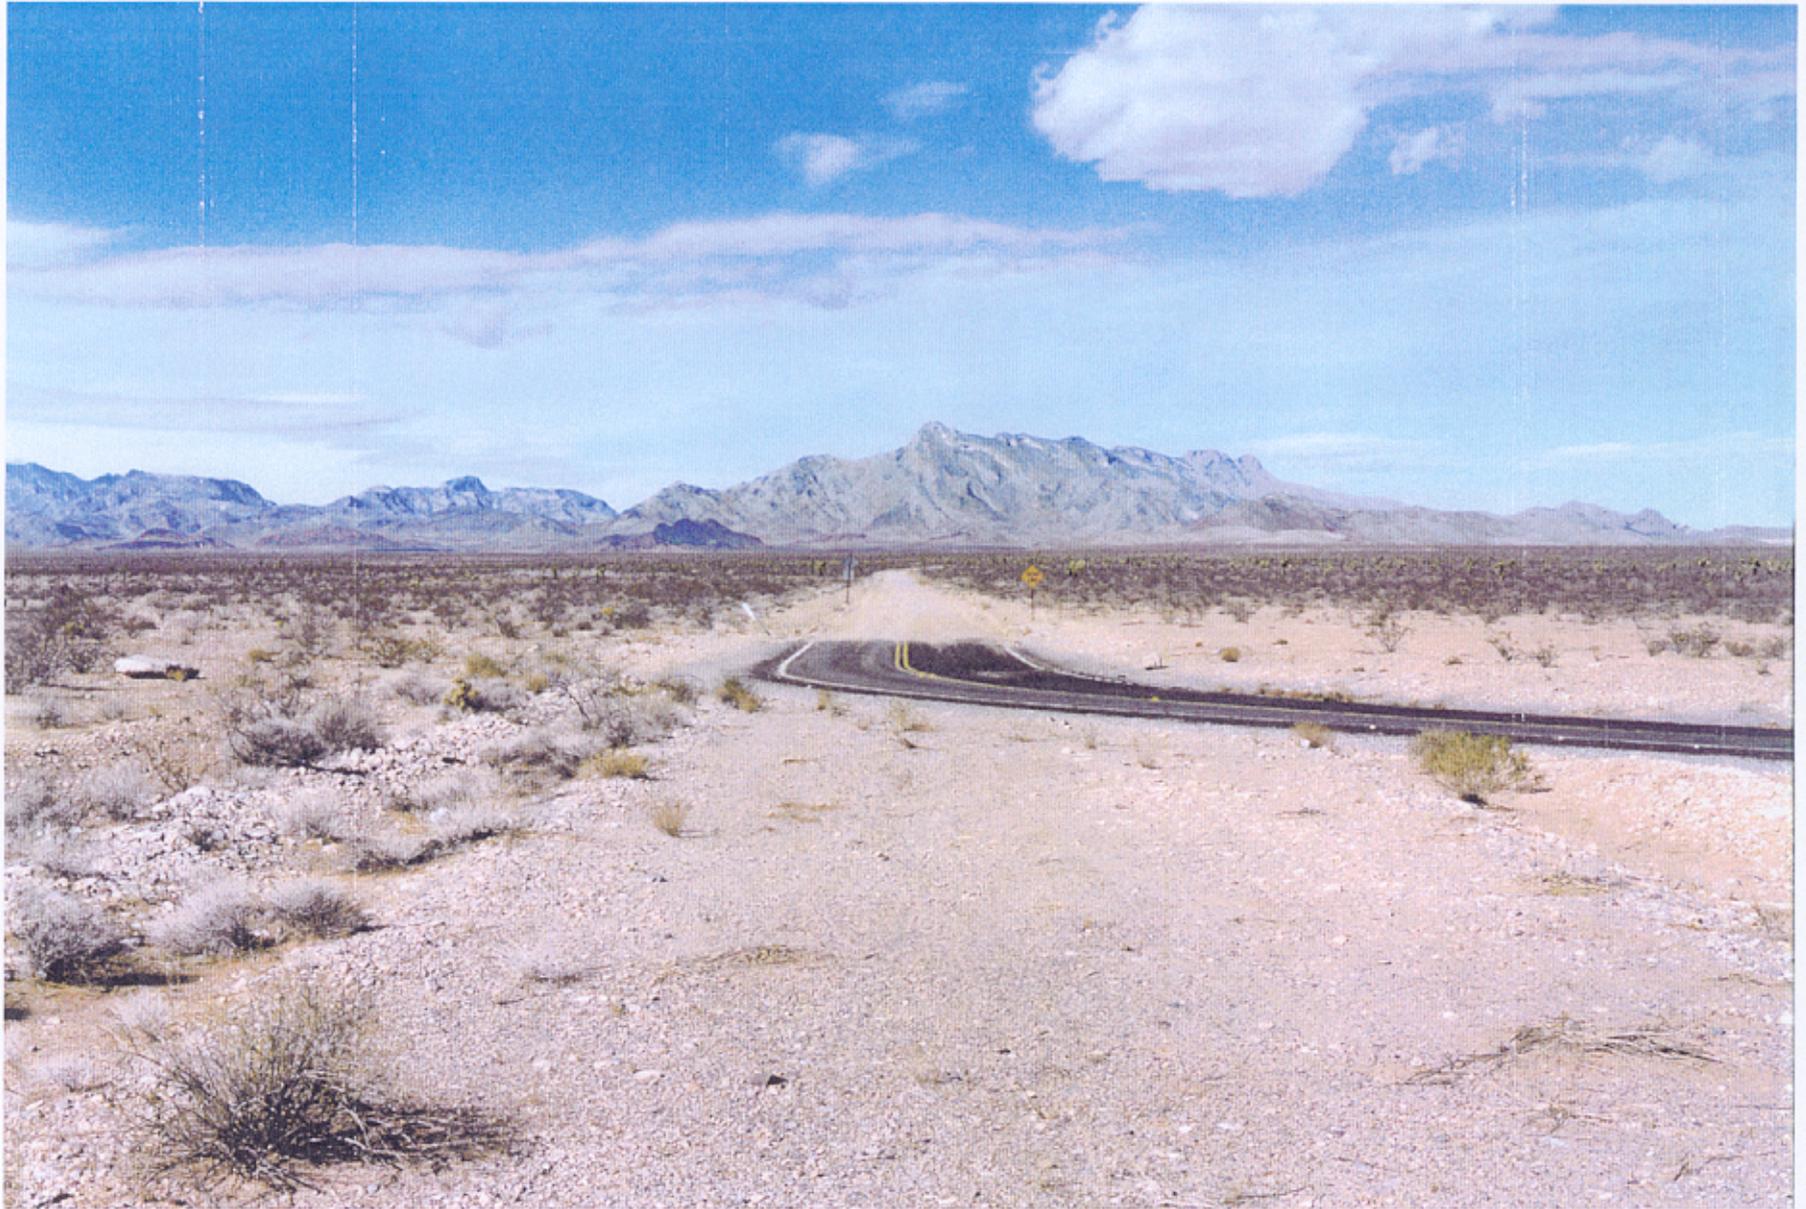
Figure 2a

Existing condition view of the frontage road that parallels I-15 on the north side of the freeway. This is the view looking north where the frontage road turns northward.

KOP 1: Existing Condition

1. LAND/WATER		2. VEGETATION		3. STRUCTURES	
FORM	Flat desert terrain in foreground. Mountains in the distance. No water bodies evident.		Low-lying sparse vegetation typical of a desert landscape.		KOP 1 (Figure 2a) shows the existing paved frontage road in the immediate foreground (approximately 20 feet wide), and where it changes to a dirt roadway.
LINE	Horizontal line created by ground surface at base of mountains. Horizontal line created by paved frontage road. Vertical line created by unpaved continuation of frontage road (dirt road) through the center of photo (Figure 2a)		Cleared swath of land (vegetation removed exposing bare soil) along existing dirt roadway and cleared area where road turns (lower portion of photo in Figure 2a).		KOP 1 (Figure 2a) shows the existing paved road, the dirt road, and roadway signs on both signs of the dirt road.
COLOR	Tan and light brown in foreground. Mountains appear shades of gray and brown in distance.		Vegetation appears as shades of brown, reddish brown, with minor hues of yellow.		Paved road is charcoal gray with a double yellow median stripe and white lines marking the roadway edge.

TEX-TURE	Gravel and bare soil provide texture.		Vegetation throughout the photo (Figure 2a) provides texture.		Minimal texture provided by existing paved and dirt roads.

COLOR	Tan and light brown in foreground. Mountains appear shades of gray and brown in distance.		Vegetation appears as shades of brown, reddish brown, with minor hues of yellow. Slightly less vegetation visible in Figure 2b when compared to Figure 2a.		Charcoal gray roadway with yellow and white striping.
TEX-TURE	Gravel and bare soil provide texture.		Minor change in vegetation due to vegetation removal for roadway widening results in little to no change in texture.		Minimal texture provided by proposed widened road.

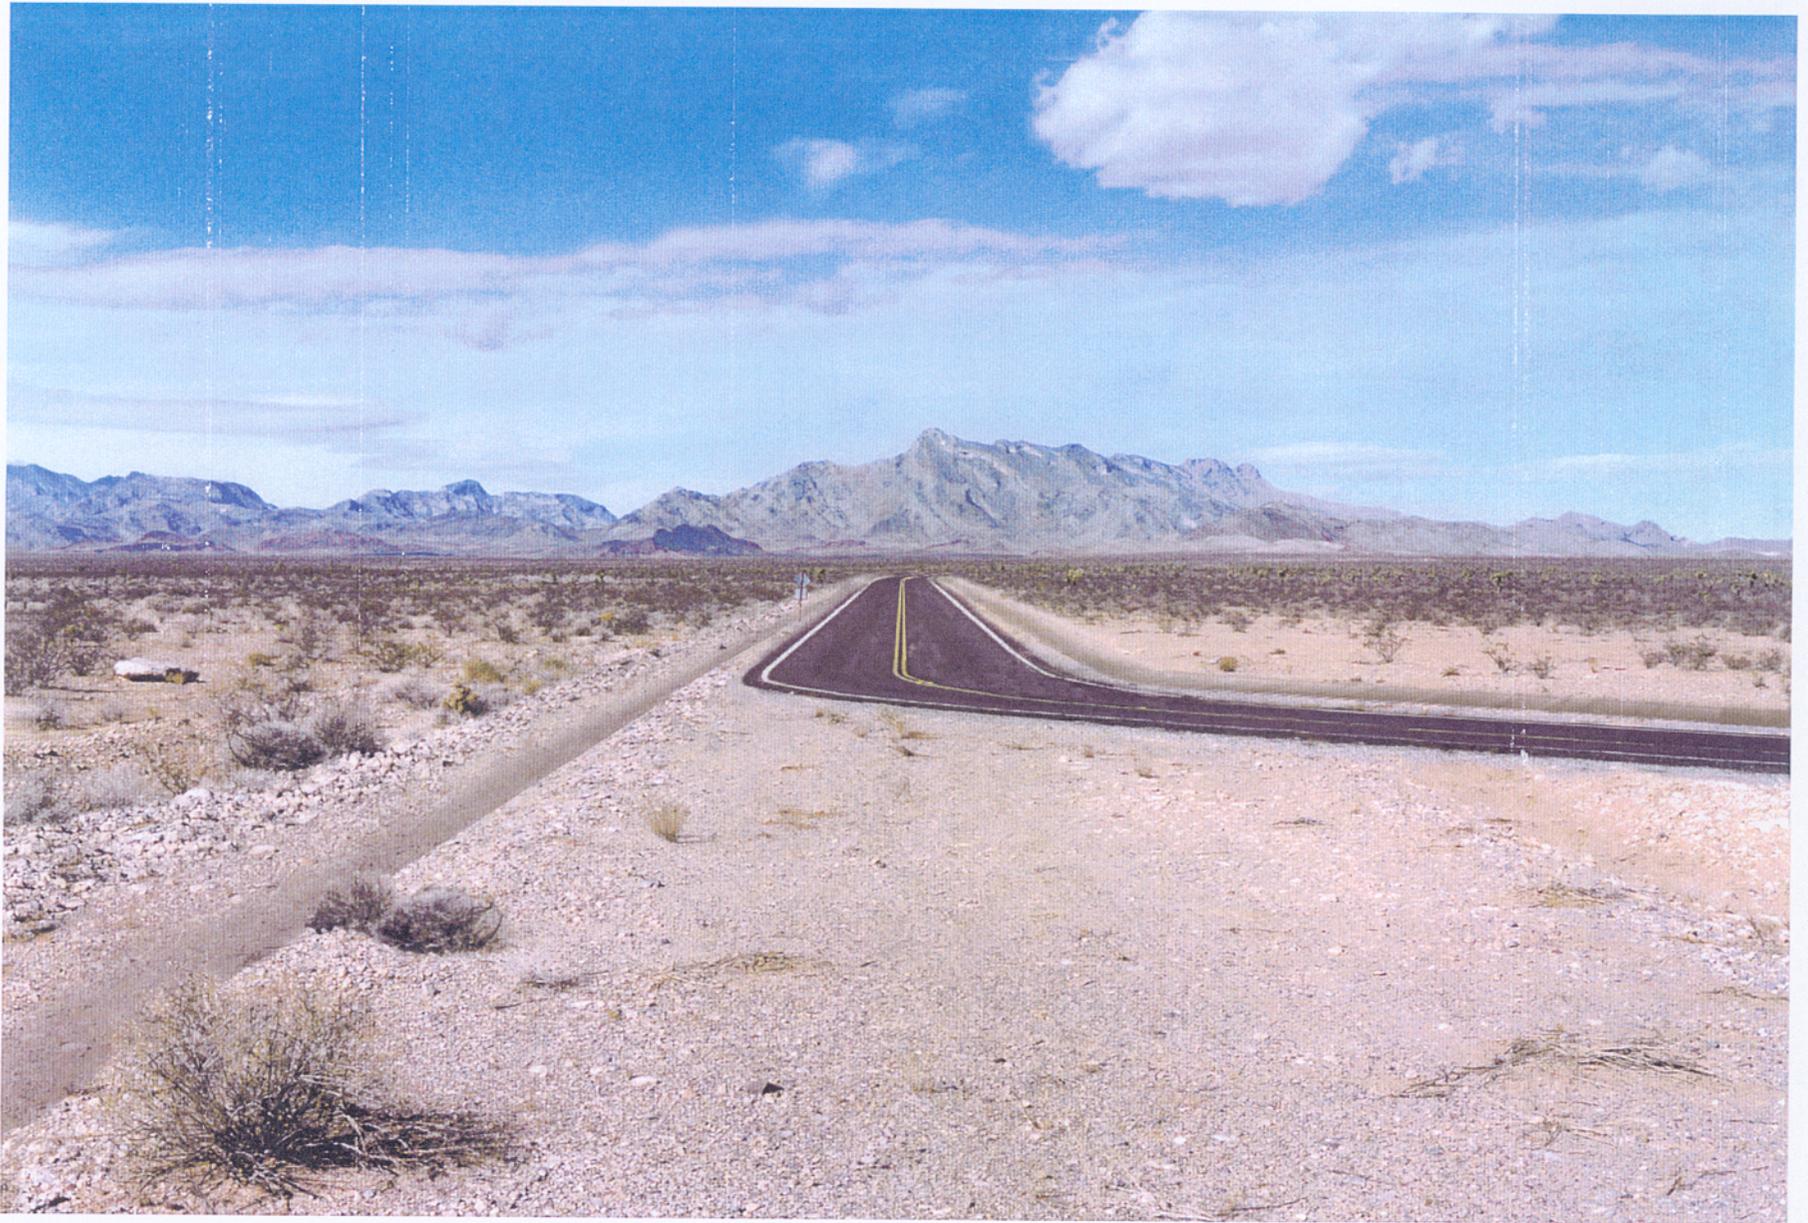
Figure 2b

Simulated view of project access road, upgraded for the Toquop Energy Project by widening, paving, and the addition of ditches for runoff on both sides of the road.

KOP 1: Visual Simulation

1. LAND/WATER		2. VEGETATION		3. STRUCTURES	
FORM	Paving the dirt road would occur, with widening the existing paved and unpaved road shown in the photo (Figure 2b).		Vegetation would be removed on both sides of the existing paved and dirt roadway to allow for roadway widening, creation of 2-foot shoulders, and the addition of ditches along the road (Figure 2b).		Roadway lanes widened to 24 feet, with 2-foot shoulders on both sides of the road, and 8.5-foot-wide dirt ditches (Figure 2b).
LINE	Minimal noticeable change to the horizontal line created by the paved frontage road. More noticeable vertical line created by paving the dirt road, resulting in moderate landscape change. Diagonal line created by dirt ditch on west side of road; this addition is a low to moderate change to the landscape.		Low to moderate change created by the clearing of vegetation due to dirt ditches. Low landscape change from the removal of vegetation due to roadway widening.		KOP 1 (Figure 2b) shows the proposed paved road, dirt ditches, and roadway sign.

The upgraded access road would include paving, lane widening, the addition of paved shoulders, and the addition of 8.5-foot-wide ditches along the roadway. It is known that ditches on both sides of the roadway would not be necessary for the entire length of the access road. It has not been determined if a ditch would be required on both sides of the roadway in the 0.4 mile of the road that is visible from I-15. However, to represent the worst-case, the visual simulation was prepared assuming that a ditch would be required on both sides of the road. It was also assumed that the ditch on the west side of the road would continue south¹, rather than turning east where the road turns east to parallel I-15 (see Figure 2b).

Conclusion: Upgrading the frontage road and dirt road to that necessary for the Proposed Action would not degrade the existing view from I-15, would not dominate the view shown in Figures 2a and 2b, would not attract or focus the attention of the casual viewer away from the mountains in the distance, and would meet the objective of the BLM VRM Class III rating of the land.
