Medford Bureau of Land Management
3040 Biddle Road
Medford, Oregon 97501

April 2008

Box R Allotment –
STANDARDS OF RANGELAND HEALTH ANALYSIS

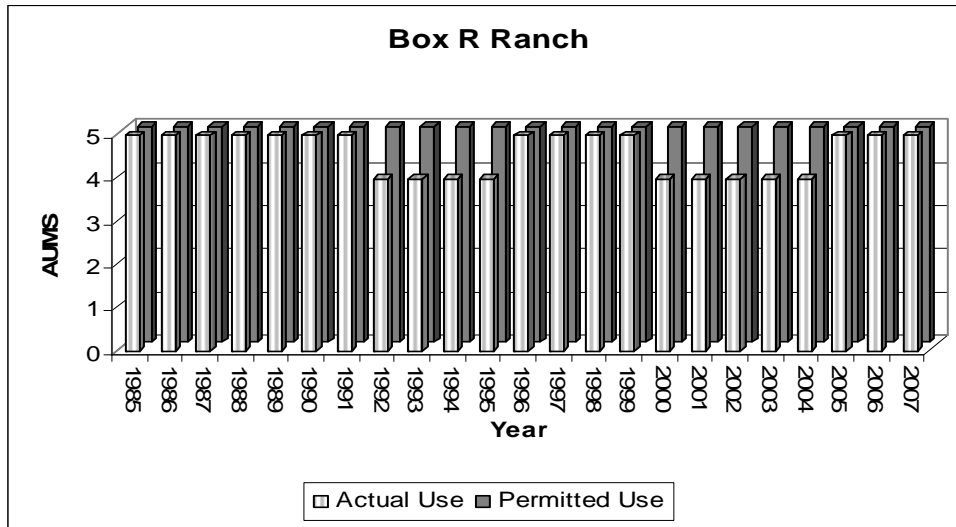
Figure 1. Actual Use Data

The actual use is currently the same as the permitted use (Figure 1). The permitted use is the AUMs authorized in the *Medford District Resource Management Plan (1995)*.

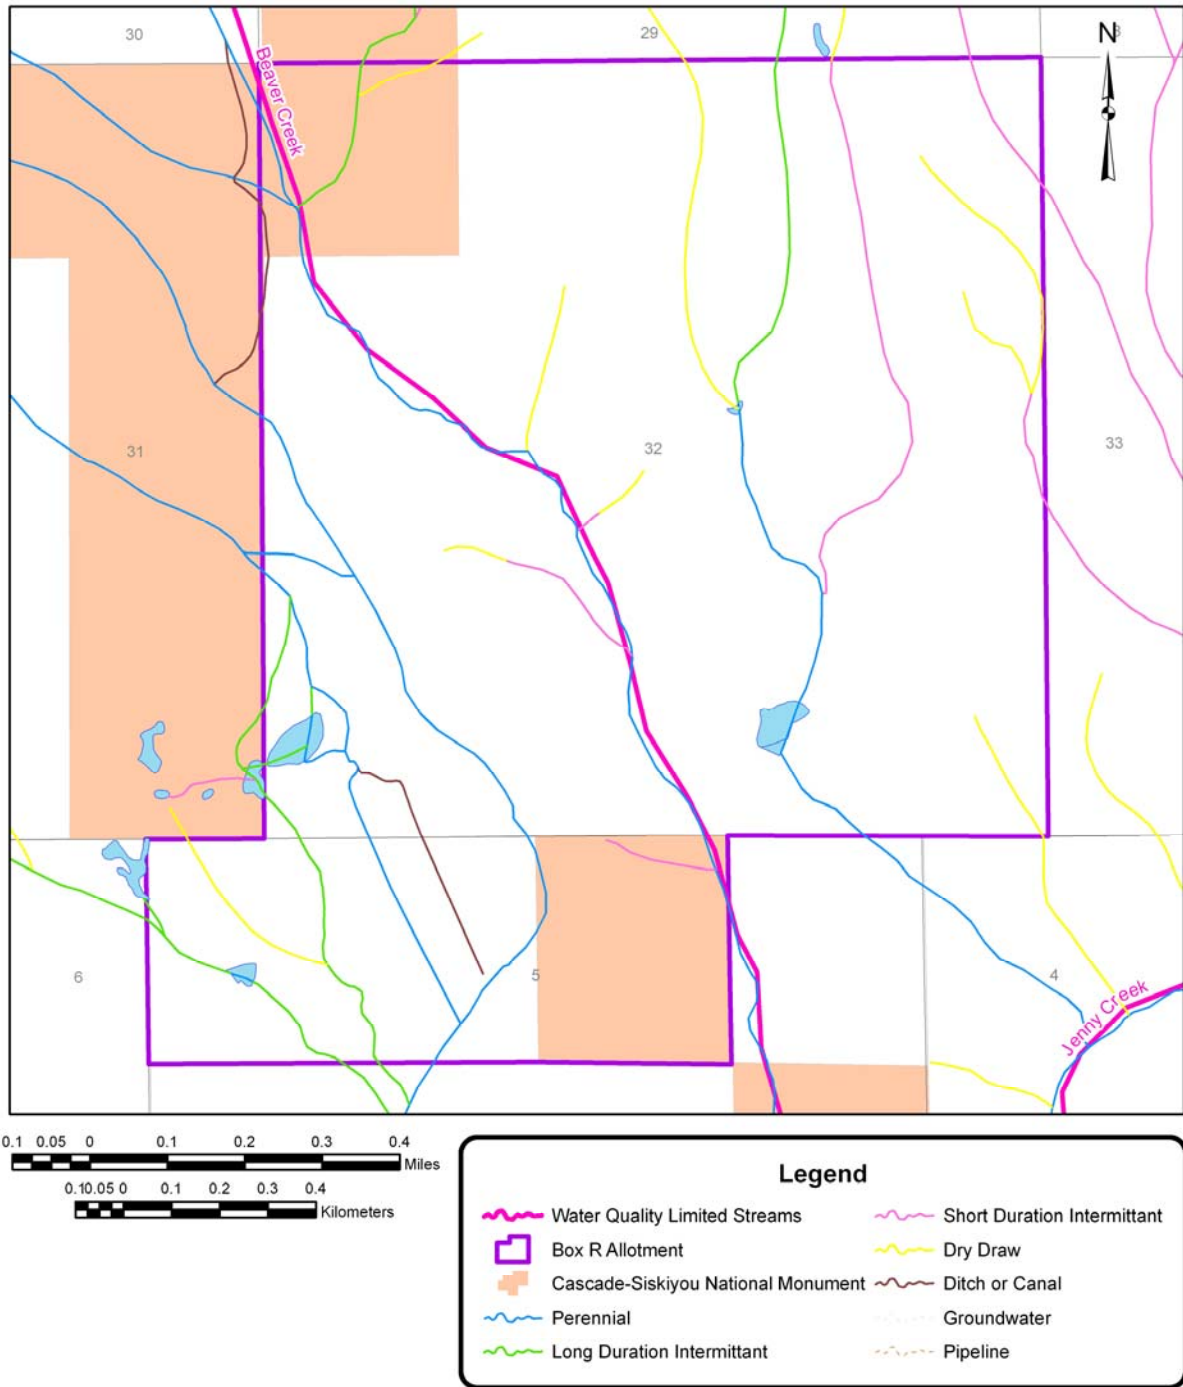
Map 2. Water Quality Limited Streams within the Box R Allotment.

The Oregon Department of Environmental Quality (DEQ) is required by the federal Clean Water Act (CWA) to maintain a list of stream segments that do not meet water quality standards for one or more beneficial uses. This list is called the 303(d) list because of the section of the CWA that makes the requirement. DEQs 2004/2006 303(d) list is the most recent listing of these streams (ODEQ 2006a). Within the Box R Allotment, Beaver Creek is the only stream on DEQs 2004/2006 303 (d) list (Map 2). Beaver Creek is listed for year-around stream temperature (non-spawning core cold water habitat for redband trout from the mouth to stream mile 5.5).

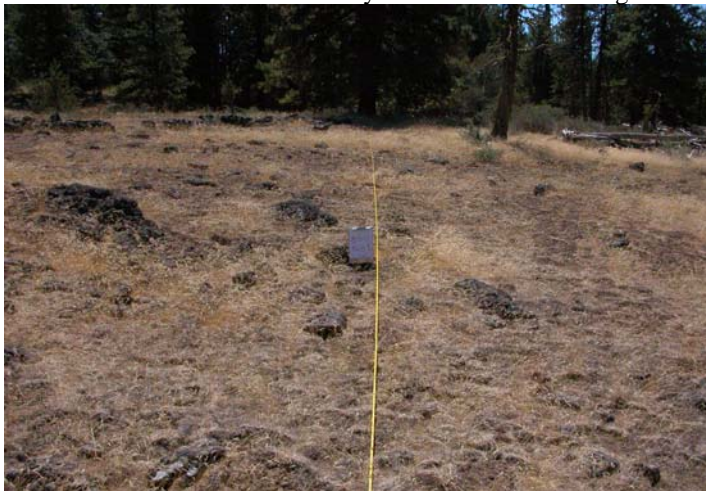
Photo 1. Photo taken at the Loamy Shrub Scabland ecological site.

The overall rating for this location is a slight-to-moderate departure from what would be expected for this site. Thirteen indicators (76 percent) were rated none-to-slight, one indicator (six percent) was rated slight-to-moderate, two indicators (12 percent) was rated moderate, one of the indicators (six percent) was rated moderate-to-extreme and none of the indicators were rated extreme-to-total.
