HORSE Heaven Creek — Oregon

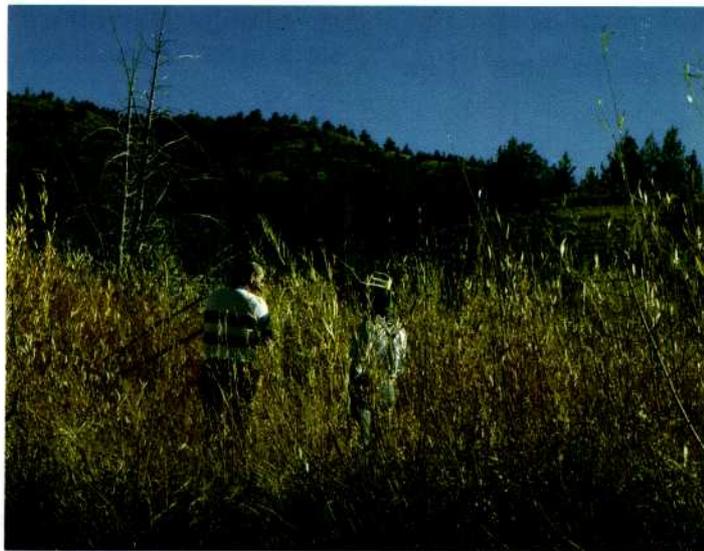
Summer of 1988 after the riparian pasture had been rested from grazing for three growing seasons (1983-85), followed by high intensity short duration spring grazing 1986-88. Willows grew profusely and stabilized the stream channel above the reservoir. As the result of reduced sediment loads and generally improved habitat conditions, trout now spawn in the stream feeding the lake.

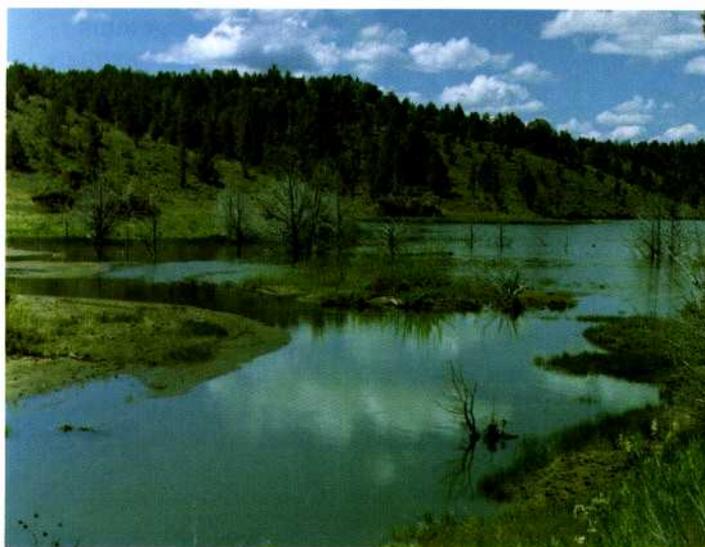
Summer of 1984 after riparian areas were fenced into separate pasture and rested for two growing seasons. Note sediment deposited in upper end of reservoir from poor condition uplands after summer thunderstorms.
