BEAR Creek — Oregon

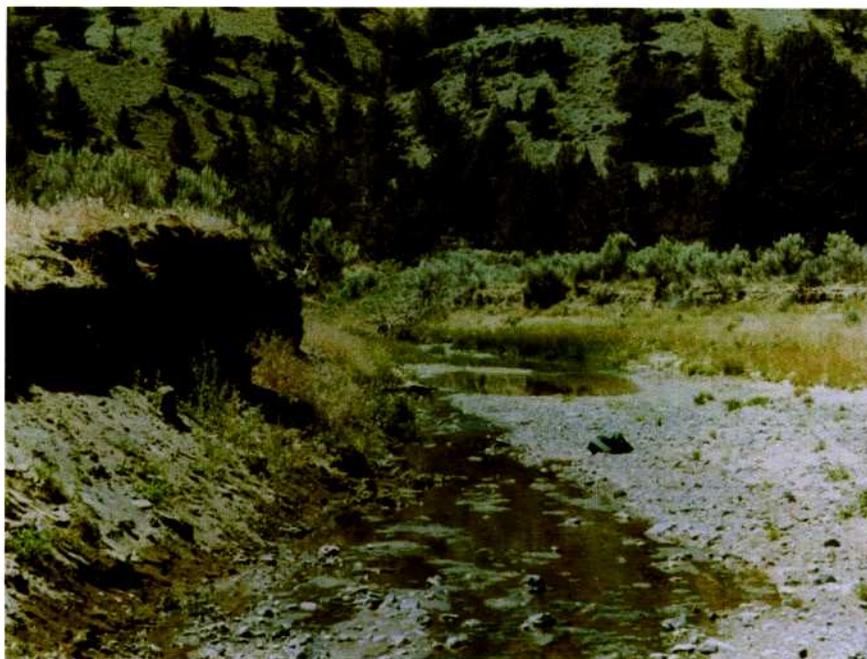
In August 1976 Bear Creek was wide, shallow, sediment-laden and warm. The stream was actively eroding the cut-bank on the left.

Under this grazing strategy streamside vegetation was low in diversity and productivity. Streambanks were actively eroding. The stream channel was deeply incised and contained medium to high sediment loads. Summer streamflow was often intermittent and low in quality.
