# Louse Canyon Wilderness Inventory Unit Index of Documents Oregon Butte OR-036-004, 32 total pages

Year: 2007 Inventory Unit Name/Number: Oregon Butte OR-036-004

# APPENDIX C - ROAD¹ ANALYSIS

# APPENDIX D - PHOTO LOG

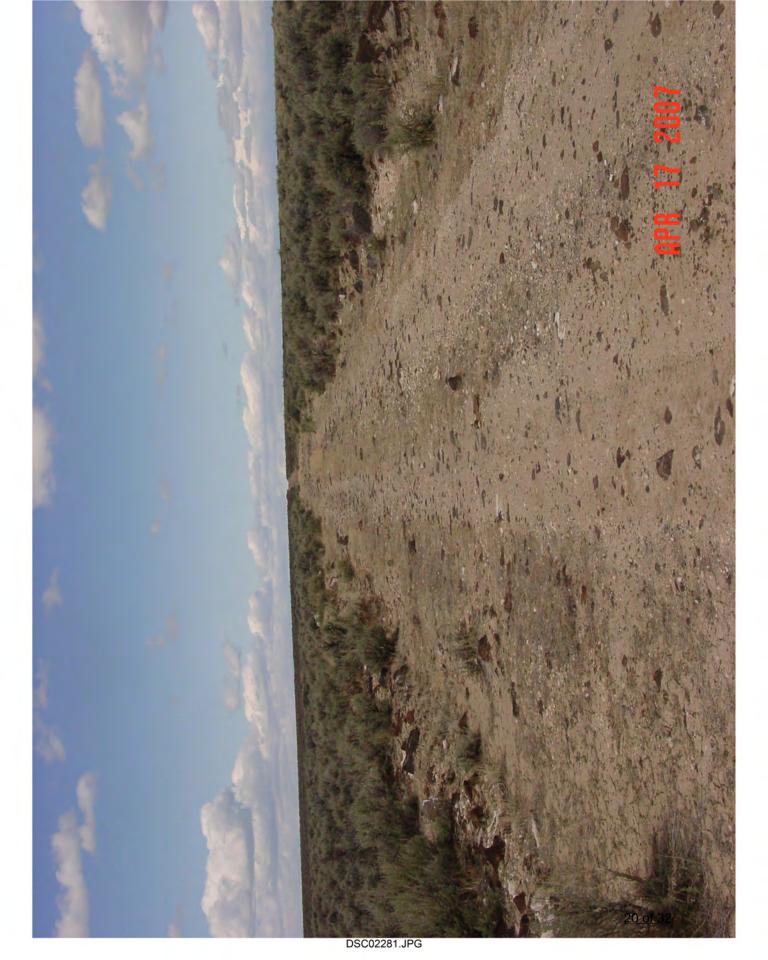
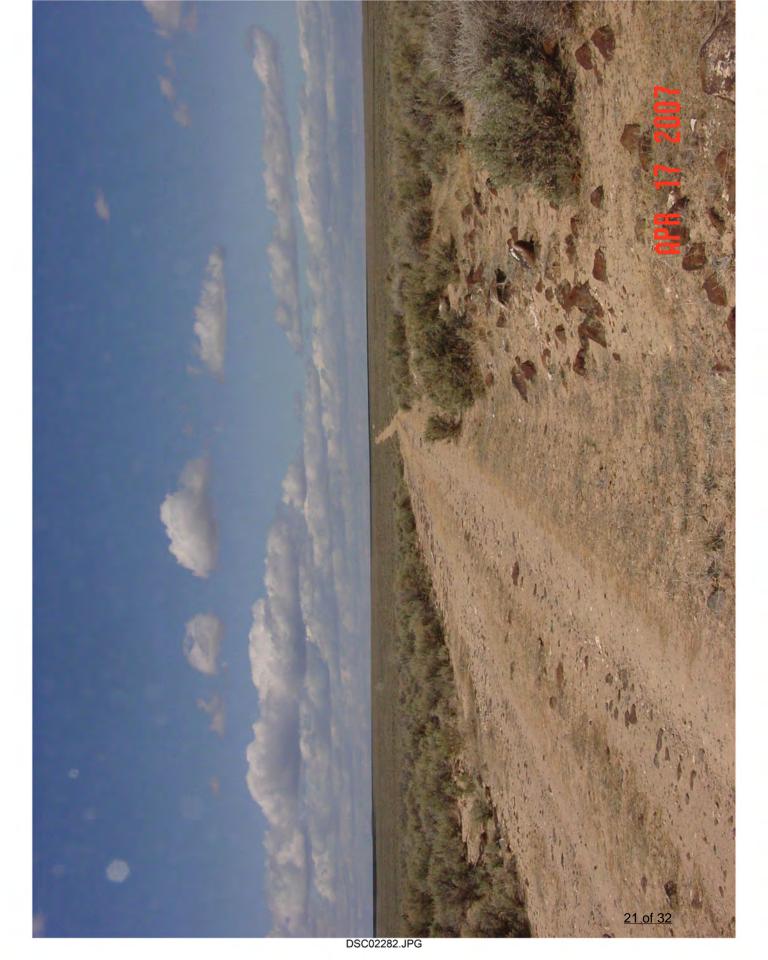
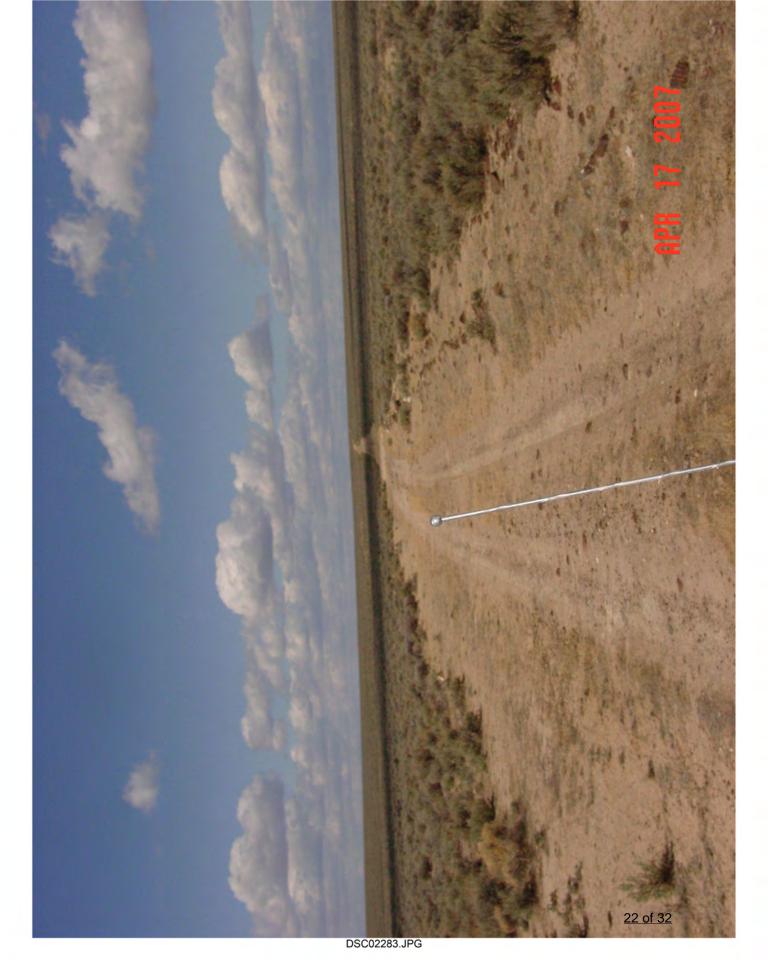
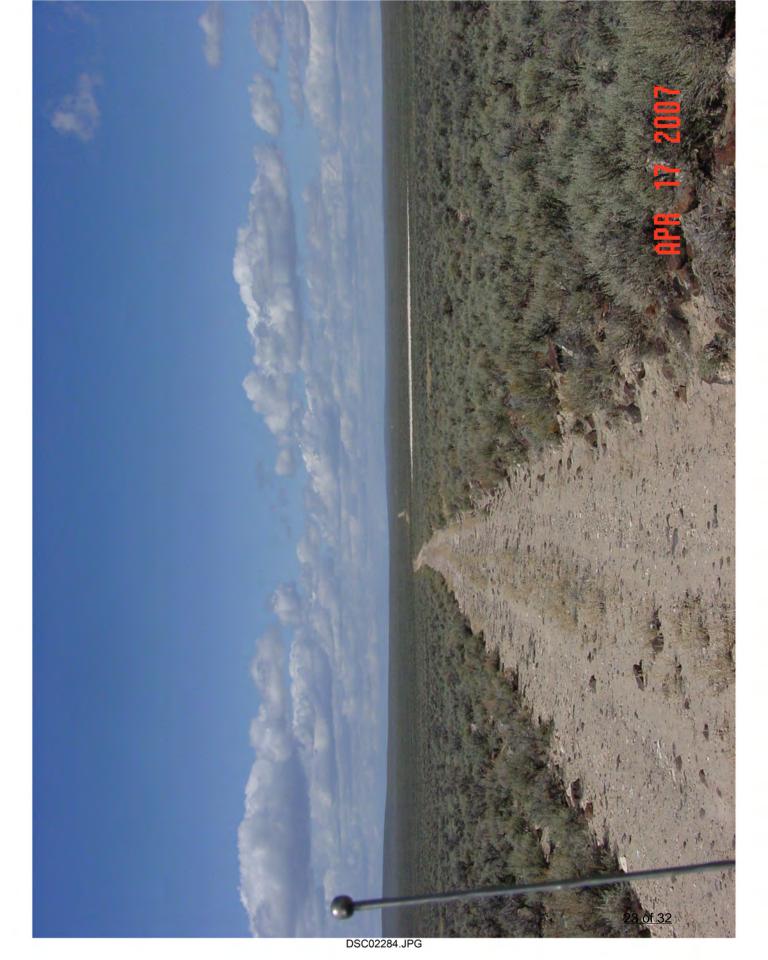
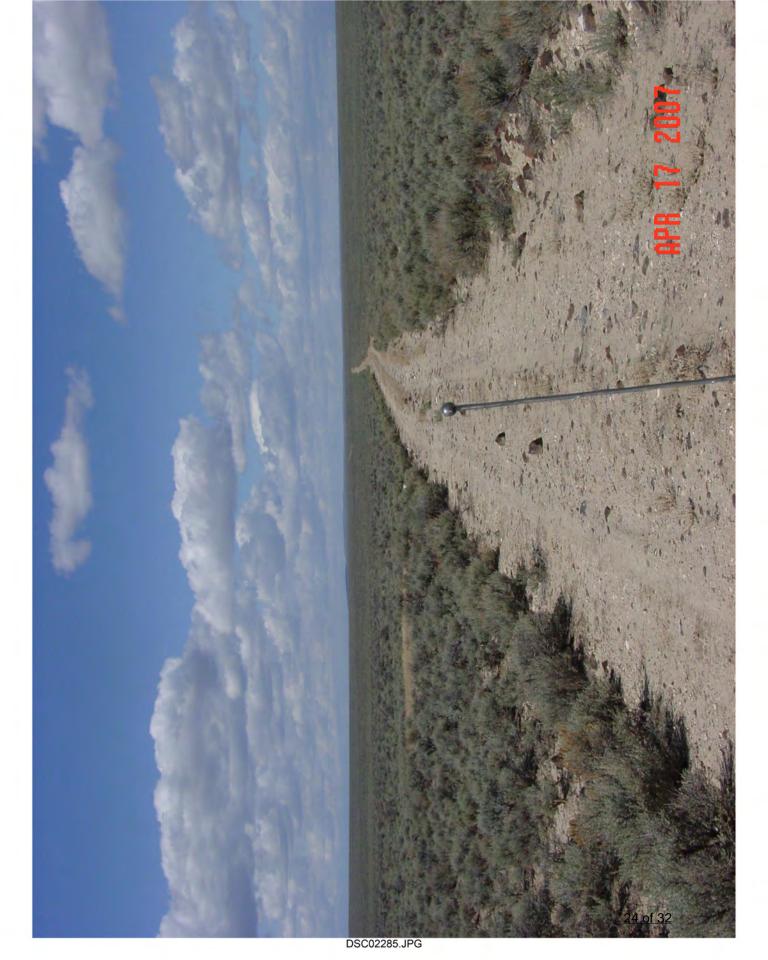
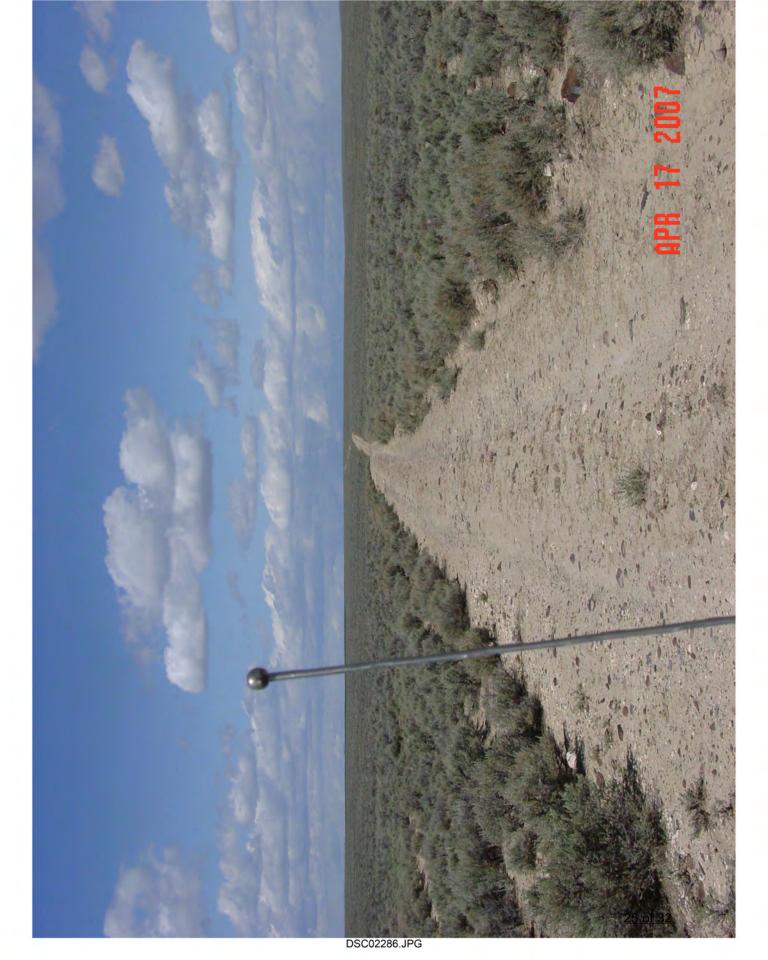
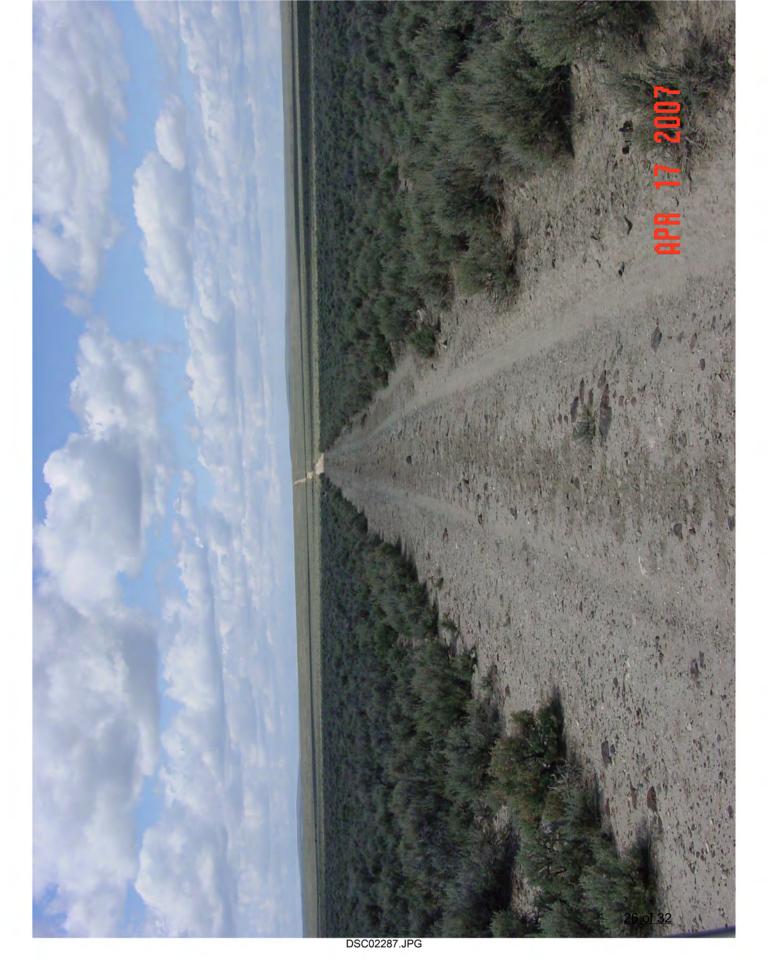
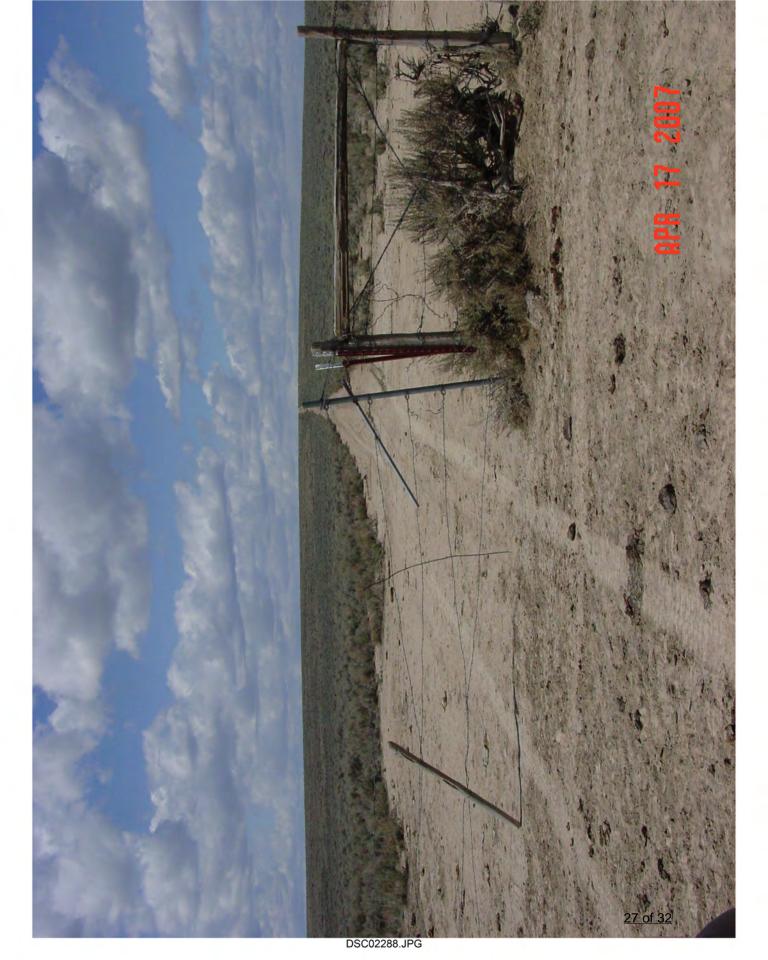
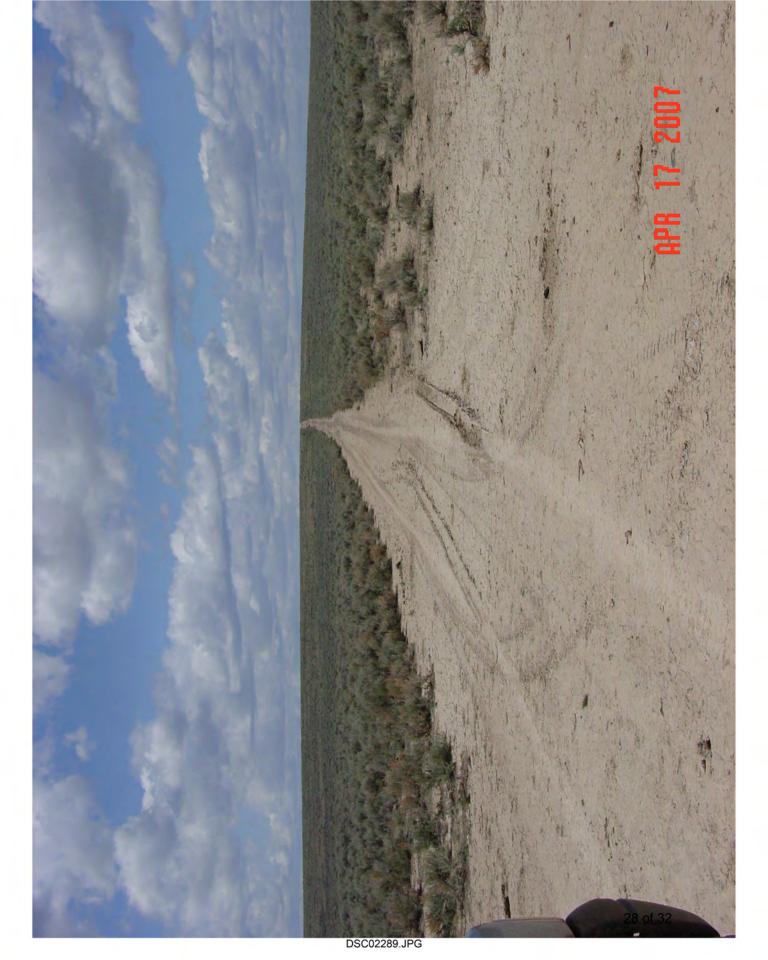
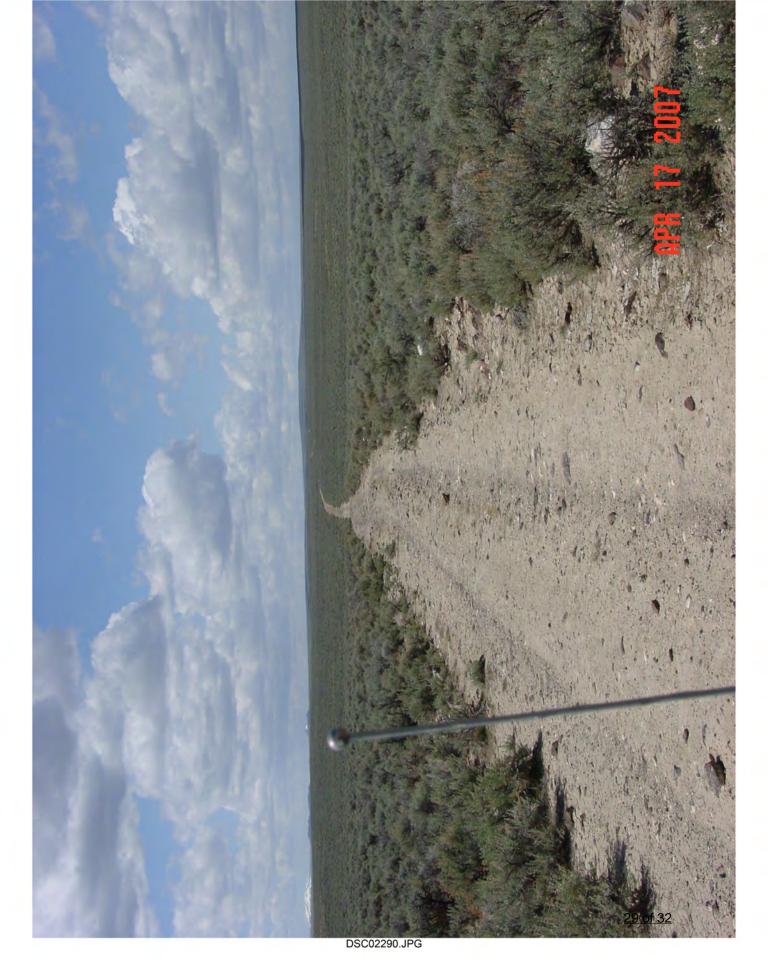
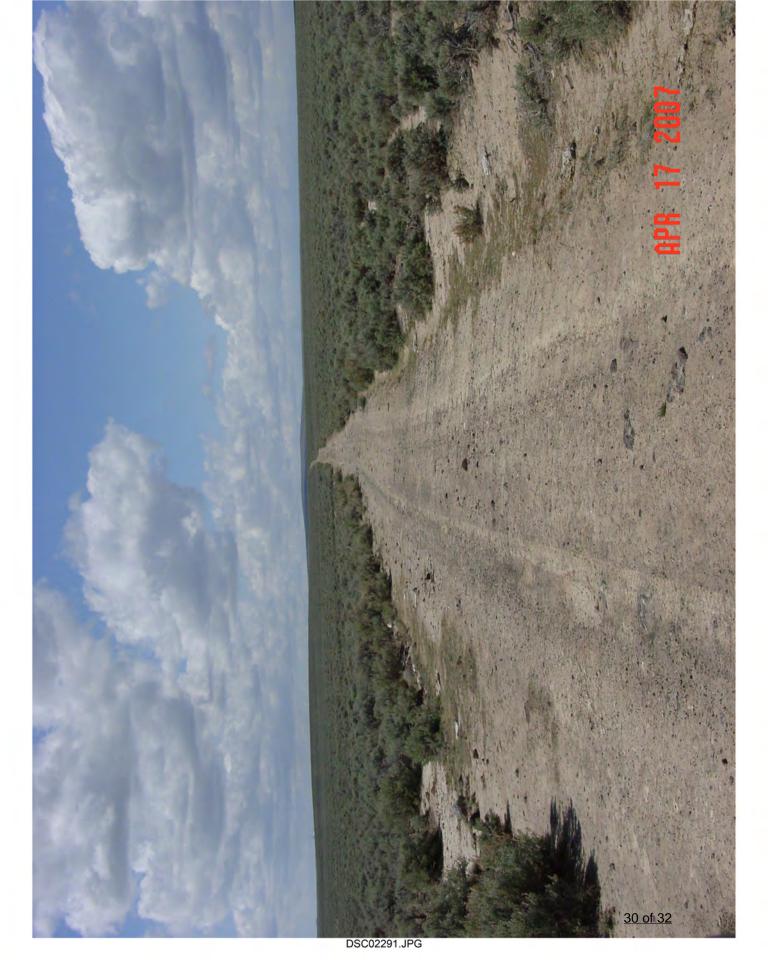
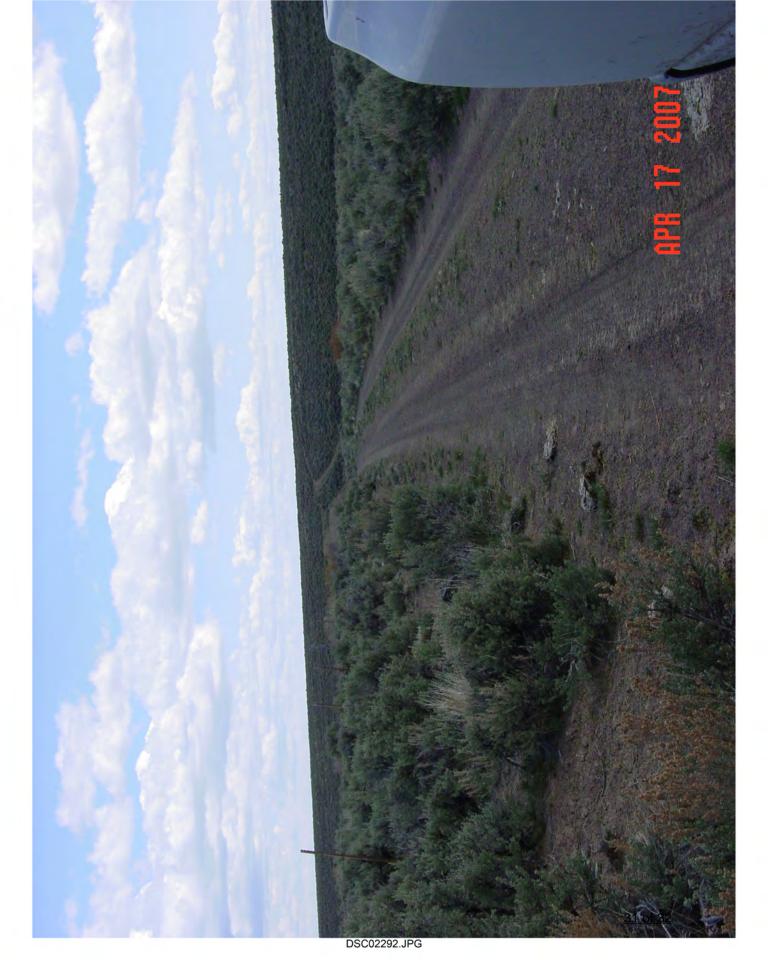
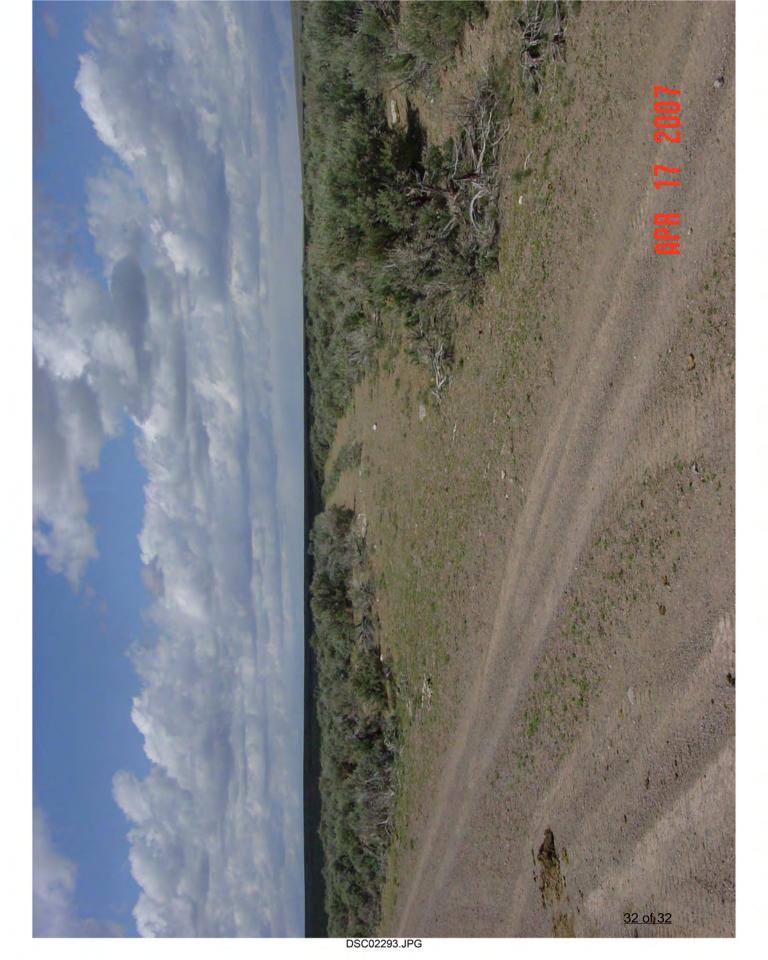
Explain: Recent maintenance (within 5 years) on BLM road 6352-0-00 is not evident although periodic maintenance of the boundary roads has occurred in the past (no confirmed dates available). Earthen berms and ditches left on the edge of the road, shown in pictures DSC02281- DSC02393, presently contain brush encroaching from

BLM road 6352-0-00 has annual use as evidence by berms, ditches, lack of brush in the road, and by well-used bare ground where vehicle tires track (DSC02281- DSC02293). ONDA's 2004 Willow Creek proposed WSA Addition document (pictures WA096-WA99) refers to BLM road 6352-0-00 as a way and as not meeting the definition of a road. BLM does not support their decision. The road is well traveled, wide along much of its length, maintenance has been performed on the roadbed periodically, and it is clearly defined on the landscape.

DATE	Frame #	Camera Direction	Description	GPS/UTM Location	Township	Range	Section
4/17/2007	DSC02281	W	Visible road	500987 4654763	T40S	R48E	Sec 36
4/17/2007	DSC02282	W	Visible Road	498722 4655131	T40S	R48E	Sec 35
4/17/2007	DSC02283	W	Good road	497756 4655272	T40S	R48E	Sec 33
4/17/2007	DSC02284	W	Good road	492752 4655816	T40S	R48E	Sec 32
4/17/2007	DSC02285	W	Good road	492330 4655816	T40S	R 48E	Sec 31
4/17/2007	DSC02286	W	Good road	489591 4656273	T40S	R48E	Sec 30
4/17/2007	DSC02287	W	Good road	487730 4657116	T40S	R47E	Sec 25
4/17/2007	DSC02288	W	Gate into S. Tent Creek Past	486536 4657089	T40S	R47E	Sec 25
4/17/2007	DSC02289	W	Visible road	486536 4657089	T40S	R47E	Sec 25
4/17/2007	DSC02290	SW	Good road	484675 4656729	T40S	R47E	Sec 27
4/17/2007	DSC02291	SW	Visible Road	481637 4655430	T41S	R47E	Sec 06
4/17/2007	DSC02292	NE	Back toward Tent Creek	478476 4654341	T41S	R47E	Sec 06
4/17/2007	DSC02293	Е	Start of Road	478300 4654427	T41S	R46E	Sec 01
