**WILDERNESS INVENTORY MAINTENANCE  
IN BLM OREGON/WASHINGTON**  
(Source: Oregon State Office Internal Guidance as of July 2007)

Year: 2010      Inventory Unit Number/Name: **Black Canyon**

**FORM 1: DOCUMENTATION OF BLM WILDERNESS INVENTORY  
FINDINGS ON RECORD:**

**FORM 2 - DOCUMENTATION OF CURRENT WILDERNESS  
INVENTORY CONDITIONS**

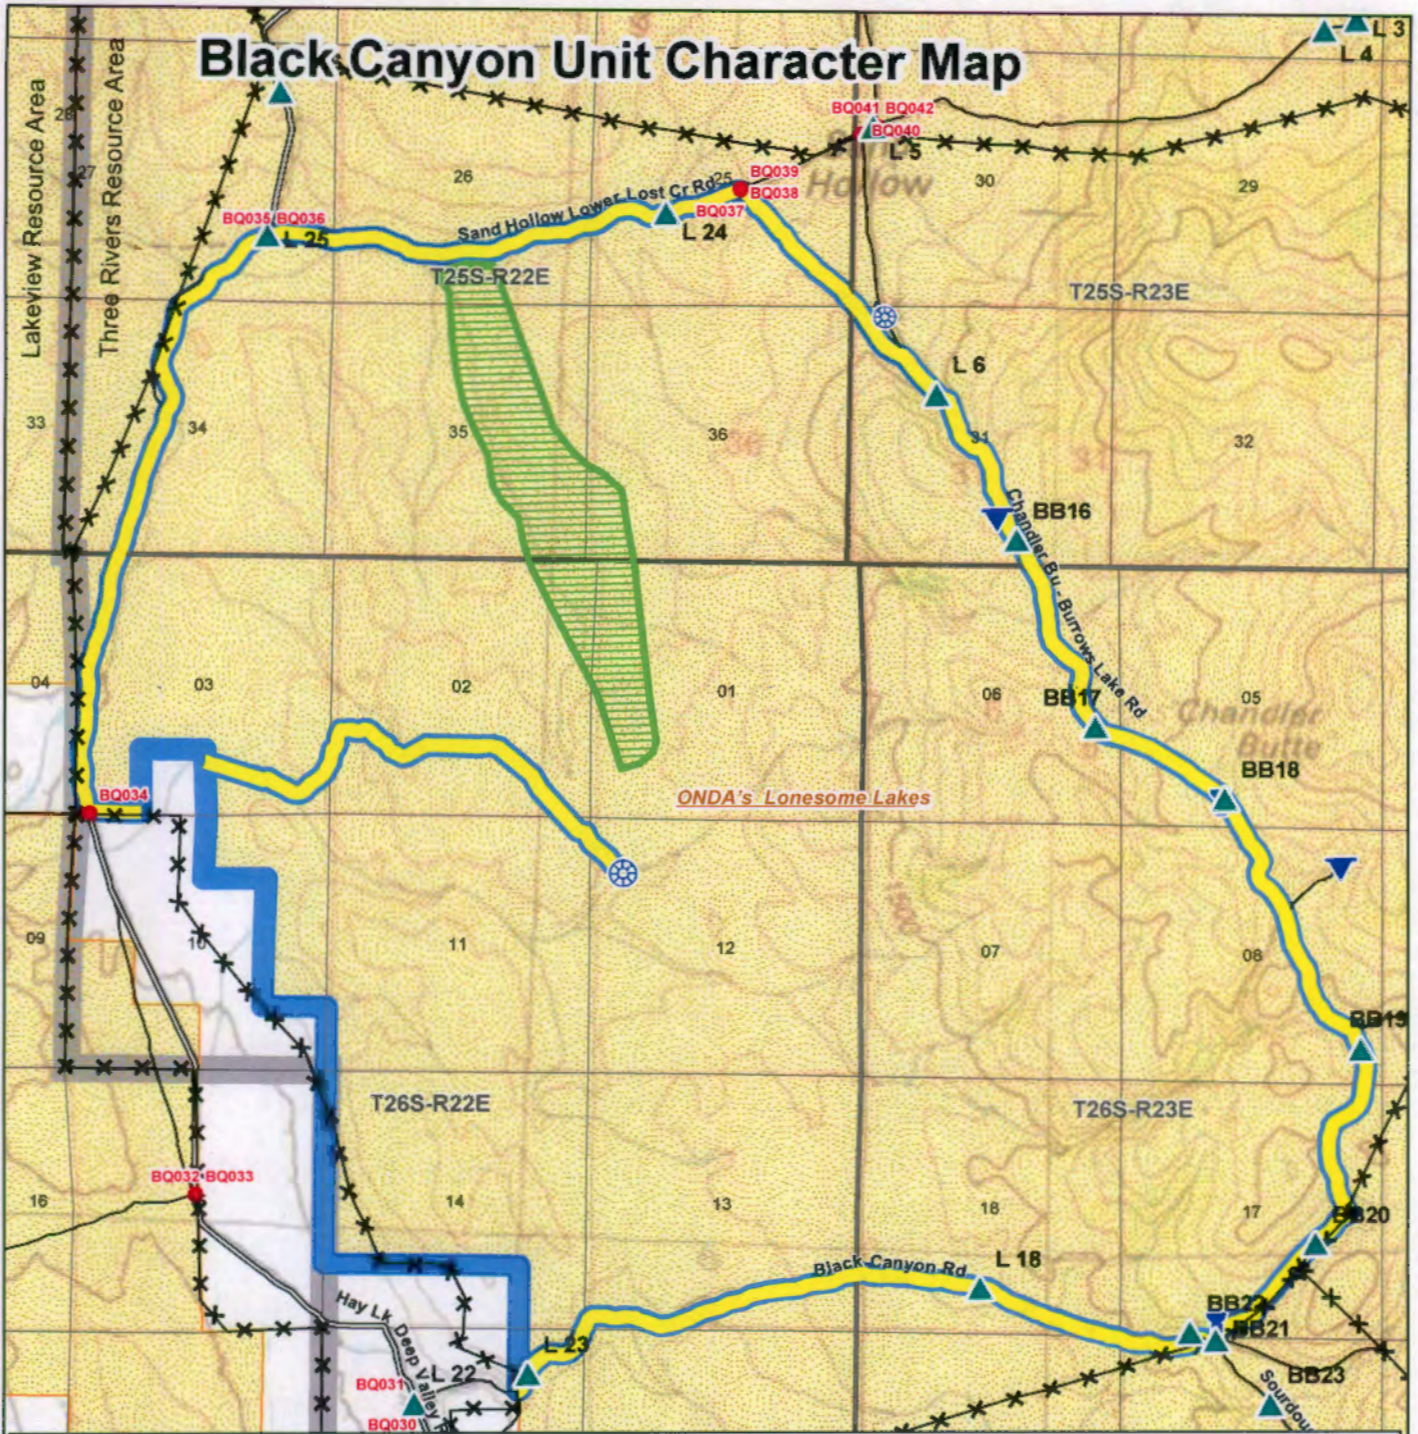
# Black Canyon Unit Character Map

**Current Unit Boundaries: (See BLM Unit Character Map):**

The unit currently has the following developments (See Unit Character Map):

- Fences: 1.3 miles
- Reservoirs: 1
- Seedings: 0 acres
- Boundary roads: 26.2 miles
- Non-boundary roads: 0 miles
- Pipelines: 0 miles
- Wells: 1
- Troughs: 1
- Waterholes: 0
- Brushbeat: 375 acres
- Guzzlers: 2
