# Monitoring Streambanks and Riparian Vegetation—Multiple Indicators

Technical Bulletin No. 2005-02

Version 2.0 May 2006

U.S. Department of the Interior Bureau of Land Management Idaho State Office 1387 S. Vinnell Way Boise, ID 83709

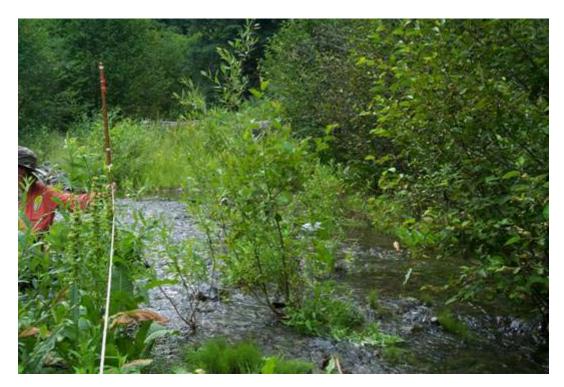
**Figure 1**—vegetation growing within the stream channel is not part of the greenline. Photo - PIBO, U.S. Forest Service

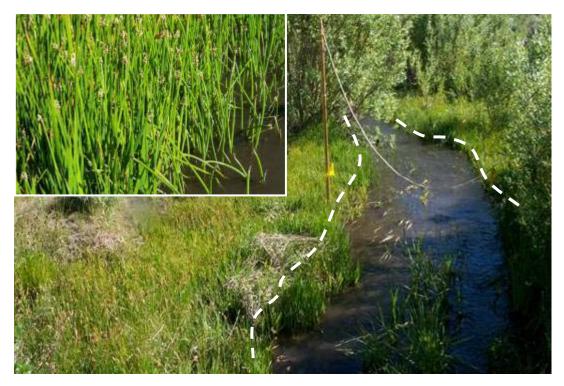
**Figure 2**—the greenline follows the vegetation line even when the vegetation is in shallow water. The inset picture shows spike rush (*Eleocharis* sp.) growing in shallow water along the margin of the stream. Photo - PIBO, U.S. Forest Service

- 4) Under some conditions, particularly in back waters where the current is slow, *Carex* spp., *Juncus* spp., *Eleocaris* spp., and *Scirpus* spp. may establish in the still shallow water along the stream during the summer low flow periods. This condition occurs most frequently during low water in a drought period. When this occurs, the greenline is along the edge of the water at low summer flow (see Appendix E, Figures 2, 3, 4, 8, and 9).

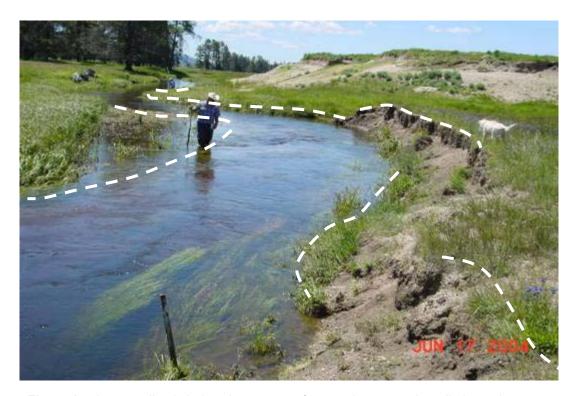
**Figure 3**—the greenline is below the water surface as the stream is well above the bankfull flow level. It is much easier to discern the greenline when streams are at summer low flows or below bankfull.

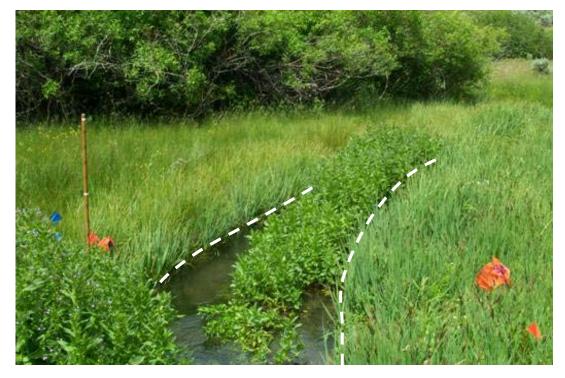
**Figure 4**—the greenline follows the (*Carex* sp.) on each side of the stream. Water speedwell (*Veronica anagallis-aquatica*) growing in the stream is not part of the greenline. Photo - PIBO, U.S. Forest Service

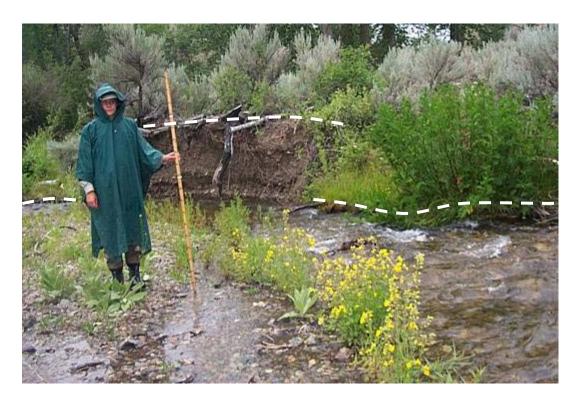
**Figure 5**—monkey flower (*Mimulus guttatus*) is an annual or short-lived rhizomatous perennial colonizing species. It is not included as a greenline species. Photo - PIBO, U.S. Forest Service

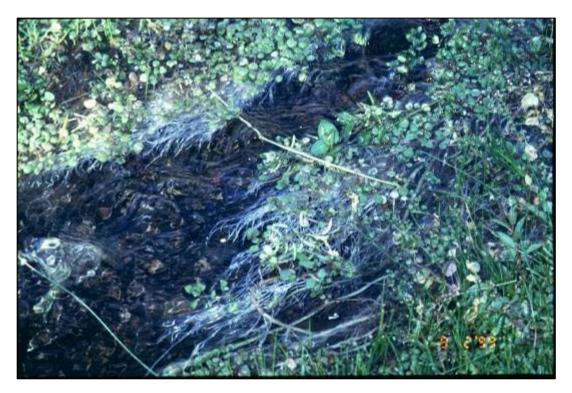
**Figure 6**—watercress (*Rorippa nasturtium-aquaticum*) is not considered part of the greenline. It should be noted in the remarks section.

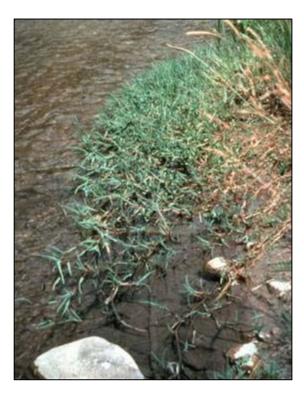
**Figure 7**— brookgrass (*Catabrosia aquatica*) is a short-lived perennial grass that occasionally grows on the streambank. It grows mostly in the margin of a stream. It is not considered part of the greenline.

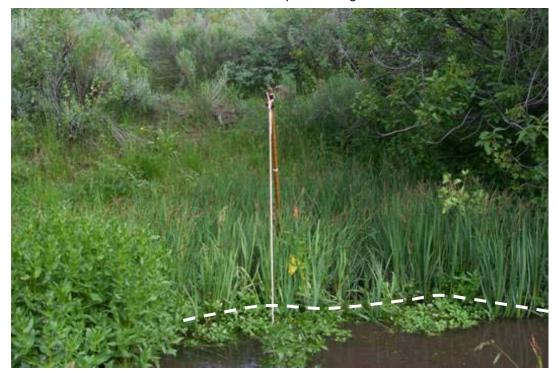
**Figure 8**—greenline follows the sedge (*Carex* sp.) or the edge of the water if the *Carex* sp. is in the water and not floating such as speedwell (*Veronica* sp.) and watercress (*Rorippa nasturtium-aquaticum*). Photo - PIBO, U.S. Forest Service

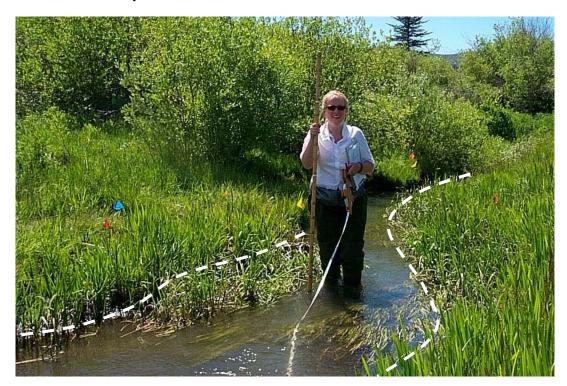
**Figure 9**—greenline follows the continuous vegetation along the edge of the water at summer low flow and not vegetation growing in the water or channel. There is a distinct line between the vegetation on the streambank and the vegetation in the channel. Photo - PIBO, U.S. Forest Service

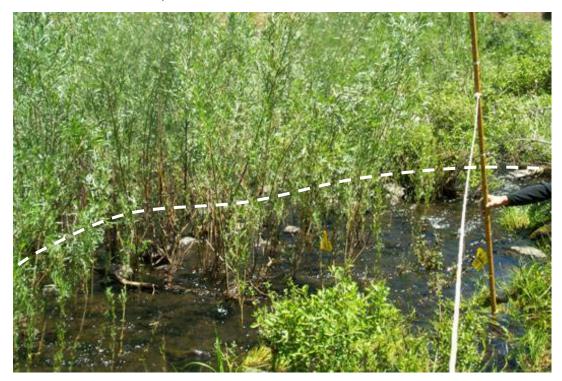
**Figure 10**—coyote willow (*Salix exigua*) spreads by rhizomes. At times, it will sprout within the stream channel on streams that have very low or no flow during part of the growing season. When this occurs the greenline is along the edge of the streambank or water's edge at summer low flow and not on the plants growing within the channel. Photo - PIBO, U.S. Forest Service

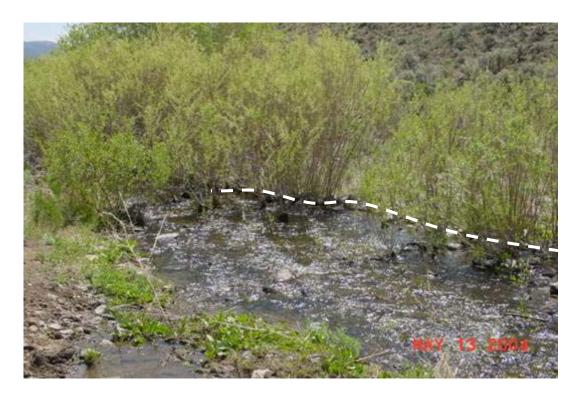
**Figure 11**—when willows grow in the channel, the greenline follows the water's edge or streambanks at summer low flow.

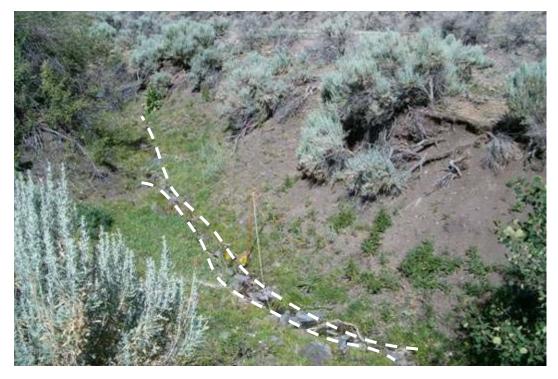
**Figure 12**—a greenline is only along stream channels. If there is no channel, there is no greenline. The photo above shows a greenline on each side of a very narrow channel. Photo - PIBO, U.S. Forest Service

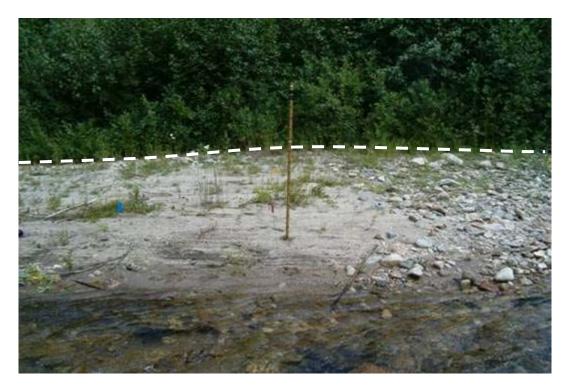
**Figure13**—greenline follows the relatively continuous line of vegetation and not the scatter vegetation on the sand/gravel bar. Photo - PIBO, U.S. Forest Service

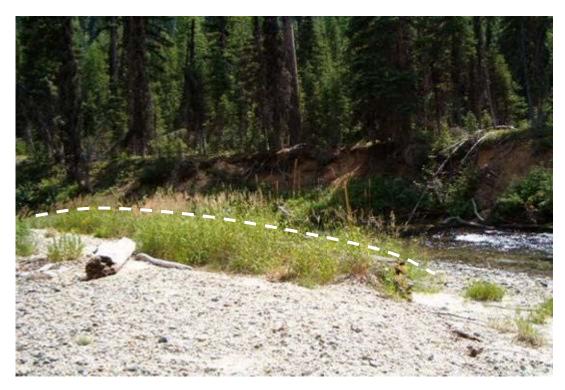
**Figure 14**—vegetation shown in the center of the photo constitutes lineal grouping of vegetation or a greenline. At the end of the vegetation, the greenline resumes again at the first continuous line of vegetation away from the stream. Photo - PIBO, U.S. Forest Service

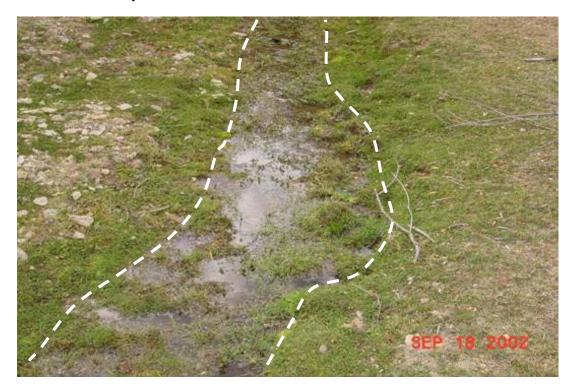
**Figure 15**—the greenline (lineal grouping of vegetation at least 15 cm  $\times$  50 cm) on this small stream is on each side of the channel.

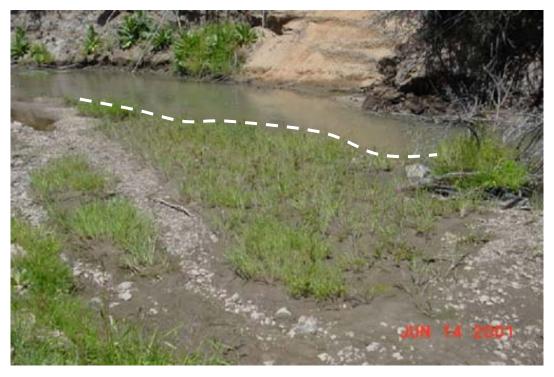
**Figure 16**—colonizing specie short-awned fox tail (*Alopecurus aequalis*) forming a lineal grouping of vegetation with at least 25% foliar cover and is at least 6 inches (15 cm) wide and 19.6 inches (50 cm) long.

- 1) Colonizer species at or near the water's edge which meet the appropriate criteria (i.e., 25 percent foliar cover, at least six inches wide and 19.6 inches long, and establish a distinct line of perennial vegetation) are considered greenline, except as described in number 2. For example, short-awned foxtail (*Alopecurus aequalis*), spike-rush (*Eleocharis palustrus*), arroyo willow (*Salix lasiolepis*) and coyote willow (*Salix exigua*) on the streambank (above the summer low flow) should be recorded as part of the greenline (see Appendix G, Figures 2 and 16). These species have moderately deep roots and the ability to stabilize streambanks.

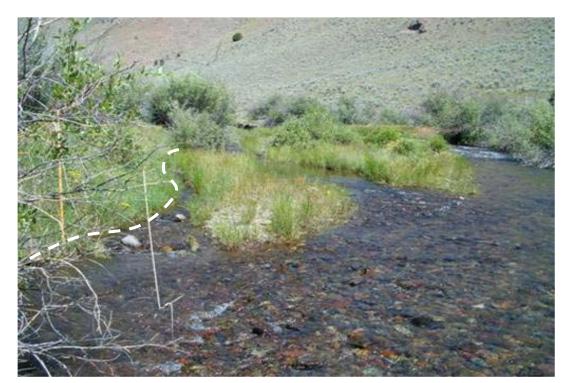
**Figure 17**—the greenline follows the outer streambank at bankfull. It does not cross a channel to the island. A small channel runs along the island on the left. Photo - PIBO, U.S. Forest Service

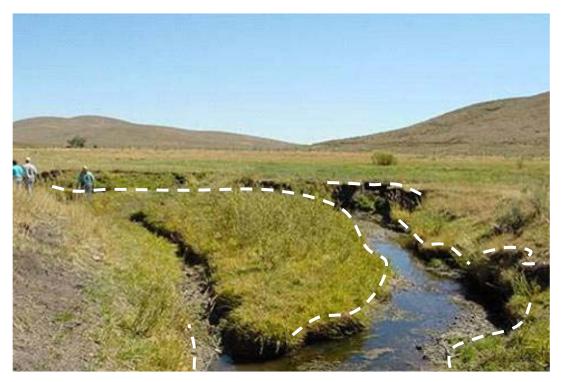
**Figure 18**—the greenline follows the vegetation line along the main channel because sediment deposition with vegetation block at the lower end of the channel. If an active channel continued creating an island, the greenline would follow the left bank along the smaller channel.

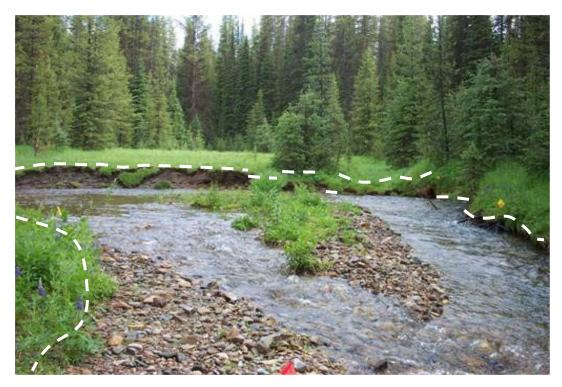
**Figure 19**—the island, even with vegetation is not part of the greenline. The slump blocks on the far bank are not counted as greenline because they still in a non-stable state. Photo - PIBO, U.S. Forest Service

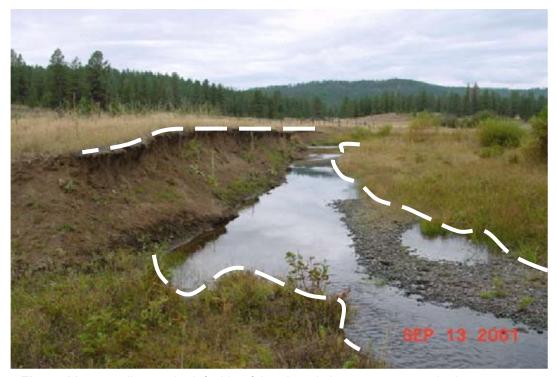
**Figure 20**—greenline on the left side of the photo is in two segments, the lower segment near the water's edge and the upper segment along the edge of the terrace with upland vegetation. The greenline on the right side of the stream is continuous along the perennial vegetation.

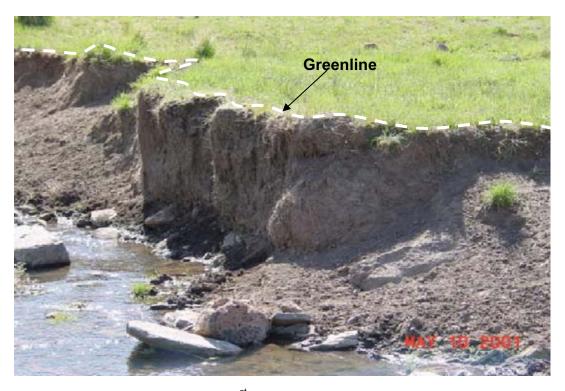
Figure 22—greenline on top of the 1<sup>st</sup> terrace.

A terrace is a relatively flat area adjacent to a stream or lake with an abrupt steeper face adjoining the edge of the stream. The first terrace is the first relatively flat area adjacent to and above the edge of the water. It may be an active floodplain or an area too high for the water to reach under the current climate and channel conditions. The second terrace is the next elevated area above the first terrace, with a distinctly steeper slope facing the stream (see Appendix G, Figures 21 and 22).

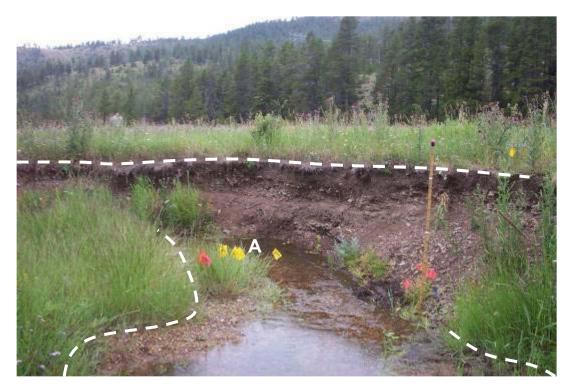
**Figure 23**—the greenline follows the relatively continuous line of vegetation. The vegetation near "A" is does not meet the greenline criteria of being at least 50 cm long. *Photo - PIBO, U.S. Forest Service*

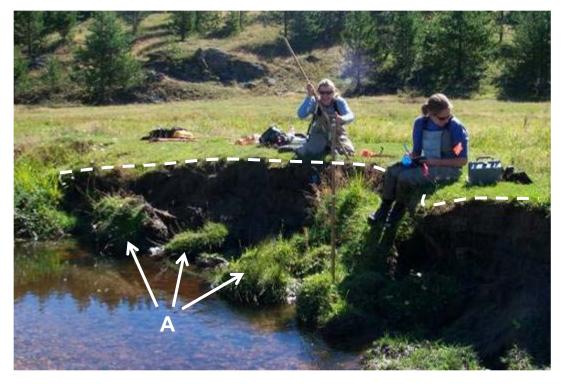
**Figure 24**—slump blocks "A" are detached and not considered part of the greenline. The dashed line shows greenline. *Photo - PIBO, U.S. Forest Service*

creating a new floodplain (false bank), the greenline is the edge of the vegetation along the stream (see Appendix G, Figures 24 through 32).

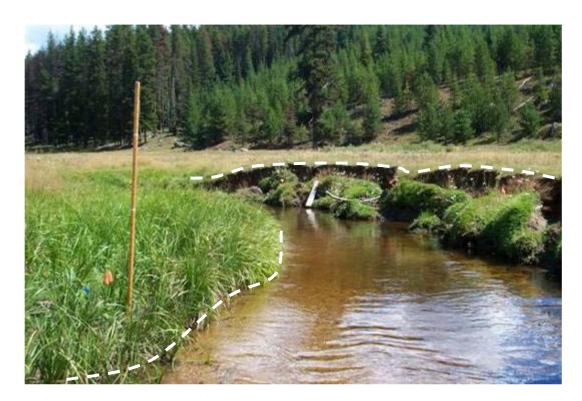
**Figure 25**—slump blocks along the far streambank are not attached by vegetation the terrace wall. *Photo - PIBO, U.S. Forest Service*

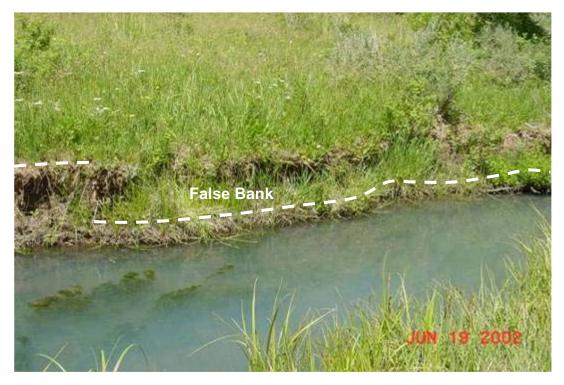
**Figure 26**—false bank is a slump block that is reattached and with vegetative cover. The slump feature is reattached to the streambank. The greenline follows the lower elevation vegetation.

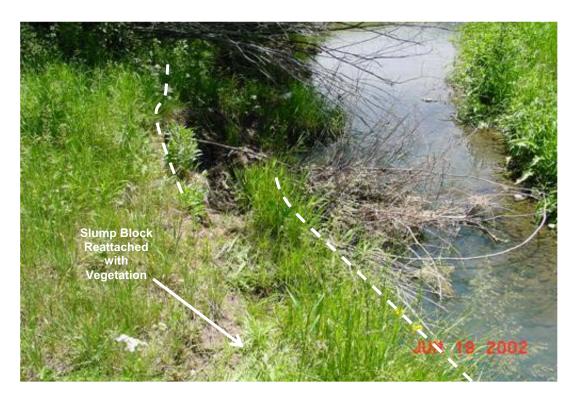
**Figure 27**—vegetation attaching slump feature to the streambank creating a new floodplain. This is sometimes referred to as a "false bank."

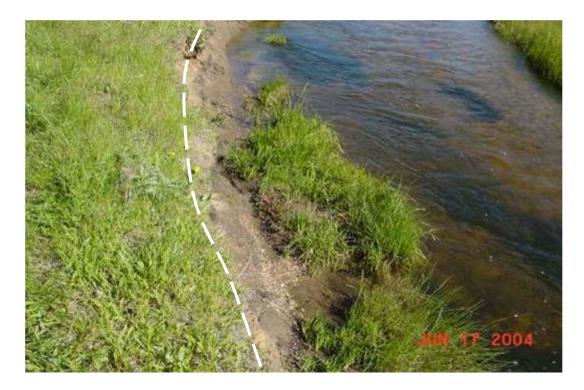
**Figure 28**—vegetation is not well established between the slump block and the vertical terrace leaving and area subject to erosion. This vegetation is considered and island.

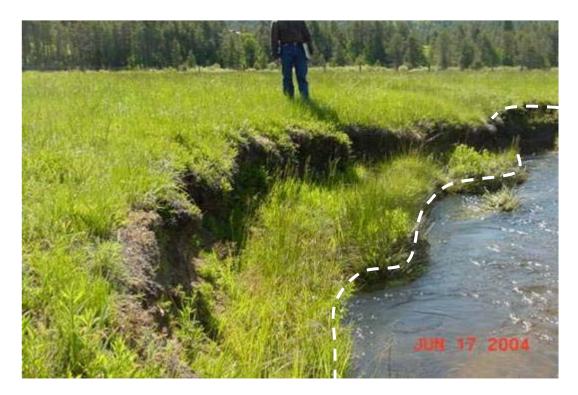
**Figure 29**—slump blocks vegetated to the terrace wall. New floodplain is being established. The vertical walls will continue to erode until they reach the angle of repose and revegetate.

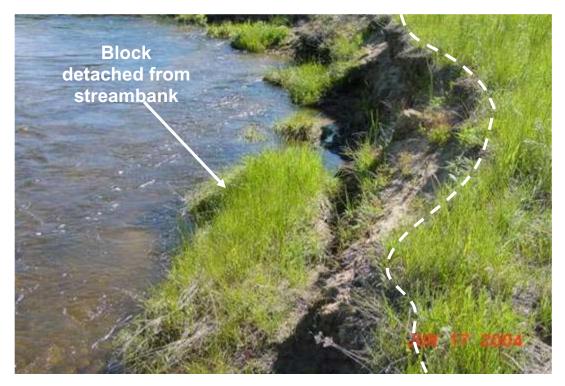
**Figure 30**—slump block detached from the terrace wall. There is still a high potential for erosion between the slump block and the terrace wall.

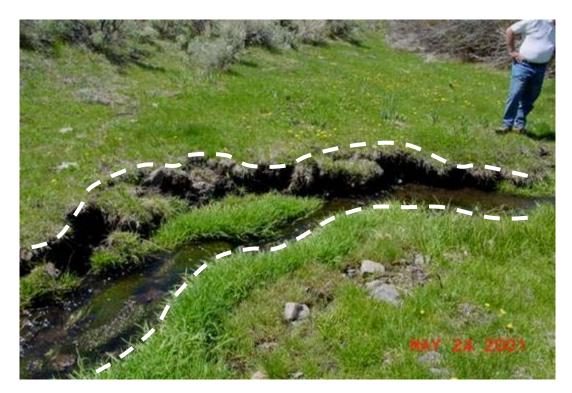
**Figure 31**—greenline follows the continuous line of vegetation. Note the blocks that have fallen into the stream channel and the block that are broken from the bank but have not fallen into the stream. The greenline goes behind the broken bank.

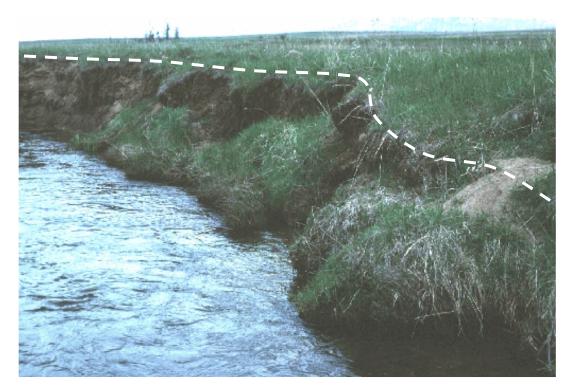
**Figure 32**—slump block detached from the streambank and not stabilized with vegetation.

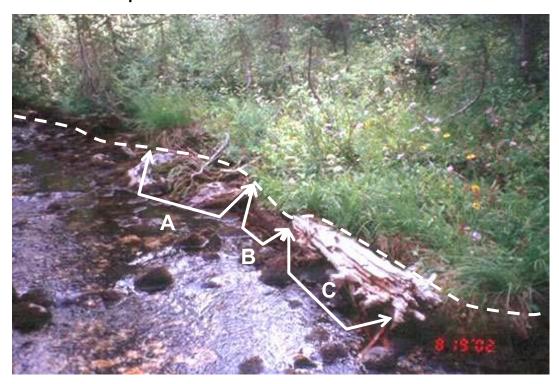
**Figure 33**—this complex greenline includes vegetation, anchored rock, and wood. Segment "A" is anchored rock, "B" is vegetation, and "C" is anchored wood.

Rocks, boulders, talus slopes, and bedrock that are part of the streambank must be of sufficient size to protect that portion of the streambank from erosion during high stream flows and be exposed along the greenline. At least 25 percent of a rockor boulder must be embedded in the streambank, with no evidence of active erosion at the edges of the rock. Appendix G, Figures 33, 37, 38, 41, and 42 provide examples of rock along the greenline.

Anchored wood consists of logs or root wads having sufficient size in or along the streambank in such a way that high flows are not likely to move them. The anchoring may be embedded in the streambank or wedged between rocks, trees, or other debris. Anchored wood must currently exert a hydrologic influence on the stream. There should be no evidence of active erosion that would destabilize the woody material. When logs are anchored and somewhat perpendicular to the stream, count the amount of anchored wood that joins the vegetation greenline on each side of the log (See Appendix G, Figures 33 through 36).

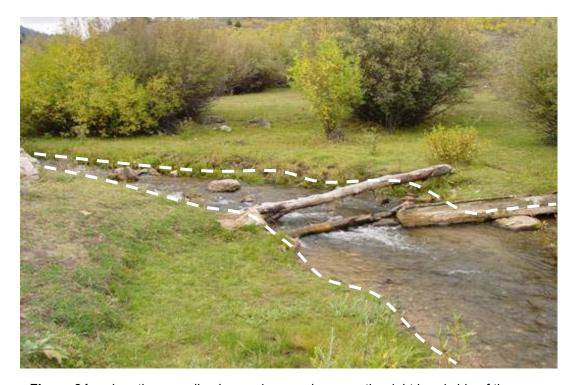
**Figure 34**—when the greenline is on a log, as shown on the right hand side of the photo, record as wood.

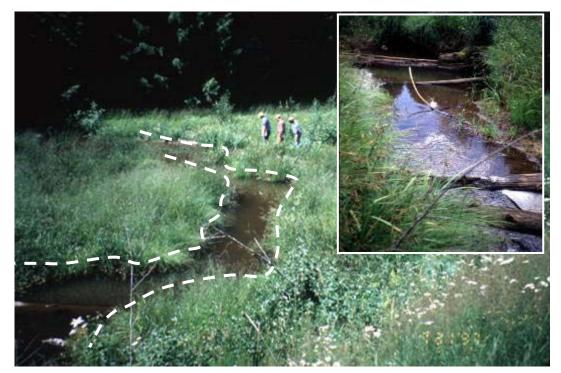
**Figure 35**—large logs, such as the cedar logs shown in the inset picture, with continuous vegetation over the top as shown above are not included in the greenline composition.

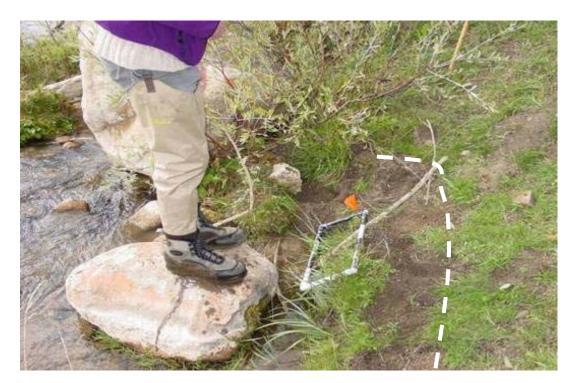
**Figure 37**—greenline is along the relatively continuous line. The patch of vegetation that the quadrant is on does not meet the 15 cm (6 in) by 50 cm (19.6 in) rule. The rock has erosion around the bank side and is not anchored to the streambank. The plot is moved perpendicular to the stream flow until adequate vegetation is within the quadrat.

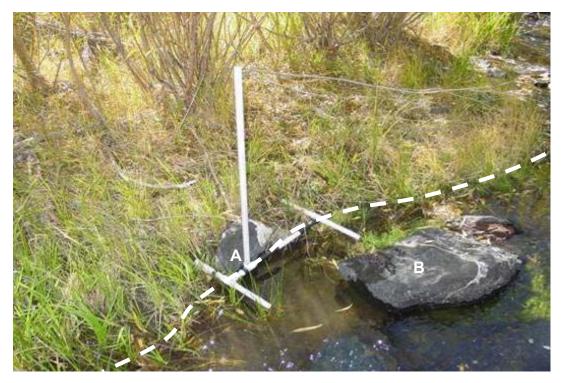
**Figure 38**—the rock "A" is anchored and part of the greenline. Active erosion exists on the streambank side of rock "B" and is not considered part of the greenline.

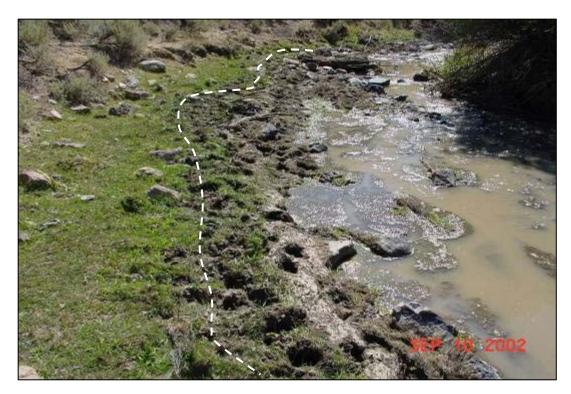
**Figure 40**—greenline follows the line of relatively continuous with lineal groupings of perennial vegetation with 25 percent foliar cover. Streambank alteration has broken the lineal grouping of vegetation shown in Figure 39.

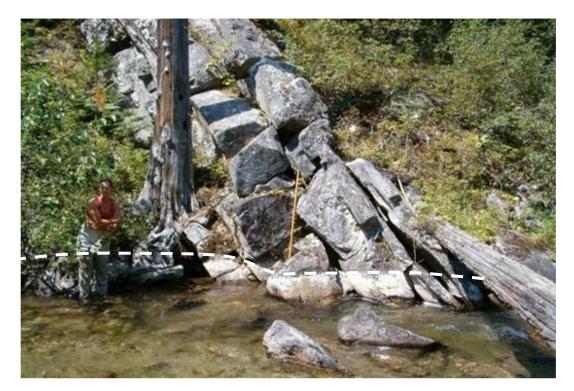
**Figure 41**—large anchored boulders and bedrock are recorded as rock. Note the color change on the rocks indicating the bankfull stage. *Photo - PIBO, U.S. Forest Service*

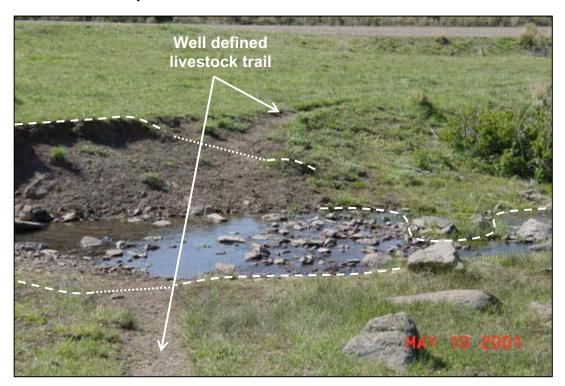
**Figure 43**—water, tributary streams, roads, and livestock trails are not considered part of the greenline. Livestock trails must be well defined by use over years of use such as the trail shown above. Heavy use during a single season does not create a well-defined trail that leads away from the stream crossing. Should the quadrat fall on a trail, it is recorded as "NG" (no greenline).

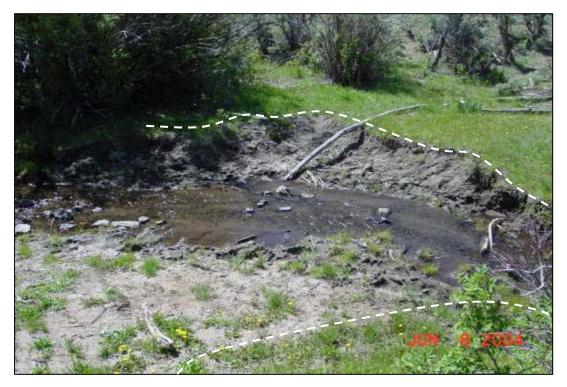
**Figure 44**—although the streambank above has been heavily trampled, there is not a defined trail leading away from the stream. Therefore the greenline is at the top of the bank.

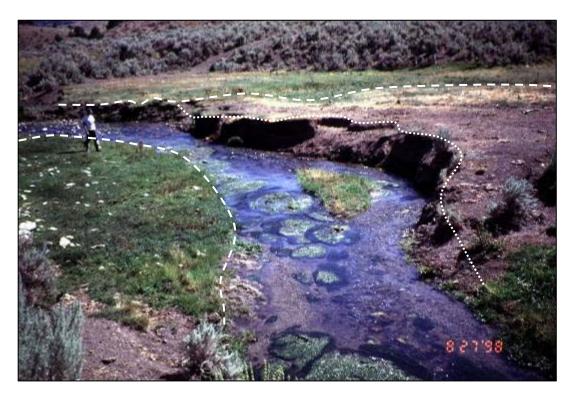
**Figure 45**—no lineal groupings of perennial vegetation is along the edge of 1<sup>st</sup> terrace (designated by the dotted line) on the bank. A second terrace does not exist and the plot is moved no more than 6 meters (20 feet) from the edge of the water. If no greenline vegetation exists, record "NG" and go to the next plot.

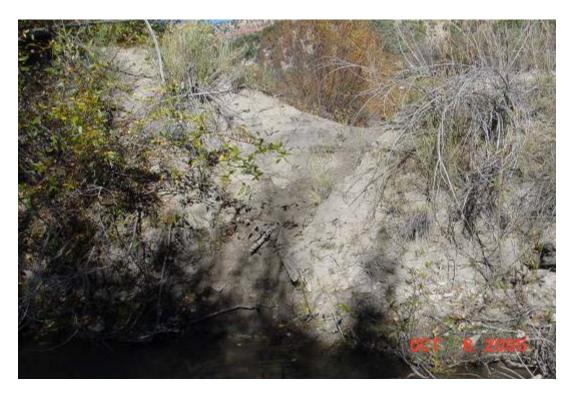
**Figure 47**—a narrow peninsula on a tight meander bend has no greenline vegetation. Place the frame with the center bar along the top of the ridge and record "NG" (no greenline vegetation). Record the applicable data.

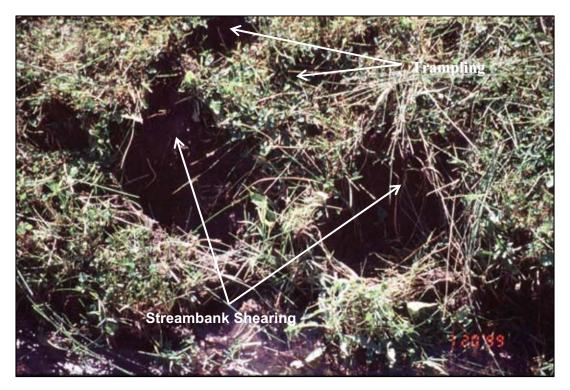
**Figure 1**—disturbance is considered trampling when a track caused by a large herbivore exposes at least ½-inch of bare soil. Streambank shearing is the physical displacement of part of the streambank downward toward the stream channel.

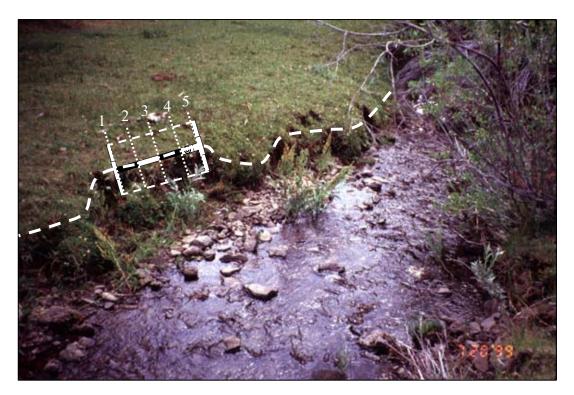
**Figure 2**—the monitoring frame is centered on the greenline and the number of lines ((0 to 5) that intersect streambank alteration (trampling or shearing) is counted and recorded. Lines 1, 2, 4, and 5 intersect streambank alteration. Four is recorded.

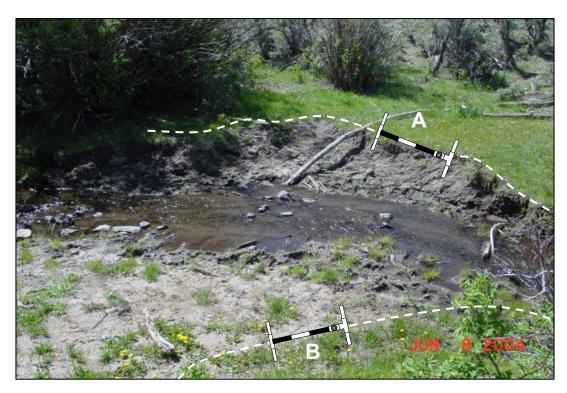
**Figure 4**—example A is heavily trampled and all five lines intersect streambank alteration. B shows no evidence of current years trampling that displaces soil at least ½ inch deep. A zero is recorded.

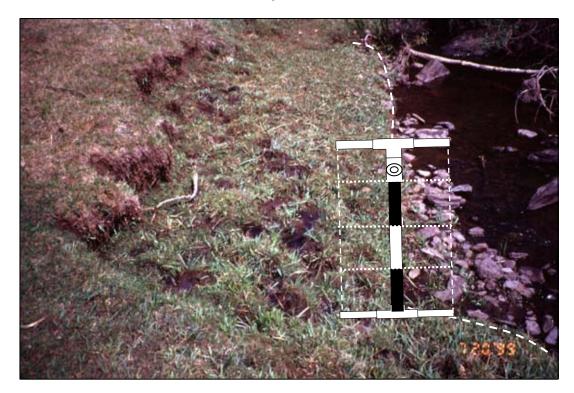
**Figure 6**—no evident streambank alteration intersects lines any of the lines within the quadrant. Zero is recorded.

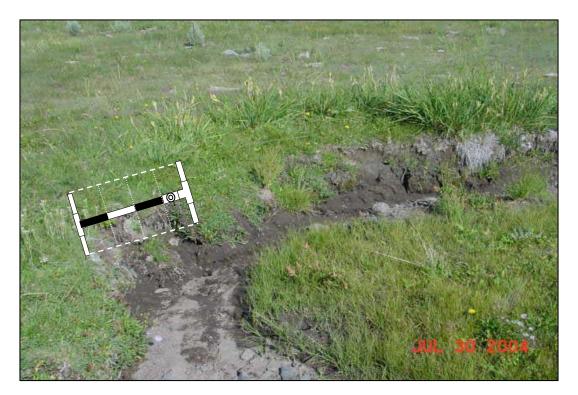
**Figure 7**—lines 2 and 4 intersect streambank alteration caused by livestock. Two is recorded.

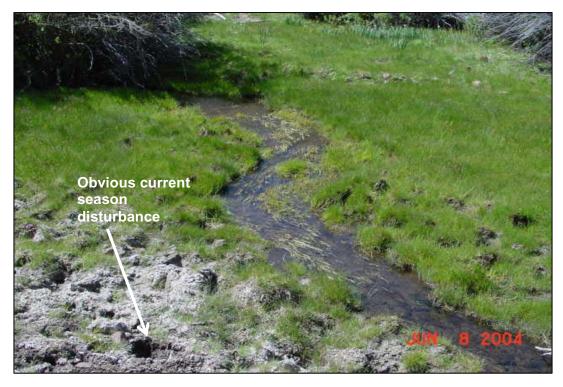
**Figure 8**—current season streambank alteration is difficult to distinguish from previous season use. Streambank alteration measurements should be made while livestock are still in the pasture or within two weeks of leaving. Streambank alteration should not be conducted on a site such as this when the alteration is difficult to distinguish from previous season grazing.

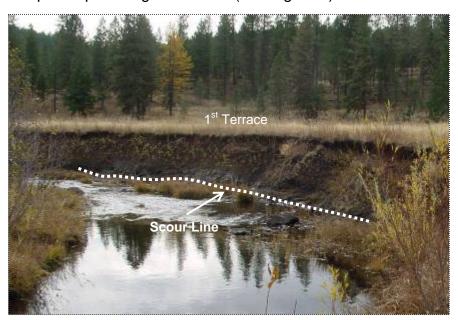
**Figure 1**—the 1<sup>st</sup> terrace is the first relatively flat area above the scour line or edge of the water. An abrupt steep face from the edge of the terrace to the scour line is a characteristic of a terrace. Slough from the terrace wall has direct access to the stream.

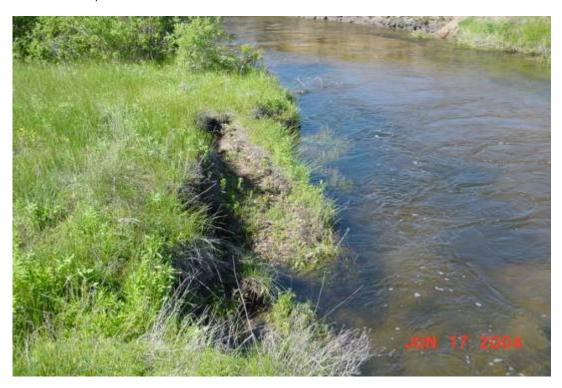
**Figure 4**—the photo above shows a fracture and a large slump that is still attached to the streambank. Vegetation cover is at least 50 percent canopy cover and is classified as covered/unstable (CU). (see Illustration 4)

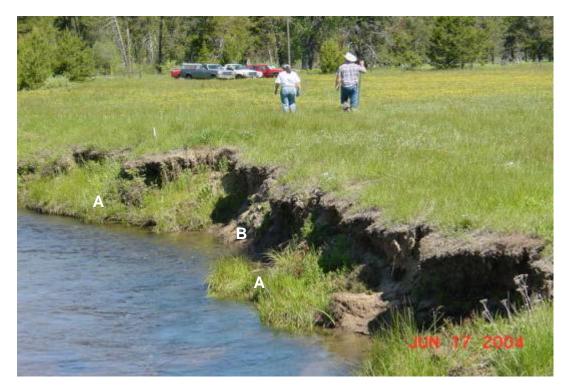
**Figure 5**—the stream in this photo is flowing at the scour line. Slumps "A" are still attached the bank above the scour line and would be classified as covered/unstable (CU) (See Illustration 4). "B" has no vegetation along the streambank and is uncovered/unstable (UU) (See Illustration 4).

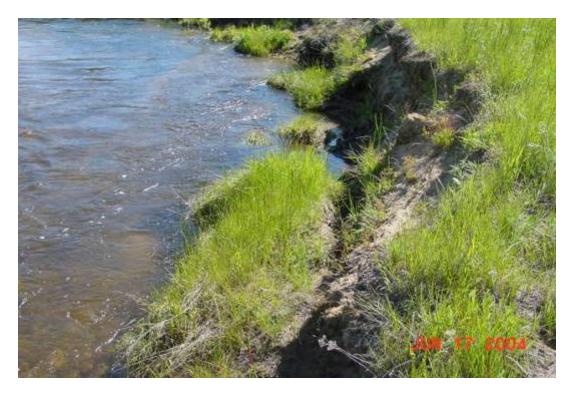
**Figure 6**—the slump bank is still attached to the bank above the scour line and is covered/unstable (CU) (see Illustration 4)

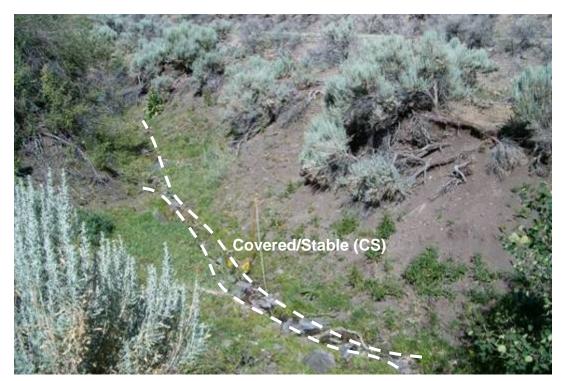
**Figure 9**—the scour line and greenline are at approximately the same location. The streambank has at least 50 percent vegetation cover and is not eroding. Thus is classified as covered/stable (CS). Photo- PIBO, U.S. Forest Service.

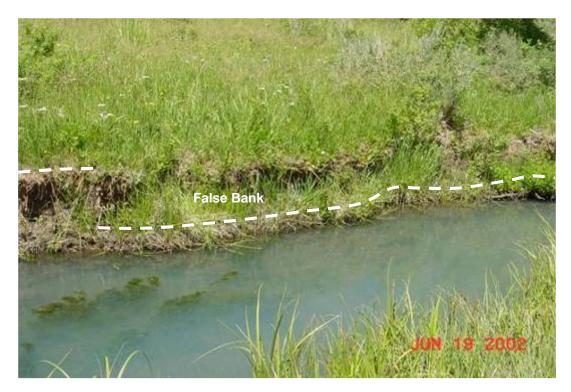
**Figure 10**—false banks are slump features that is reattached and with deep-rooted vegetative cover and is stable.

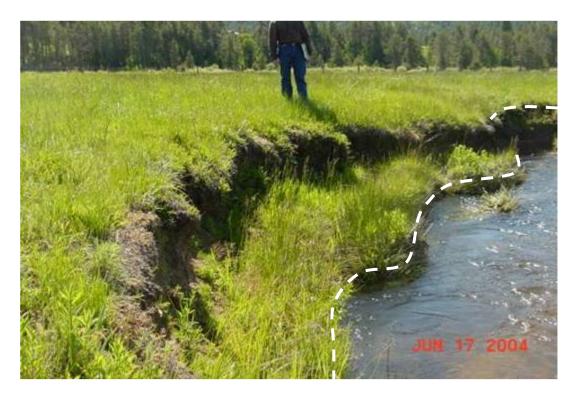
Figure 11—this is a false bank (FB) and is stable.

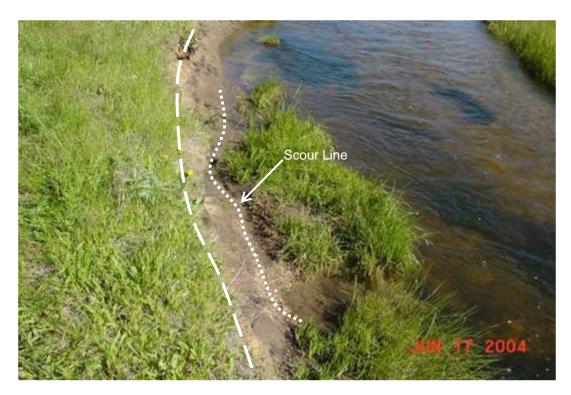
**Figure 12**—vegetation is not well established between the slump block and the vertical terrace leaving and area subject to erosion. The classification is uncovered/unstable (UU).

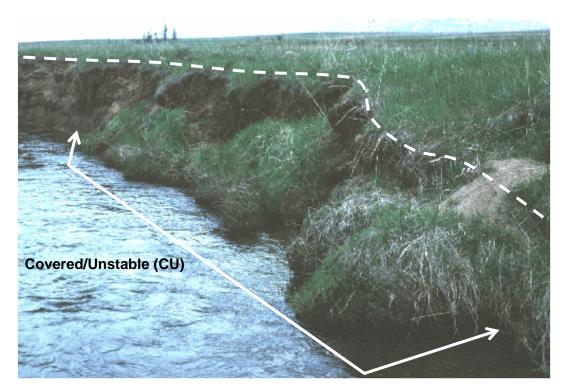
**Figure 13**—slump blocks and slumping banks with the blocks and attacked bank above the scour line are covered/unstable (CU).

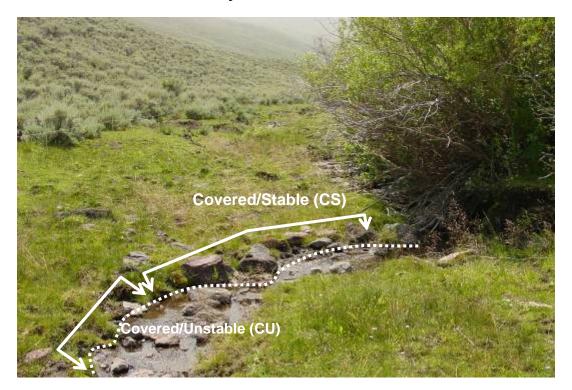
**Figure 15**—livestock and/or big game caused slumping banks that result in the covered/unstable (CU) classification. The remainder of the bank is covered/stable (CS).

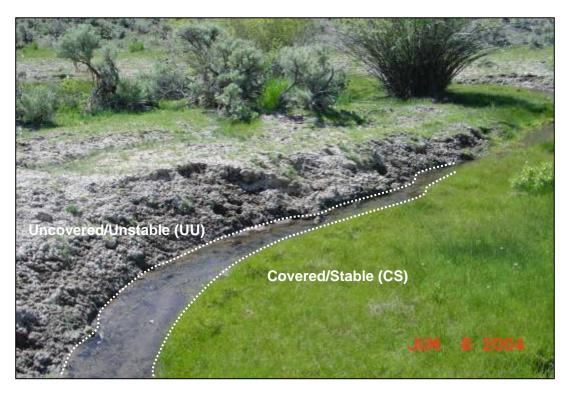
**Figure 16**—the streambank on one side of the stream is uncovered/unstable (UU) and the other side is covered/stable (CS).

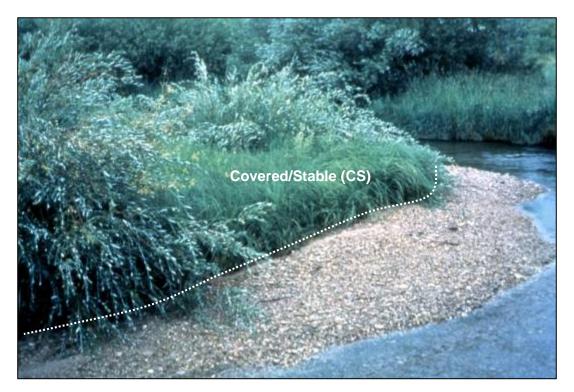
**Figure 17**—gravel area below the scour line (dotted line) is not considered part of the streambank (see Illustration 1 above). Streambank is covered/stable (CS). Photo – Alma winward

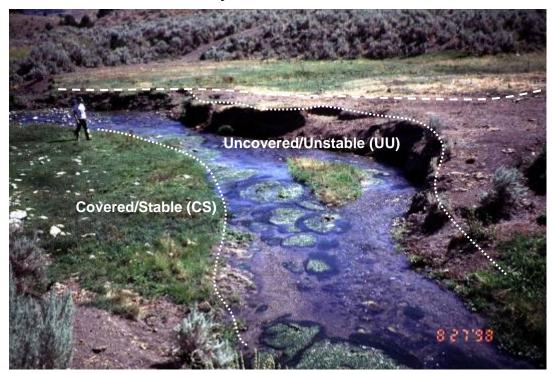
**Figure 19**—this is one of the few exceptions to following the greenline (dashed line). Because the greenline deviates from the stream, the monitoring line flows the stream until the greenline is closer to the streambank. The scour line (dotted line) is near the surface water level.

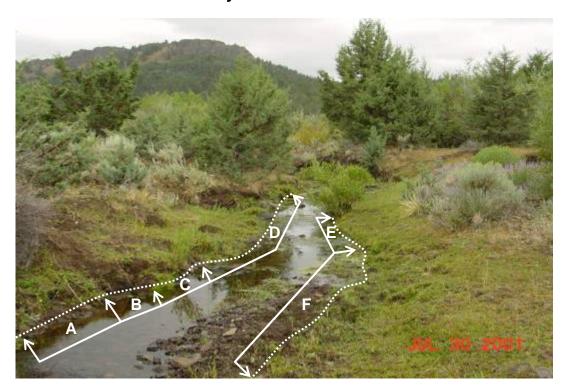
**Figure 21**—the dotted line in the scour line. "A" has bare bank above the scour line with vegetation on top (covered/unstable (CU). "B" is uncovered/unstable (UU). "C" is covered/unstable (CU). "D and E" has a vegetation cover with little erosion, covered/stable (CS). And, "F" is covered/unstable (CU) as a result of livestock trampling.

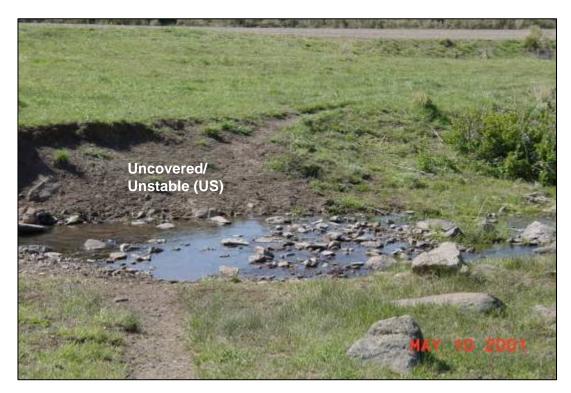
**Figure 24**—highly compacted areas such as this livestock trail and slough is directly entering the stream is classified as uncovered/unstable (UU).

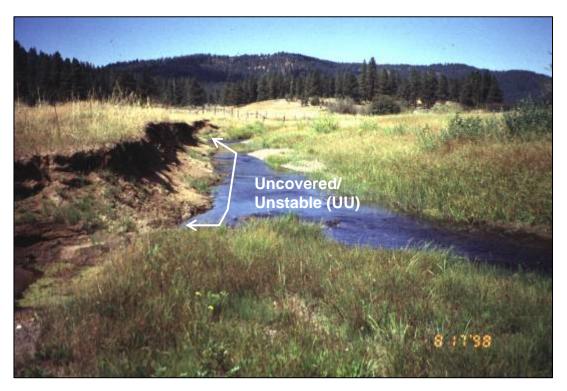
**Figure 25**—the streambank is not covered with vegetation, rock, or wood. It has a bank angle of more than 10 degrees from vertical with no terrace to capture the sediment and thus the sediment enters directly into the stream making it uncovered/unstable (UU).

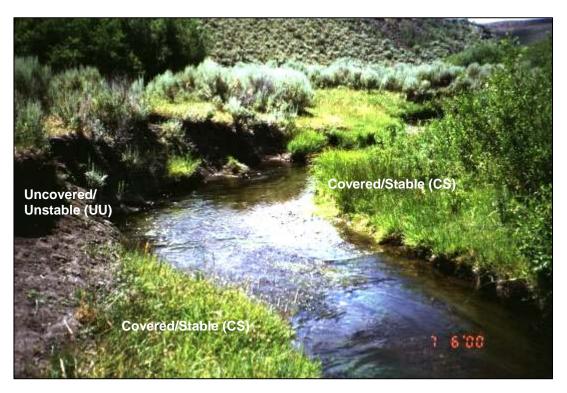
**Figure 26**—these streambanks include areas that are covered/stable (CS) on the inside bends and uncovered/unstable (UU) on the outside of the bends.

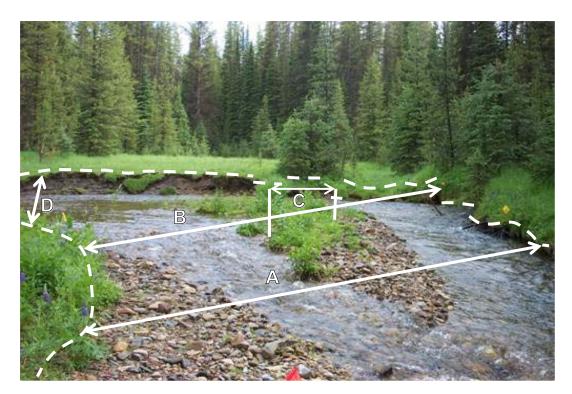
**Figure 4**—line "A" is the total length of the greenline-to-greenline width (GGW). The gravel bar has no vegetation. When the GGW crosses a an island with at least 25 percent cover, the non-vegetative portion is calculated (total length of line "B" – line "C") to determine the non-vegetated portion of the two channels. *Photo - PIBO, U.S. Forest Service*

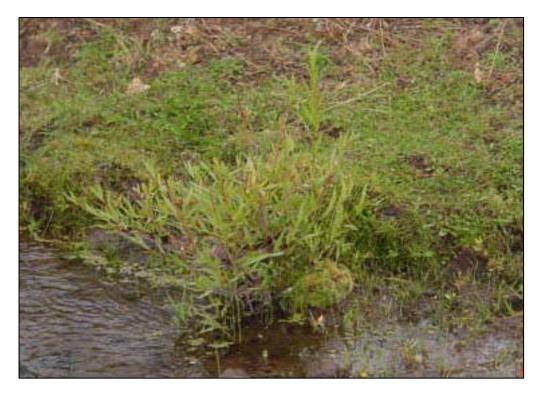
**Figure 2—Slight to Light.** There is obvious evidence of leader use. The available leaders appear cropped or browsed in patches and 60 - 89% of the available leader growth of browse plants remains intact. Mid-point is 25.

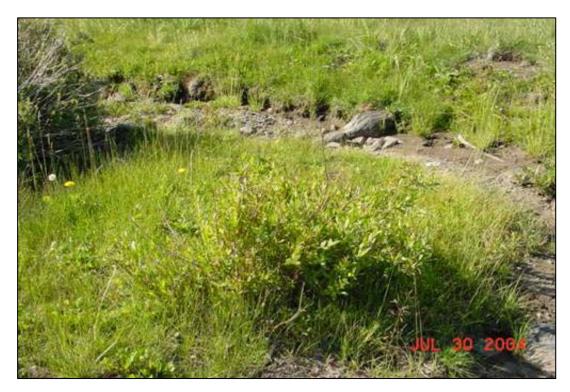
**Figure 3—Moderate**. Browse plants appear rather uniformly utilized and 40 - 60% of available annual leader growth of the plants remains intact. Mid-point is 50.

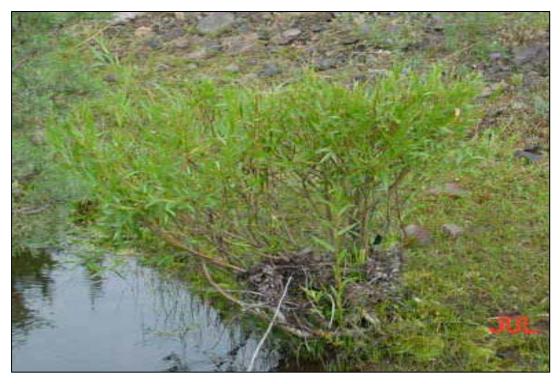
**Figure 4—Moderate**. Browse plants appear rather uniformly utilized and 40 - 60% of available annual leader growth of the plants remains intact. Mid-point is 50.

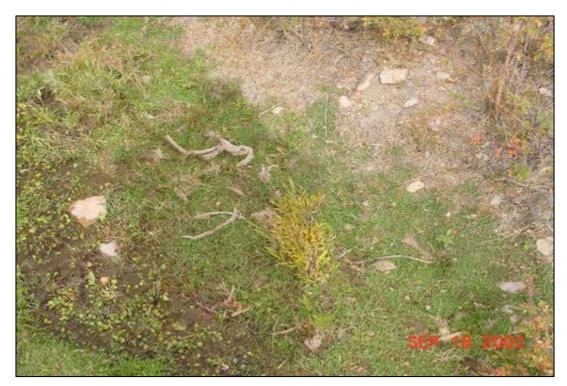
**Figure 5—Heavy to Severe**. The use of the browse gives the appearance of complete search by grazing animals. The preferred browse plants are hedged and some clumps may be slightly broken. Only between 10 and 40% of the available leader growth remains intact. Mid-point is 75.

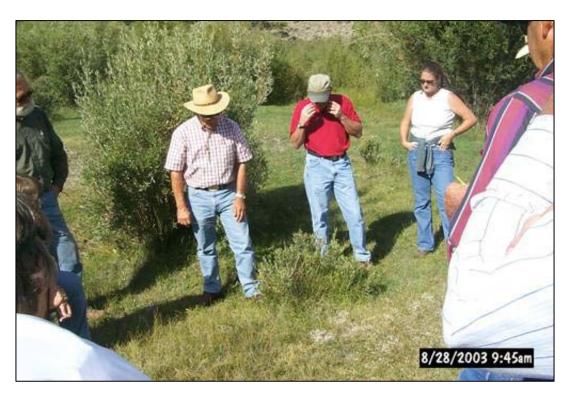
**Figure 6—Heavy to Severe**. The use of the browse gives the appearance of complete search by grazing animals. The preferred browse plants are hedged and some clumps may be slightly broken. Only between 10 and 40% of the available leader growth remains intact. Mid-point is 75. Photo – Warren Ririe

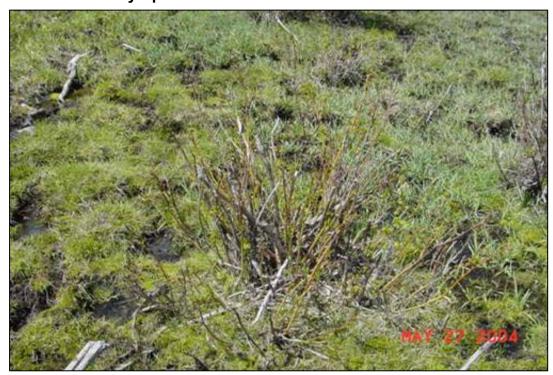
**Figure 7—Extreme**. There are indications of repeated grazing. There is not evidence of terminal buds. Some patches of second and third years' growth may be grazed. Hedging is readily apparent and browse plants are frequently broken. Repeated use at this level will produce a definitely hedged or armored growth form. Ten to 40% of the more accessible second and third years' growth of browse plants has been utilized. All browse plants have major portions broken. Mid-point is 95.

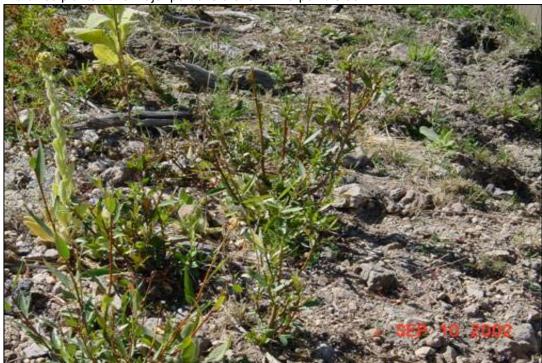
**Figure 8—Extreme.** There are indications of repeated grazing. There is not evidence of terminal buds. Some patches of second and third years' growth may be grazed. Hedging is readily apparent and browse plants are frequently broken. Repeated use at this level will produce a definitely hedged or armored growth form. Ten to 40% of the more accessible second and third years' growth of browse plants has been utilized. All browse plants have major portions broken. Mid-point is 95.
