Inventory Unit Number/Name Telford OR 135-011

DOCUMENTATION OF BLM WILDERNESS INVENTORY FINDINGS ON RECORD:

DOCUMENTATION OF CURRENT WILDERNESS INVENTORY CONDITIONS

APPENDIX C – ROAD* ANALYSIS

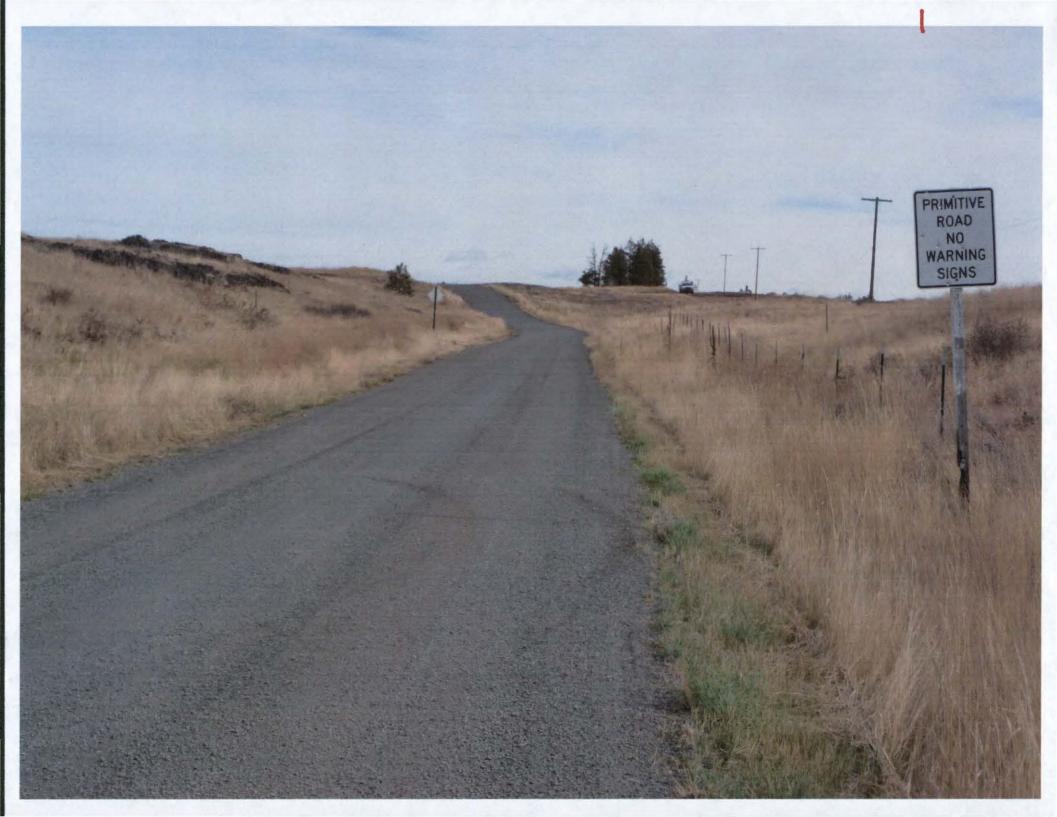
I. LOCATION: refer to attached Field map, BLM Minerals Management Status Map, 1/100,000 Scale and BLM corporate data (GIS). List photo point references (where applicable): <u>T 25 N., R. 35 E., Section 27</u> to <u>T 26 N.,</u> R. 35 E., Section 23; see photos #1 and #2

Date	Frame #	Camera Direction	Description	GPS/UTM Location	Township	Range	Sec.
10/12/11	1	northeast	North Telford Road		25 N.	35 E.	4
10/12/11	2	southwest	South Telford Road		265N.	35 E.	4
-							
					111
