# AQUATIC INVENTORIES OF THREE MOUNTAIN LAKES IN NORTHERN IDAHO

Robert F. Raleigh  
Raleigh Consultants  
P.O. Box 65  
Council, Idaho 83612

23 September 1993  
Robert F. Raleigh  
Raleigh Consultants  
P.O. Box 66  
Council, ID 83612  
208-253-6883

Raleigh, R.F. 1993. Aquatic inventories of three mountain lakes in northern Idaho. Bureau of Land Management, Technical Bulletin 93-3, Boise, Idaho.

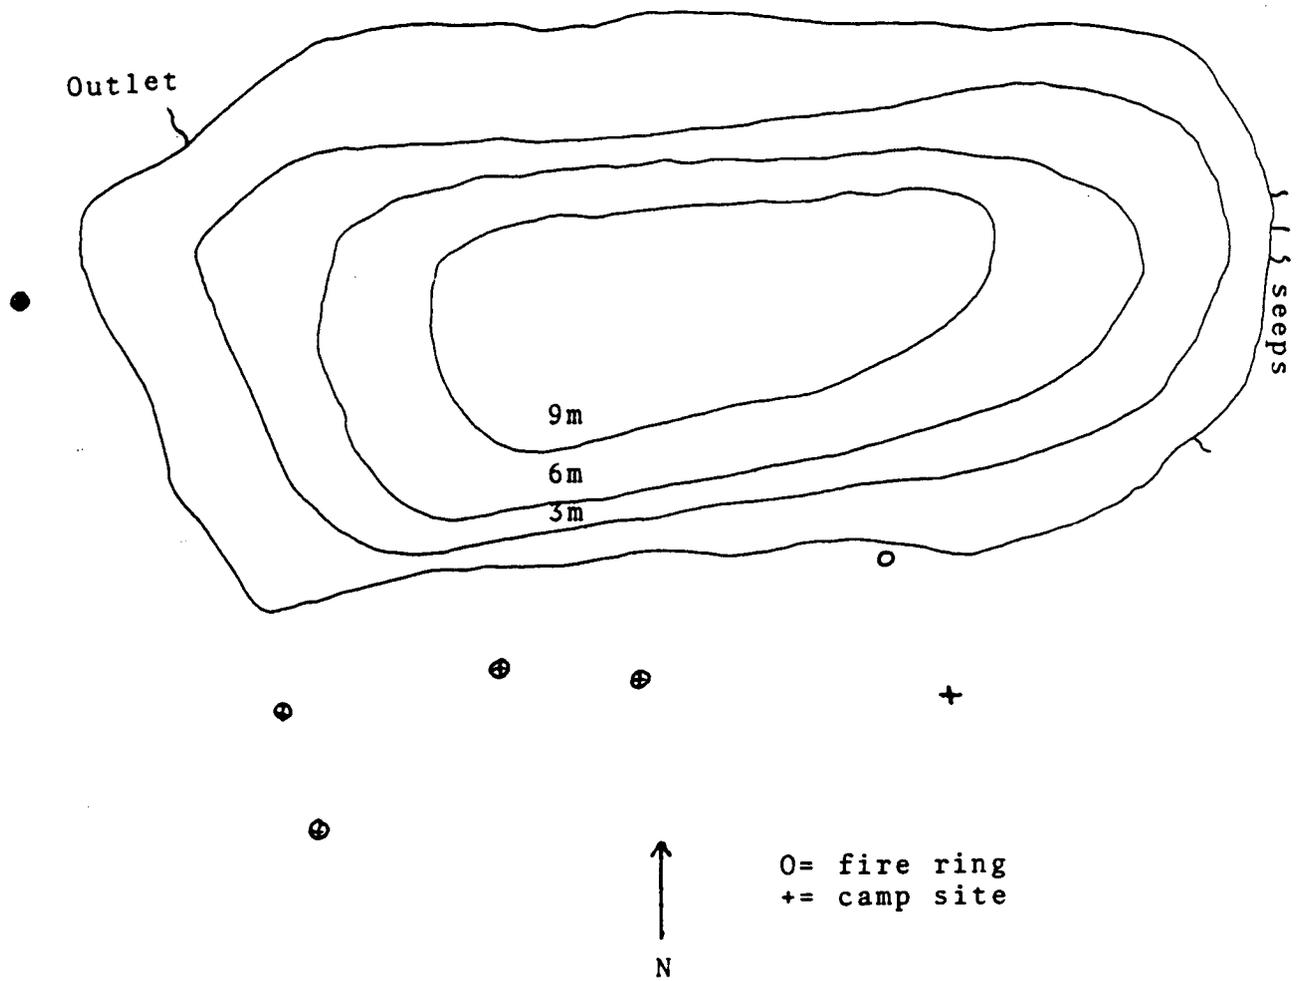
Figure 1. Antelope Lake with three meter depth contours.

Location and Morphology. Antelope Lake is a small (7.7 hectare), cirque lake located east of Clark Fork, Bonner County, Idaho in Township (T) 55N., Range (R) 2E., Section (S) 12 in the Idaho Panhandle National Forests area. The lake is located at an elevation of 2770 feet. About two thirds of the lake is on private land. Only the eastern one third of Antelope Lake is located on lands managed by the BLM. The lake is surrounded by steep mountains on three sides with a western exposure. About 12.1 hectares of watershed drains directly into Antelope Lake. The lake is fed by small springs and seeps. The lake outlet stream is very small with an estimated outflow of about 0.1 cfs at the time of the inventory. Antelope Lake has a maximum depth of 10.2 meters with about 60% of the lake <6 m deep. Depth contour lines at three meter intervals, lake shape, and lake shore development are displayed in figure 1. The lake substrate from shore to the three meter depth contour is comprised of 35% rooted aquatic plants, 50% dark, fine textured mud and silt, 5% submerged logs, and 10% boulders and gravel.

The water supply to the lake is from a series of springs and seeps primarily around the south and east sides of the lake. The surface water temperature was warm. Water temperatures varied from 23 C. at the surface to 16.5 C. at the bottom at mid-day on August 12. Fish food production in the lake and trout growth appear to be high. The density of submerged, rooted aquatic plants may cause occasional periods of low dissolved oxygen concentrations during winters with a deep snow pack, but the lake depth would mitigate any possible low oxygen problem.

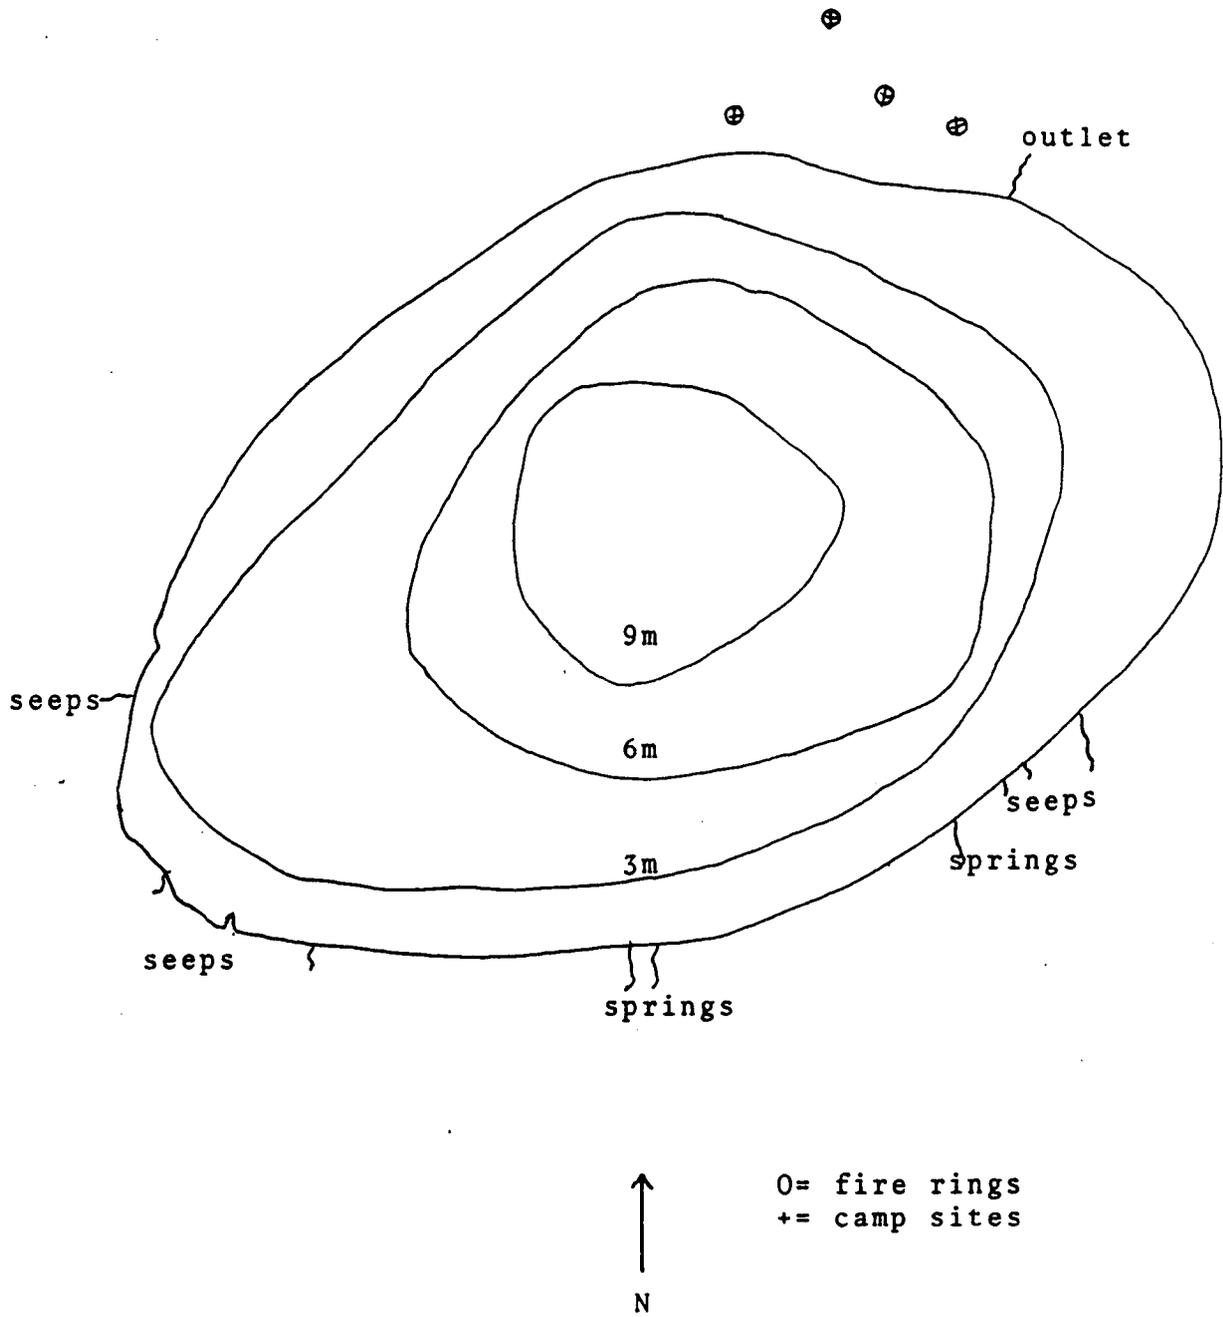
Figure 2. Crystal Lake with three meter depth contours.

The lake is fed by nine small springs and seeps along the south and south west sides (Figure 2). The largest spring had an estimated flow of about 0.4 cfs. The outlet stream is to the north with a boulder-rubble substrate and an estimated flow of about 3-4 cfs at the time of the survey. The outlet stream is small and brushy. There is no inlet stream per. se. and no usable spawning gravel in the system.

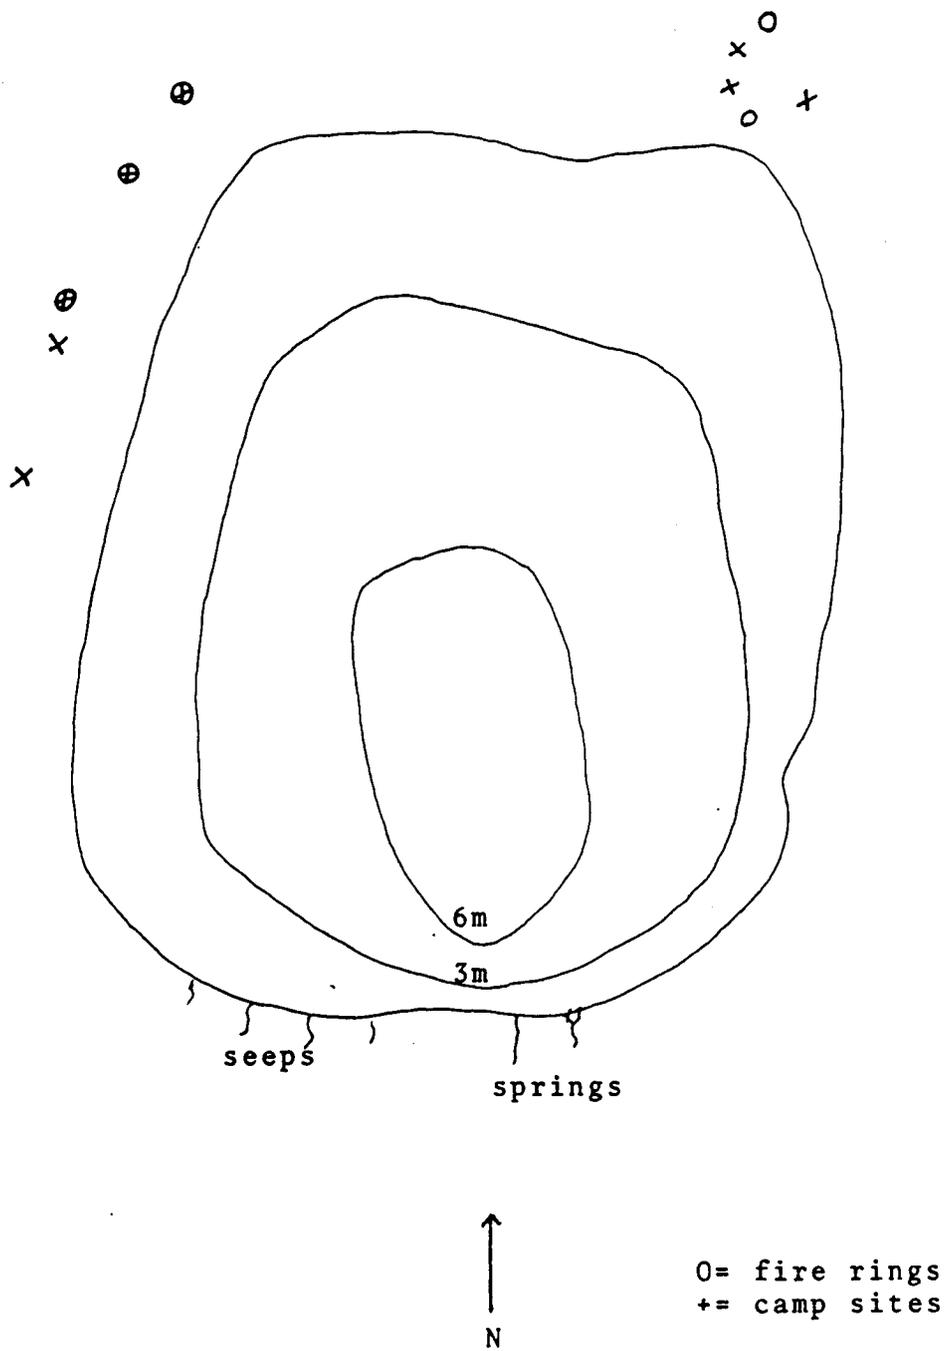
Figure 3. Mirror Lake with three meter depth contours.

Location and Morphology. Mirror Lake is a small, 0.93 hectare, cirque lake located in Kootenai County, Idaho in the Twin Lakes Quadrangle, T 47N., R 1E., S 8. The lake is located at an elevation of 5780 feet immediately below Latour Peak on lands managed by the BLM in the Idaho Panhandle National Forests area. The lake is surrounded on three sides by steep mountain slopes with a north facing exposure. The lake has a maximum depth of 6.3 m., and an average depth of 3.2 m. About 18.1% of the lake is  $\geq 6$  m. deep. Lake depth contour lines at 3 m. intervals and the lake shore development are illustrated in Figure 3. The lake substrate to the 3 m. depth contour is comprised of large to small boulders, cobble, and gravel scattered over a silt substrate. There are submerged logs along the west shore with a small log jam in the south west corner (Figure 3).
