IDAHO BLM  
**TECHNICAL BULLETIN**

IDAHO RIPARIAN AND AQUATIC PROTECTION AND  
ENHANCEMENT PROGRAM

PART A: INTRODUCTION THROUGH IDAHO FALLS DISTRICT

TECHNICAL BULLETIN 87-3A

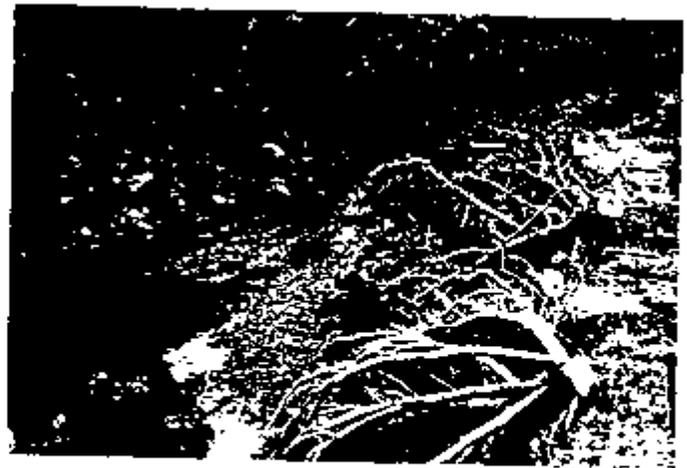
*Juniper Creek showing cut juniper trees cabled along the stream for bank stabilization.*

2. Accelerated streambank erosion caused by livestock overgrazing has deteriorated riparian/fisheries habitats. Objectives were to trap stream sediments in branches of juniper trees placed at bank cuts to rebuild banks.

4. Results: Tons of sediment was trapped along the 2700' of treated streambank. Some trees were lost due to high spring runoff in 1984 & 85. Willow cuttings have approximately 85% success with some over 5'. Unchecked livestock grazing is still occurring and success is reduced from what its potential recovery could be. Project failure is imminent since livestock use continues to prohibit vegetative recovery of streambanks.

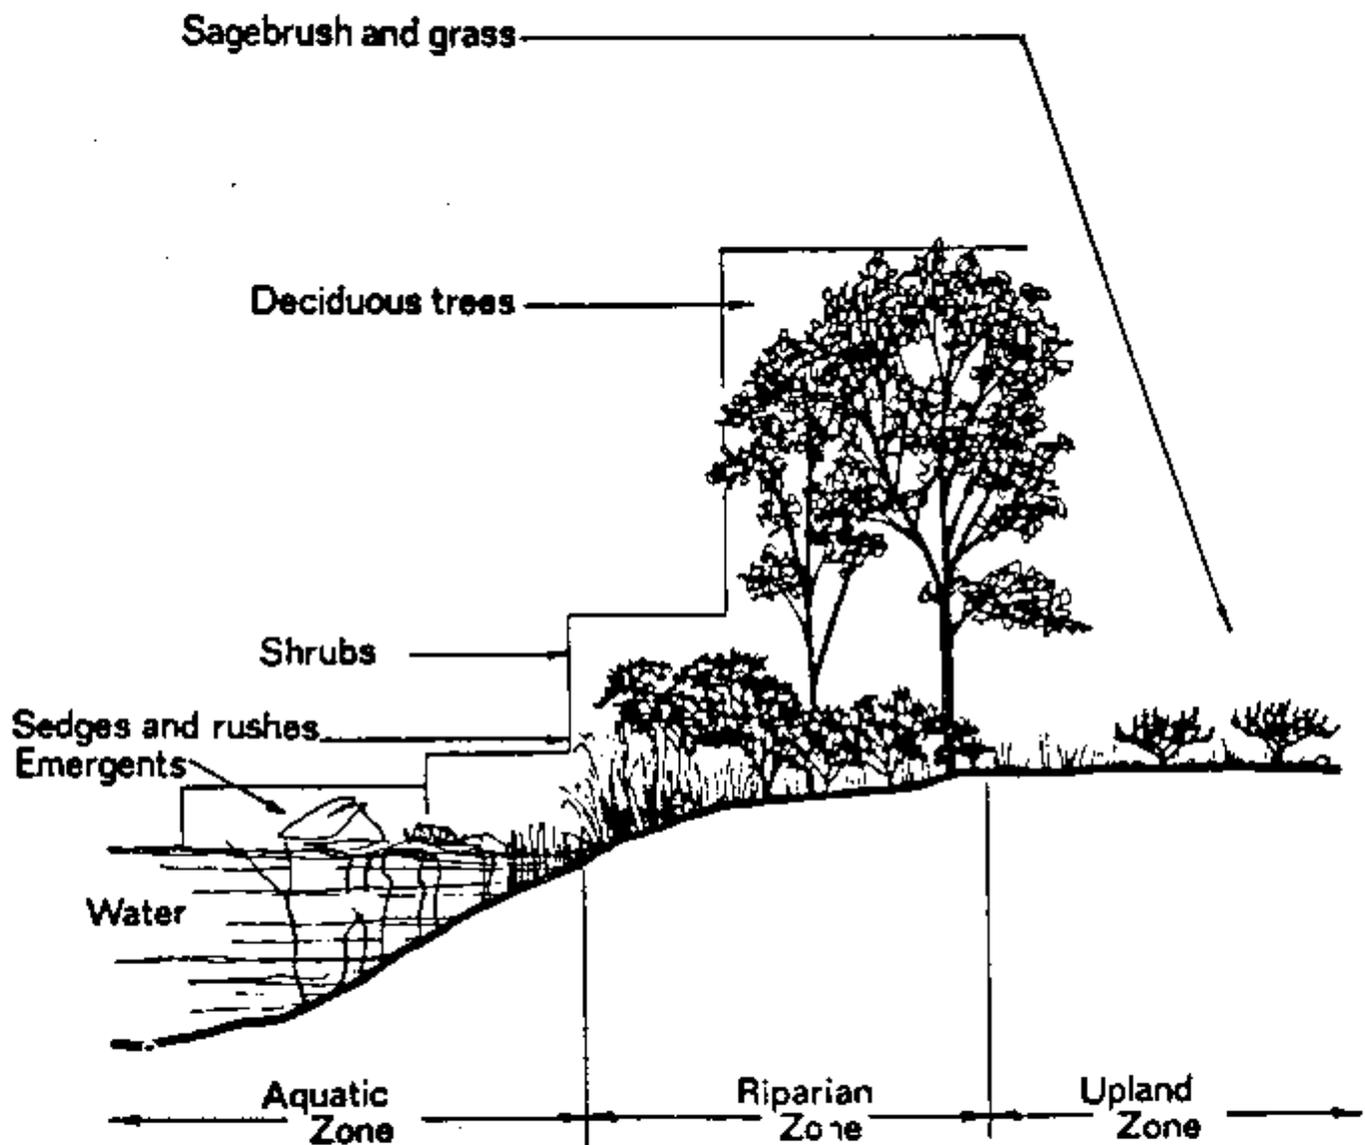
# SEEN A RIPARIAN AREA LATELY? GOOD ONES ARE GREEN!

*The figure shows streamside vegetation as it should be – along the stream is a healthy riparian area of diverse kinds and sizes of plants which gradually shift into the dominant upland vegetation as you travel further from the stream. Unfortunately, too many BLM drainages contain wide, shallow stream channels with unstable flows; the upland vegetation reaches the top of the eroded streambanks and the water table drops. The riparian area all but disappears.*

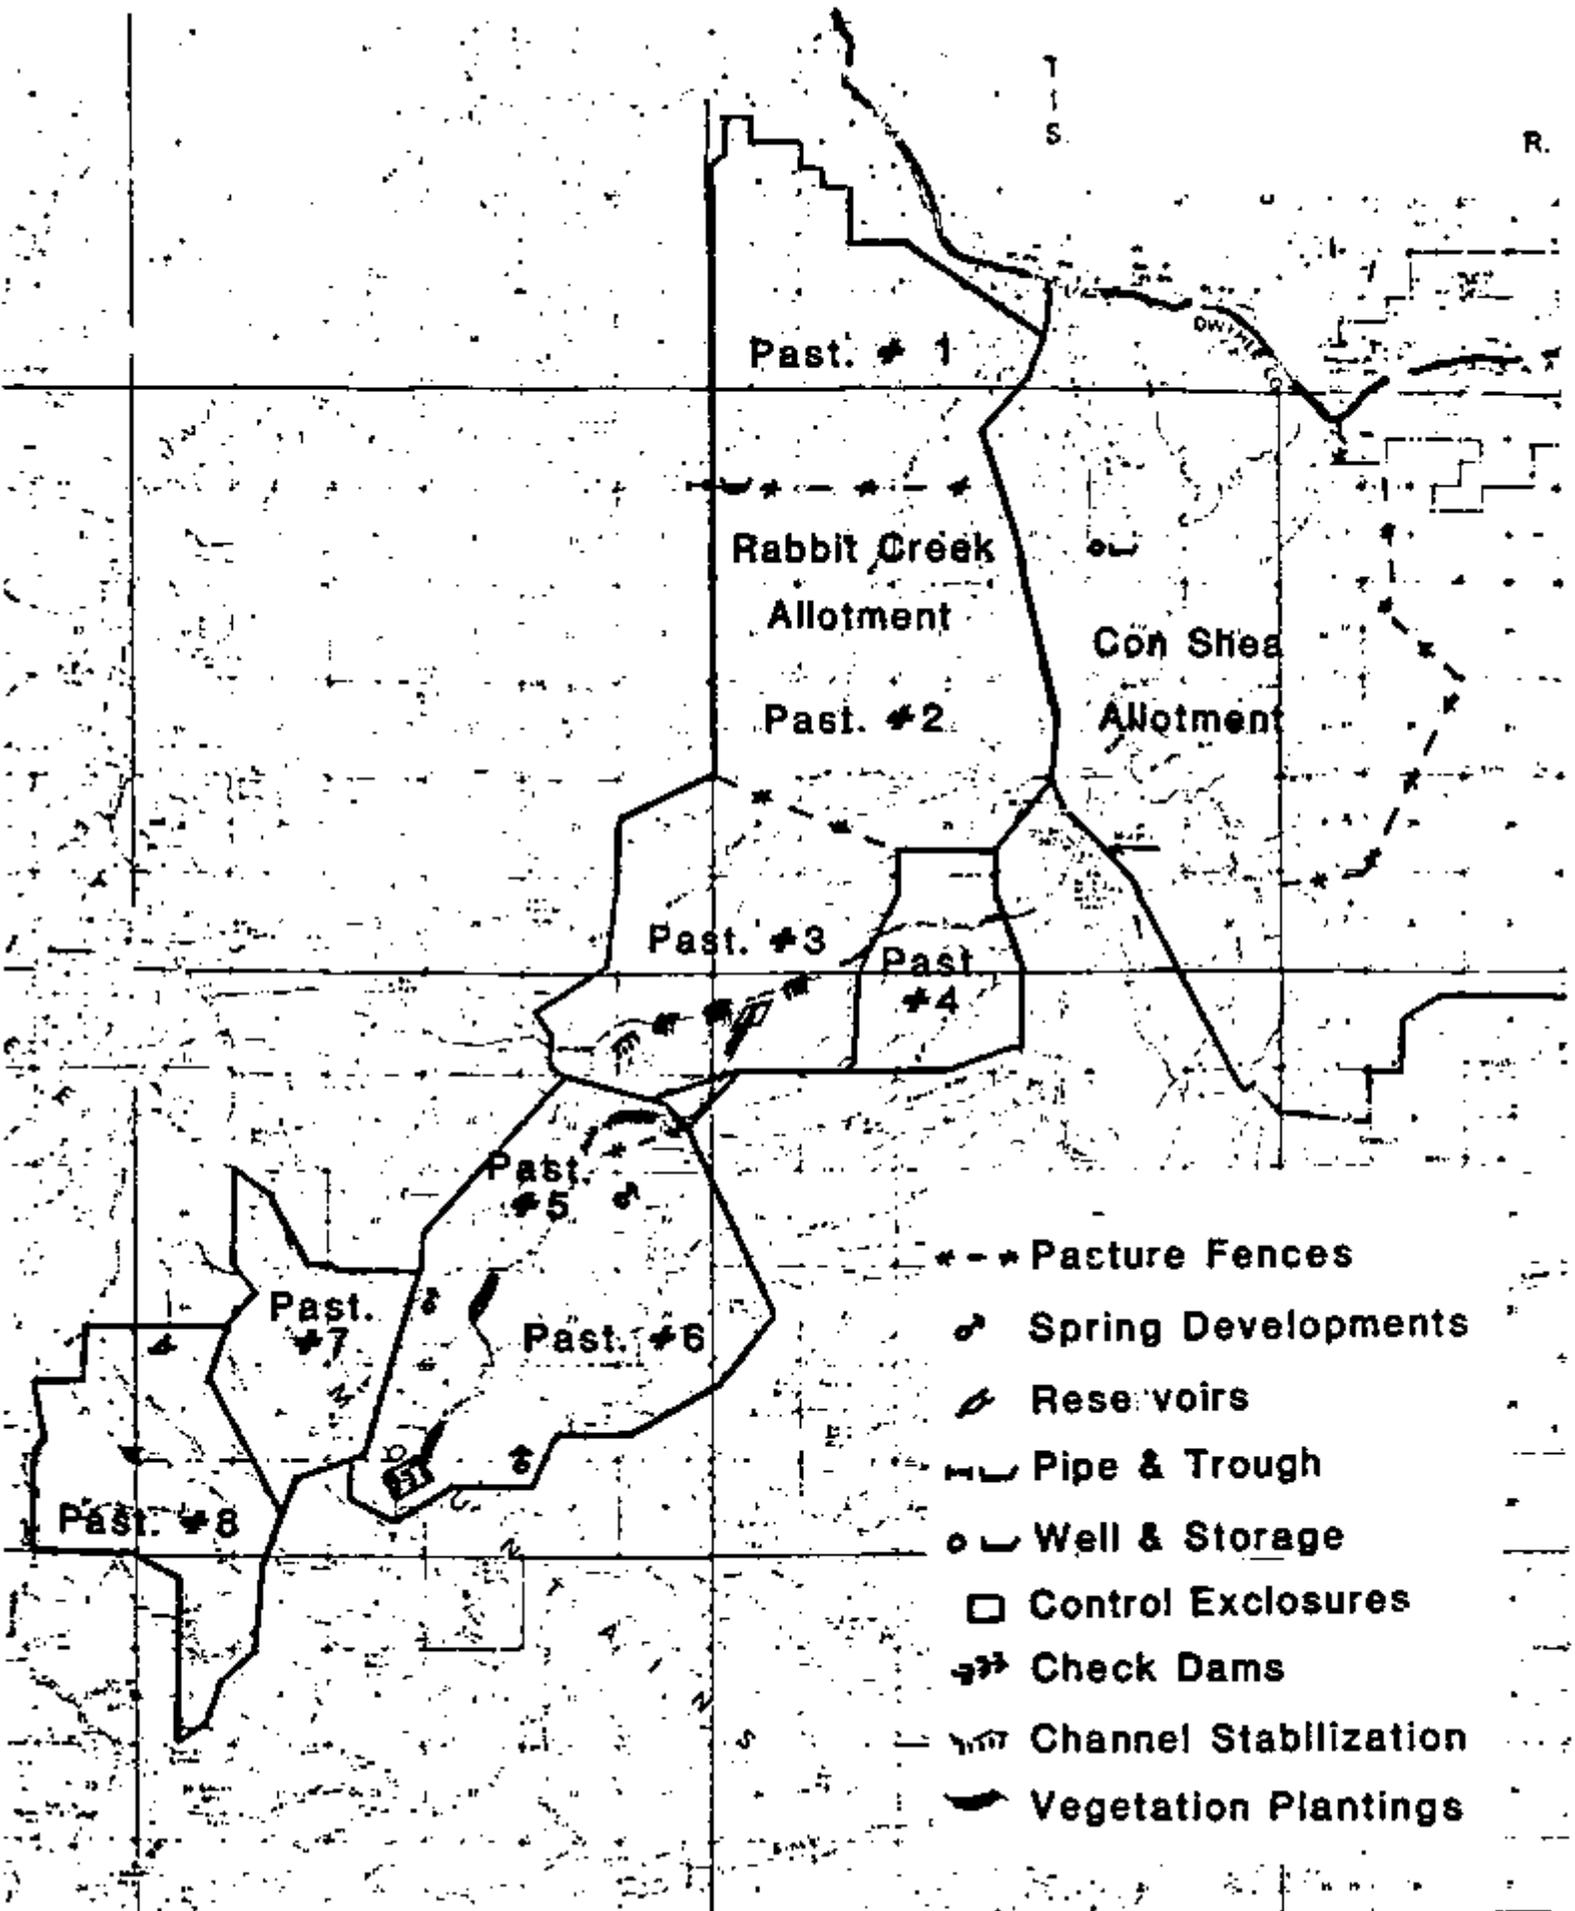
# Rabbit Creek Pilot Riparian Project

- \*--- Pasture Fences
- ⊕ Spring Developments
- ⊖ Reservoirs
- |— Pipe & Trough
- | Well & Storage
- Control Enclosures
- ▲— Check Dams
- |~| Channel Stabilization
- |~| Vegetation Plantings

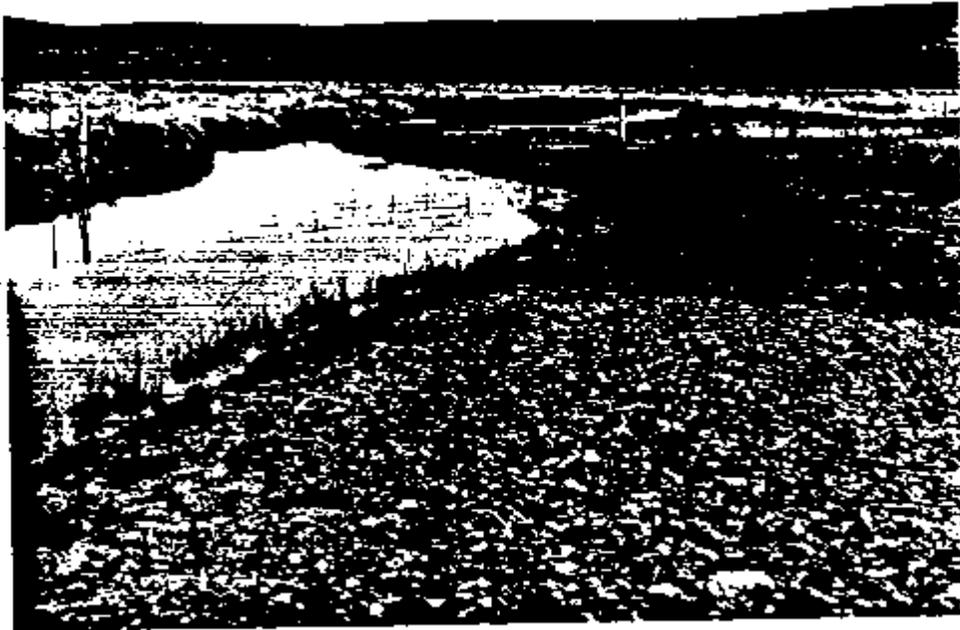
1. Upper project area with 1983 exclosure fence line crossing upper photo. Gravel bar in foreground remains unvegetated under grazing pressures.

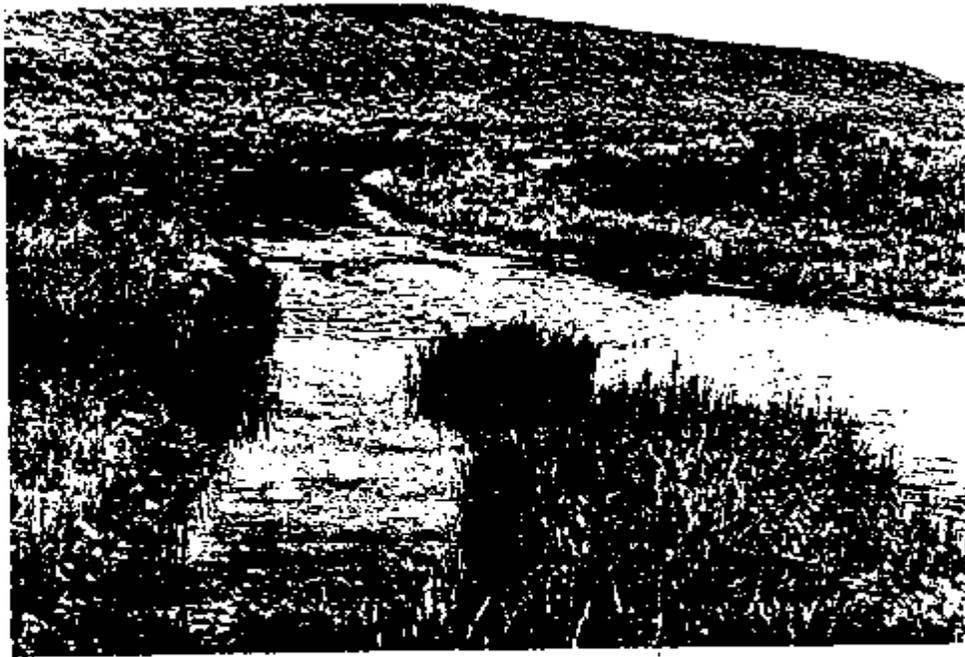
4. Bank stability and instability inside eight-year-old enclosure.

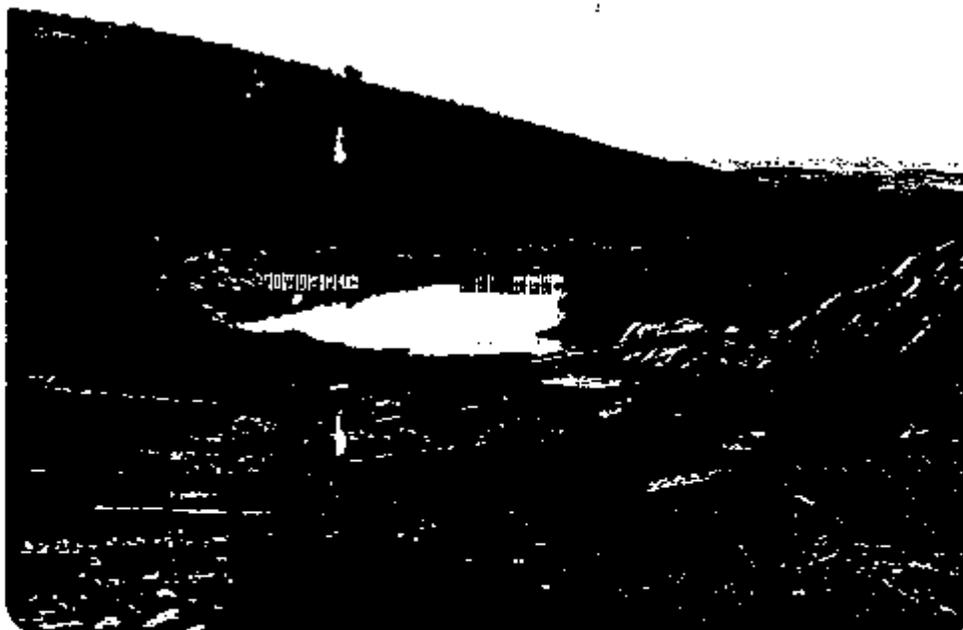
2. These structures were used to retain water and restore wetland soils/vegetation.

The treatment has worked to date. The objectives of improved soil stability sediment and water retention and vegetative diversity are being realized. We used three types of channel structures; loose rock, fence with rock, and metal sheet with rock, and each has performed as designed with minimal maintenance. Cut banks that were barren four years ago are now covered with forbs and perennial grasses. The excelsior has degenerated but it stayed in tact protecting the soil until vegetation established. The pole fence has been very successful in excluding livestock, allowing wetland species to repopulate the bottom, and sediment is gradually filling the gully back to gentler contours.

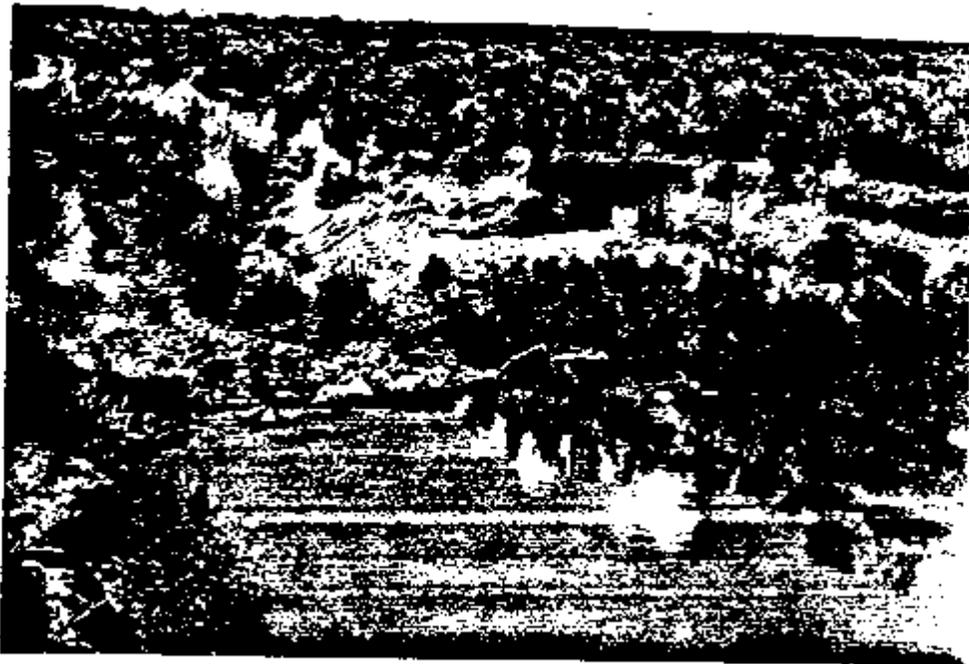
1. Structures used to hold water/sediment and take the punch out of flash floods.

The project was initiated to take the punch out of flash floods that perennially caused county road damage. It was also felt we could enjoy off shoot riparian benefits. In the fall of 1983 ten gully plugs were constructed in the drainage using corrugated steel sheet with rip rap aprons. They worked well until an intense thunder storm in July of 1985 flushed the system and breached a majority of the structures. They were maintained in the fall of that year using heavier rock and filter cloth to patch the undermines. At this time a dozen extra structures were built downstream of the initial ten to add storage. These lower, new structures were composed of large dense stones without extra support.

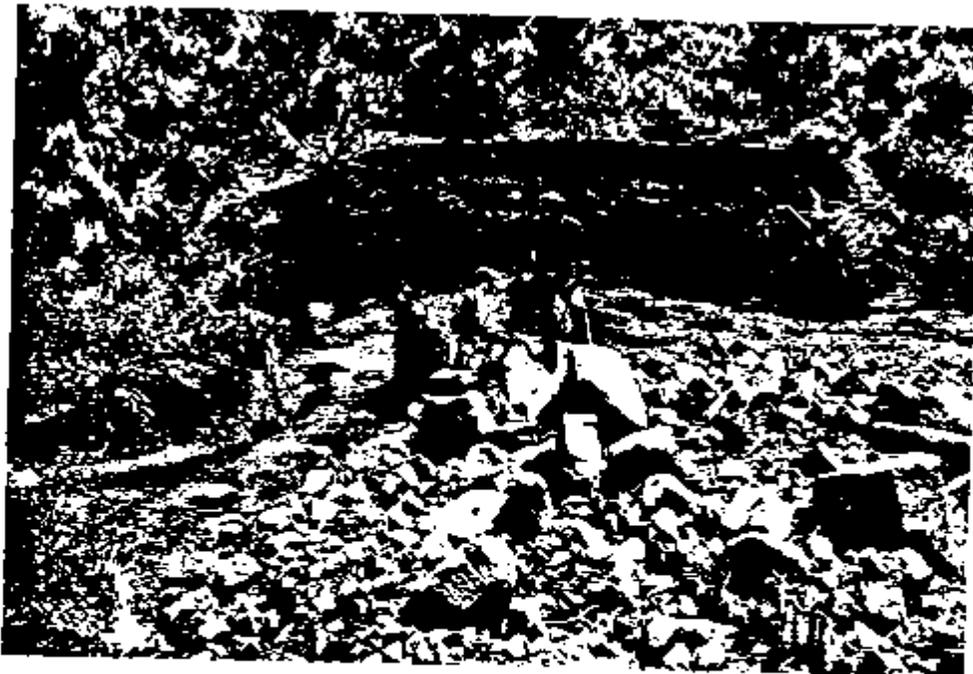
2. When maintained in "85" this structure's spillway was blocked with added rip rap. The channel found a new route and maintenance was again needed in "87".

The system has functioned well since it was maintained, retaining water and sediment throughout, plus removing significant flood potential. Although desirable water loving plants have yet to pioneer the project area, the native arid varieties are flourishing with the added moisture, adding stability to the previously unconsolidated banks. Willow cuttings will be planted throughout the project area in the spring of 1988.

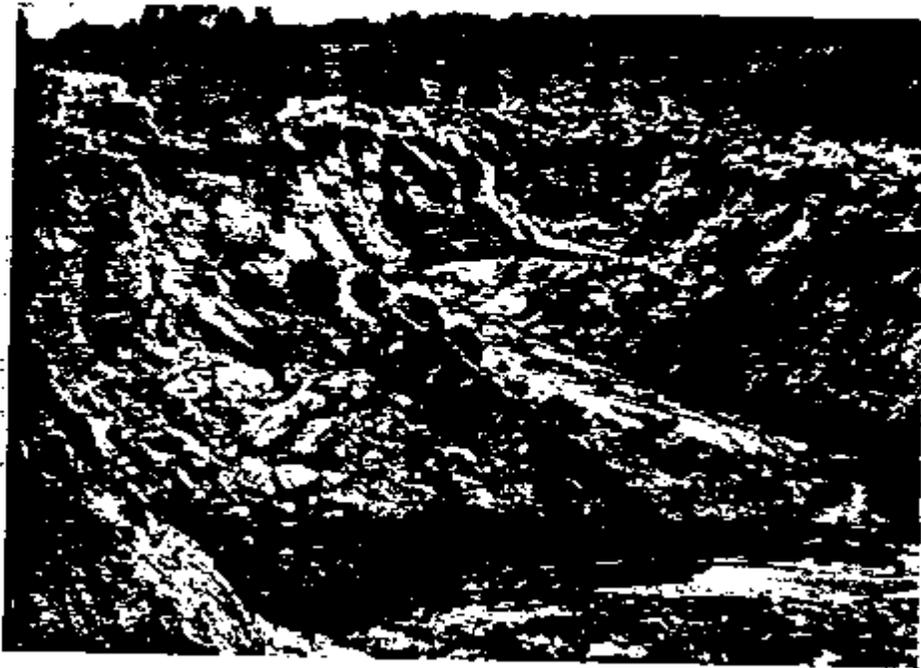
Severe erosion where the proposed remedy will be to fence off exclosures and water lanes in the gully systems while providing rest and subsoiling treatment to uplands to increase water absorption.

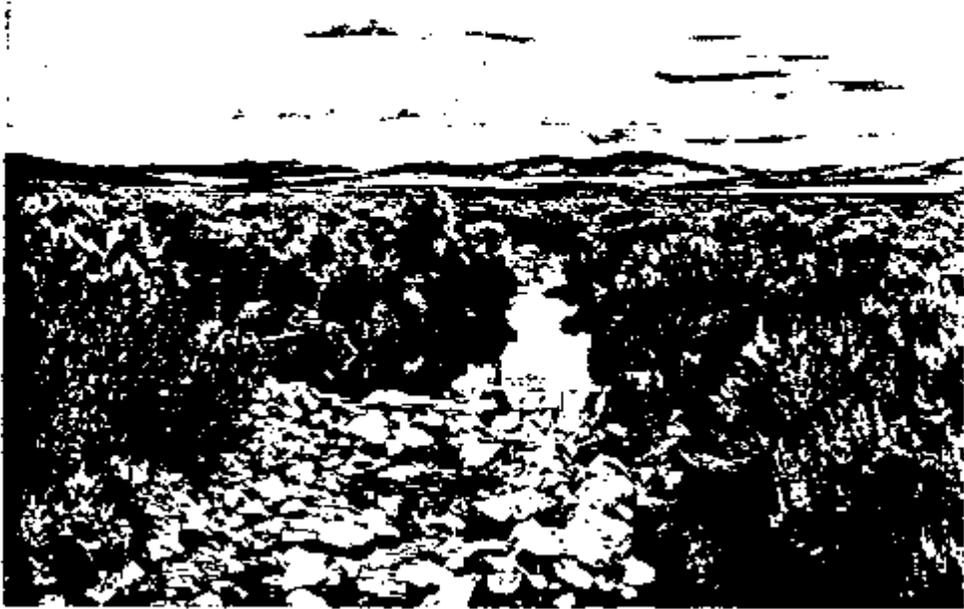
Small earthen structure built on private land below project area filled with sediment in one summer storm.

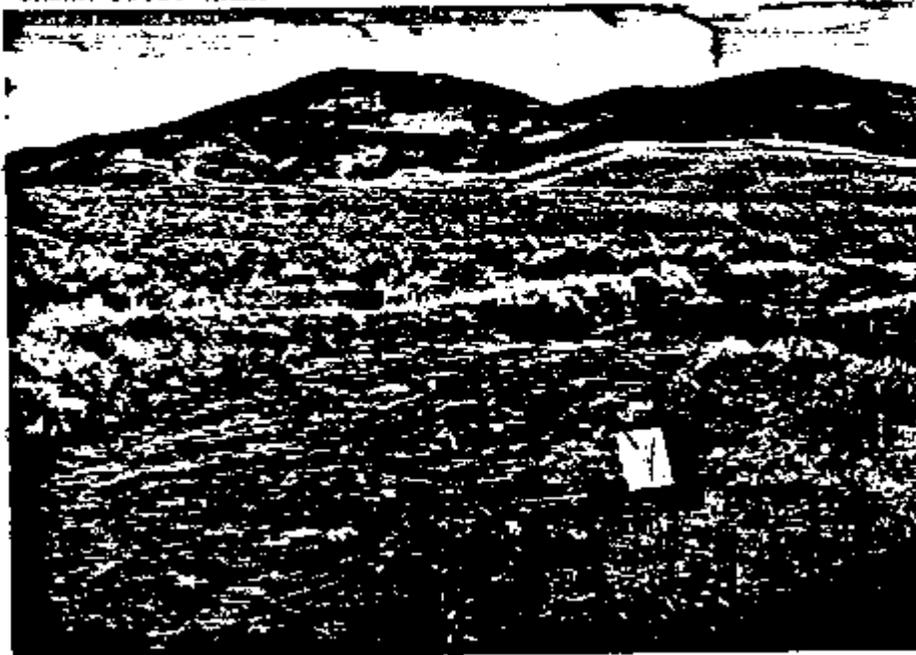
Transect, Alternatives to Fencing Study.

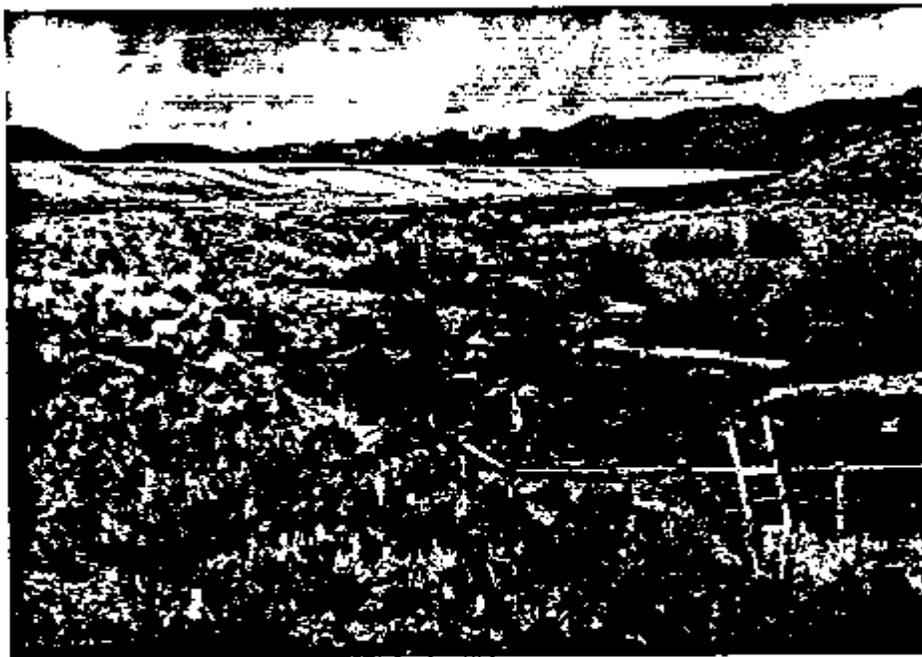
Savory(Holistic) Grazing Method Riparian Studies.

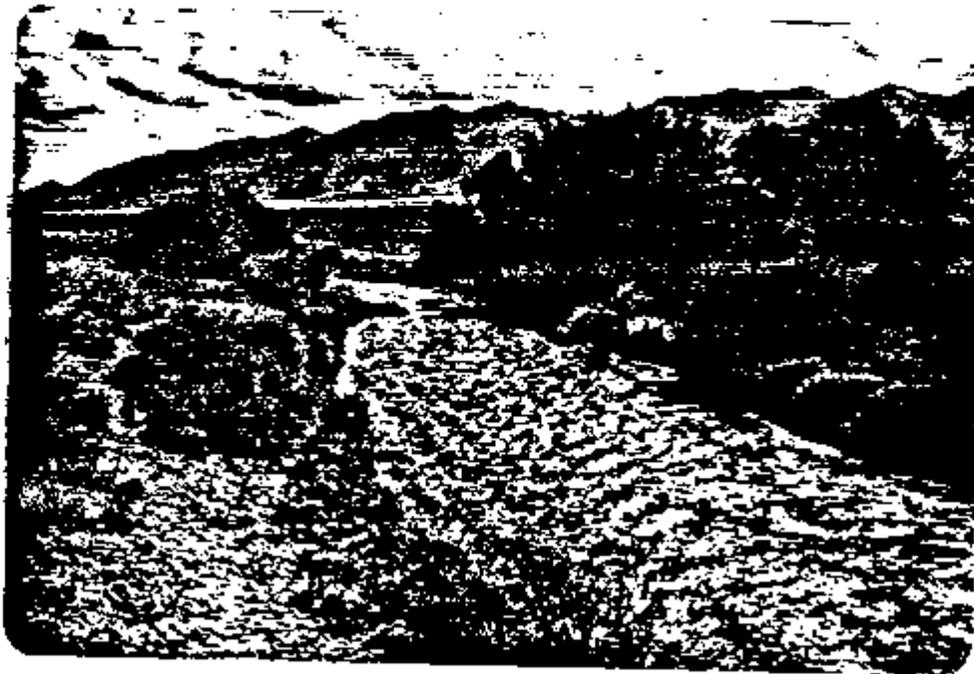
Ungrazed segment of Birch Creek.

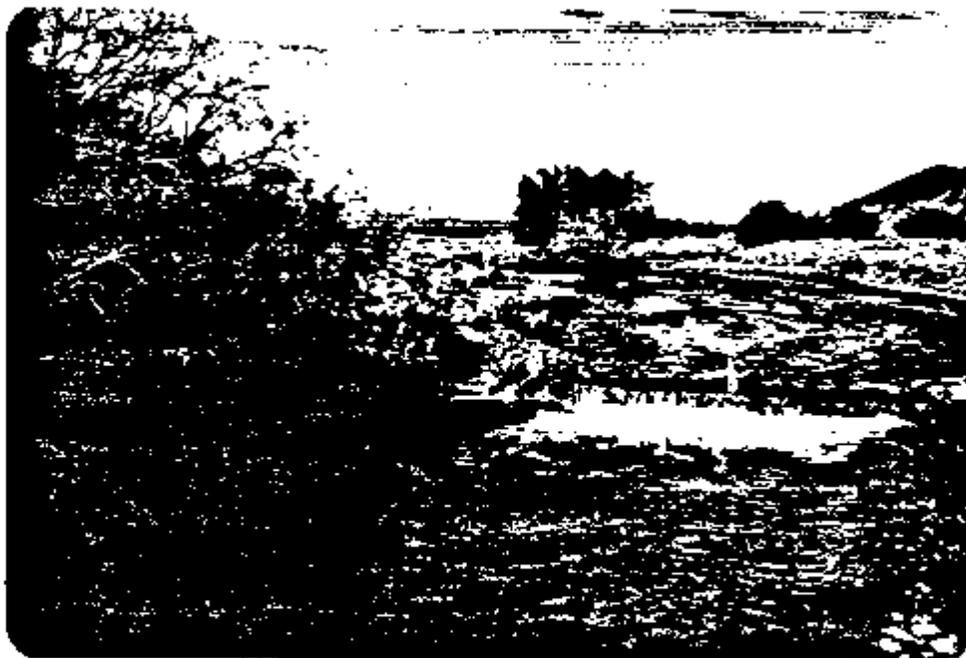
Instream structure (K dam) in Birch Creek.

of the flow being lost. A heavy recreation fishery occurs on the stream. To improve fish habitat, we have constructed a number of instream structures (gabions and K-dams) and placed large "habitat" rocks in the stream.
