**KOP 18**  
**Hwy 278 at Frasier Creek**

Figure 3.9-19

Falcon to Gonder Project EIS

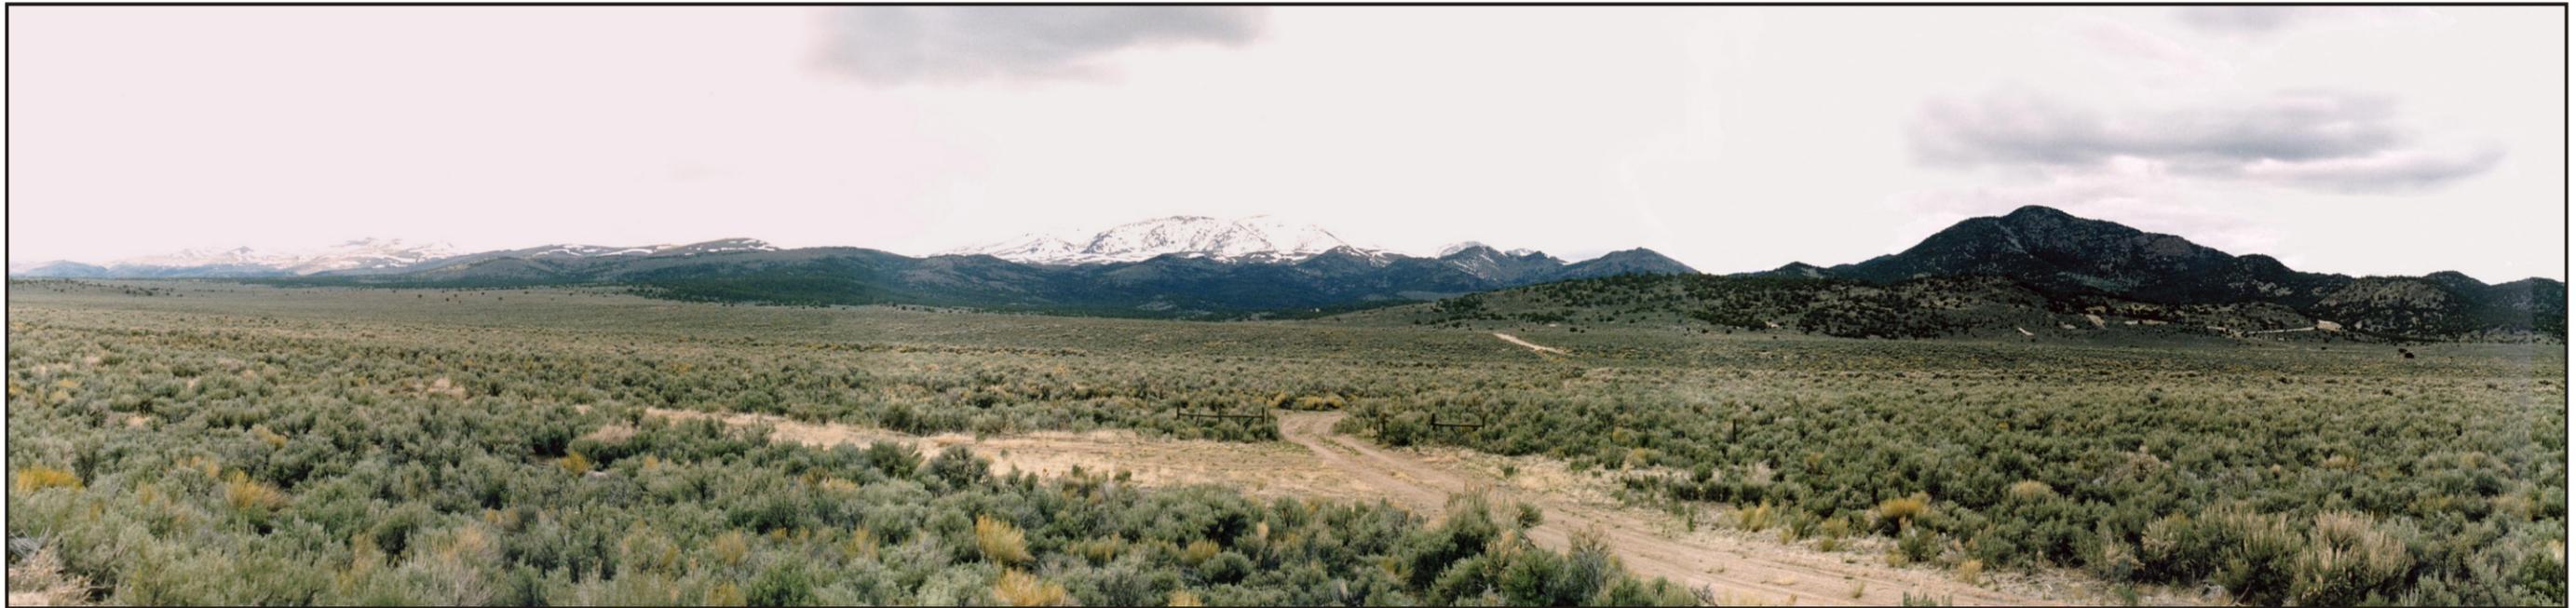
**Existing Conditions**

Type/Sensitivity of Users: Local highway travelers with a moderate concern for scenic quality  
 Volume of Users: Moderate  
 T/L Distance from Viewer: Primarily foreground (less than one-half mile) and midground views  
 T/L Prominence in Landscape: Low - seen against the near backdrop of the Roberts Mountains  
 Existing Modifications: Essentially none

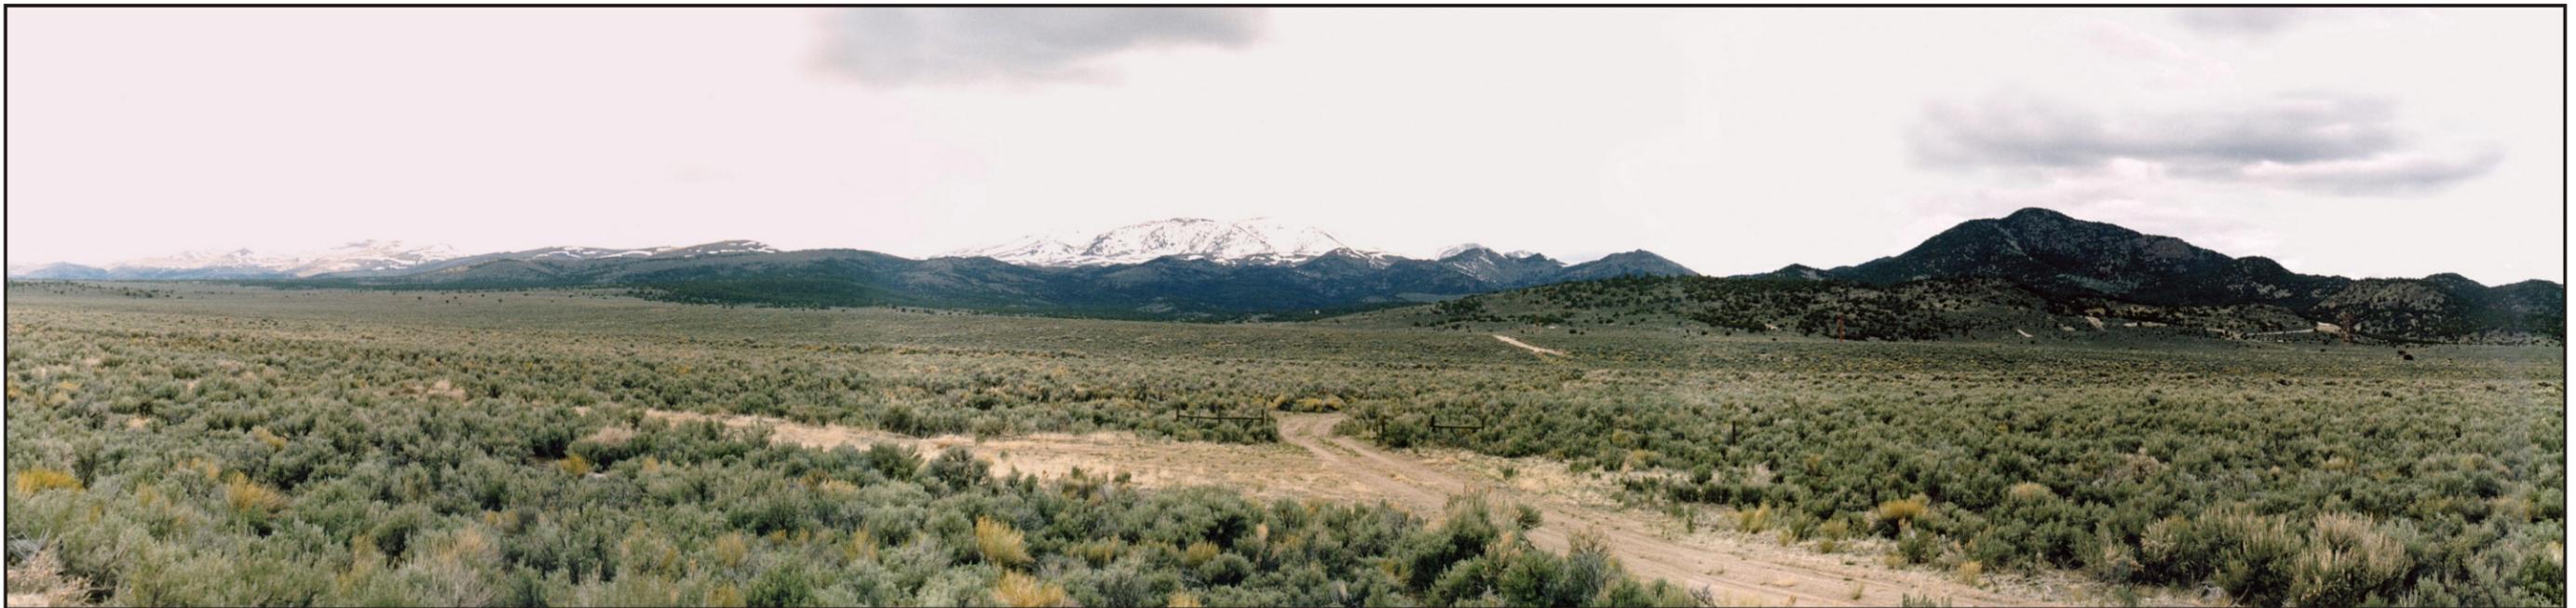
**Future Conditions**

Note: Transmission line is located against mountain backdrop and obscured by the dark background.

Contrast Rating: Moderate  
 VRM Class: IV  
 Visual Impact Rating: Low
