KOP 10
Eureka-Palisade RR Grade

Figure 3.9-11

Falcon to Gonder Project EIS

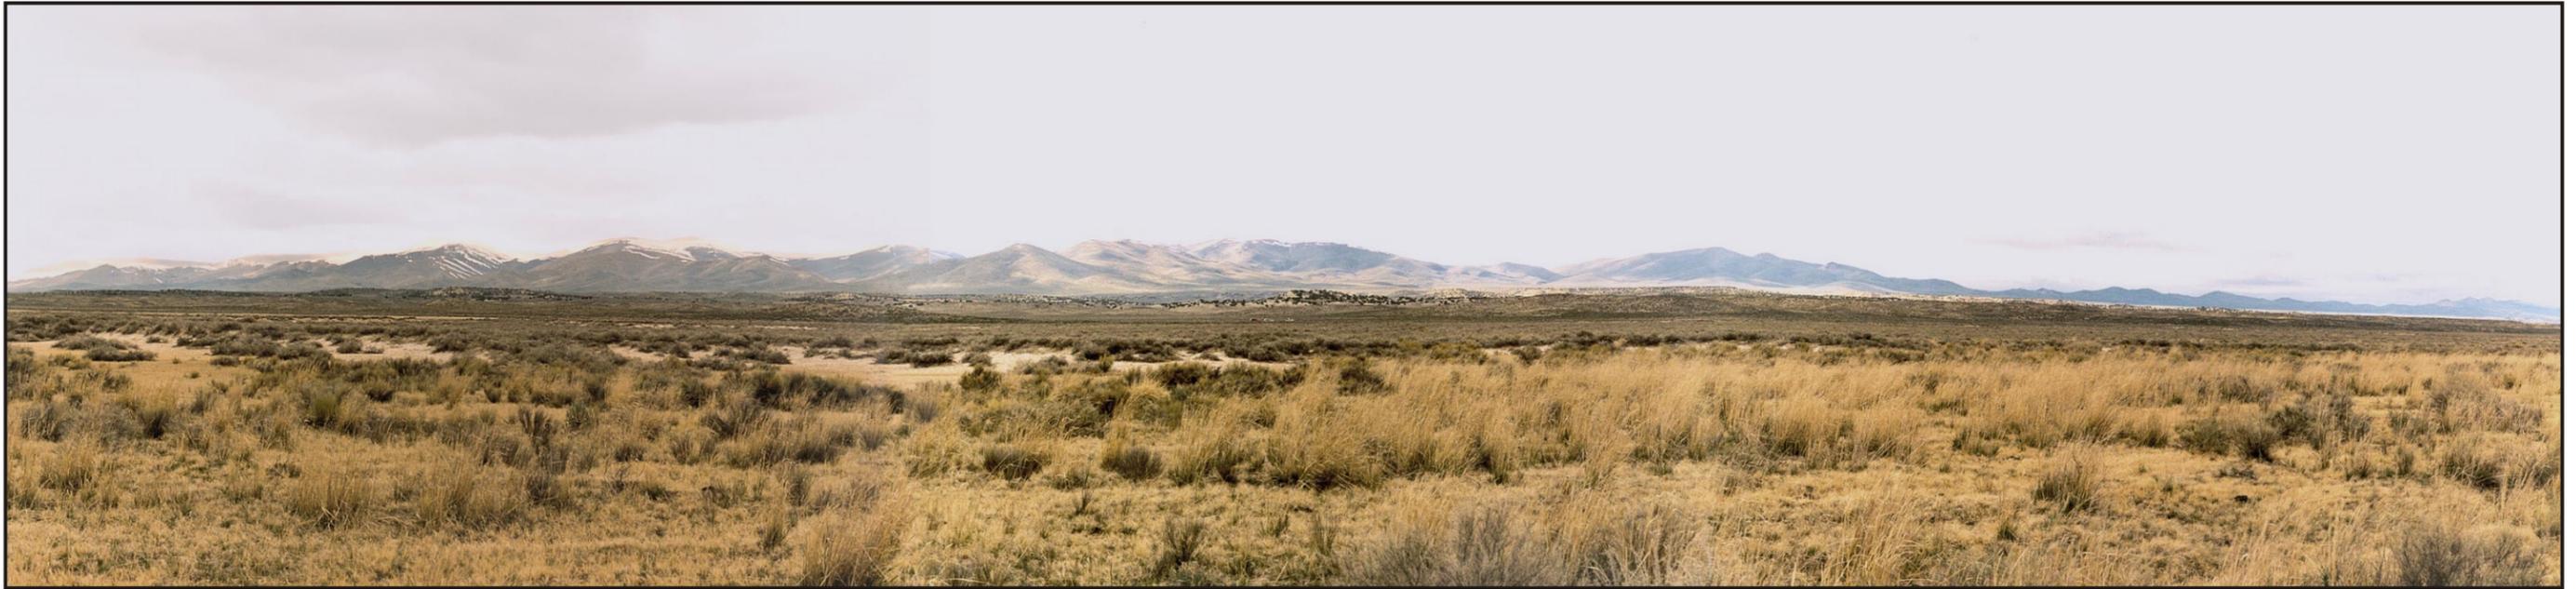
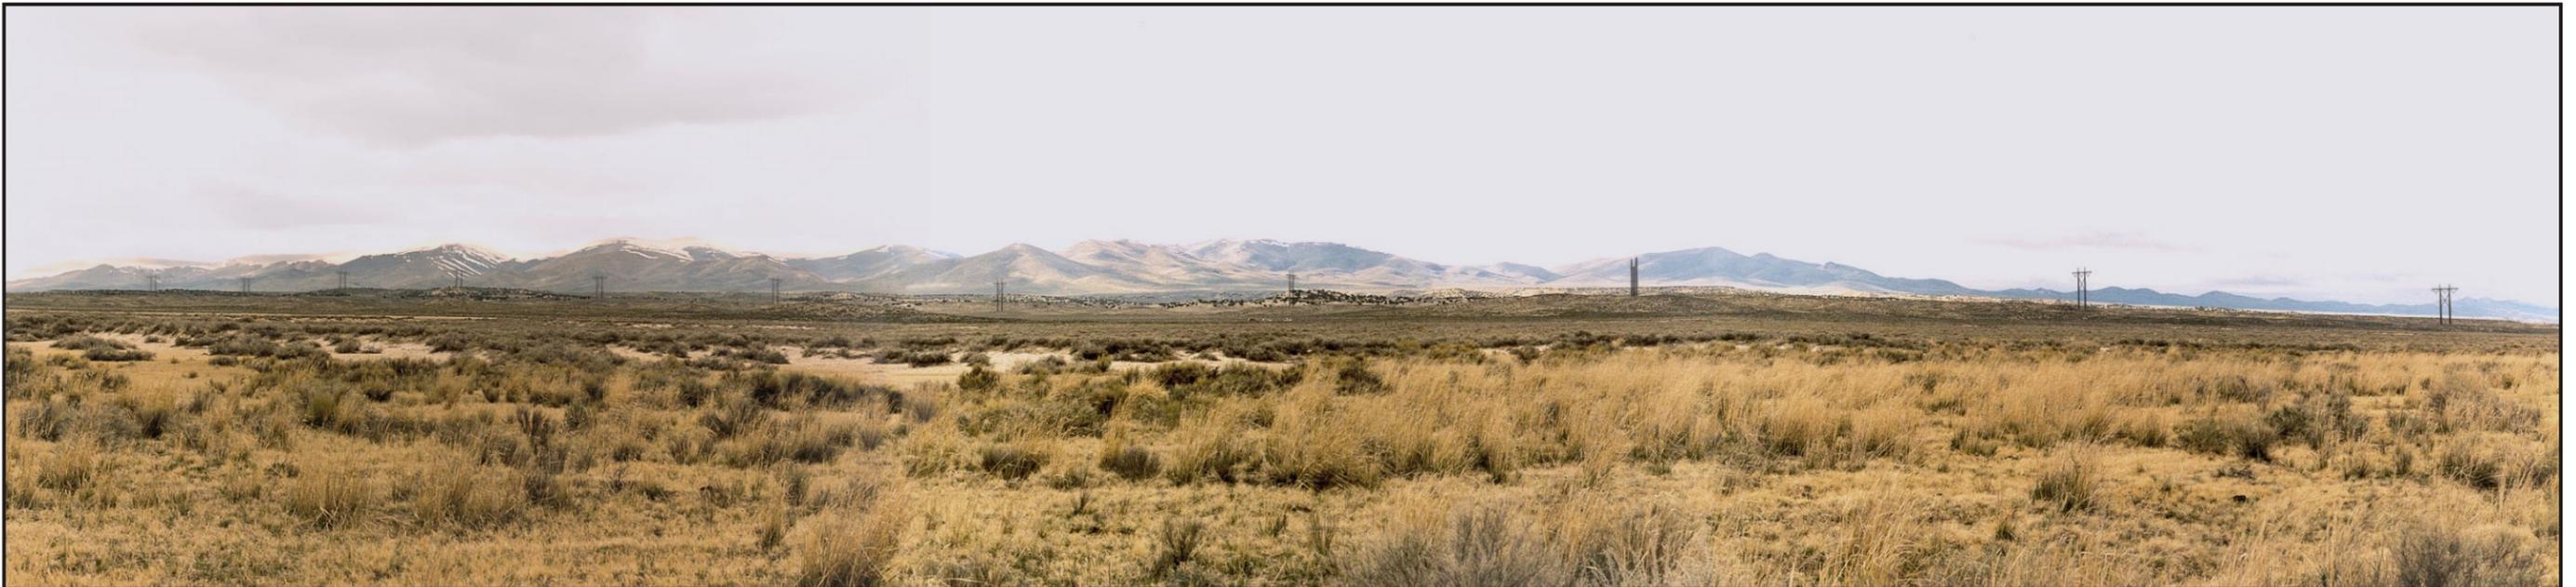
Existing Conditions

Future Conditions

Summary of Visual Changes

Type/Sensitivity of Users: Historians/history enthusiasts with a high interest in the context of the site
Volume of Users: Few
T/L Distance from Viewer: Middleground - approximately one-half mile
T/L Prominence in Landscape: Moderate - backdropped by distant mountains
Existing Modifications: Essentially none

Contrast Rating: Moderate
VRM Class: IV
Visual Impact Rating: Medium
