**KOP 26**  
**Hwy 50 Marking Corral**

Figure 3.9-27

Falcon to Gonder Project EIS

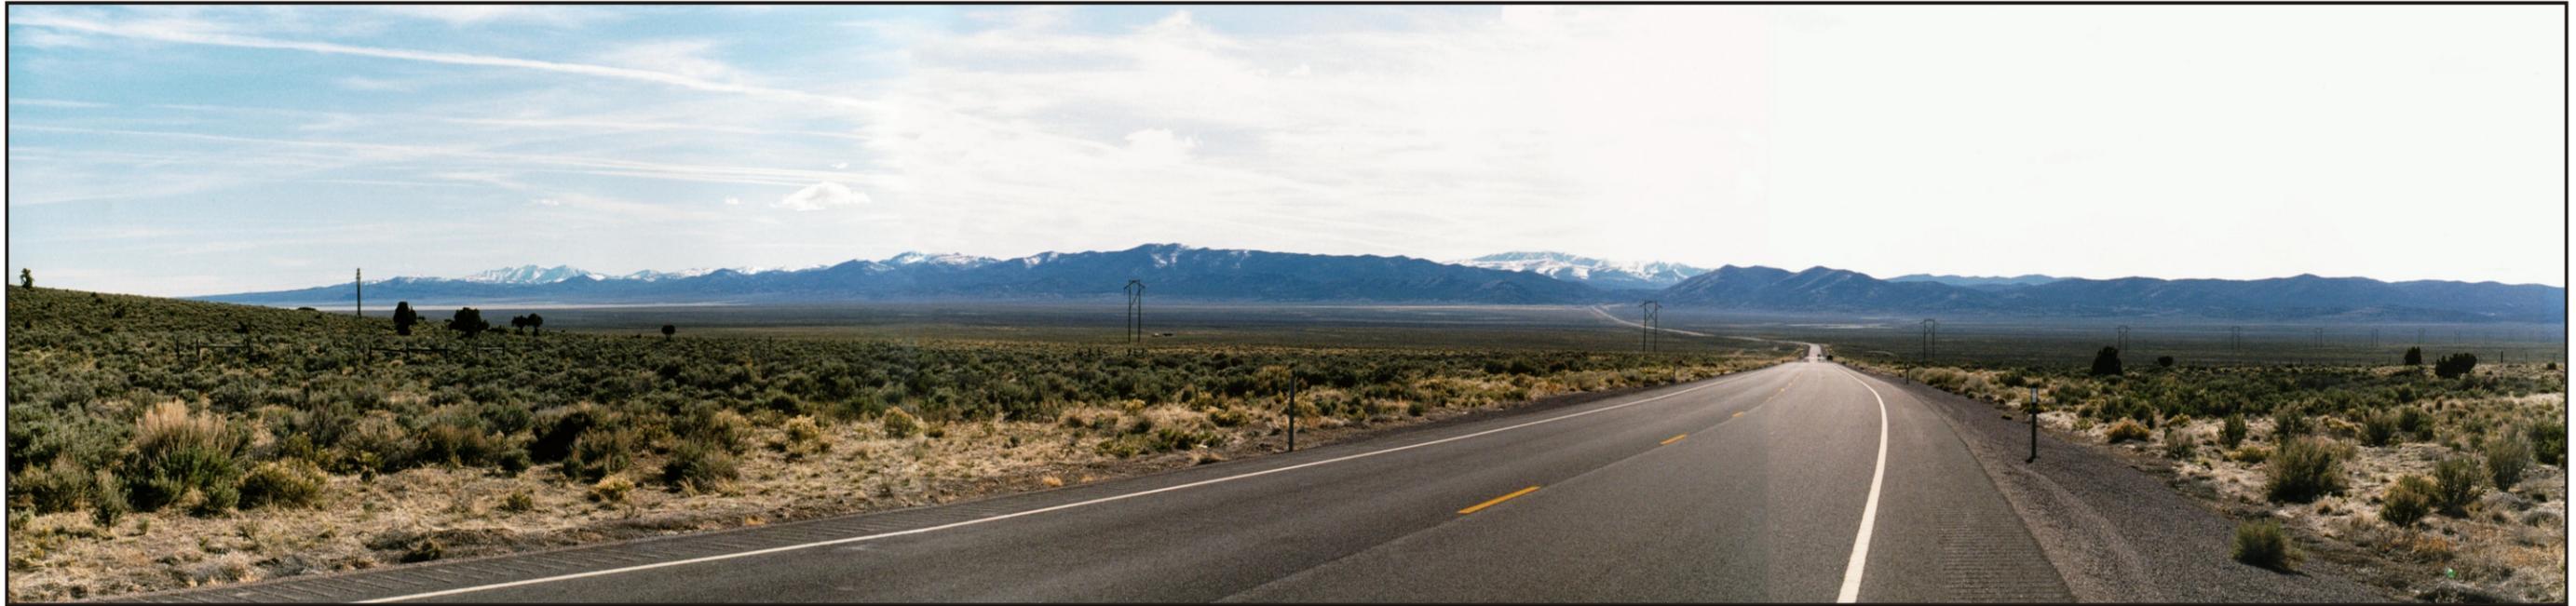
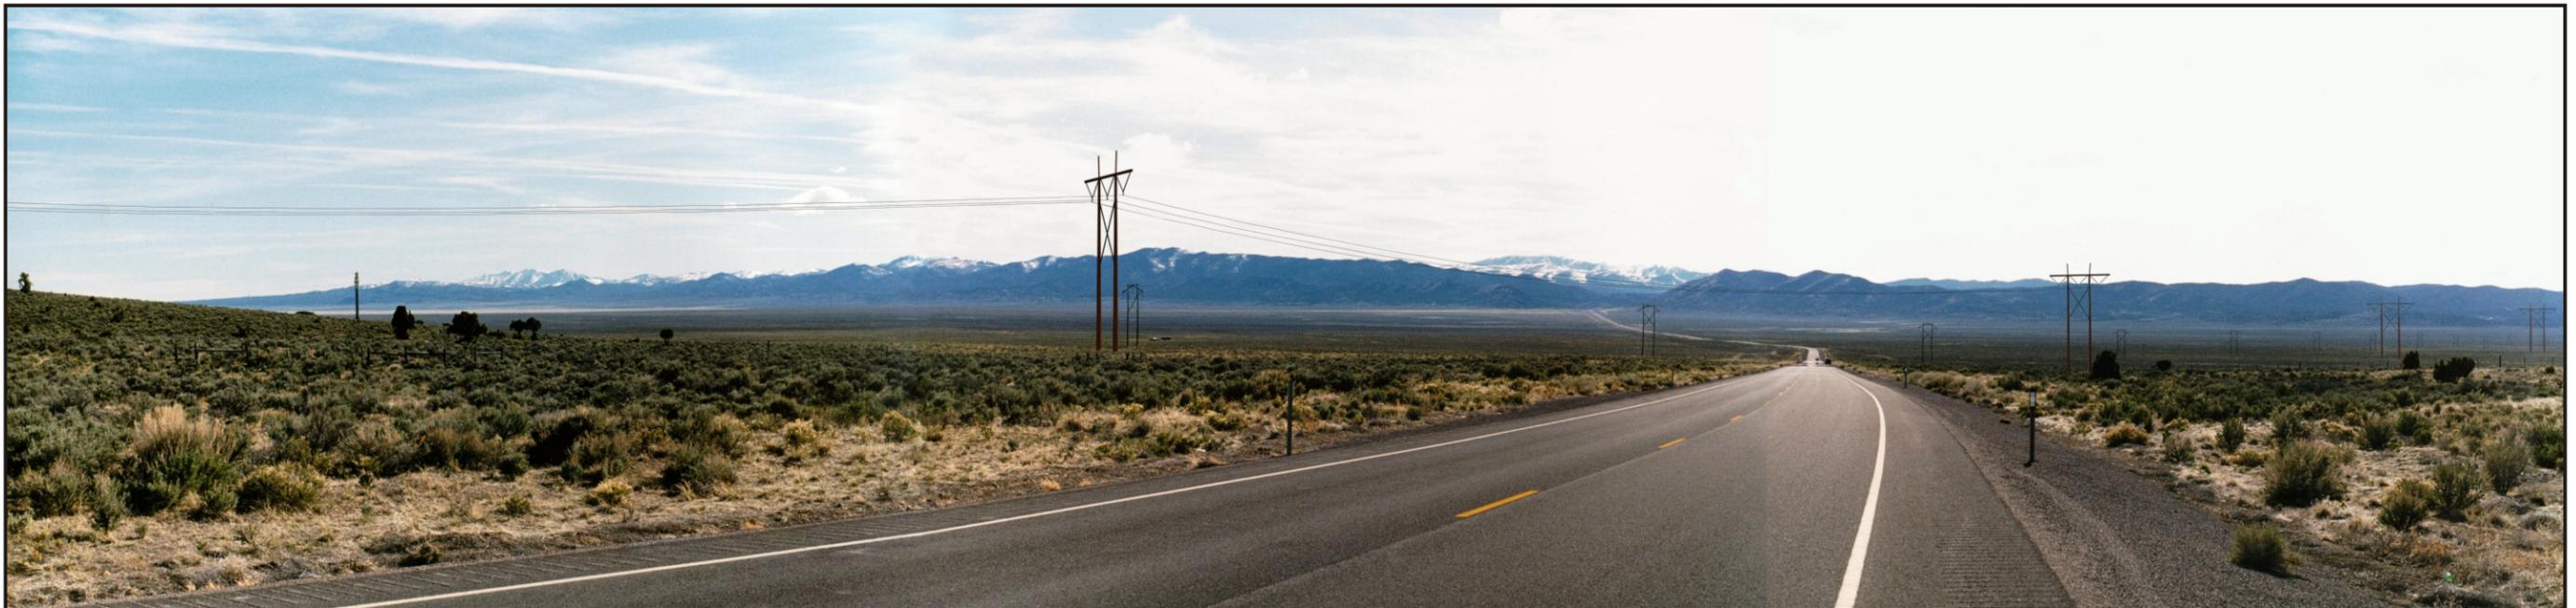
Existing Conditions

Future Conditions

Type/Sensitivity of Users: Local and long distance highway travelers with a moderate interest in the visual quality of the area  
 Volume of Users: High  
 T/L Distance from Viewer: Background to foreground crossing views  
 T/L Prominence in Landscape: Moderate - generally backdropped  
 Existing Modifications: Existing wood pole transmission line

Contrast Rating: Moderate  
 VRM Class: IV (Interim)  
 Visual Impact Rating: Low
